***INVESTIGATION OF SURFACE ENGINEERING AND MONITORING
FOR RELIABLE WIND TURBINE GEARBOXES***

A thesis submitted to
The University of Birmingham
for the degree of
DOCTOR OF PHILOSOPHY

by
JUN ZHOU

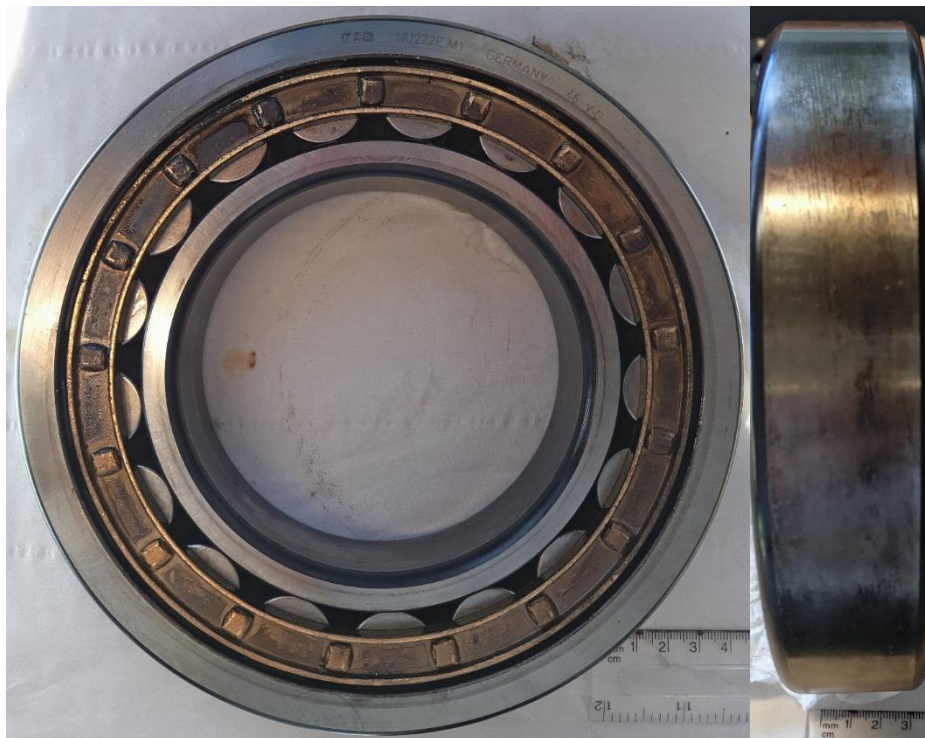
Figure 4.1.1-1 The front and side view of the whole bearing for high-speed stage

The failed high-speed shaft bearing (as shown in Figure 4.1.1-1) was used to hold the high-speed shaft of the wind turbine gearbox rotating at about 1100 r/min. The model of the failed high-speed shaft bearing considered herewith was FAG NU222E-M1; this is a cylindrical roller bearing with single row, straight bore, removable inner ring, brass cage, 110 mm inside diameter, 200 mm outside diameter and 38mm width. It is a non-locating bearing with two ribs/flanges on the outer ring, none on the inner ring, allowing outer and inner rings to be axially displaced relative to each other from the central position. Its removable inner ring allows lubrication to take place. The operational temperature range of this bearing is between -30 and +150 °C (Hong-Kong-Bearing-Company, 2017).

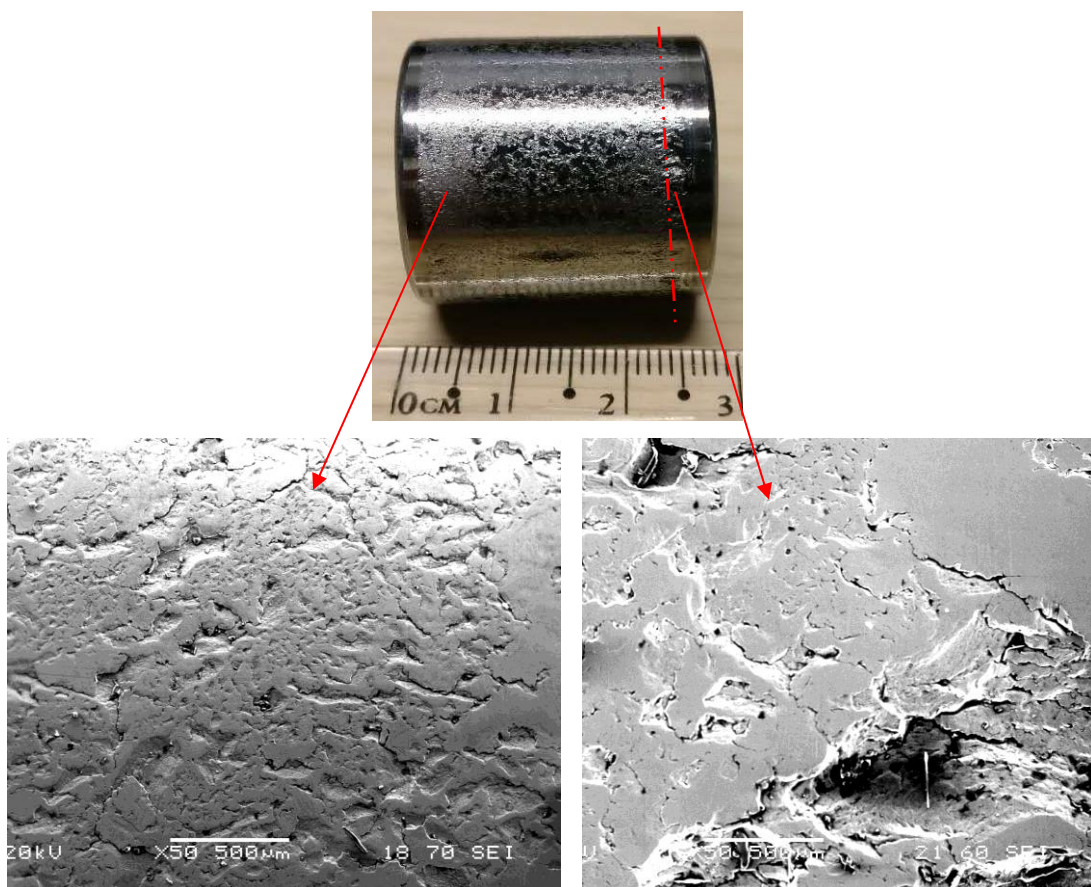
Figure 4.1.1-3 The surface of the rollers is damaged in the form of macro-pitting and micro-pitting, and the surface morphology of the left side is different to the right side.

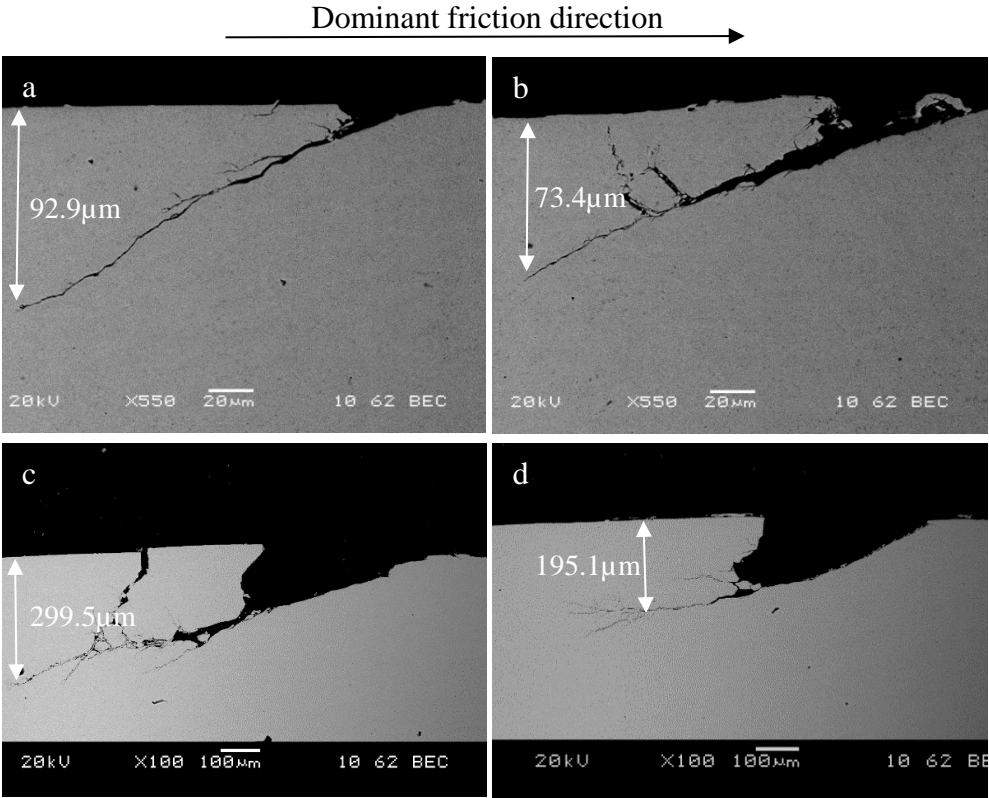
crack will branch up. someone of the branches will eventually propagate towards the surface. When a critical depth has been reached, a fragment of material will break off, leaving a micro-pit behind it (D. Nélías et al., 1999, Shuangwen Sheng, 2010).

Figure 4.1.1-6 Cross section of typical micro-/macro-pitting cracks on the roller

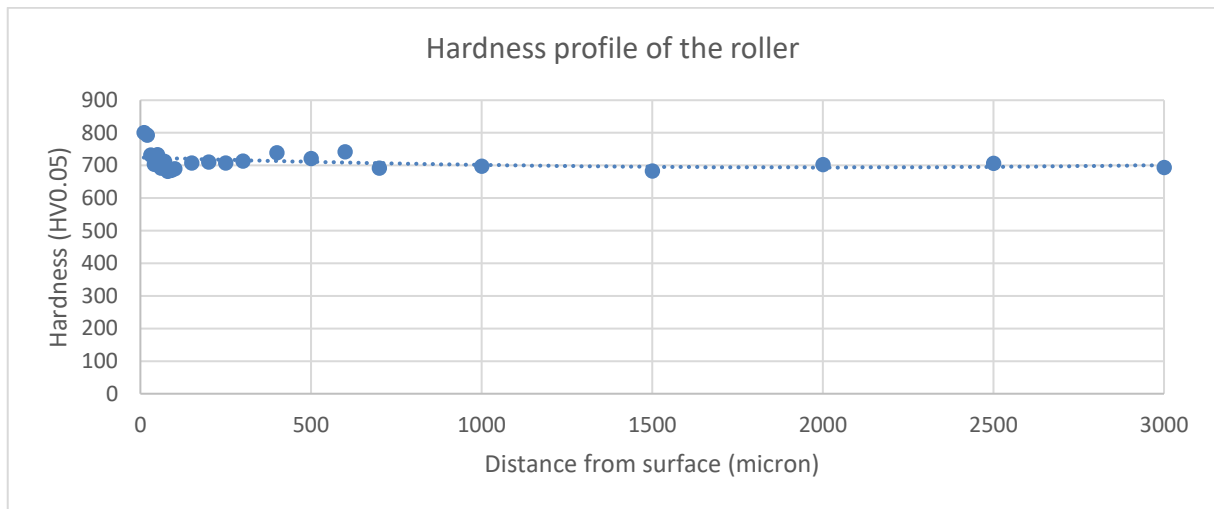
Figure 4.1.1-16 The hardness profile of the roller proving the roller was through hardened before service. The average hardness of the roller between 30 μm and 3000 μm is 706.50 ± 18.09 HV0.05

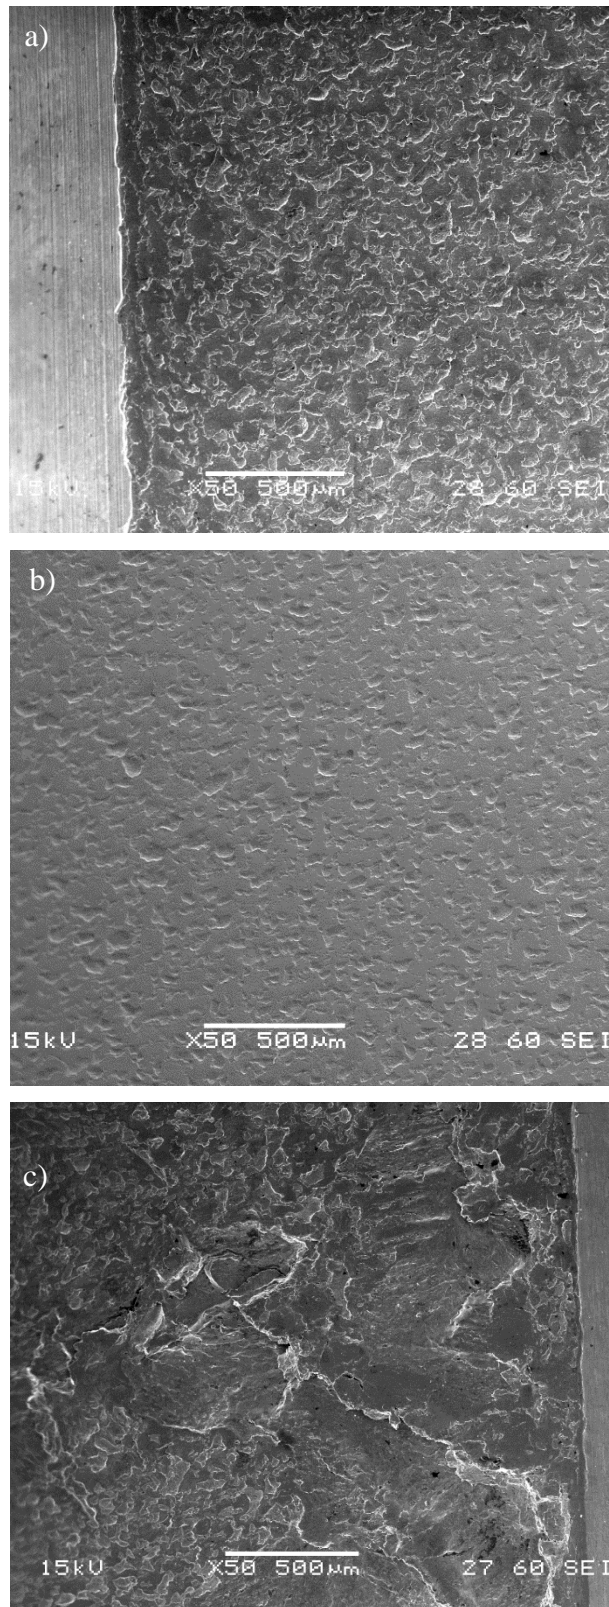
Figure 4.1.1-43 SEM images showing the surface damage of the outer ring raceway, a) micro-pitting in the left end of the raceway, b) also micro-pitting in the middle, and c) macro-pitting in the right end

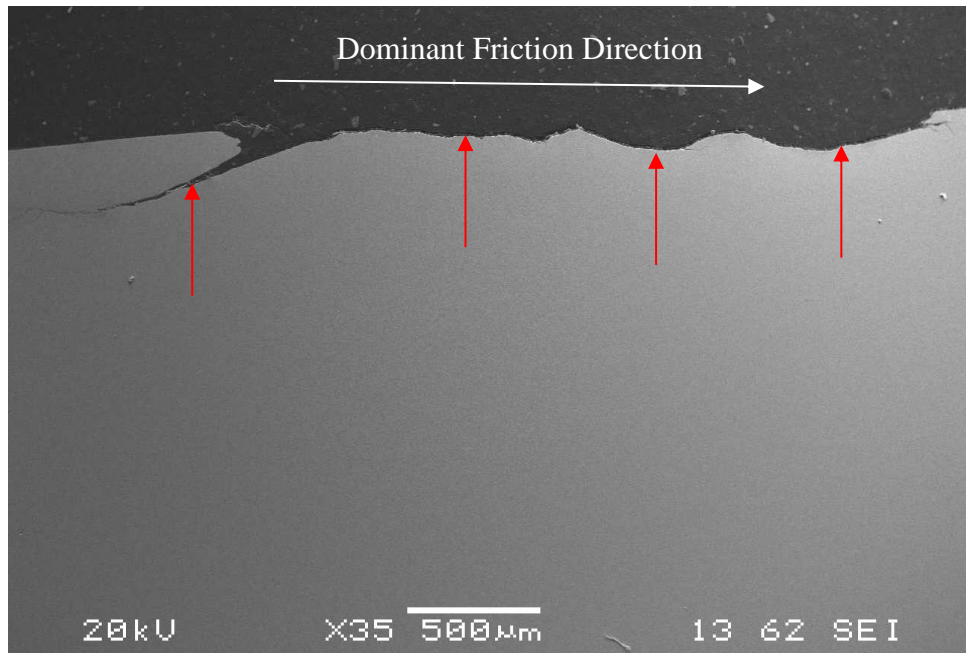
Figure 4.1.1-55 The cross section of the big crater in the roller surface, indicating it is composed of several small craters as arrowed

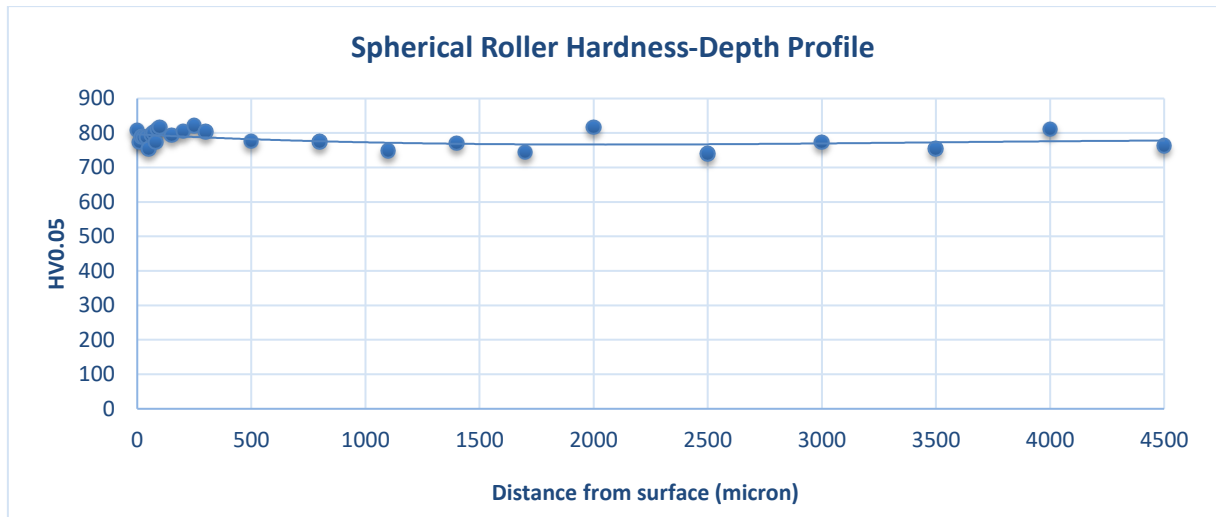
Figure 4.1.1-60 Hardness-depth profile of the spherical roller from low-speed planetary gear bearing showing the average value of 784.26 ± 23.69 HV0.05.

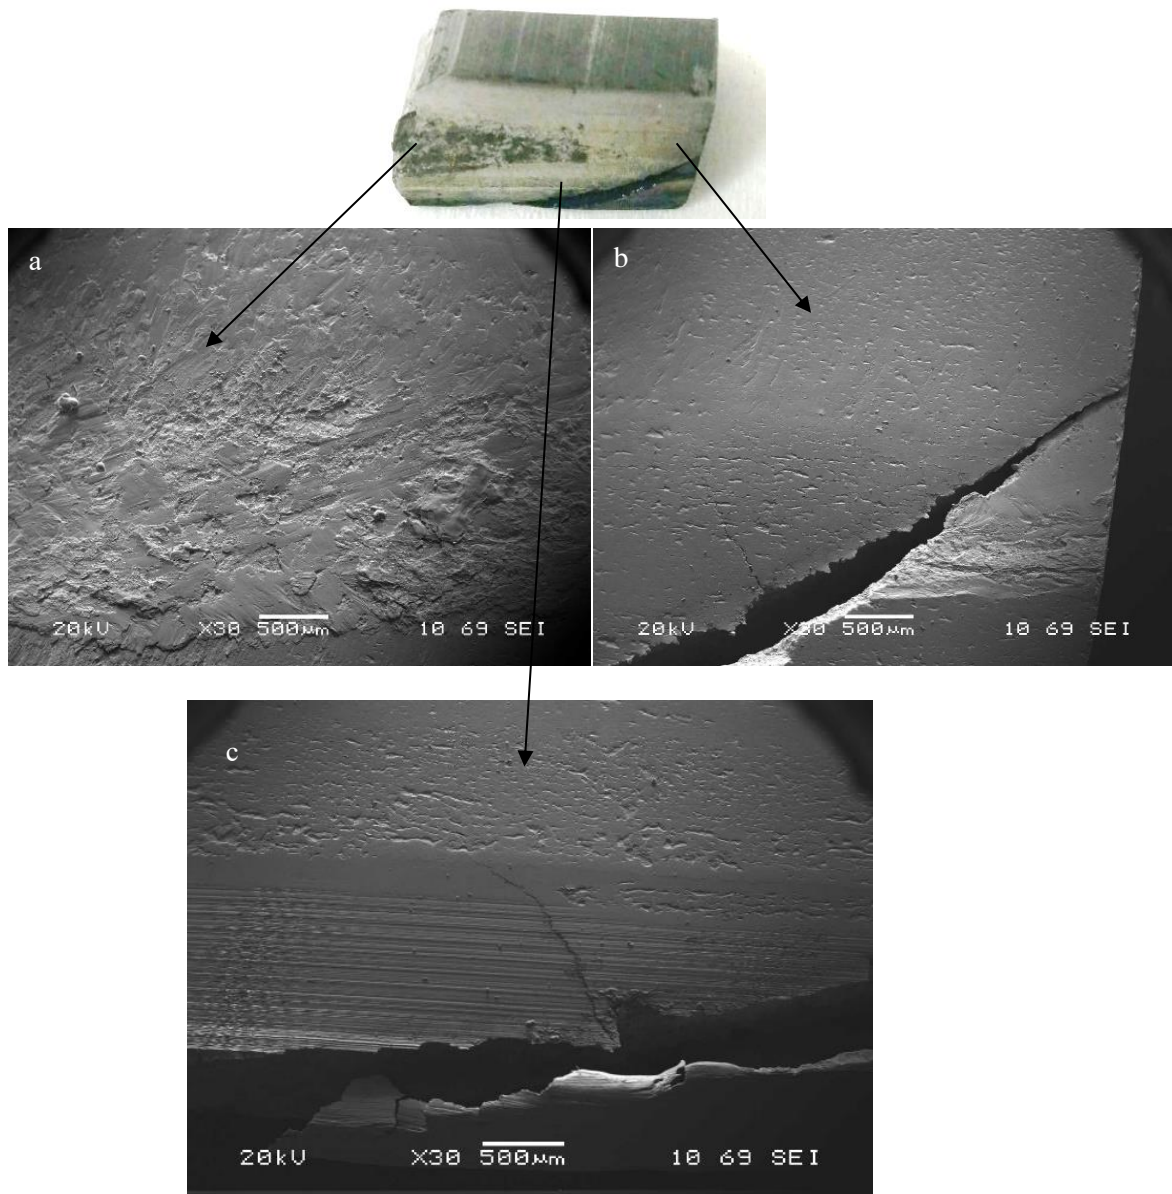
Figure 4.1.2-2 Surface morphology of the damaged contact surface of the gear tooth, showing severe scuffing, micro-pitting and cracking

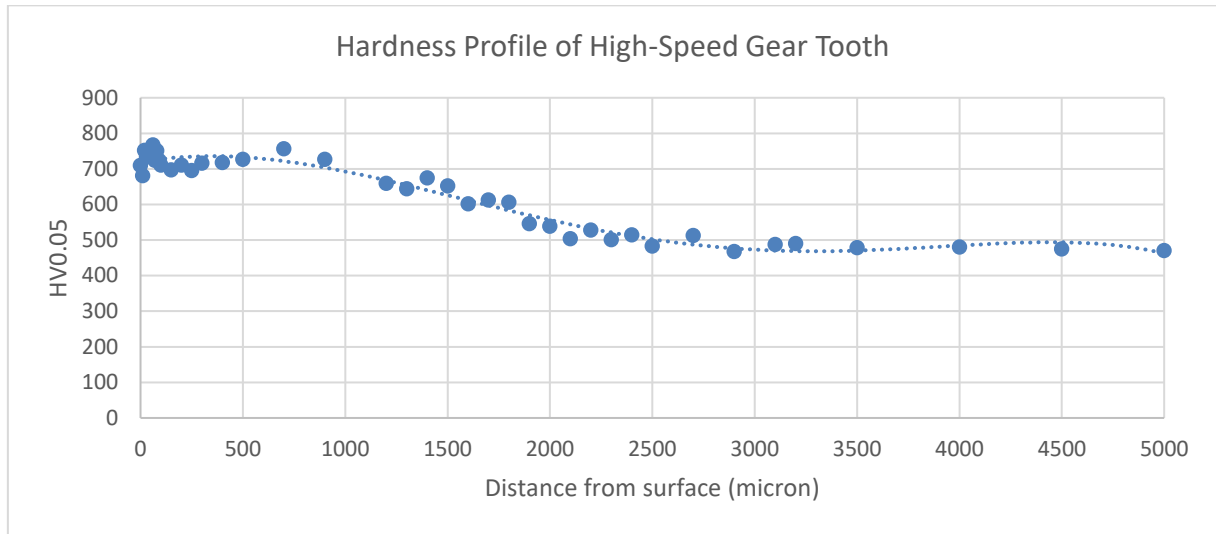
Figure 4.1.2-3 Hardness-depth profile of the gear tooth from high-speed stage showing the superficial hardness of the gear tooth is around 750 HV0.05, and the core hardness value is around 490 HV0.05.

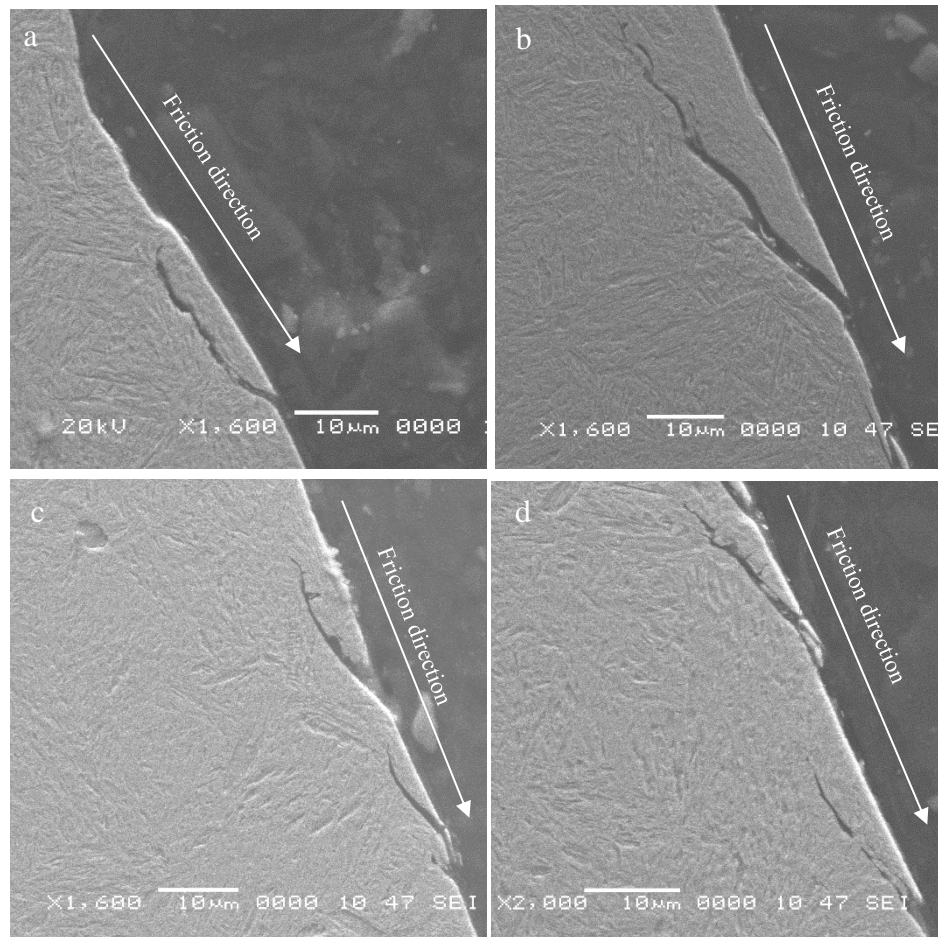
Figure 4.1.2-6 Cross section of the micro-pitting cracks in the high-speed gear tooth

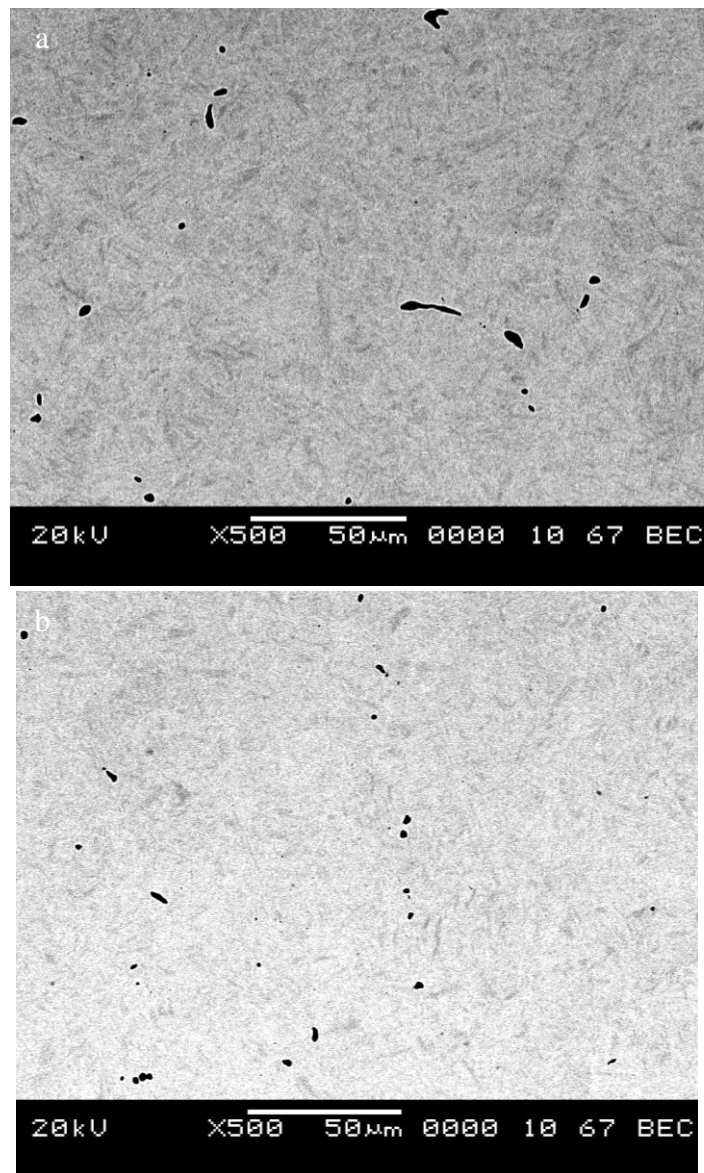
Figure 4.1.2-13 Back-scattered-electron images of the gear tooth cross-section, showing the material containing large amount of coarse MnS inclusions

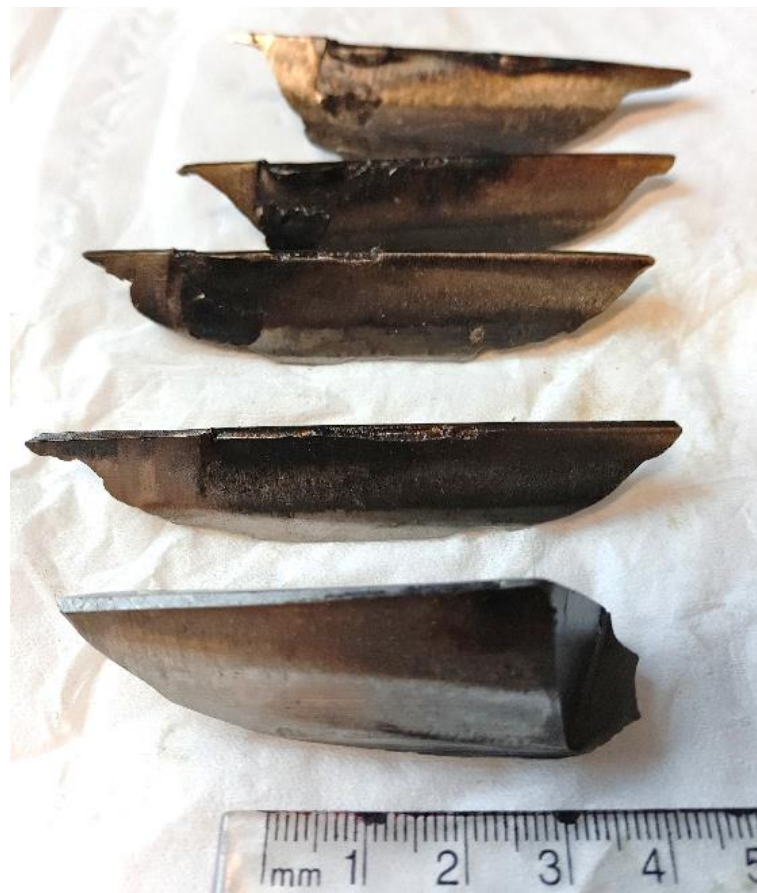
Figure 4.1.2-14 Five broken gear teeth from intermediate stage

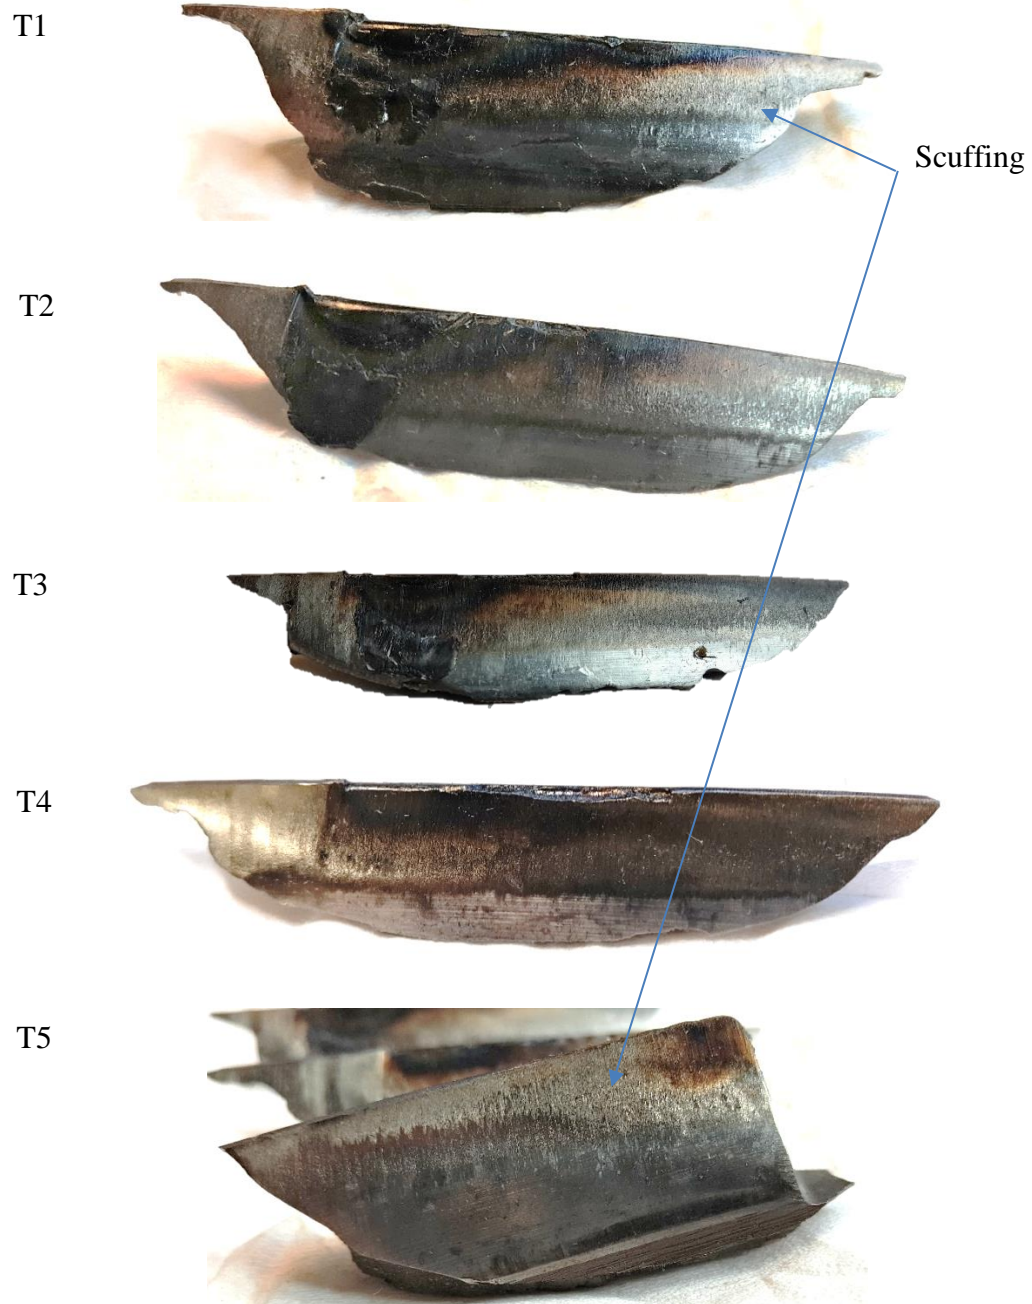
Figure 4.1.2-15 Discolouration and scuffing can be seen on all the teeth surface, and the tips of teeth T1-T4 are all deformed/broken.

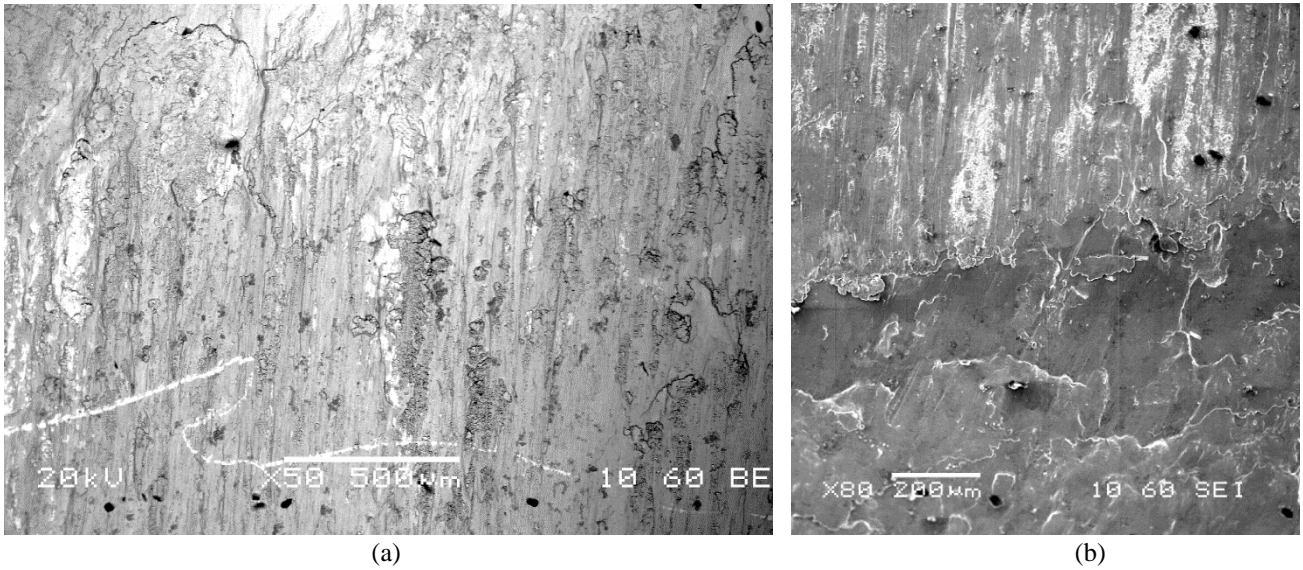
Figure 4.1.2-16 The tooth surface is scuffed, cracked and plastically deformed

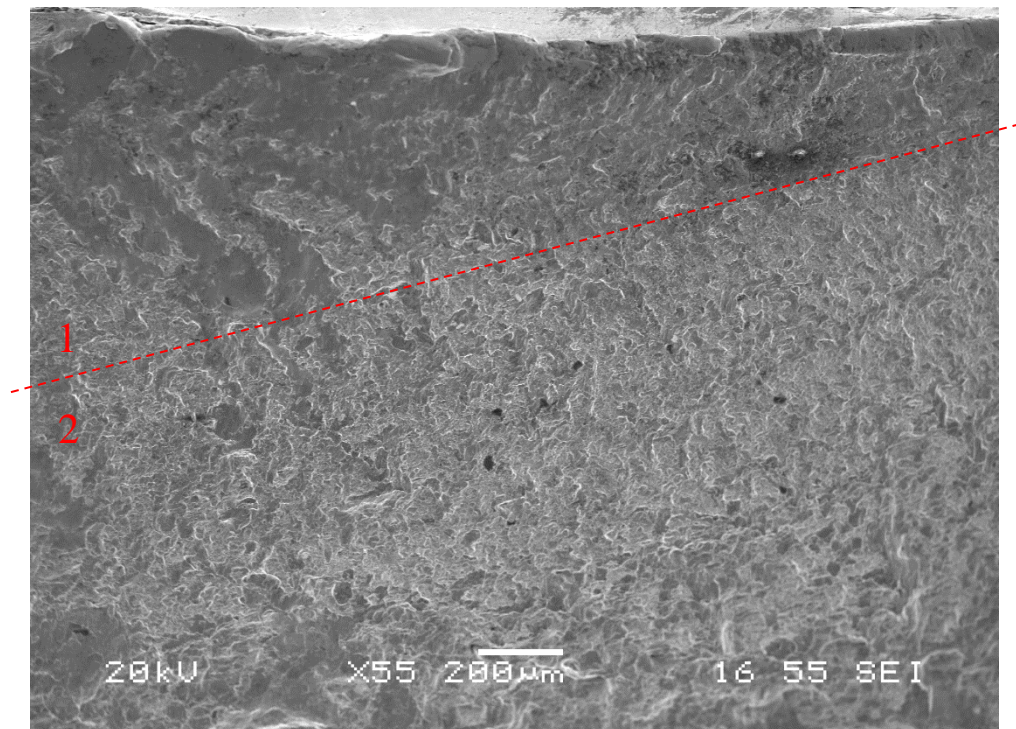
Figure 4.1.2-17 The SEM image of the fracture surface of the broken gear tooth

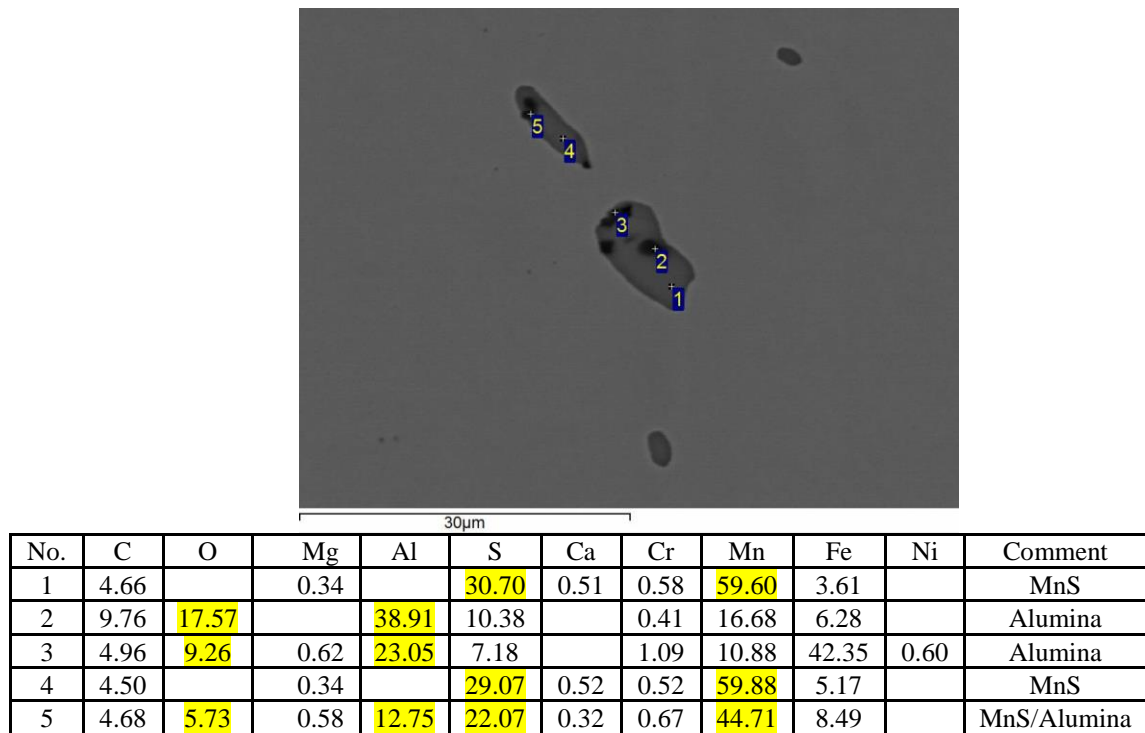
Figure 4.1.2-21 Alumina inclusions surrounded by MnS in gear material (all results in weight%)

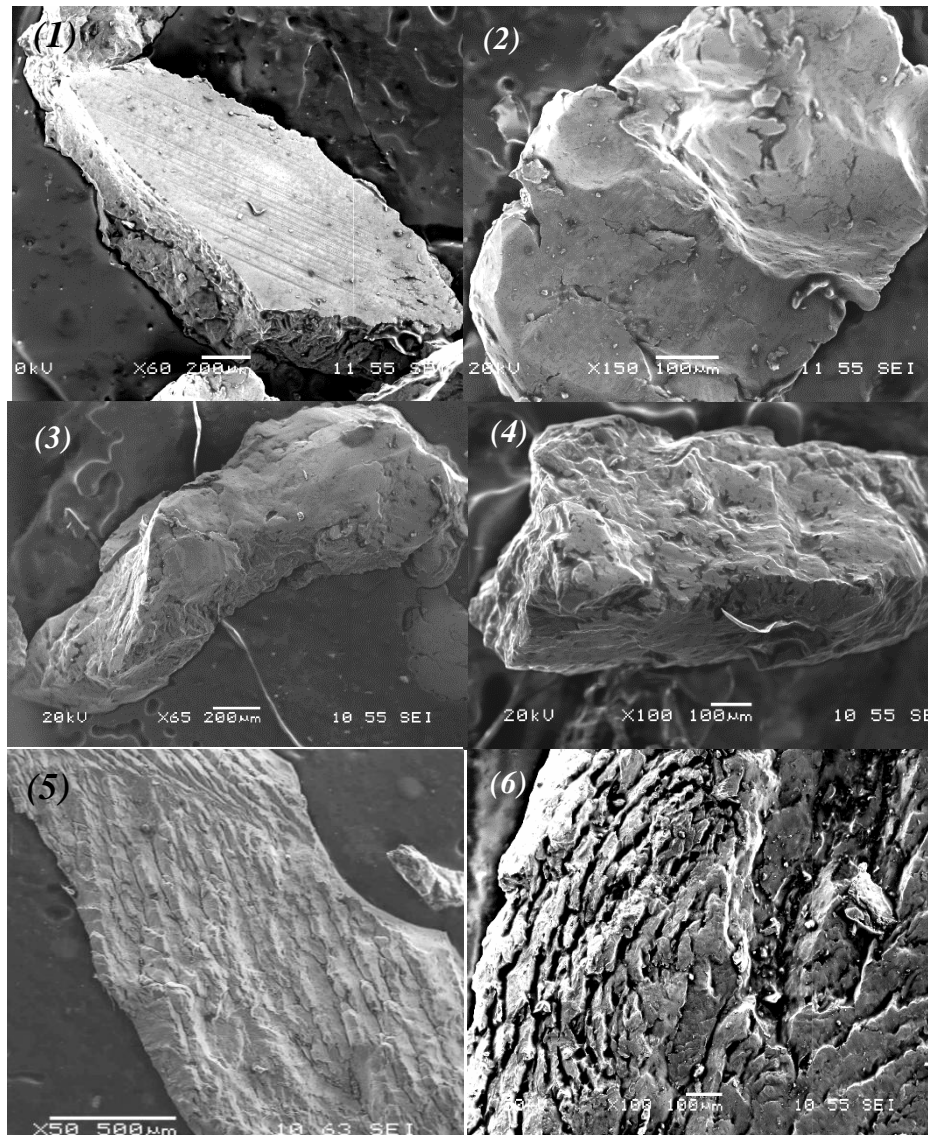
Figure 4.1.2-23 SEM images of debris in various shape and with different morphology from the planetary stage
