**A HOLISTIC APPROACH TO REMOTE
CONDITION MONITORING FOR THE
ACCURATE EVALUATION OF RAILWAY
INFRASTRUCTURE AND ROLLING STOCK**

A thesis submitted to
The University of Birmingham
for the degree of
DOCTOR OF PHILOSOPHY

School of Metallurgy and Materials
College of Engineering and Physical Sciences
University of Birmingham
September 2019

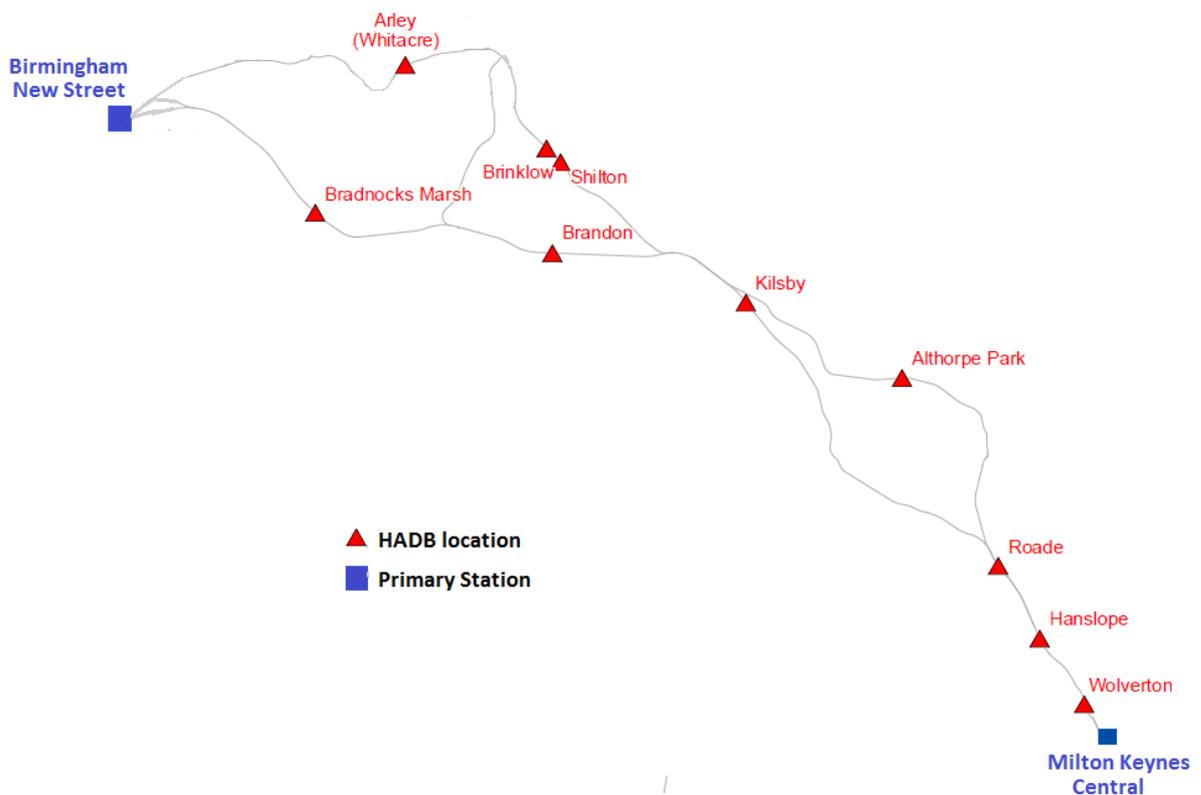
Figure 1: Map showing the sites between Birmingham New Street and Milton Keynes on the UK Rail Network instrumented with existing Hot Axle Box Detector (HABD) RCM systems (courtesy of Nick Pinder, Network Rail)

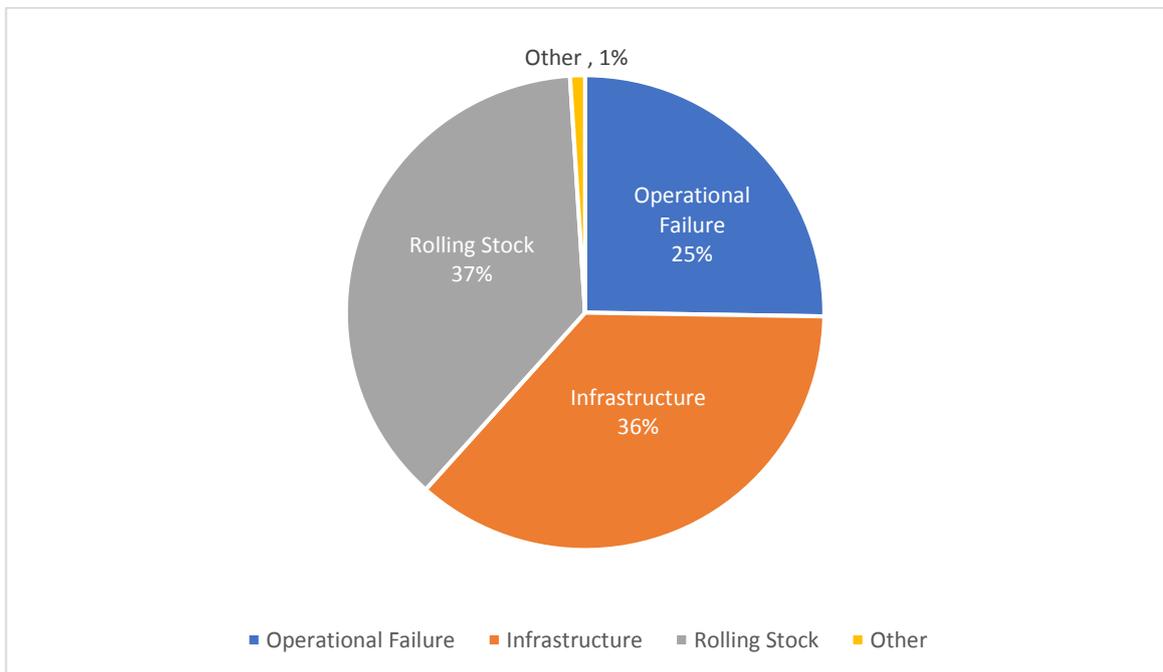
Figure 3: Railway accidents considered in D-RAIL FP7 project classified based on their root cause [14].

A research study carried out in 2011 as part of the European D-RAIL FP7 project by Det Norske Veritas (DNV later merged with Germanischer Lloyd to become DNV-GL) considered railway accidents that had been reported in 23 countries over recent years. It was revealed that out of the 700 accidents considered, 37% had been the result of rolling stock faults Figure 3 [14]. Moreover, 84% of all rolling stock-related accidents were attributed to wheelset and bogie-related defects as shown in Figure 4.

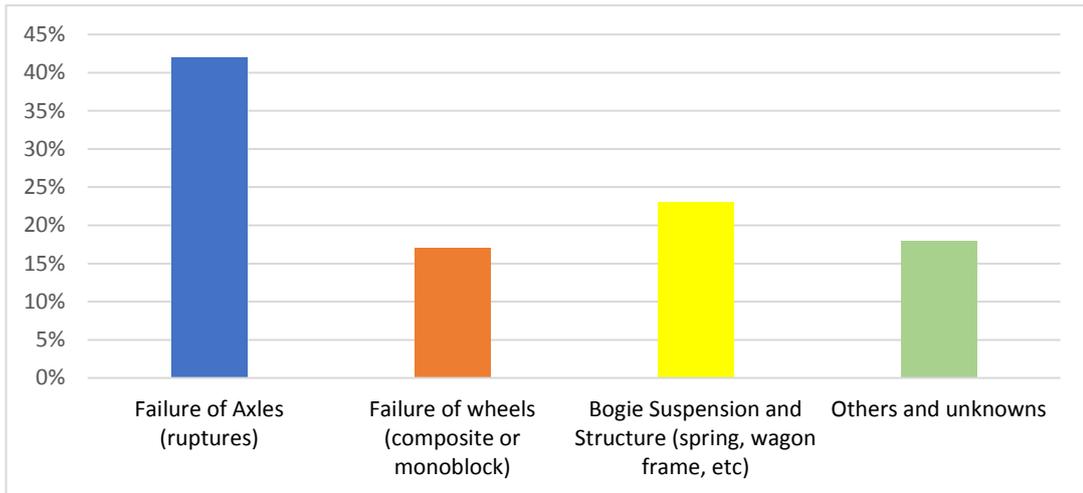
Figure 4: Rolling stock related accidents classified by root cause [14].

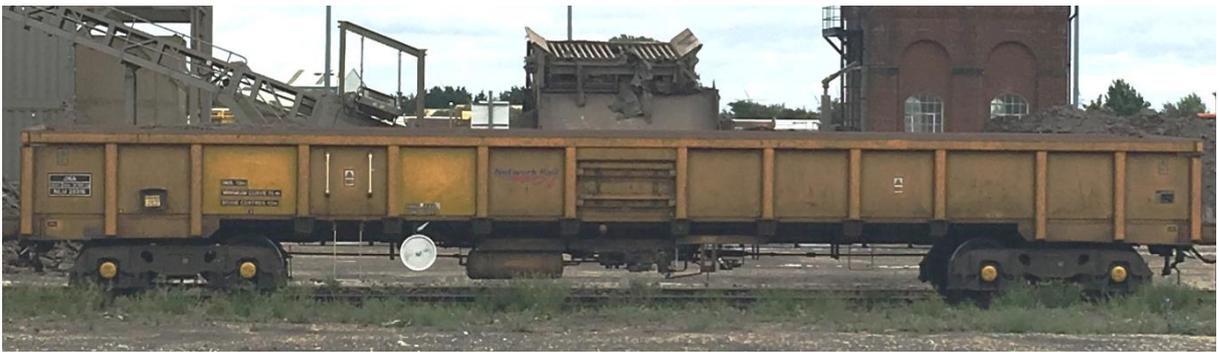
Figure 5: Photograph of a Falcon Wagon

There are numerous different types of locomotives, carriages and wagons cleared for use on the UK rail infrastructure and the majority of major railway networks across the world. The rolling stock used on the UK rail network has a variety of uses for both passenger and freight carriage services. A typical example of freight rolling stock is shown in Figure 5. This is a Falcon wagon that weighs 26 tonnes, has a maximum capacity of 60 tonnes and is approximately 17 metres long and can travel at speeds up to 100 km/h. Other types of passenger and freight rolling stock are shown in the photographs listed in Figure 6.

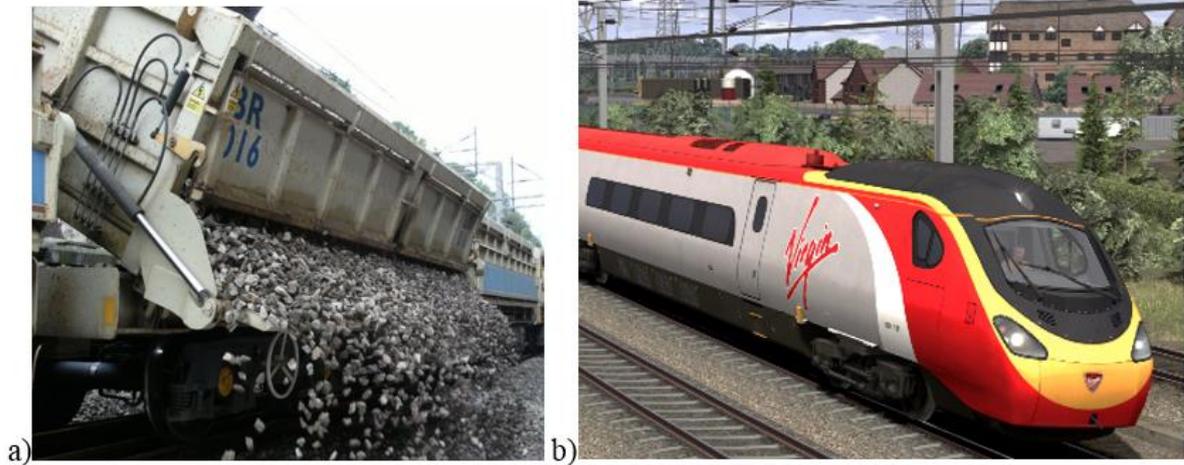
Figure 6: a) Ballast side tipper wagon and b) Virgin BR Class 390 'Pendolino' EMU

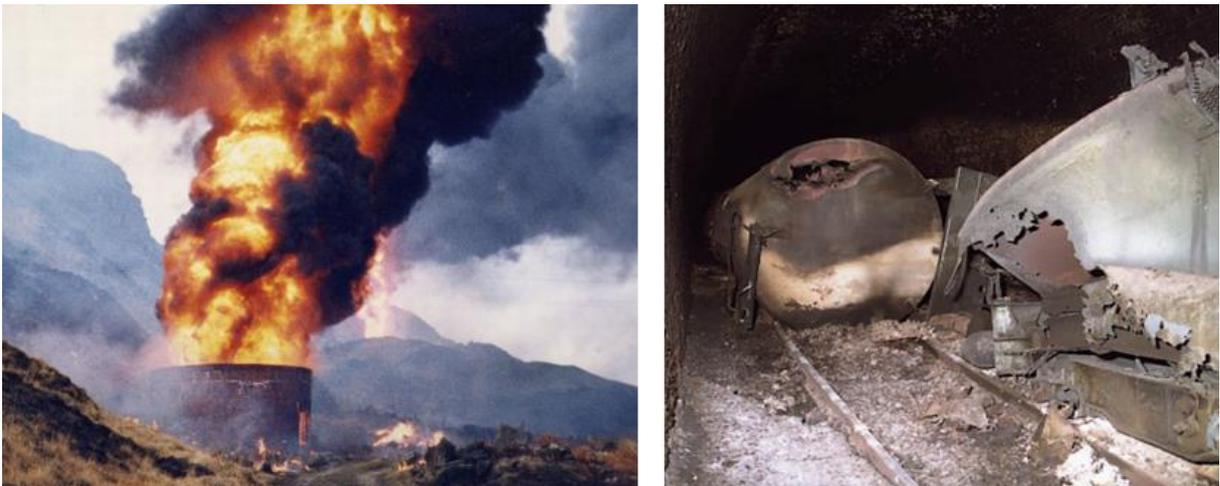
Figure 7: The Summit Tunnel accident and subsequent fire caused by the derailment of a train carrying fuel. The derailment was initiated by a faulty axle bearing that led to the rupture of the axle while the train was moving through the tunnel derailing the train [28].

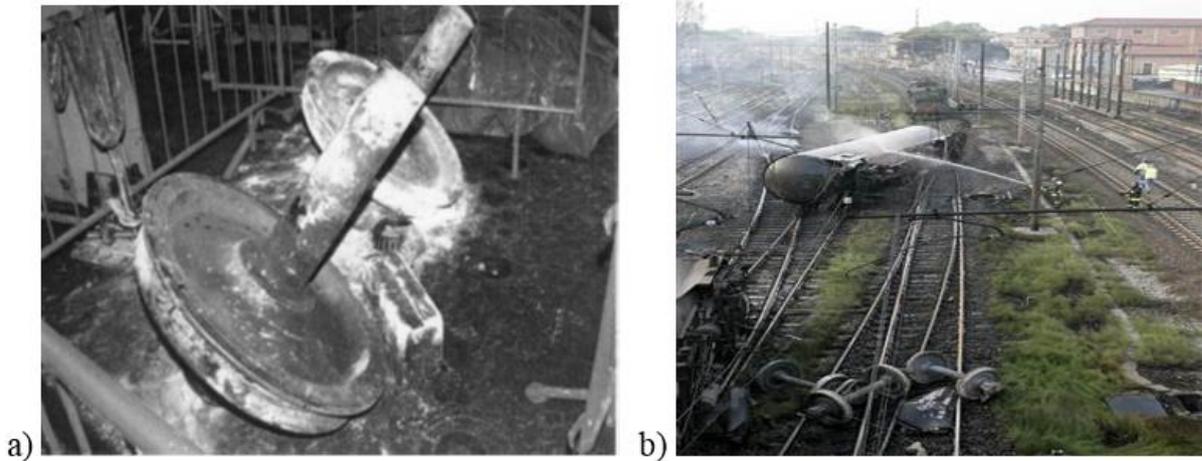
Figure 8: The Rickerscote accident in the UK in 1996 [16] and b) the Viarregio accident in Italy involving a tanker freight train carrying fuel [29].

Certain severe derailments such as the ones shown in Figure 8 are likely to involve casualties e.g. the Rickerscote accident [16] and in certain cases can cause significant environmental damage e.g. the Viarregio accident [29].

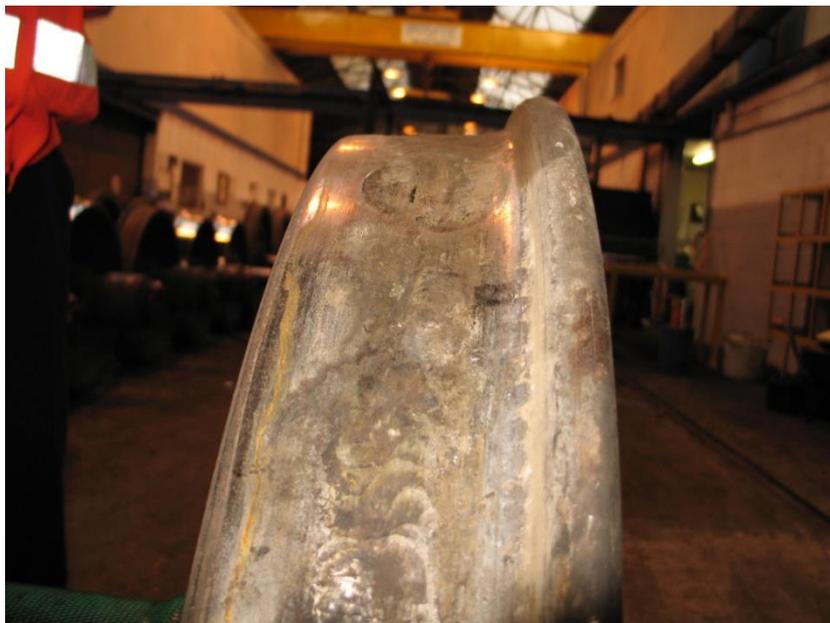
Figure 10: Photograph of a freight wagon monoblock wheel containing multiple wheel flats

Figure 10 shows an example of a wheel flat that occurred as the consequence of aggressive braking causing the wheels to lock. Wheel flats are often identified by the impact sound every time the affected wheels rotate. Wheel flats can cause collateral damage to the infrastructure or result in derailment of the affected train if not taken out of service in time.

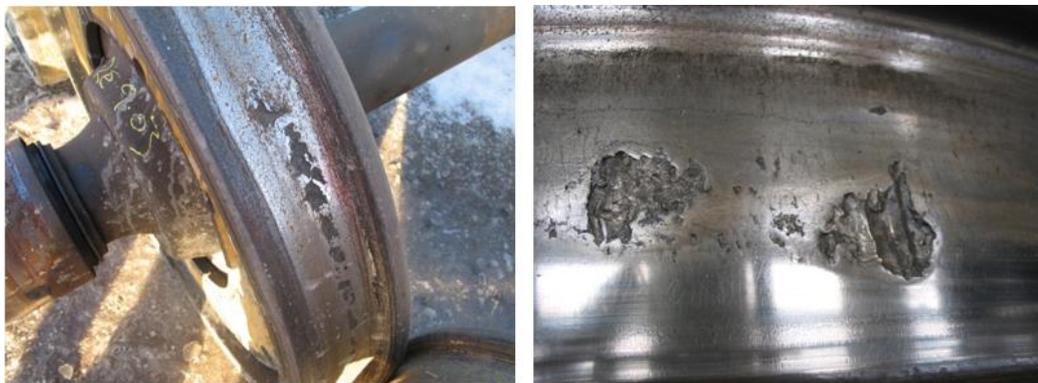
Figure 11: Examples of shelling on freight (left) and passenger wheels (right).

Shelling of the tread can occur when parts of the surface break off and are unevenly distributed along the surface of the wheel. RCF or thermal fatigue cracks can be a precursor to shelling.

Shelling can cause problems with the braking quality and adhesion of the wheel-rail interface. Moreover, in a similar way as flats, it can induce additional stress in the wheel rail contact area causing increased vibration and passenger discomfort.

The higher impact stresses can cause damage to the rail as well as the wheel itself causing its eventual fracture, albeit this is rare [16, 18-19]. The photographs in Figure 11 shows examples of wheel shelling.

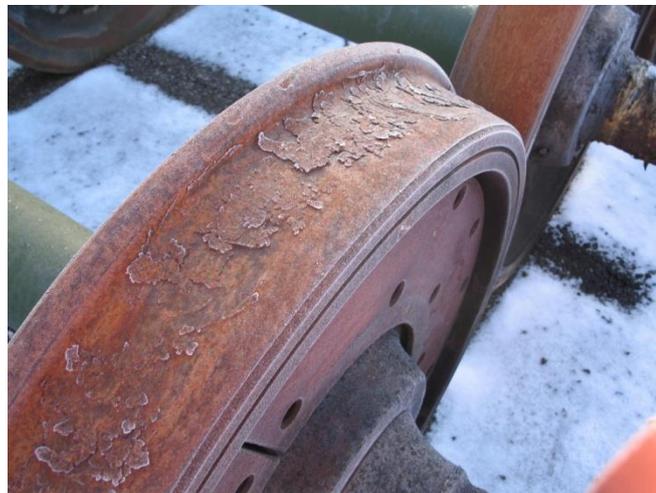
Figure 12: Metal build-up on the surface of the tread of a freight monoblock wheel.

Extreme heat in the wheel arising as a result of friction from brakes sticking or wheel locking can cause metal overheating. Metal overheating can lead to the surface of the tread to become partially liquid. The stresses at the wheel-rail interface can cause the near-liquid metal to flow over the wheel and its circumference causing metal build-up or give the wheel a scaled appearance [19]. The photograph in Figure 12 shows a case of metal build-up on a freight wheel.

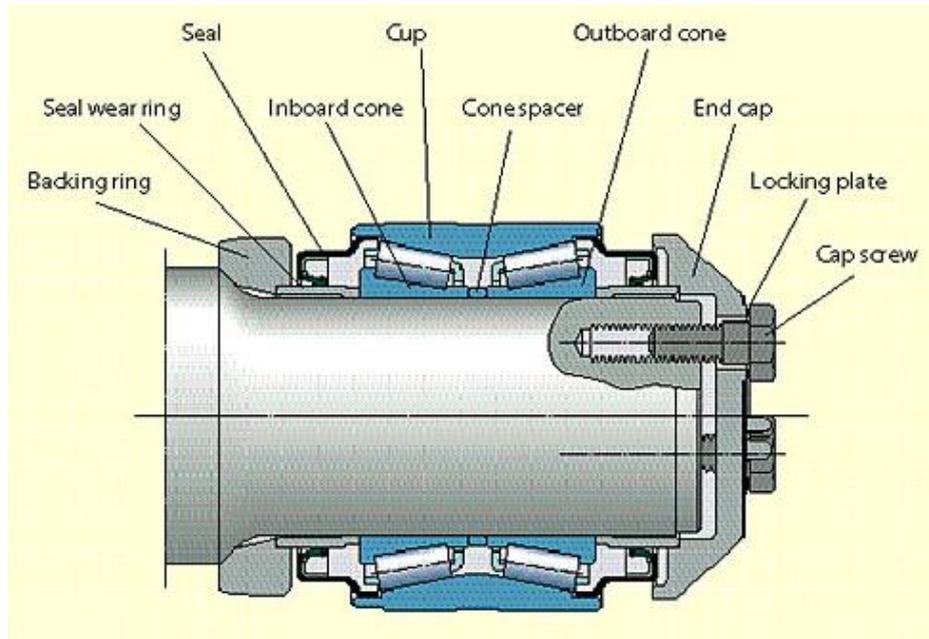
Figure 13: Tapered Roller Bearing (Courtesy of Roller Bearing Industries Inc.)

Axle bearings are lubricated rotating components installed between the axle and the wheel. The typical construction of a commonly used tapered roller bearing is shown in the schematic diagram in Figure 13. The bearing is attached to the journal of the axle and held in place by cap screw and locking plate.

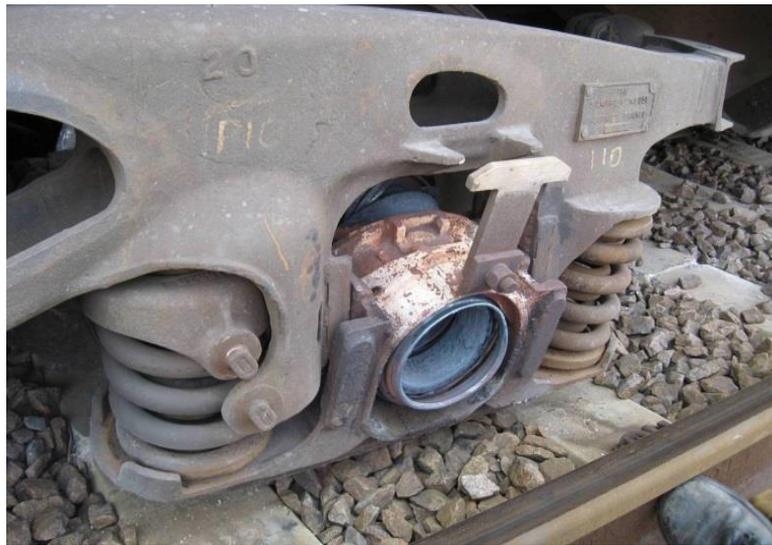
Figure 14: Derailment due to axle bearing failure (courtesy of Mr. Nick Pinder, Network Rail).

These components need to sustain high stresses and occasional impact without loss of performance. Nonetheless, occasionally defects may initiate and evolve either due to poor maintenance or due to the aggressive in-service conditions that these components are exposed to. If left unchecked an axle bearing defect can evolve rapidly causing the bearing to seize and subsequently blocking the wheel. As soon as the wheel becomes blocked the axle of the affected wheelset will begin to move abnormally and experience very high stresses [18-19, 45].

This stress is caused because one wheel is rotating normally and the other is blocked. The abnormally high stresses sustained will very quickly cause the axle to rupture, most likely derailing the train affected. The photograph in Figure 14 shows a recent derailment of a freight train caused by the failure of an axle bearing.

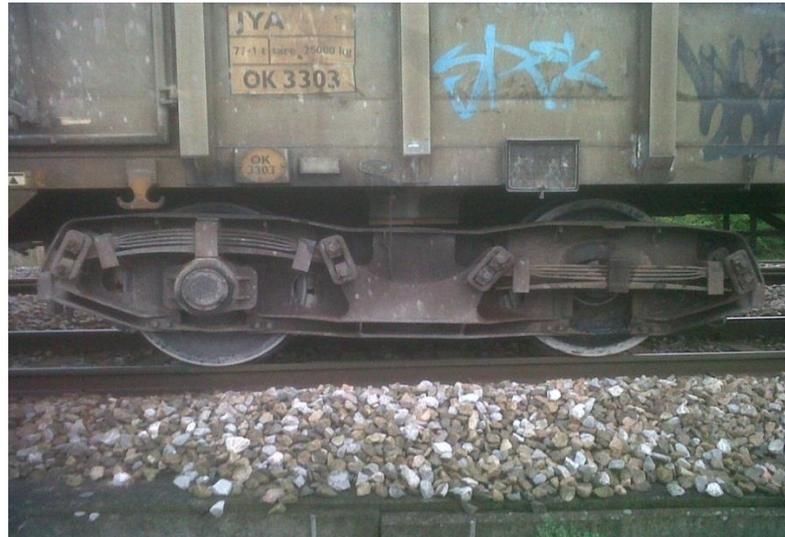
Figure 15: Photograph showing a sheared axle bearing (Courtesy of Mr. Nick Pinder, Network Rail).

The photograph in Figure 15 shows a freight train which was stopped in May 2012 in the area of Wantage, UK after a HADB generated an alarm. Subsequent inspection of the train

concerned revealed a seized axle bearing which resulted in such high forces that the axle bearing sheared completely. If the train had not been stopped it could definitely been derailed within a few miles.

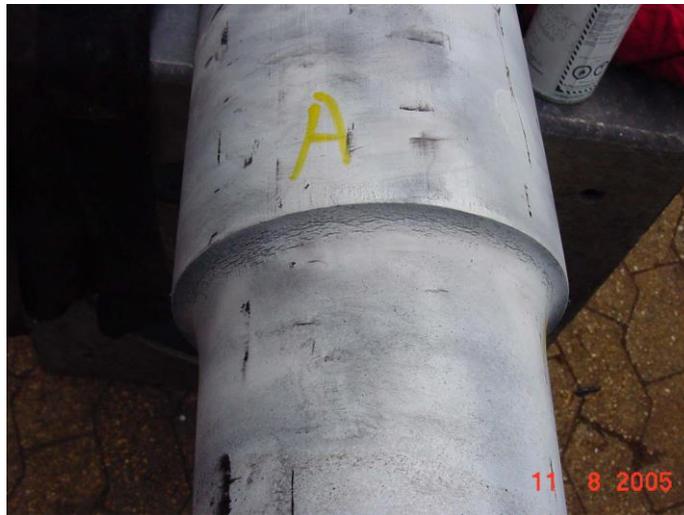
Figure 16: Photograph of fatigue cracks on the surface of the axle (Courtesy of Dr John Rudlin, TWI Limited).

Axles can with time and under overloading conditions (above the permitted axle loads) develop fatigue cracks, see photograph in Figure 16.

If fatigue cracks develop then if they are shallow enough they can be removed by grinding away the affected region. Alternatively, the affected axles should be replaced with new ones.

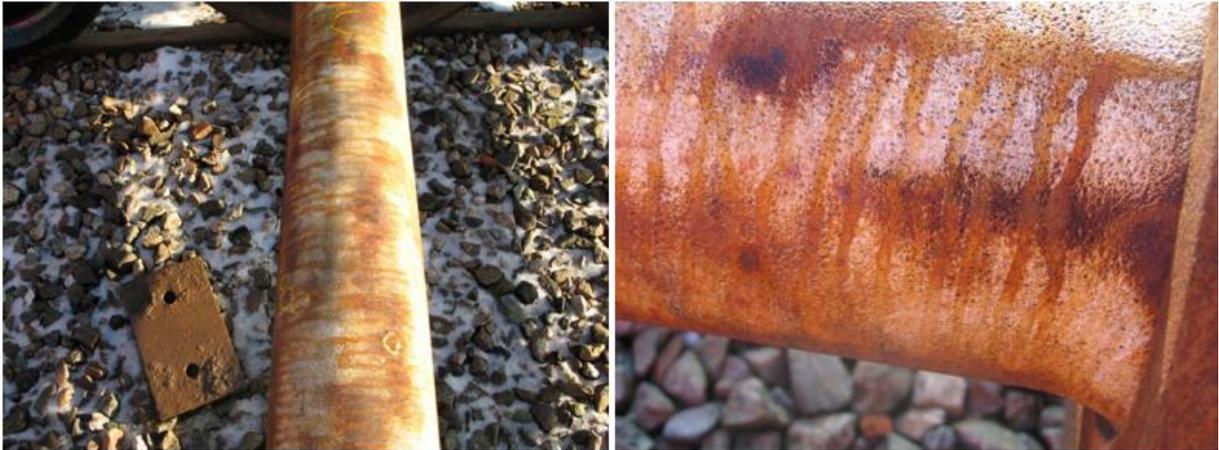
Figure 17: Photographs of pitting corrosion on a freight axle.

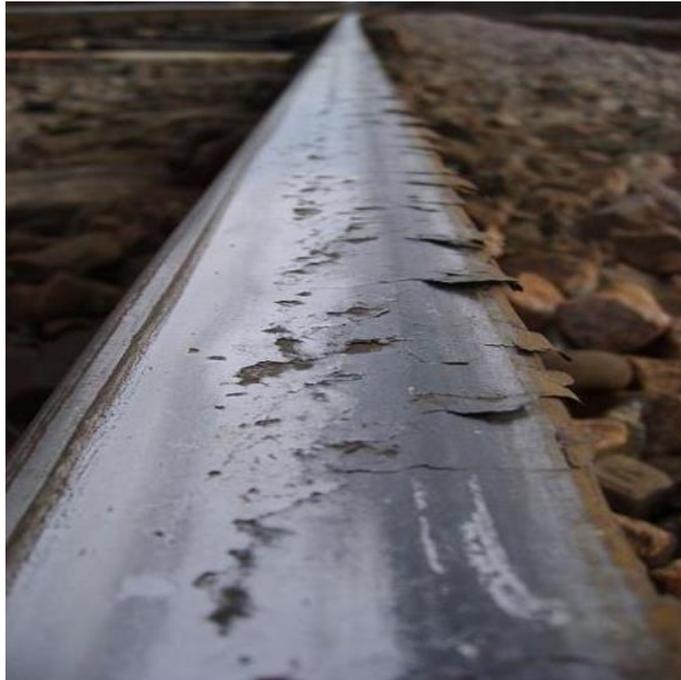
Figure 18: RCF cracks with high level of plastic flow (photo courtesy of Brian Whitney, Network Rail)

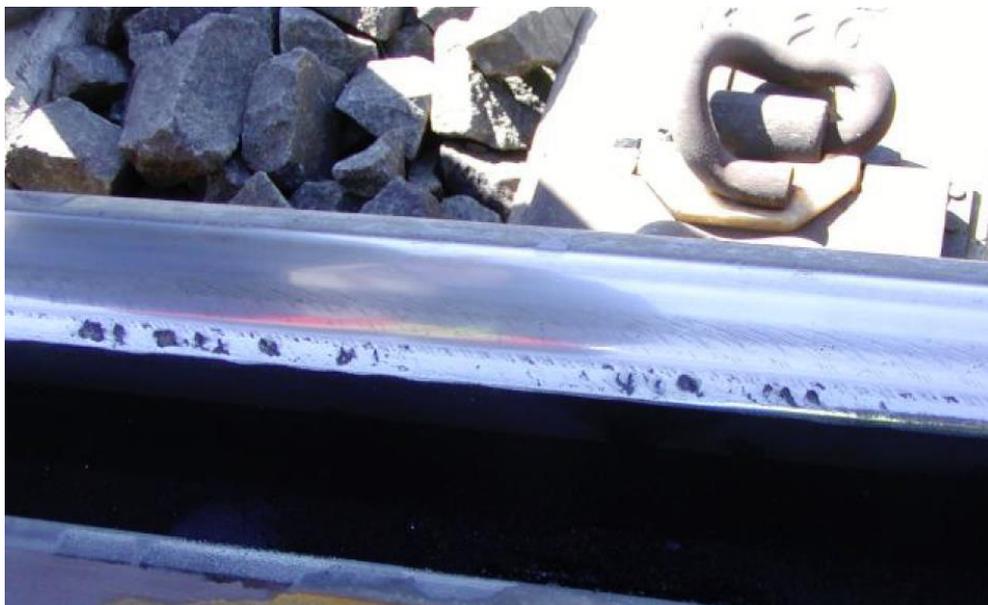
Figure 19: Shelling of the running surface of the rail [53].

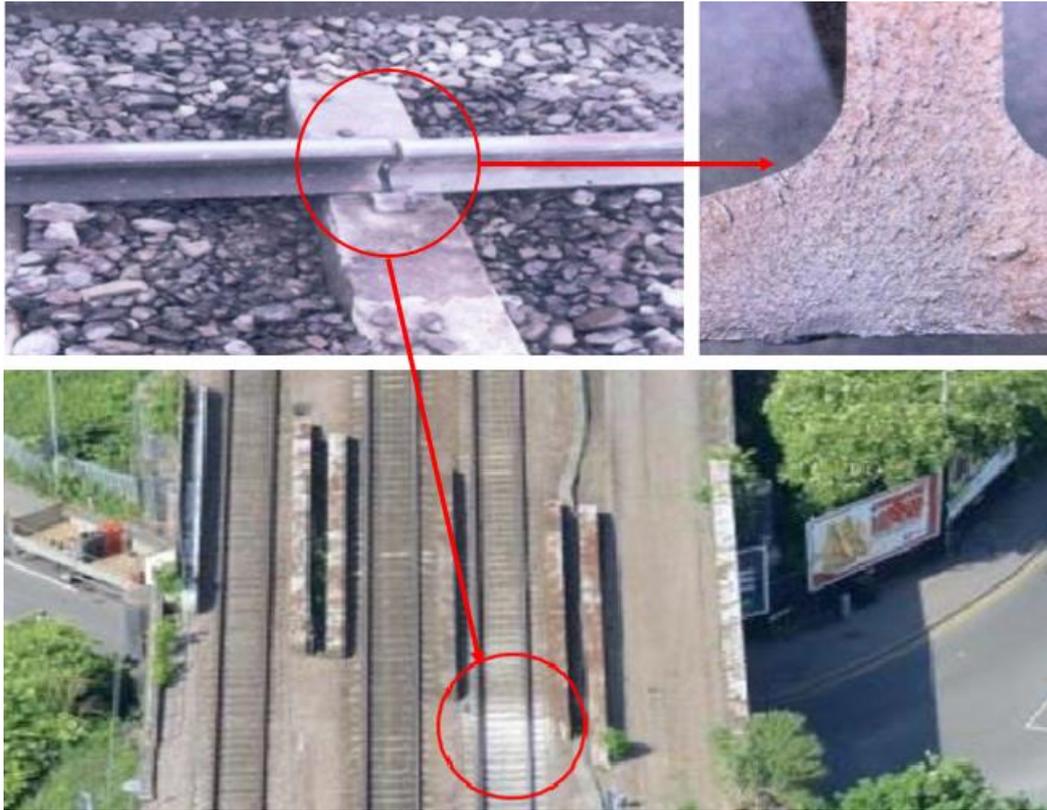
Figure 20: Photograph of a plain rail that fractured as a result of a crack which developed in the base of the rail. The rail sat on a sleeper with a degraded rail pad in an area of voiding on a transition to a bridge structure (photographs courtesy of Brian Whitney, Network Rail).

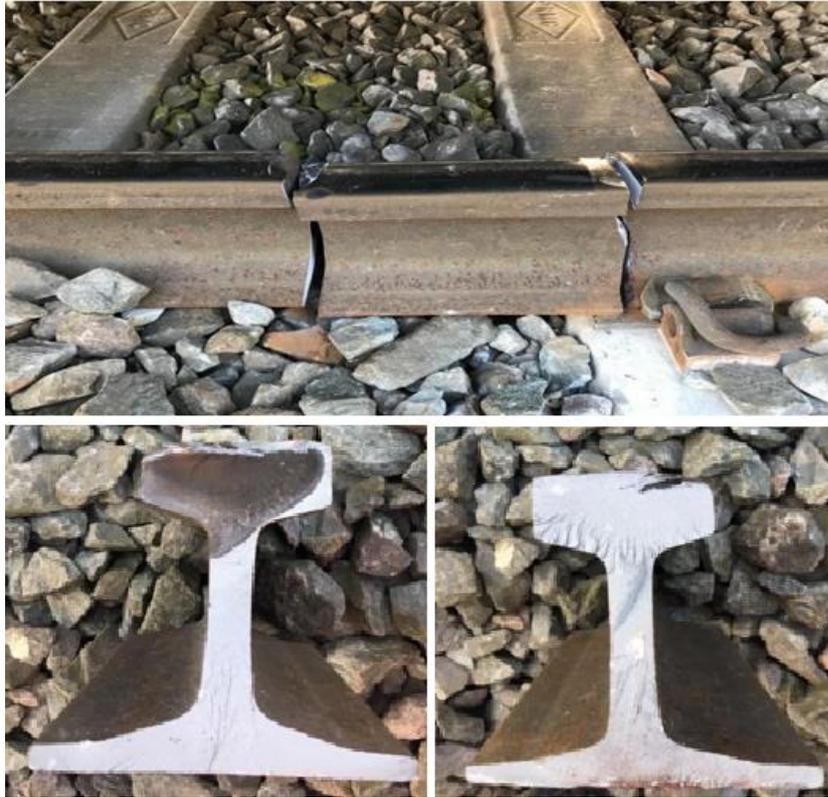
Figure 21: Photograph showing classic tache oval fatigue crack (courtesy of Brian Whitney, Network Rail)

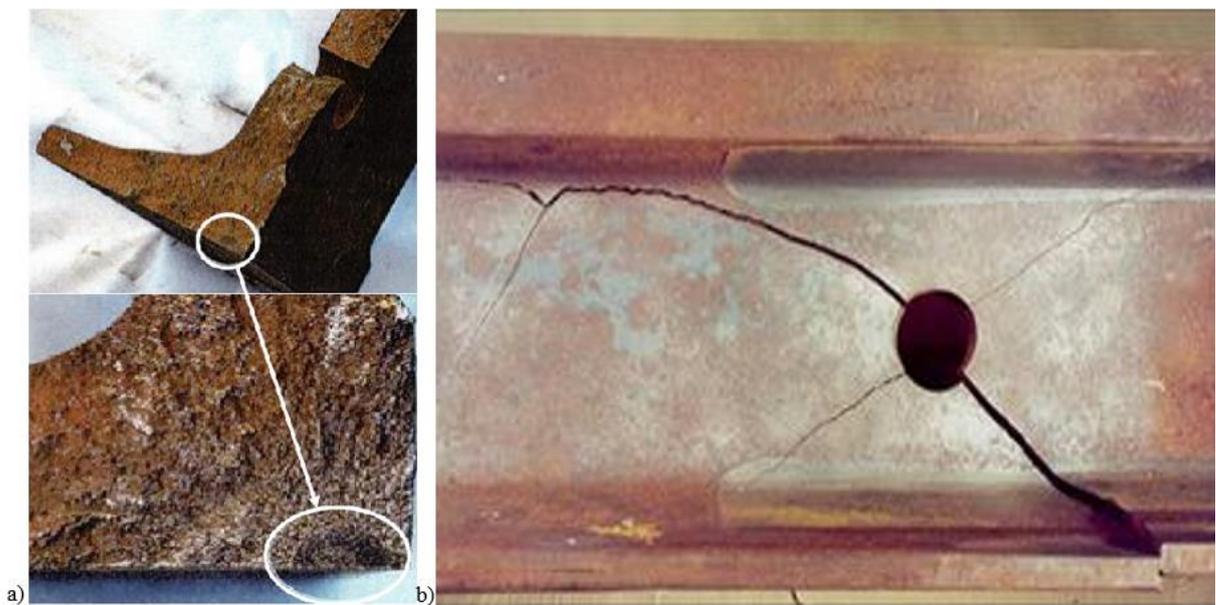
Figure 22: a) Rail foot corrosion (courtesy of Brian Whitney, Network Rail) and b) bolt hole cracking [53].

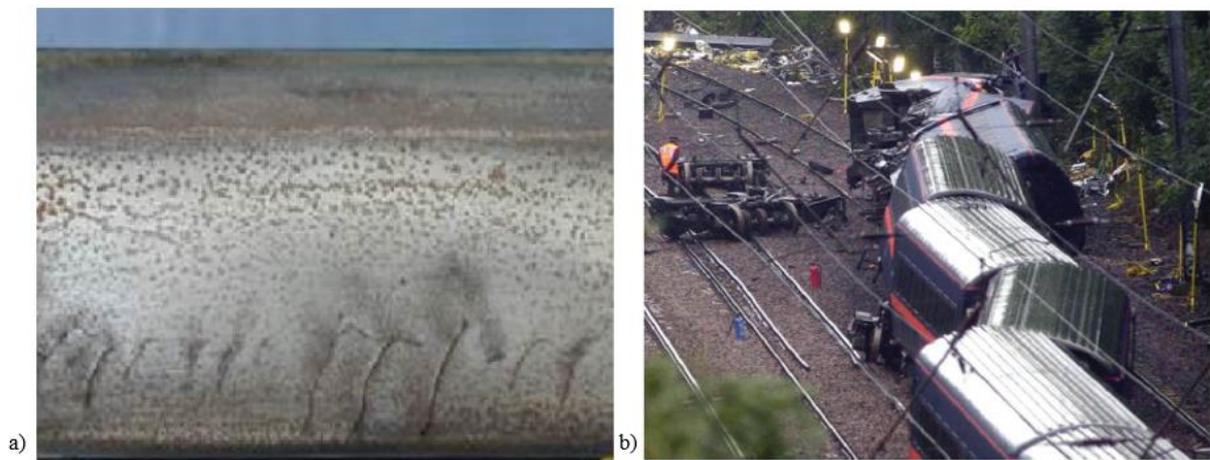
Figure 23: a) Heavy RCF cracking on rail section revealed from service [53] and b) the site of the Hatfield accident [50].

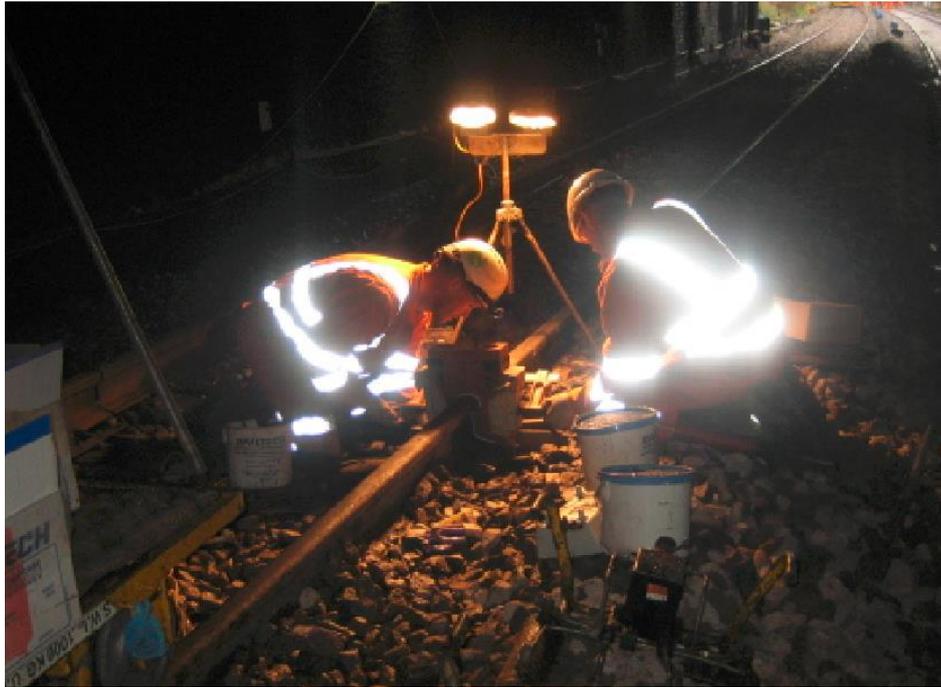
Figure 24: Aluminothermic weld preparation, Shugborough Tunnel, December 2012.

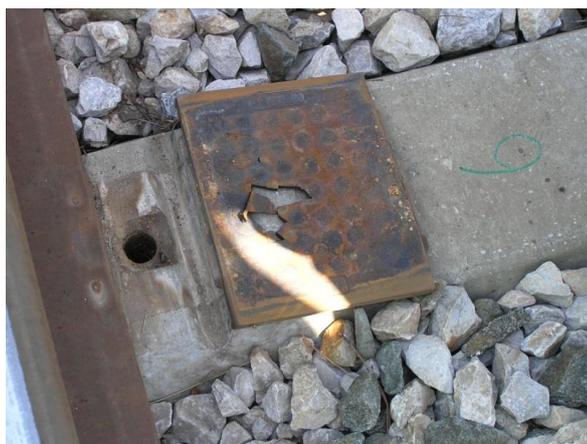
Figure 25: Photograph of a failed rail pad.

Accidental impacts and vibrations combined with the presence of failed rail pads or manufacturing defects can cause concrete sleepers to crack and eventually fail. Normally one failed sleeper will not pose a problem but two or more consecutive sleepers are a cause for concern necessitating repairs to take place. Sleepers can also be influenced by ‘wet beds’ which is where water is captured beneath the sleepers causing the track system to pump each time a train passes over.

Wet beds apart from causing decreased stiffness of the rail track also result in much higher bending moments to be experienced by the rails increasing the likelihood of fatigue cracks initiating and propagating in the affected areas. Wet beds can also reduce passenger comfort and increase vibration and noise particularly when the train is travelling at high speeds. Figure 25 shows an example of a failed rail pad sleeper.

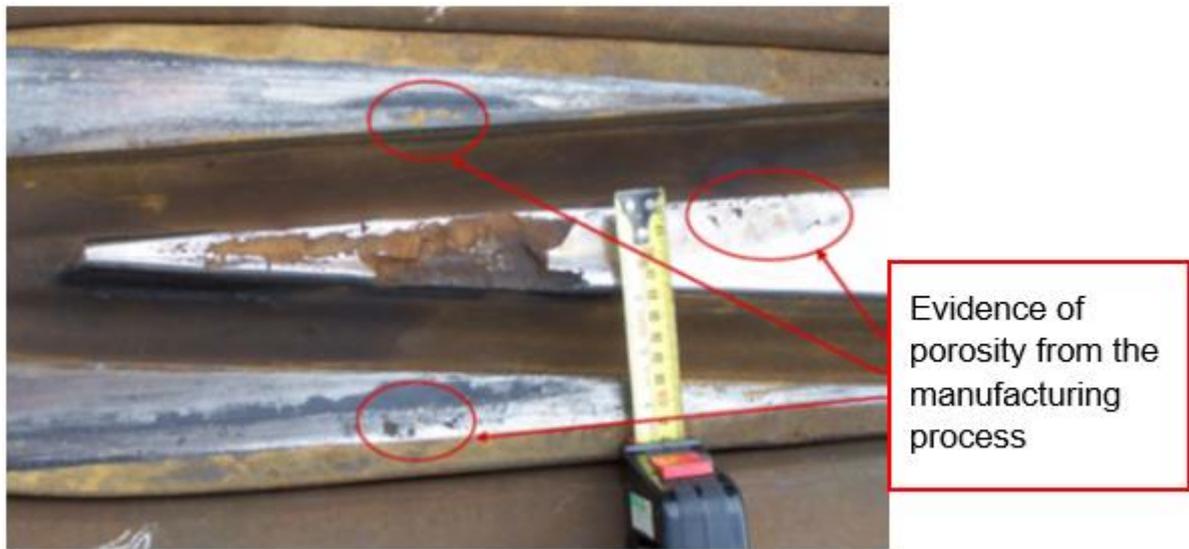
Figure 26: Photograph of damaged crossing showing evidence of porosity due to the manufacturing process (the photograph is from Hardface Technology Presentation on Repair and Rebuild of Manganese crossings using Hardface Welding, 2003).

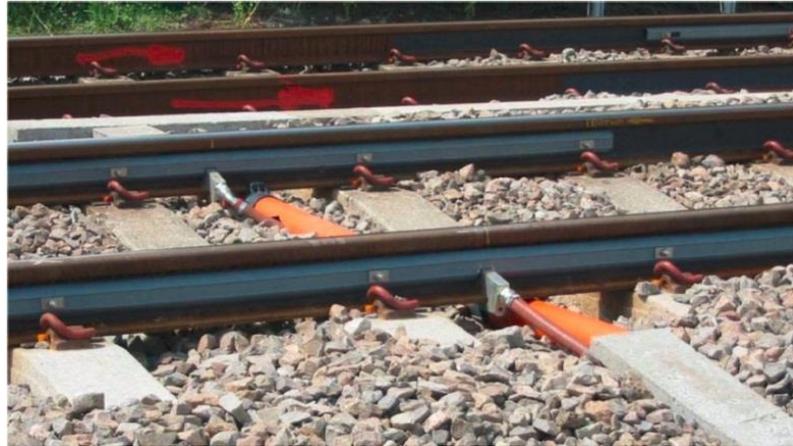
Figure 28: Photograph of a Wheelcheck system (the photograph is courtesy of Network Rail).

The technology used by the different system manufacturers vary. The WheelChex systems (shown in Figure 28) employ strain gauges welded on the web which measure the change in resistance whereas the FactIS system (mostly found in Canada, USA, Brazil, and Australia), uses cameras to capture images of the wheels as they pass. This is similar to the Argus system which uses a combination of scanning laser and cameras. Other systems make use of accelerometers that measure vibration instead. Vibration-based wheel check systems employ a more complex data processing approach in comparison with strain gauge-based systems. However, they do not require temperature compensation during data analysis [66-68].

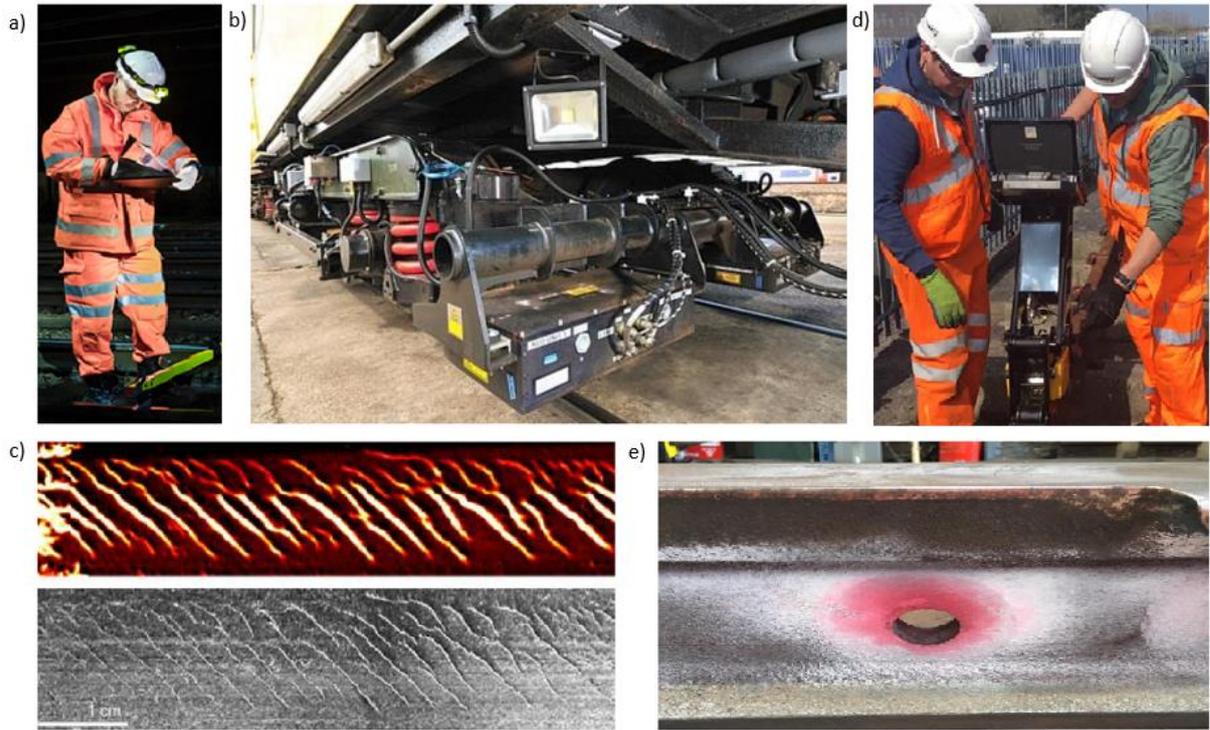
Figure 34: a) a visual inspection being carried out at night by a NR Engineer, b) the undercarriage of a NR ultrasonic test unit, c) images produced by a thermographic rail head inspection [125], d) Inspection using the Eddie Current roller search unit, and e) an inspection in progress where liquid has been applied to a crossing bolt hole under inspected at NR's recycling depot at Whitmoore, Cambridgeshire (images a, b, d & e courtesy of Network Rail).

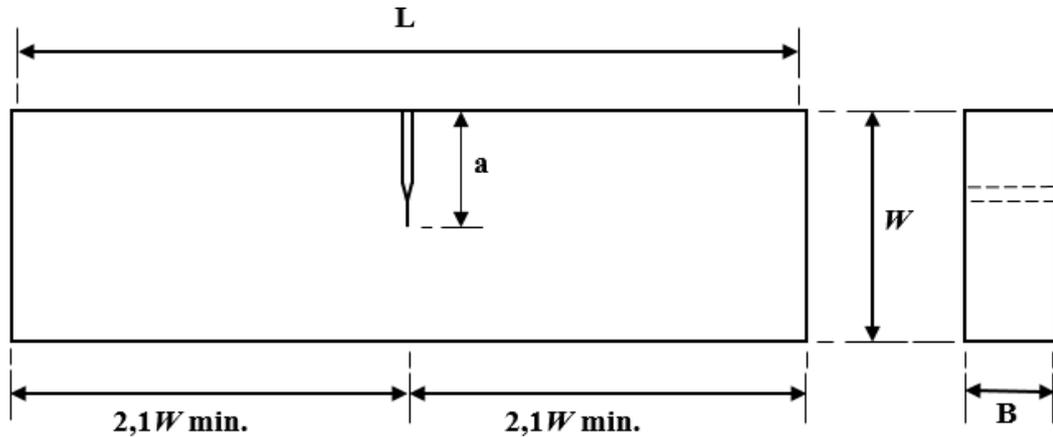
B = thickness
W = width = $2B$
a = effective crack length = $0,45W$ to $0,55W$
L = loading span = $4W$

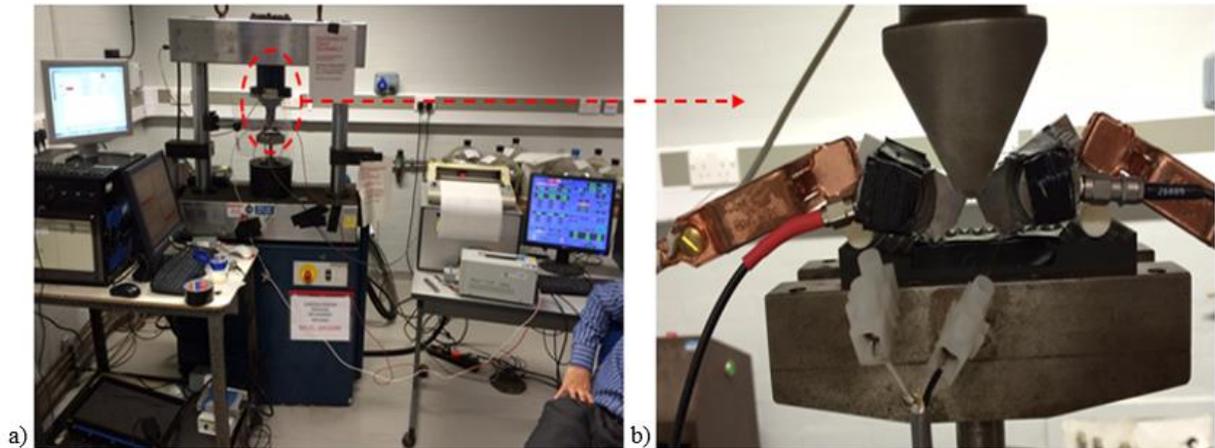
Figure 39: a) Experimental setup with PAC and customised acoustic emission system. The sample is in place and undergoing cyclic loading. Crack length is continuously monitored with the DCPD instrument. b) this photograph shows a close-up of a failed sample. The two acoustic emission sensors are visible together with the DCPD instrument connections. The sample has been loaded using three-point cyclic loading.

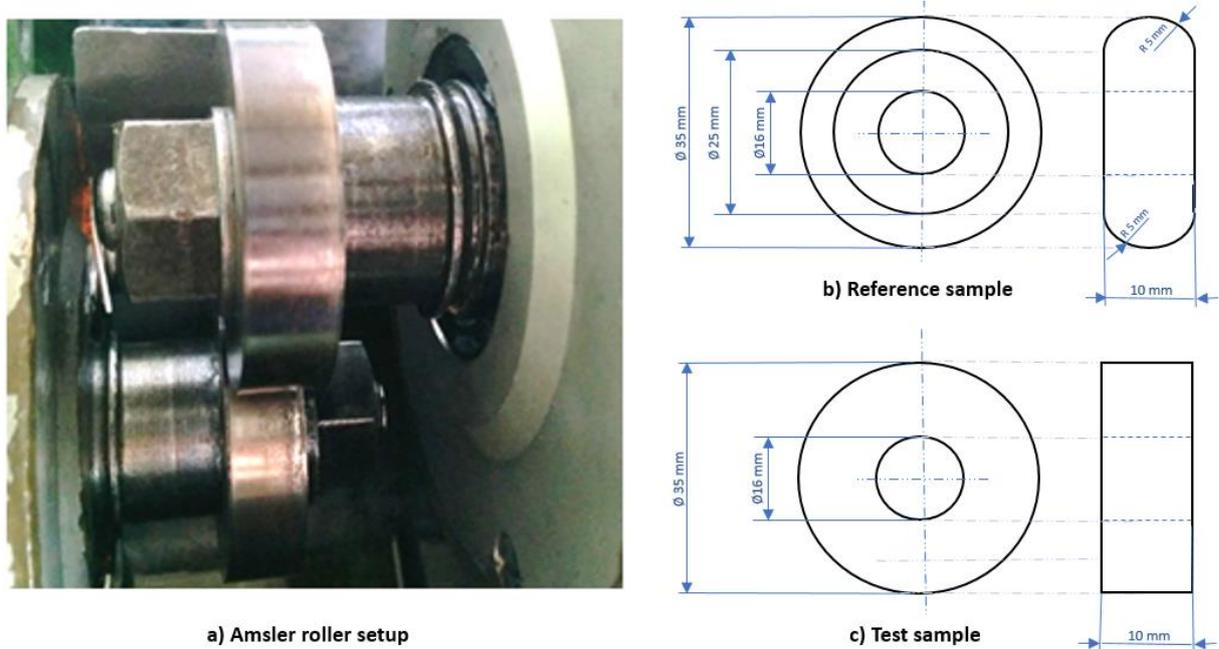
Figure 40: a) Example of Amsler rolling testing setup, b) Reference sample geometry, and c) Test sample geometry.

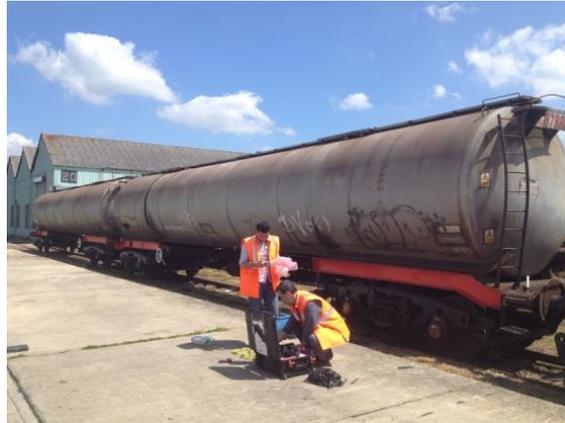
Figure 41: Tanker freight wagons with several axel bearings artificially damaged in the roller or race using a power tool.

A customised AE and vibration analysis system for onboard and wayside evaluation of axle bearings and wheels, which can be rapidly installed and removed from the train tested using magnetic hold-downs was developed in-house in collaboration with other researchers. Experiments using simulated faults were carried out on freight rolling stock in Long Marston. The tanker wagons used during the tests were provided by VTG and contained a variety of artificially damaged axle bearings. The photographs in Figure 41 show an example of the rolling stock used during the Long Marston trials. Rolling stock used during the Long Marston trials

were clearly marked so they would not be returned for service by accident on the actual network with artificially induced faulty wheels or axle bearings.

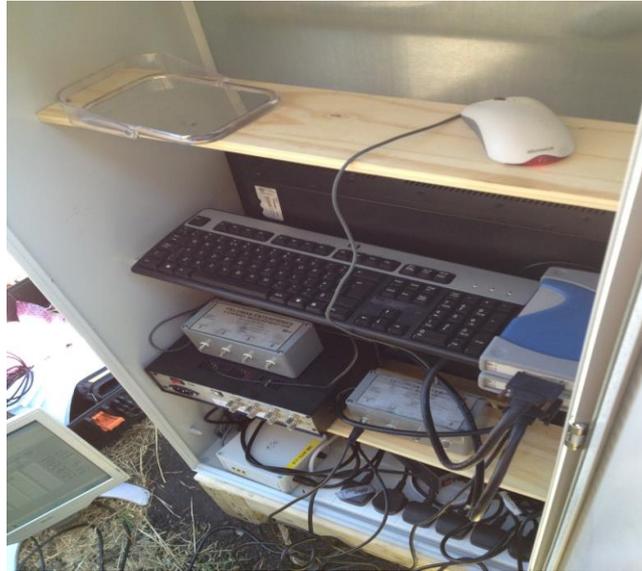
Figure 42: The customised data acquisition equipment used during trials at Long Marston.

The customized AE/vibration analysis system shown in the photograph of Figure 42 consists of the following components: a) resonant acoustic emission sensors manufactured by Physical Acoustics Corporation (PAC), b) industrial accelerometers with sensitivity 100mV/g manufactured by Wilcoxon, c) pre-amplifiers manufactured by PAC, d) amplifiers manufactured by Krestos, e) accelerometer power supply manufactured by Krestos, f) Agilent four-channel decoupling hub manufactured, g) 2531A Agilent four-channel data acquisition

card with a maximum sampling rate of 2 MS/s in single channel mode and h) Amplicon industrial computer with customized data logging and analysis software [2-5, 18-19].

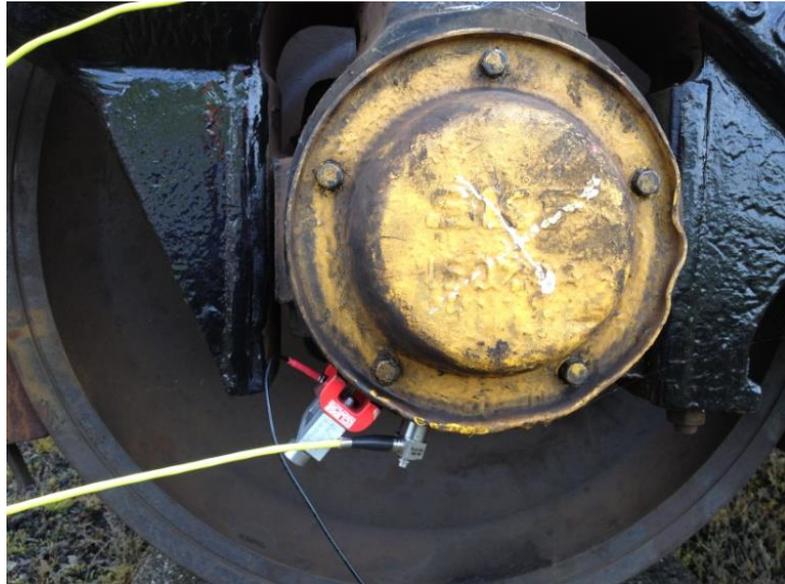
Figure 43: AE sensors and accelerometer installed in one of the axle bearings of the tanker freight wagons tested in Long Marston.

Onboard AE and acceleration measurements were carried out in order to confirm the condition of the healthy and defective axle bearings, while the tankers were moved over a straight rail track section a few hundred meters long at a speed of 24 km/h. Various axle bearing defects were induced including roller defects of different magnitudes 2, 4 and 8 mm deep and outer race defects 2, 4 and 8mm deep were induced using a power tool. The photograph in Figure 43 shows the way the sensors were installed onboard. A similar set up was used for the wayside measurements, but in this case the accelerometers and AE sensors were mounted on the web of the rail.

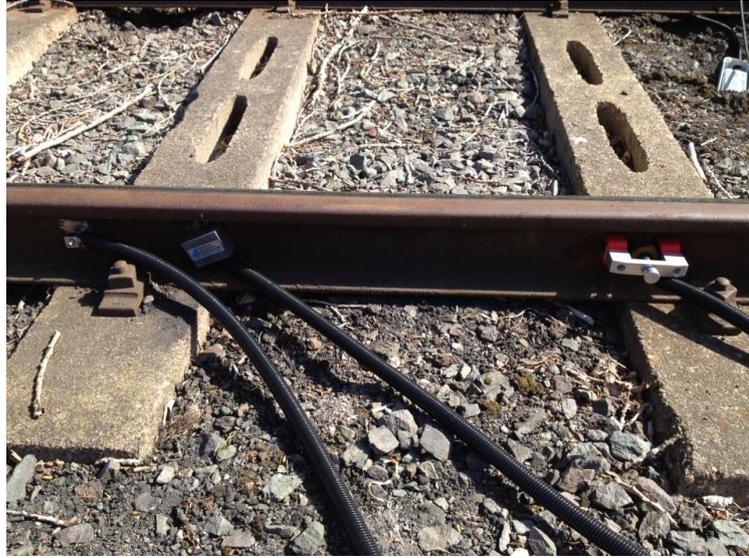
Figure 44: Wayside installation of AE sensors and accelerometers at Long Marston.

The acquisition rate for the AE measurements was set at 500 kSamples/s per channel. For the vibration measurements the acquisition rate was set at 25 kSamples/s per channel. The photograph in Figure 44 shows the wayside installation of AE sensors and accelerometers.
