**A HOLISTIC APPROACH TO REMOTE
CONDITION MONITORING FOR THE
ACCURATE EVALUATION OF RAILWAY
INFRASTRUCTURE AND ROLLING STOCK**

A thesis submitted to
The University of Birmingham
for the degree of
DOCTOR OF PHILOSOPHY

School of Metallurgy and Materials
College of Engineering and Physical Sciences
University of Birmingham
September 2019

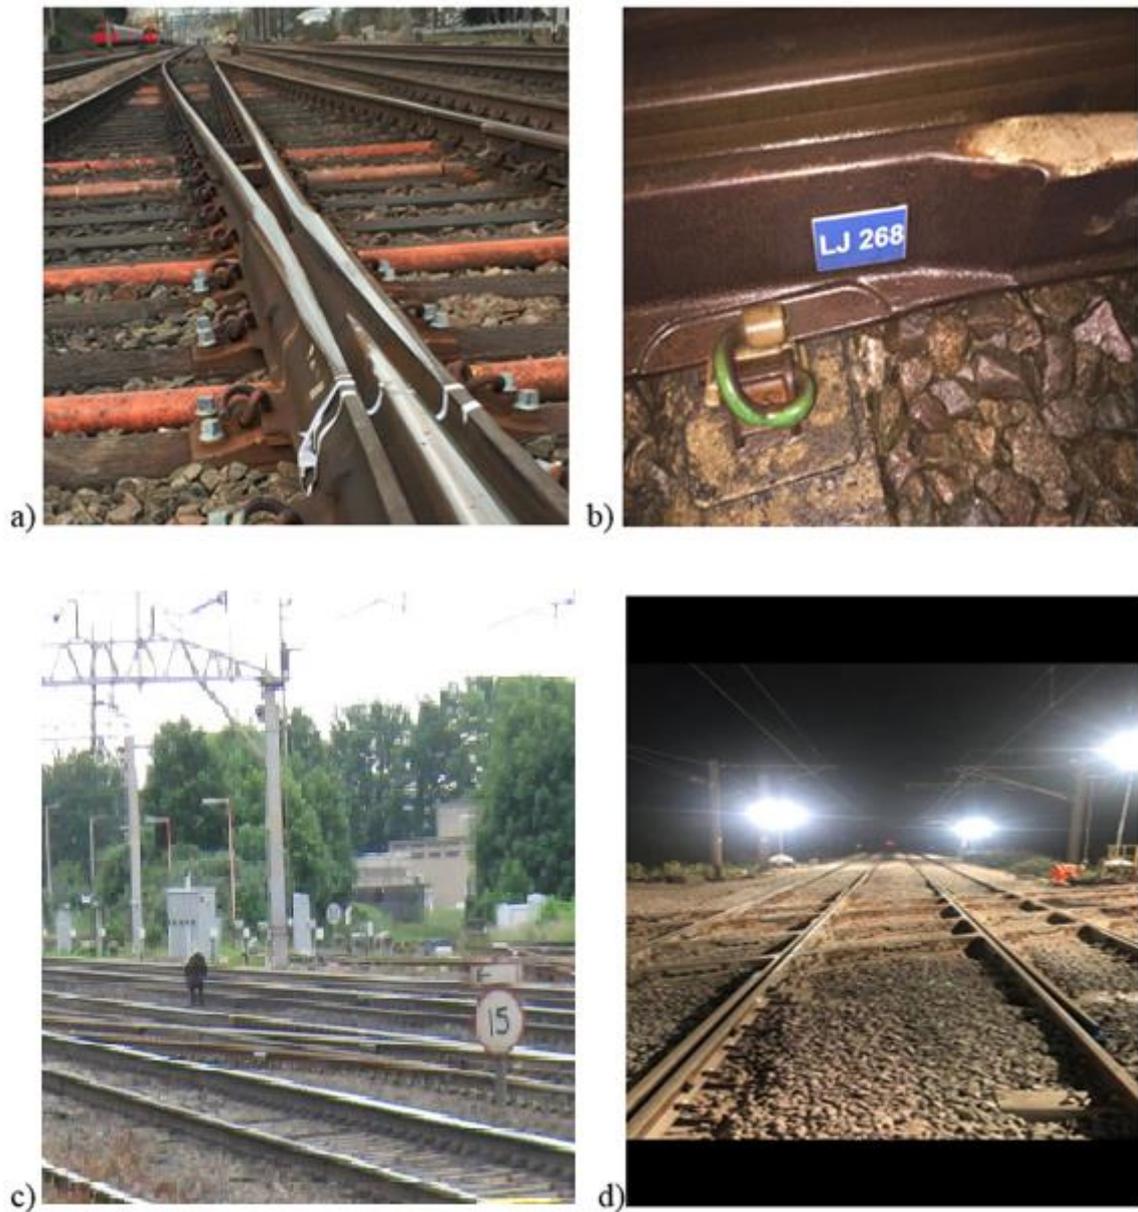
Figure 45: Crossing tested in a) Wembley, b) Hatton, c) Watford and d) Newark

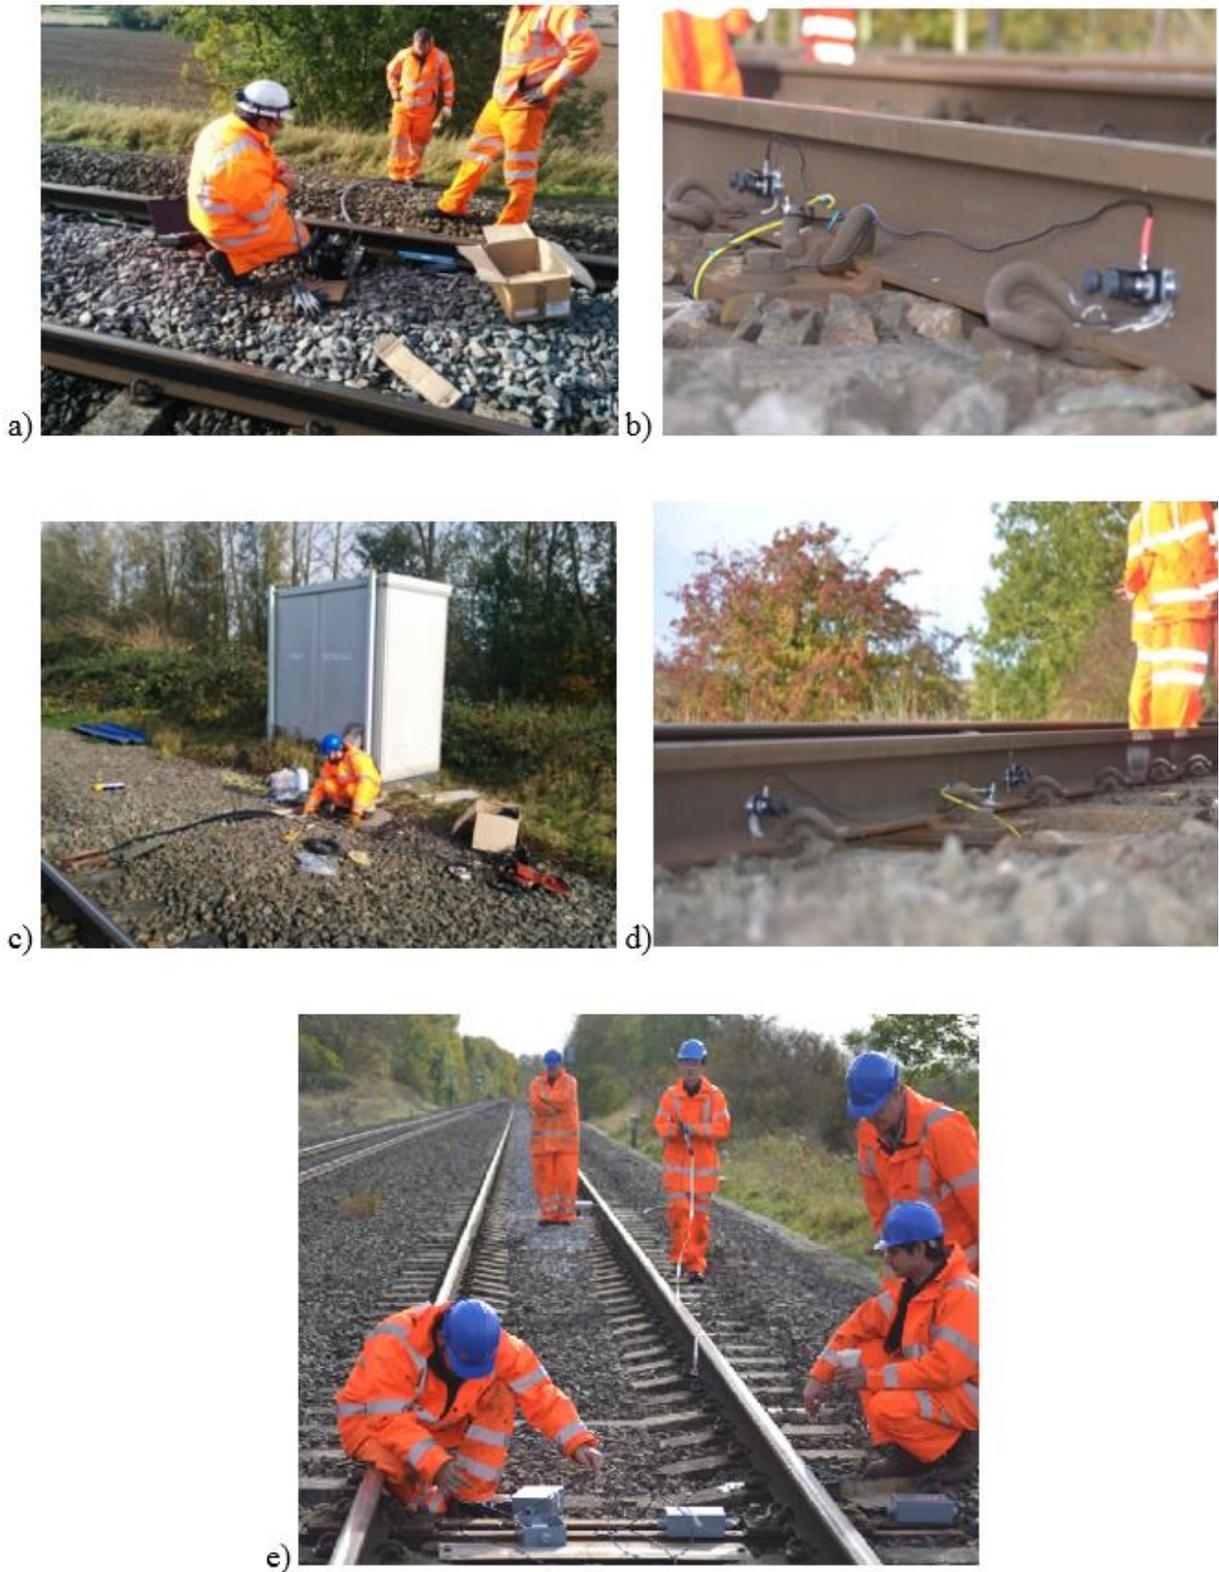
Figure 47: Photographs showing the installation of the customised 12-channel AE-vibration system at the Cropredy site, direction from London towards Birmingham.

For the long-term evaluation of the capability of the integrated AE and vibration monitoring system in detecting wheel and axle bearing faults of in-service rolling stock a site at Croppedy was chosen for instrumentation, Figure 47. The site selected was adjacent to an existing commercial HABD. The installation of the customised system took place by a combined team of University of Birmingham (UOB), Network Rail and Krestos Limited engineers, including the author of this study. The installed system comprised 12 channels with 3 Agilent 2531A DAQs being employed. In the existing layout 7 channels were used in total as follows: four

Although 18 seconds are sufficient for monitoring the entire length of passenger trains, freight trains which are up to 25 wagons long may not be captured in their entirety depending on how fast they are moving. This is due to the fact that a fixed acquisition time has been chosen. The system was installed in September 2015 and has been operating on a daily basis with very little maintenance since that time. It monitors approximately 200 trains each day.

The AE sensors have been ultrasonically coupled with araldite, also providing adhesion. For additional safety of the installation magnetic hold-downs have also been used. The industrial accelerometers have been installed with magnetic hold-downs alone at the rail foot.

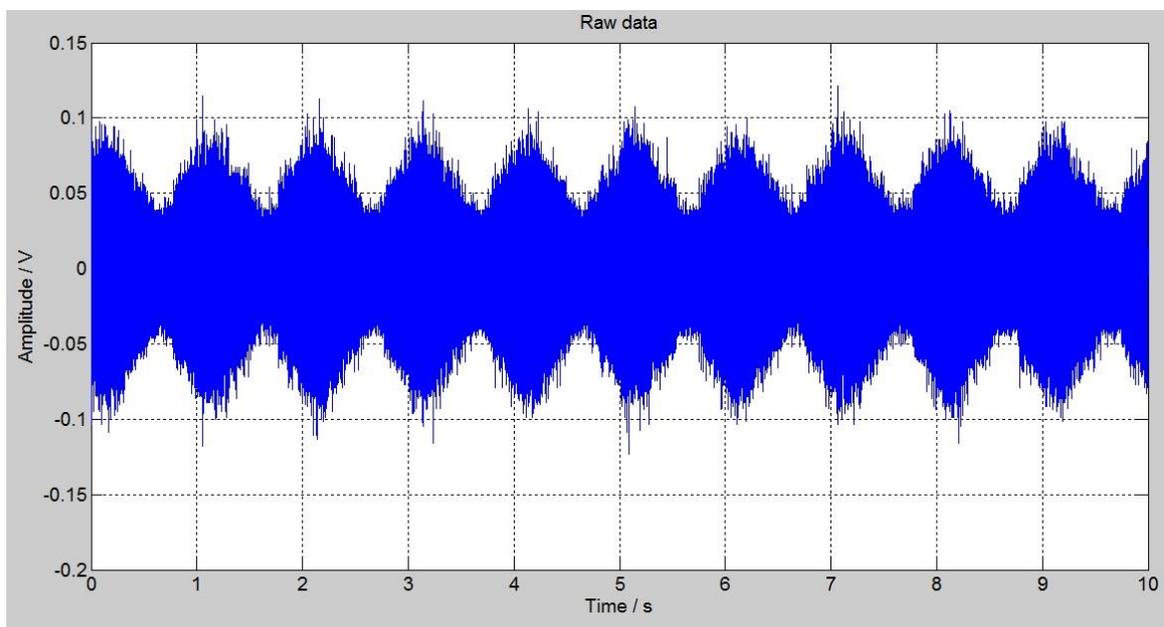
Figure 49: AE activity for the reference sample over 10s long acquisition at 1 MS/s. The thickening of the signal occurs during the loading stage and arises from the bending moments. During unloading the signal amplitude drops to background noise. There are no other visible peaks indicating crack growth. Some minor peaks visible in the signal are due to noise from the DARTEC servo-hydraulic mechanism. The peak-peak value does not exceed ± 0.11 V

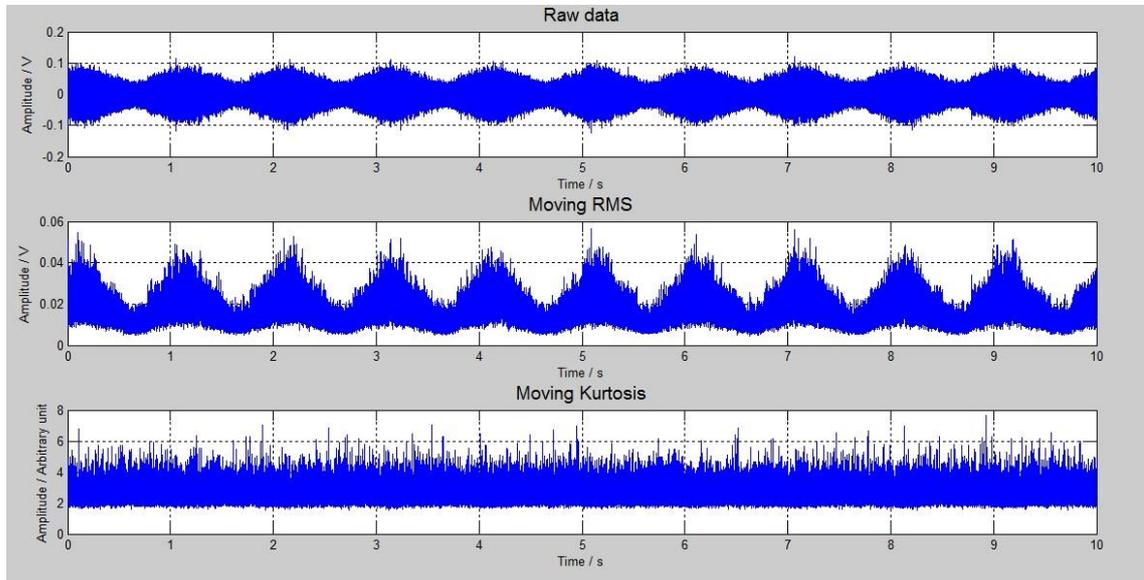
Figure 50: Raw dataset together with moving RMS and moving Kurtosis graphs. No crack indication is visible

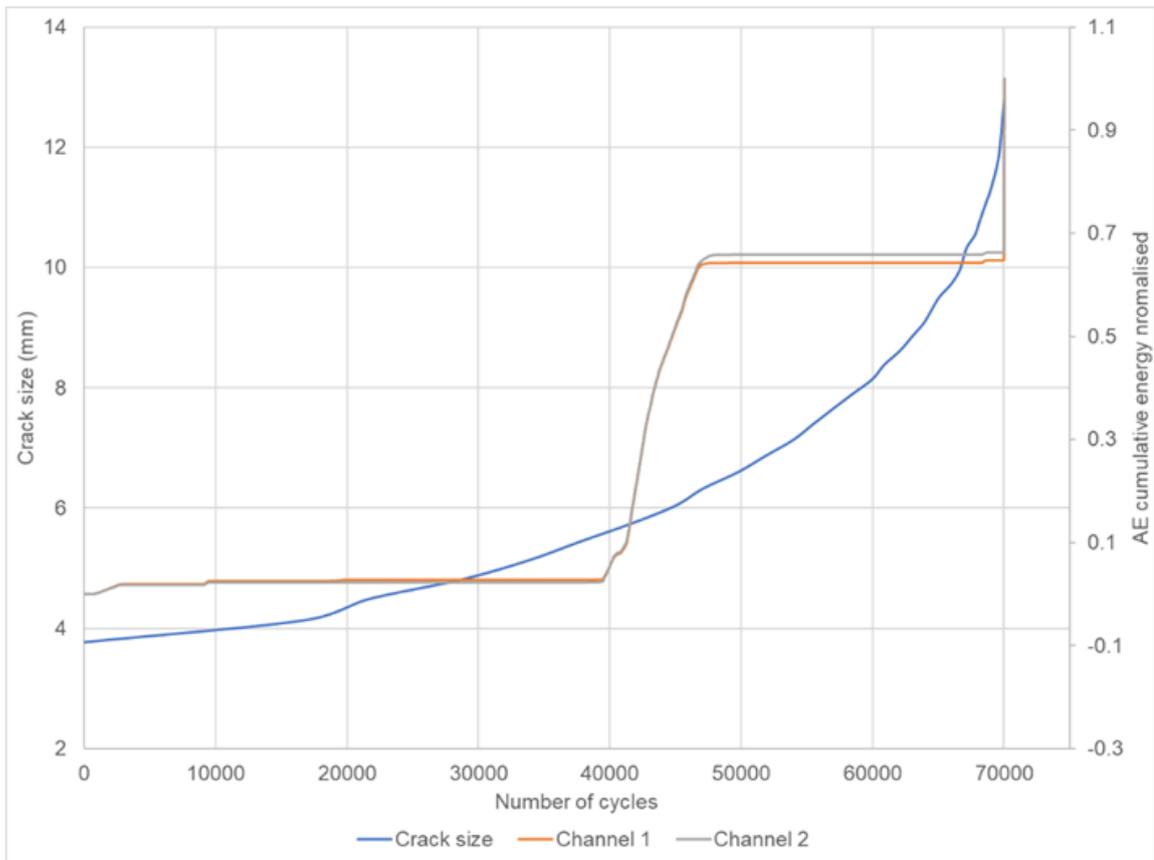
Figure 51: Plot showing crack growth with normalised cumulative AE activity up to the point of failure for a pre-cracked cast manganese steel sample.

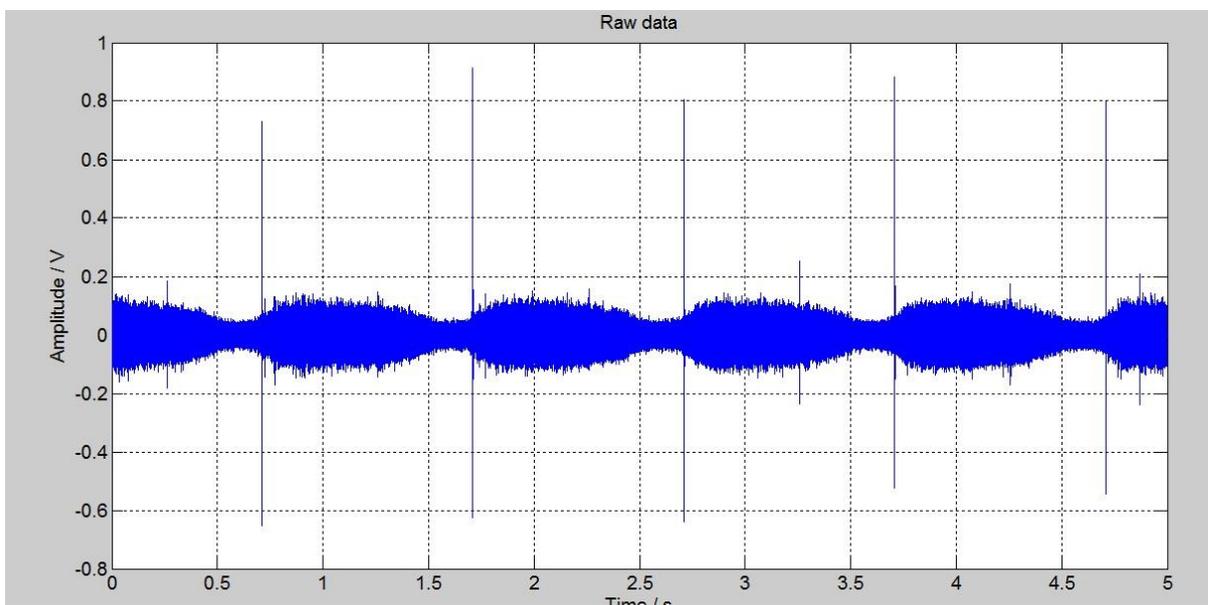
Figure 52: Raw acoustic emission dataset at mid-stages of the test for one of the pre-cracked cast manganese steel sample. The AE activity is clearly intense with crack growth occurring at every loading cycle.

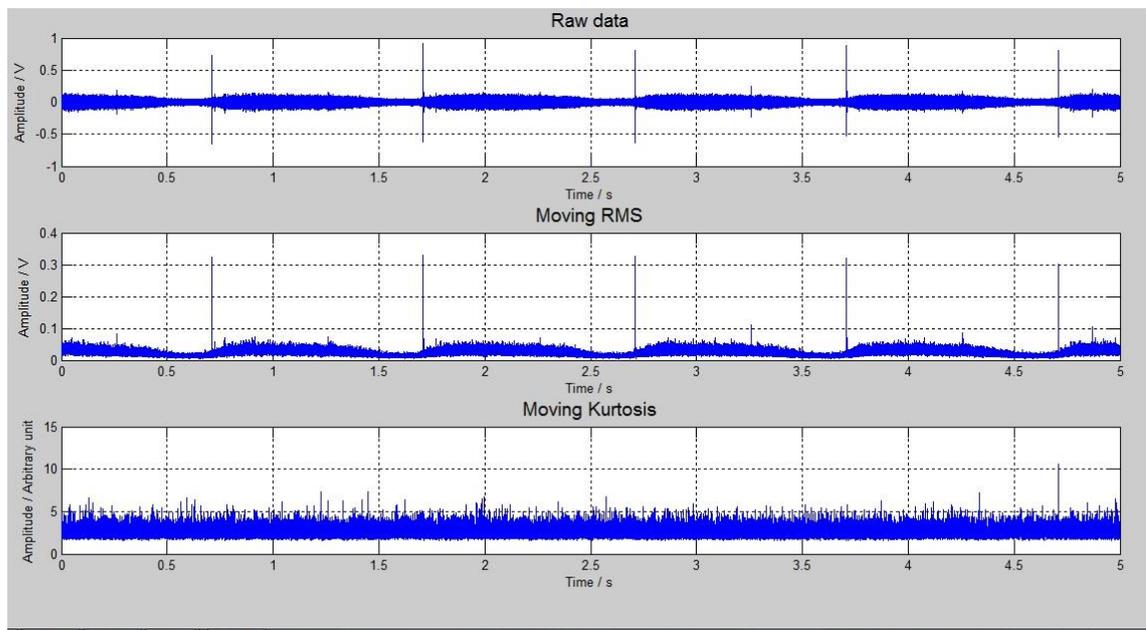
Figure 53 : Raw AE dataset, moving RMS and moving Kurtosis at the middle stage of the fatigue test for the cast manganese steel sample.

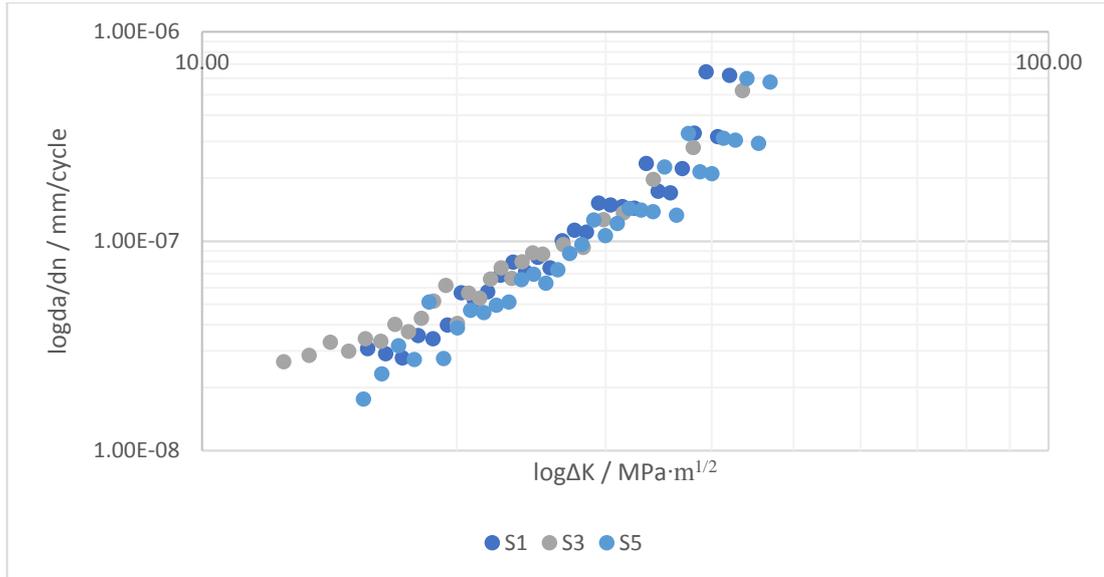
Figure 54: The Paris-Erdogan law plot for some of the R260 grade steel samples tested under three-point fatigue bending testing.

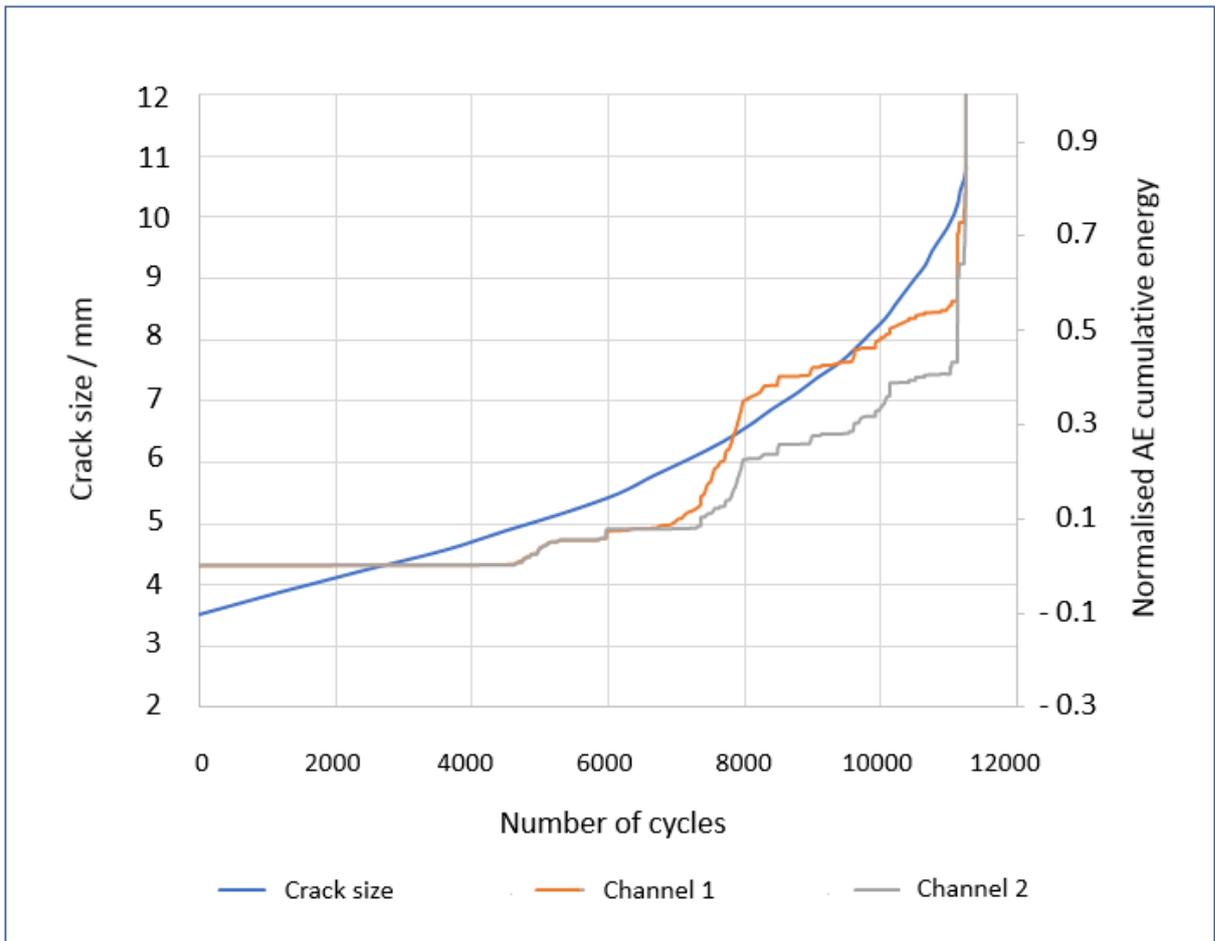
Figure 55: Normalised AE cumulative energy detected with respect to crack growth measured with DCPD and increasing loading cycles plot for R260 rail sample S1 up to final failure

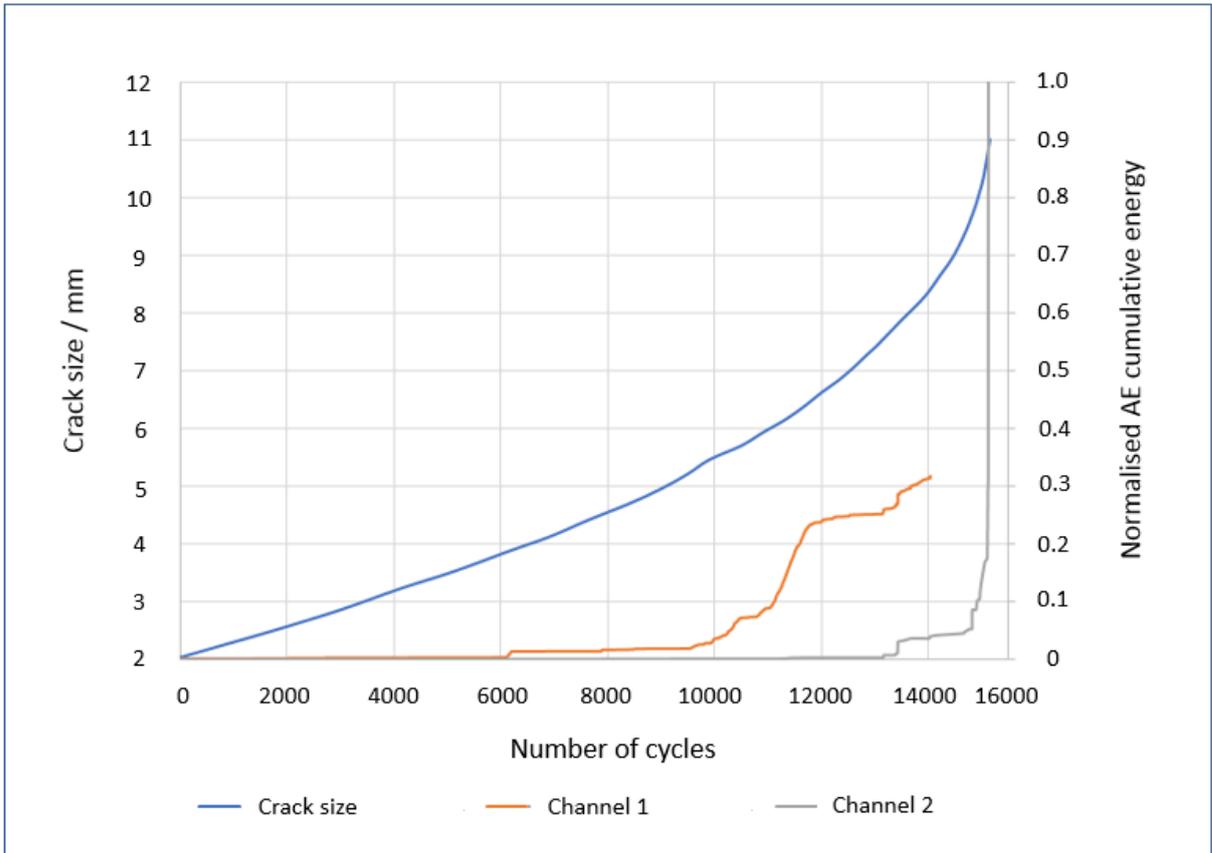
Figure 56: Normalised AE cumulative energy detected with respect to crack growth measured with DCPD and increasing loading cycles plot for R260 rail sample S3 up to final failure. Sensor 1 operation stopped earlier due to loss of coupling and hence the discrepancy in the trend also

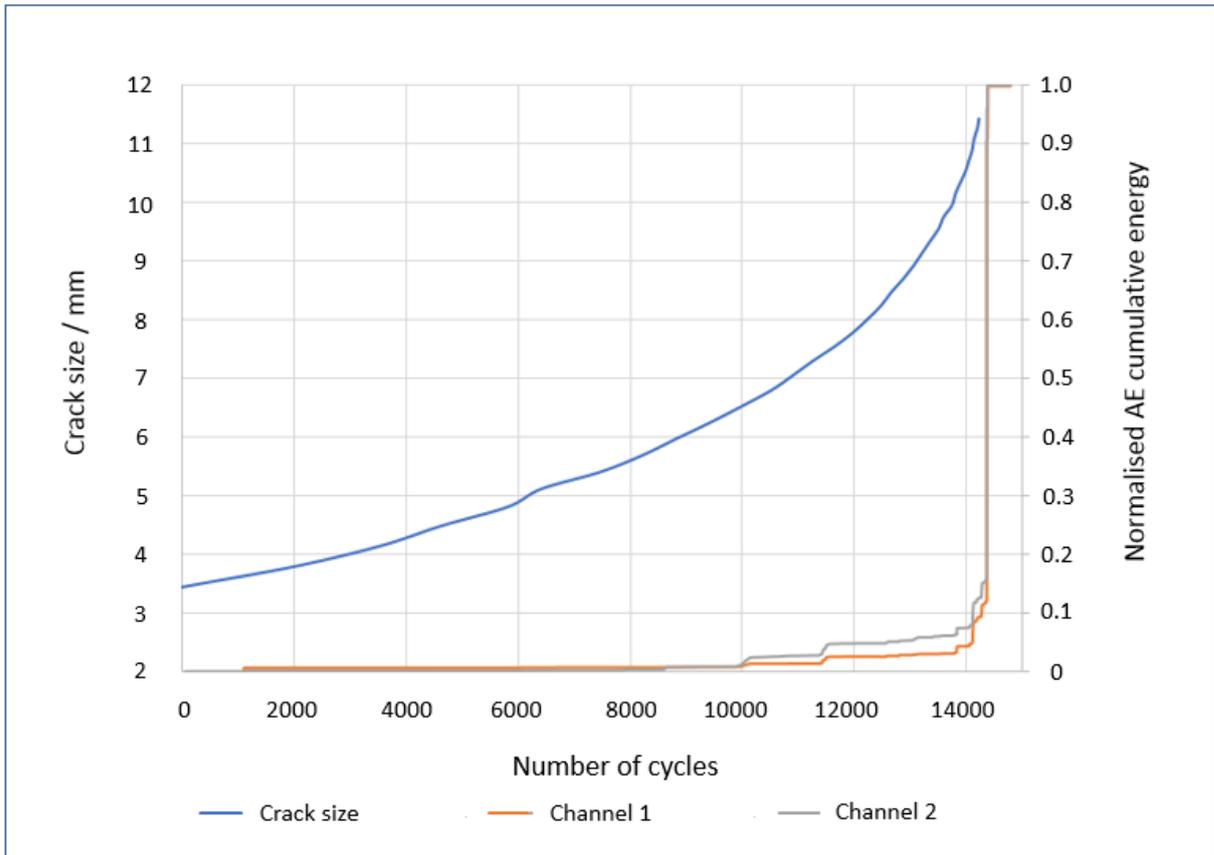
Figure 57: Normalised AE cumulative energy detected with respect to crack growth measured with DCPD and increasing loading cycles plot for R260 rail sample S5 up to final failure.

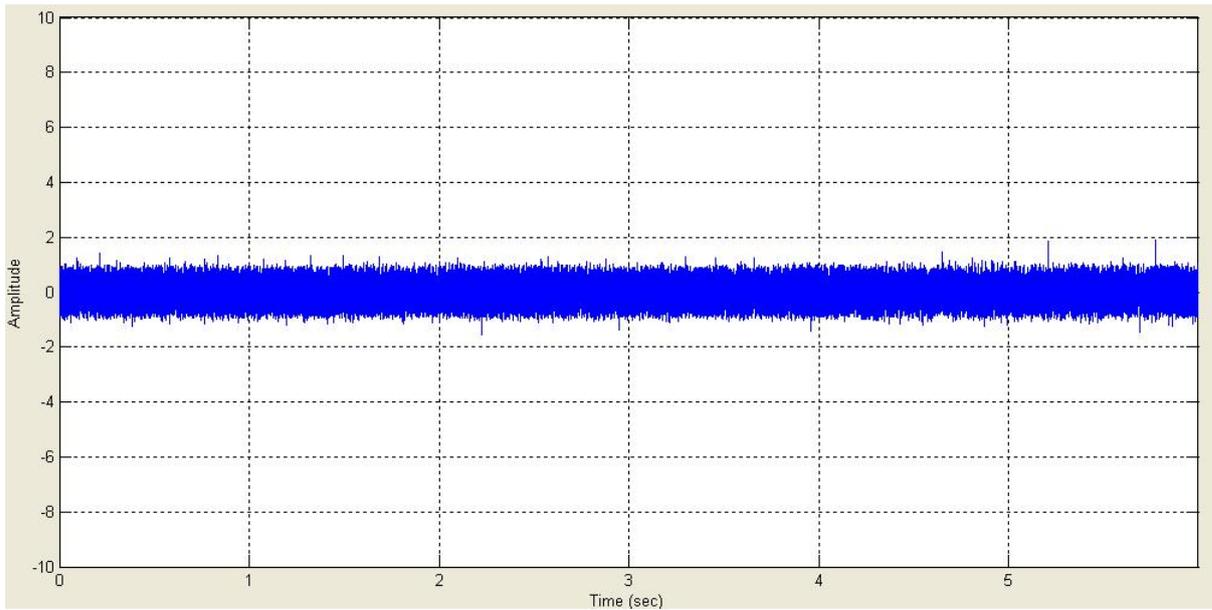
Figure 58: Raw AE waveform for Amsler test on wheel samples with no defects present.

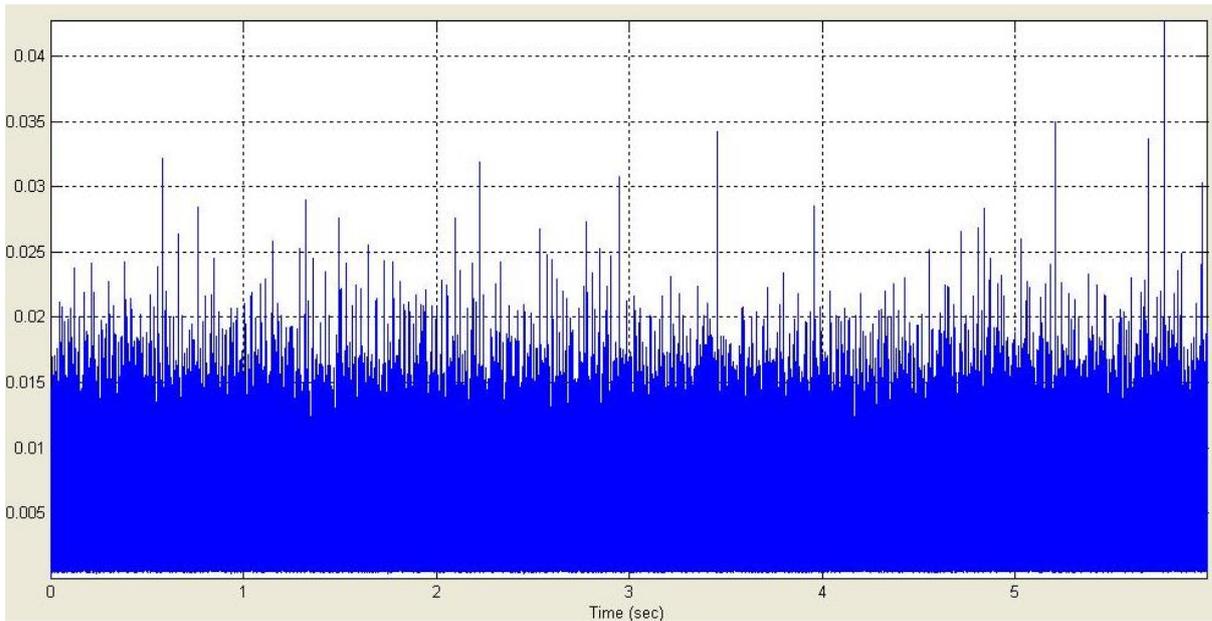
Figure 59: Moving RMS plot of the AE signal. The low intensity peaks visible are largely related to the background noise arising from a known faulty Amsler bearing and not from the sample wheels.

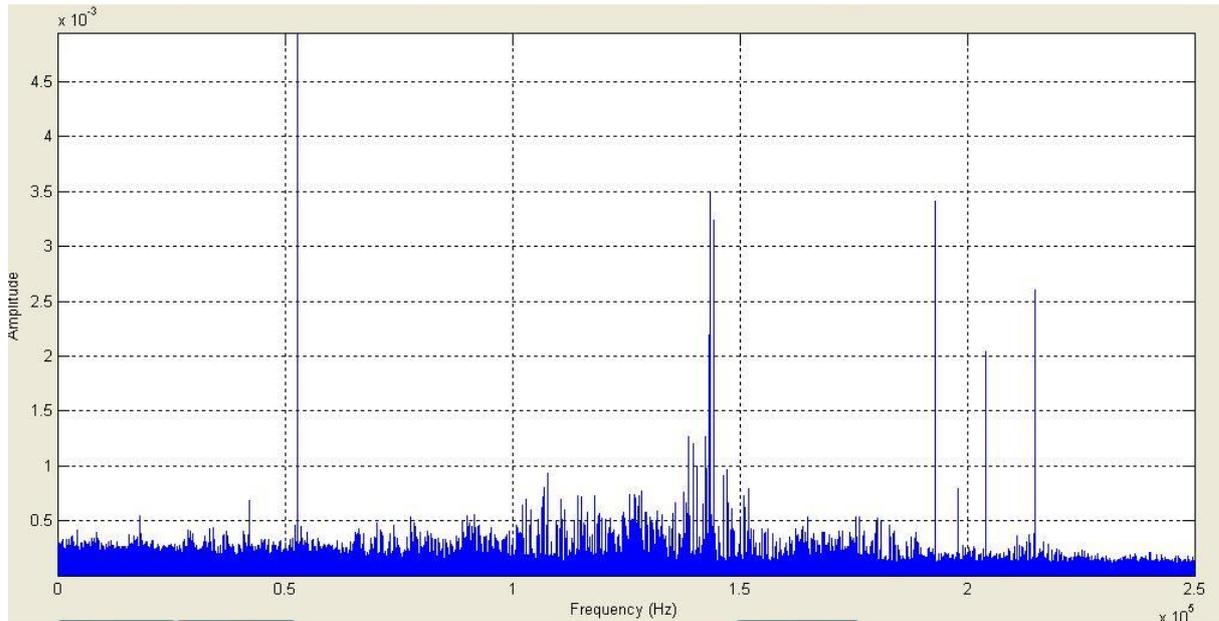
Figure 60: Power spectrum of the AE waveform captured for the wheel samples with no defects present. The peaks evident are associated with the background noise arising from the Amsler machine itself, particularly the known faulty bearing

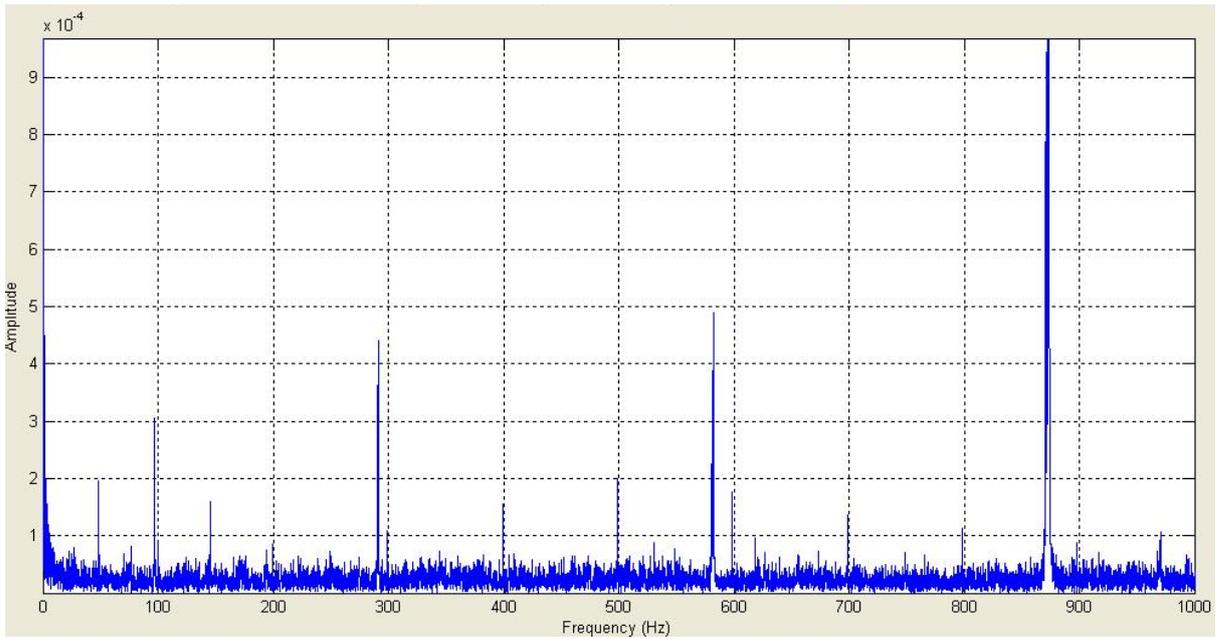
Figure 61: Spike energy plot showing some low intensity peaks (max amplitude does not exceed 10^{-3} V^2) which are associated with the bearing fault only in the Amsler machine itself and not the wheel samples which are in good condition.

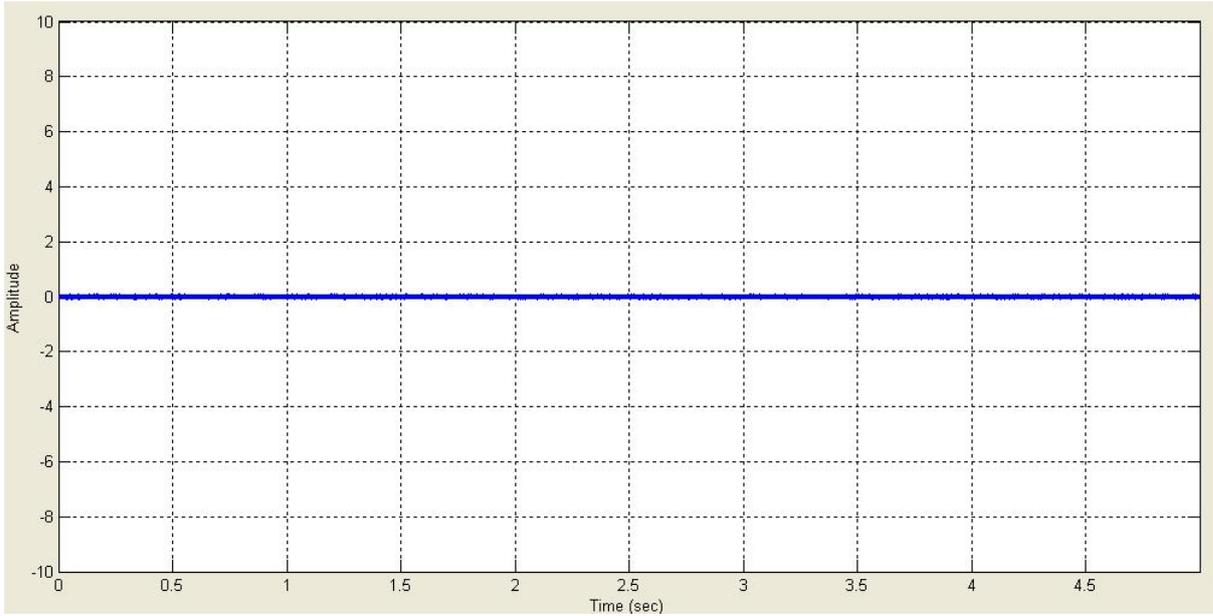
Figure 62: Raw AE waveform for the healthy wheel samples after load has been removed.

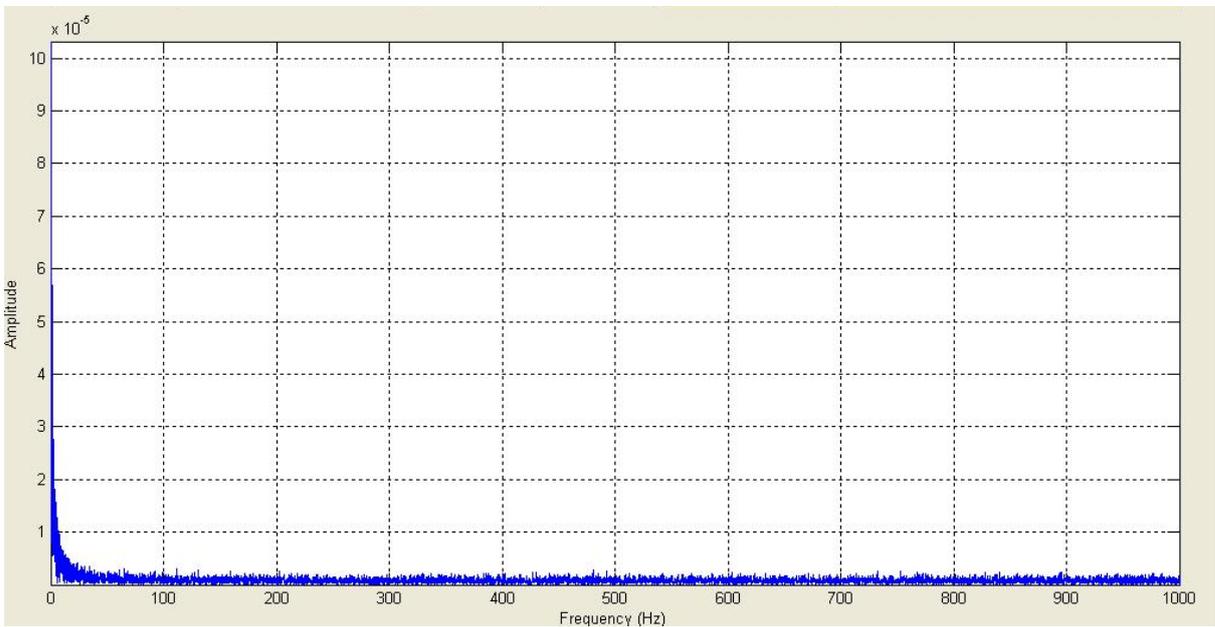
Figure 65: No peaks are evident in the spike energy plot either.

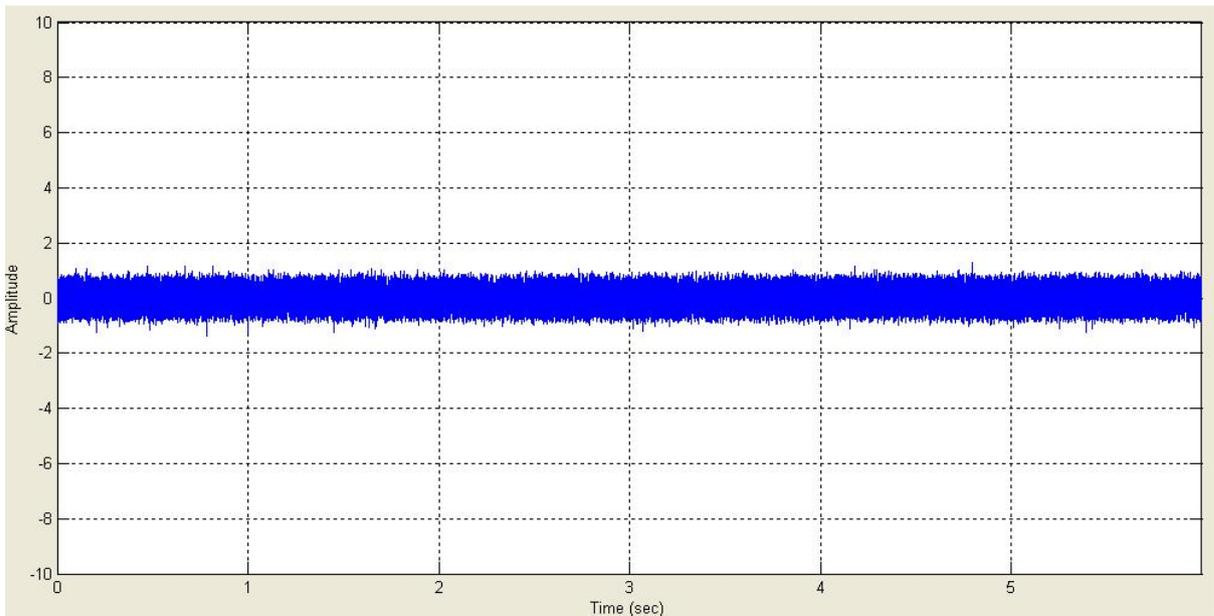
Figure 66: Raw AE waveform for the defective wheels after an 8 kg load has been applied.

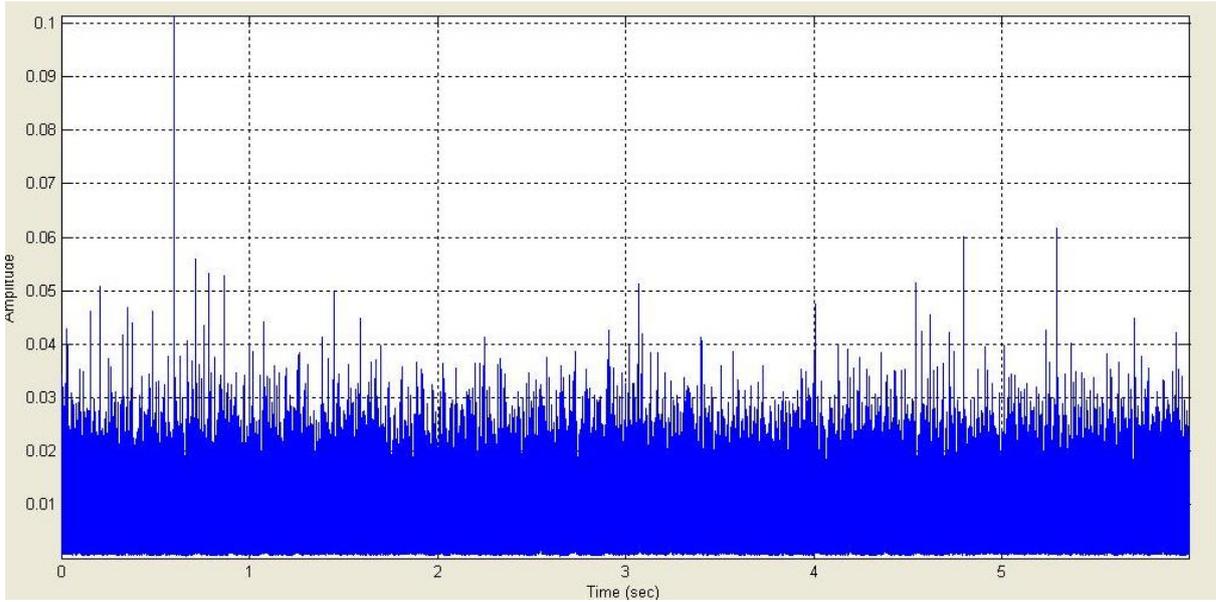
Figure 67: Moving RMS plot with several peaks present indicating the presence of a fault.

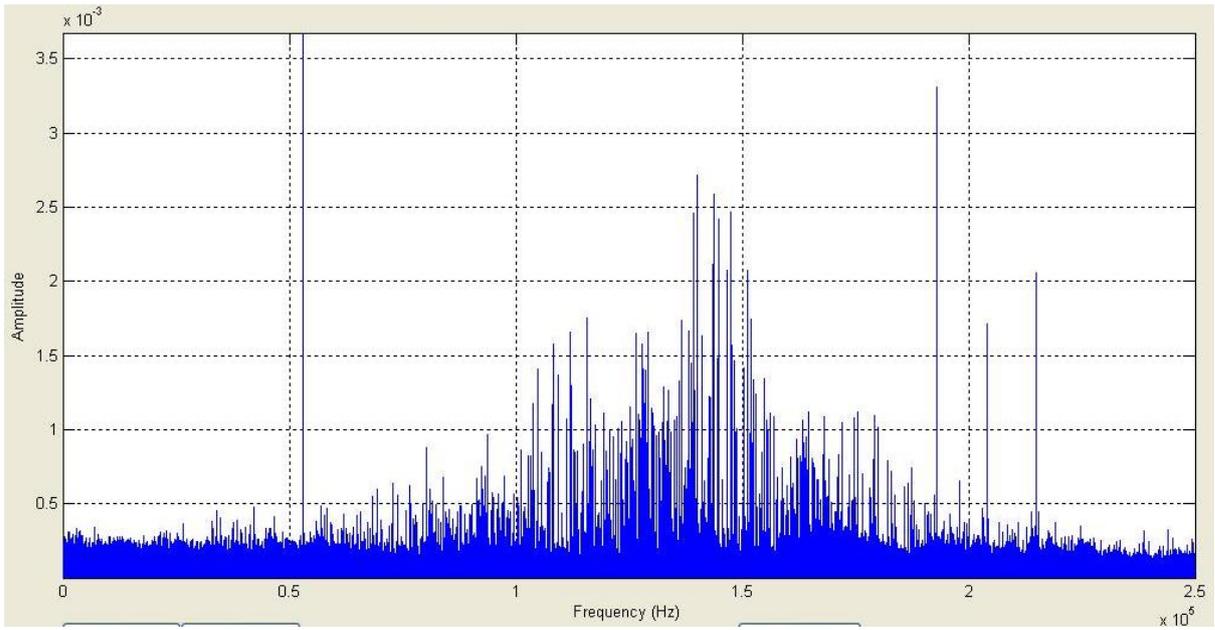
Figure 68: Power spectrum showing a much richer frequency content when the wheel defect is present in comparison with the healthy wheel setup.

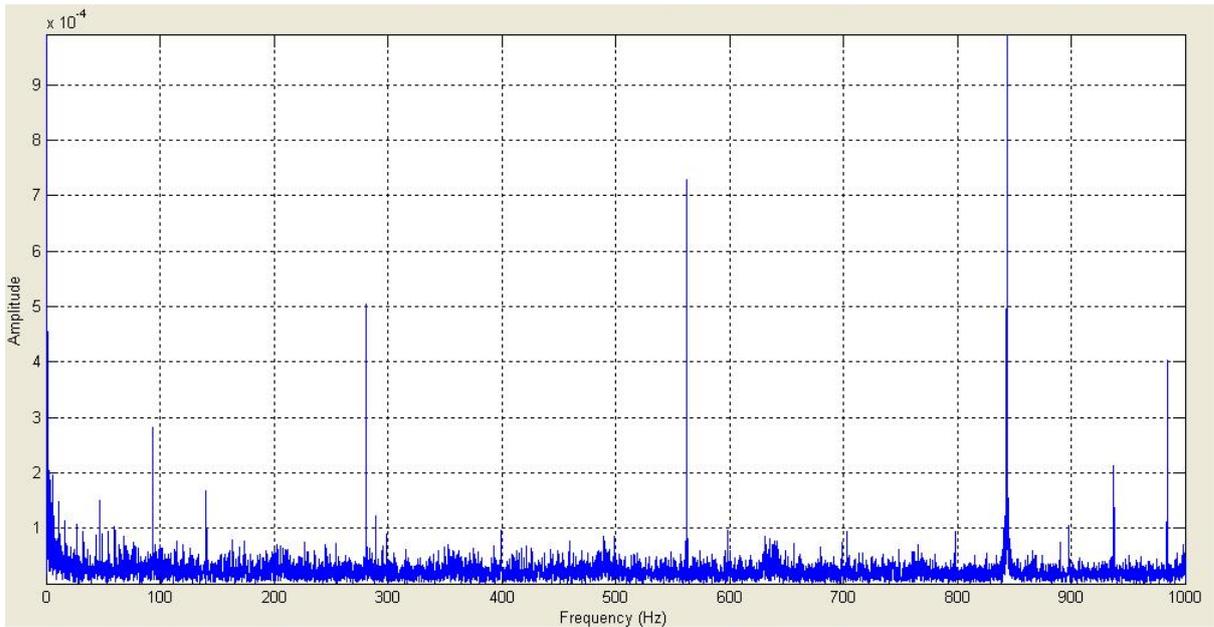
Figure 69: Spike energy plot indicating peaks at additional frequencies. However, the peaks for the bearing fault remain dominant.

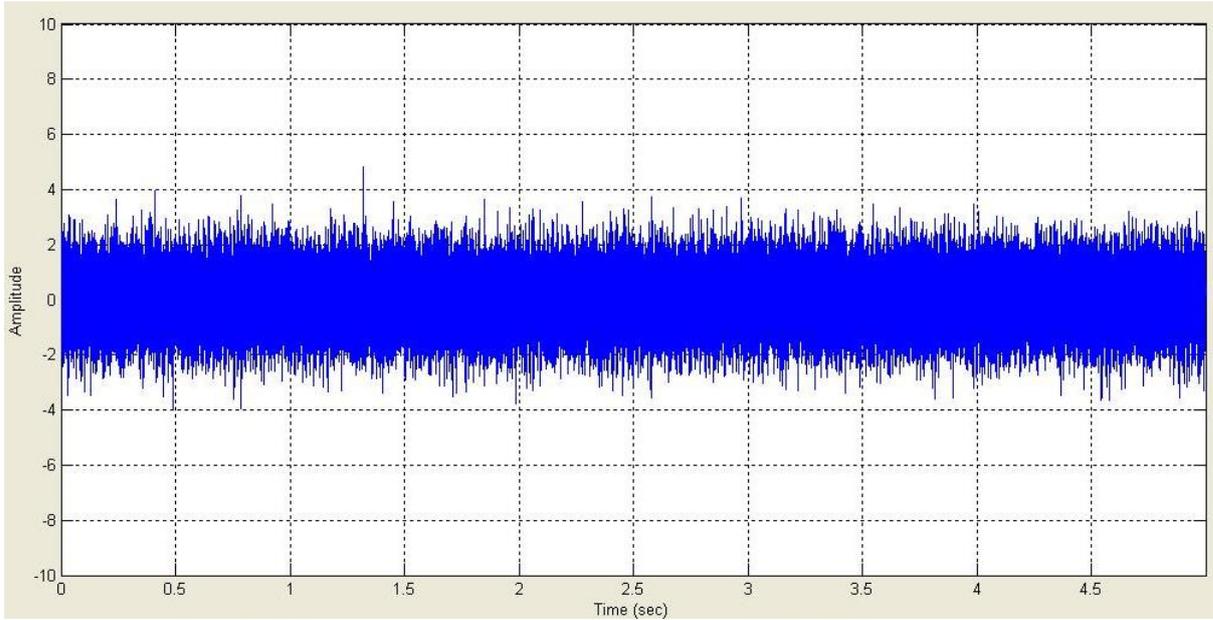
Figure 70: Raw AE waveform with multiple peaks evident above the background noise.

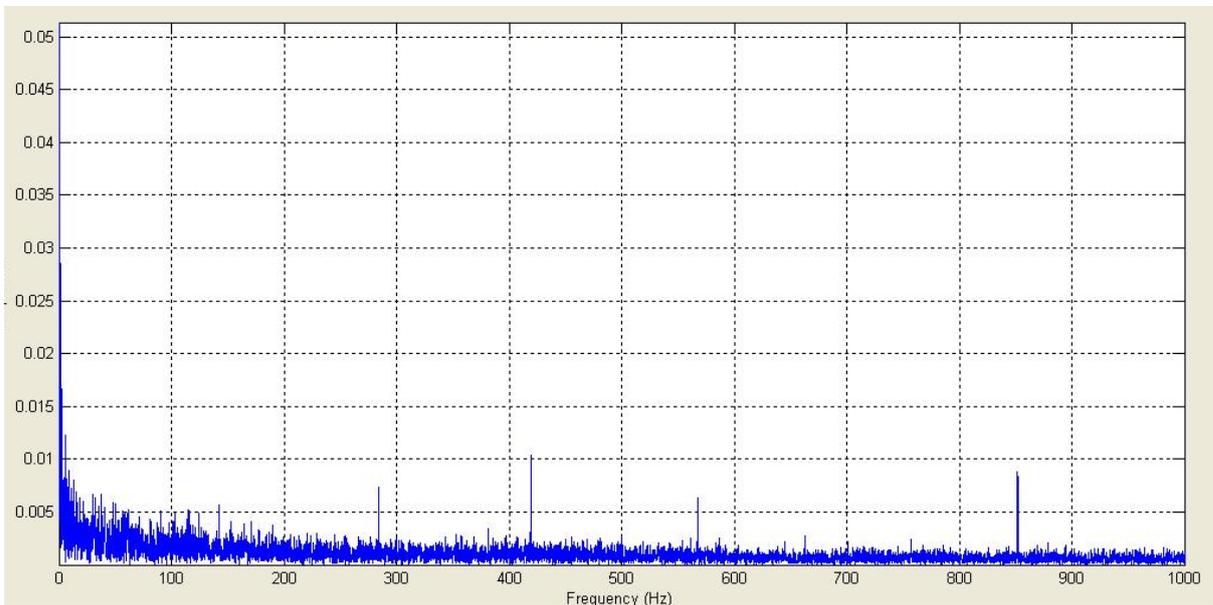
Figure 73: Spike energy plot with noticeable peaks at lower rotational frequencies associated with the rotation of the wheels. The peaks associated with the bearing fault are also still present but not as dominant as before in comparison with the wheel defect.

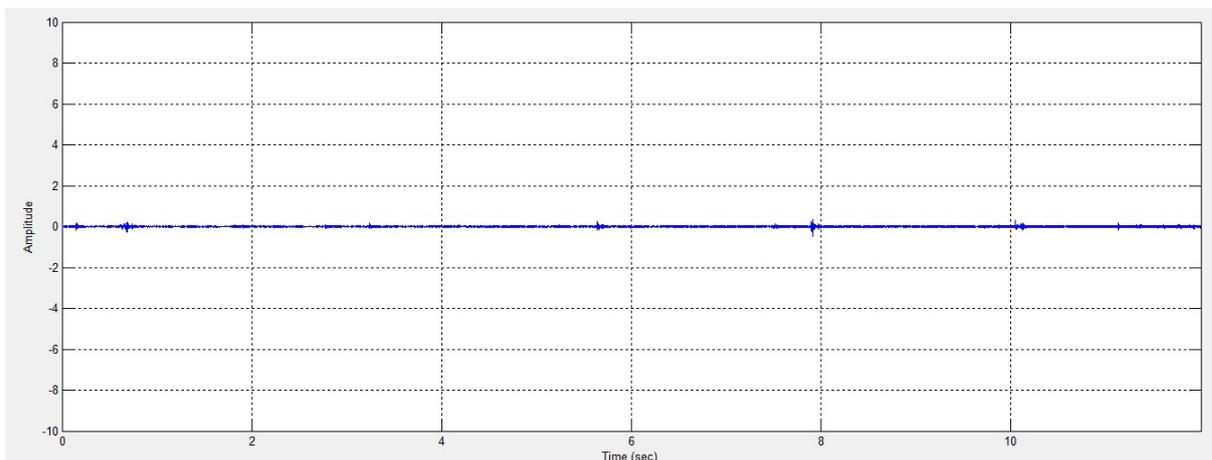
Figure 74: Onboard raw vibration signal for a healthy axle bearing.

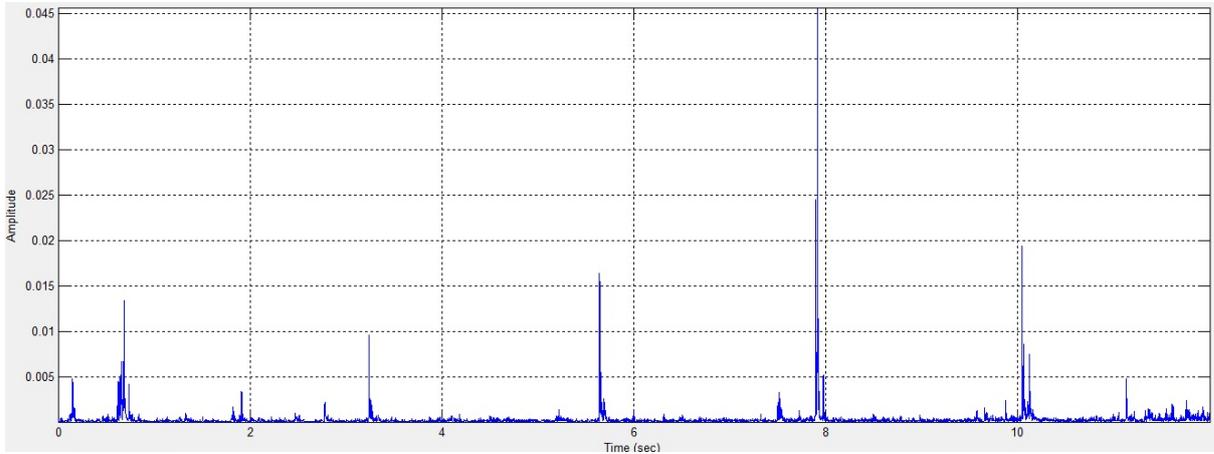
Figure 75: Moving RMS of the onboard vibration signal. The peaks are associated with joints on the track as the test train moves over them.
