**A HOLISTIC APPROACH TO REMOTE
CONDITION MONITORING FOR THE
ACCURATE EVALUATION OF RAILWAY
INFRASTRUCTURE AND ROLLING STOCK**

A thesis submitted to
The University of Birmingham
for the degree of
DOCTOR OF PHILOSOPHY

School of Metallurgy and Materials
College of Engineering and Physical Sciences
University of Birmingham
September 2019

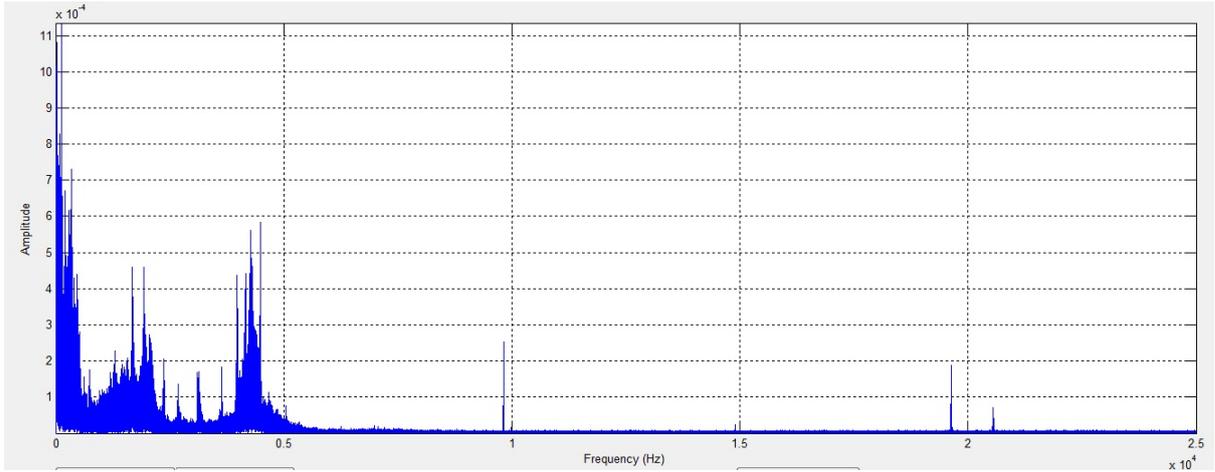
Figure 76: Power spectrum of the vibration signal. Some peaks evident are associated with the vibration arising from the movement over the joints.

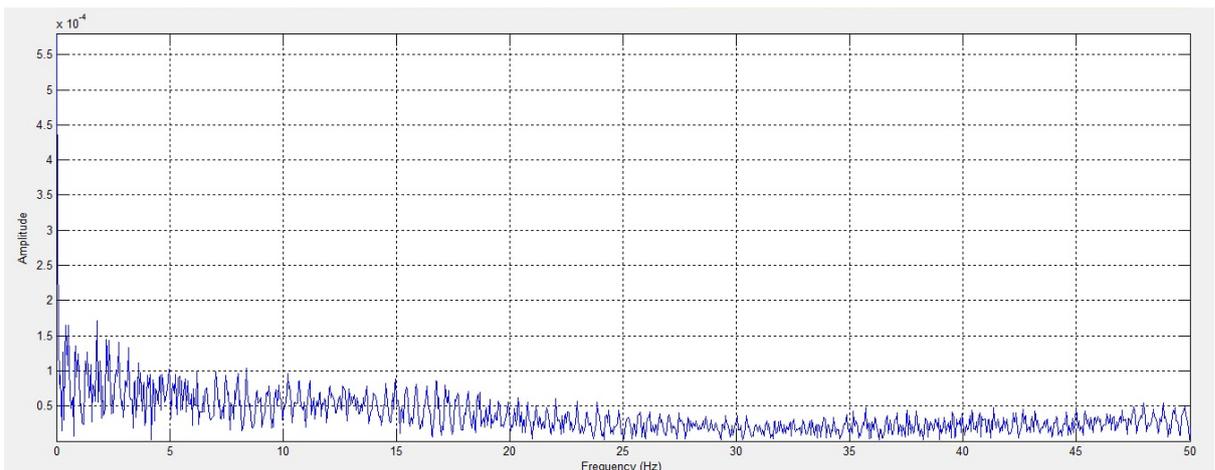
Figure 77: Spike energy plot with no peaks evident, suggesting that the monitored bearing is healthy.

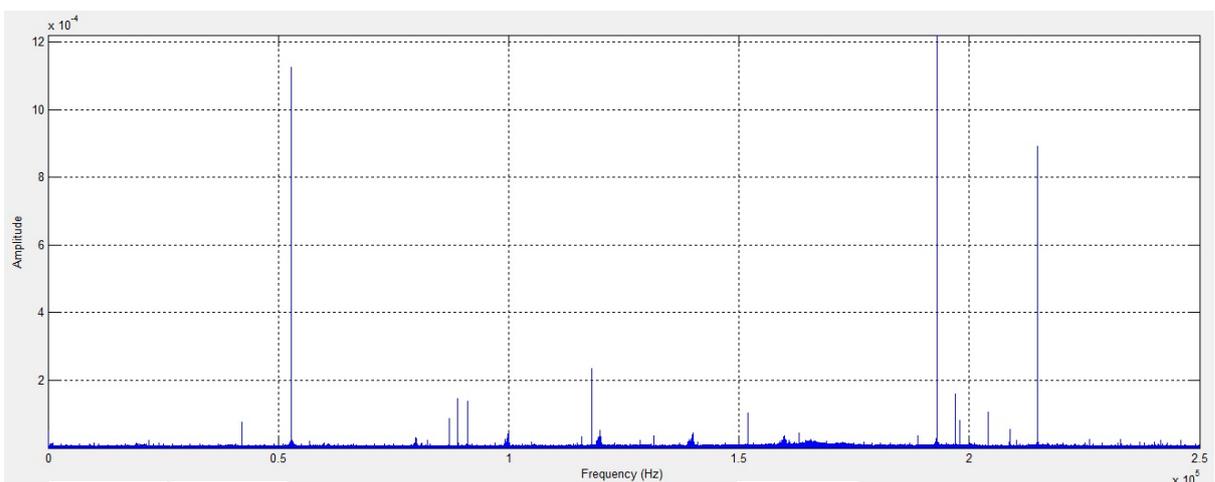
Figure 80: Power spectrum of the vibration signal for the faulty bearing showing considerable peaks at particular frequencies which are associated with the bearing fault rather than the impacts arising during the transition over the jointed parts of the track

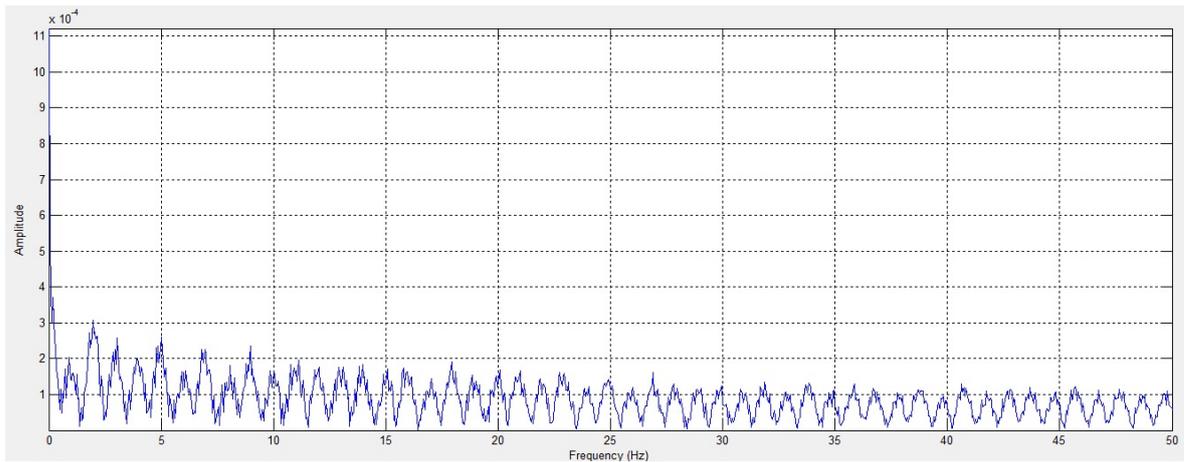
Figure 81: Spike energy plot for the vibration signal associated with the faulty bearing.

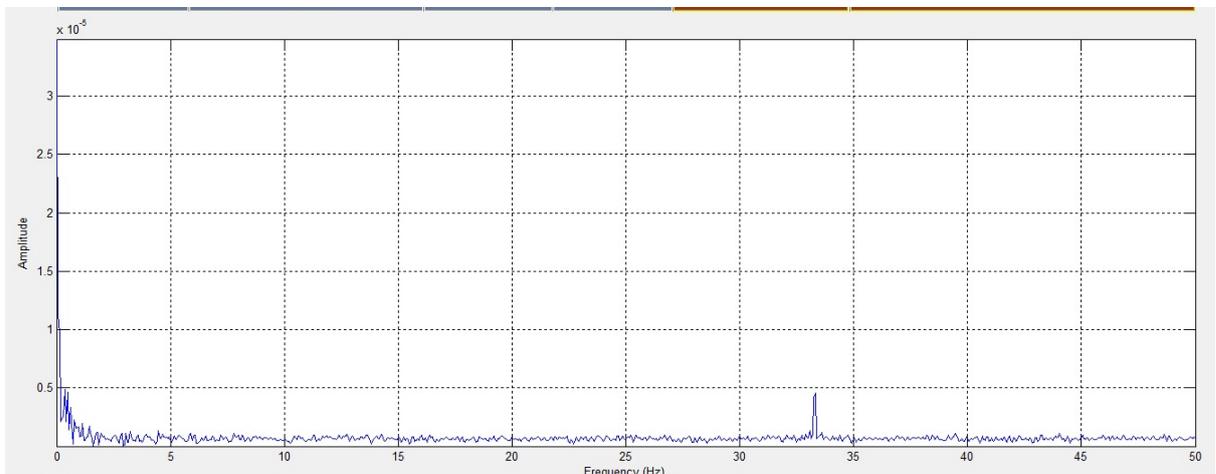
Figure 85: Spike energy plot of the AE signal. Notice the absence of any peaks with the exception of a very low amplitude peak at approximately 33.5 Hz. It is unknown what has given rise to this particular peak, but it is likely related to a background source, possibly the power axles of the locomotive pulling the test freight wagon.

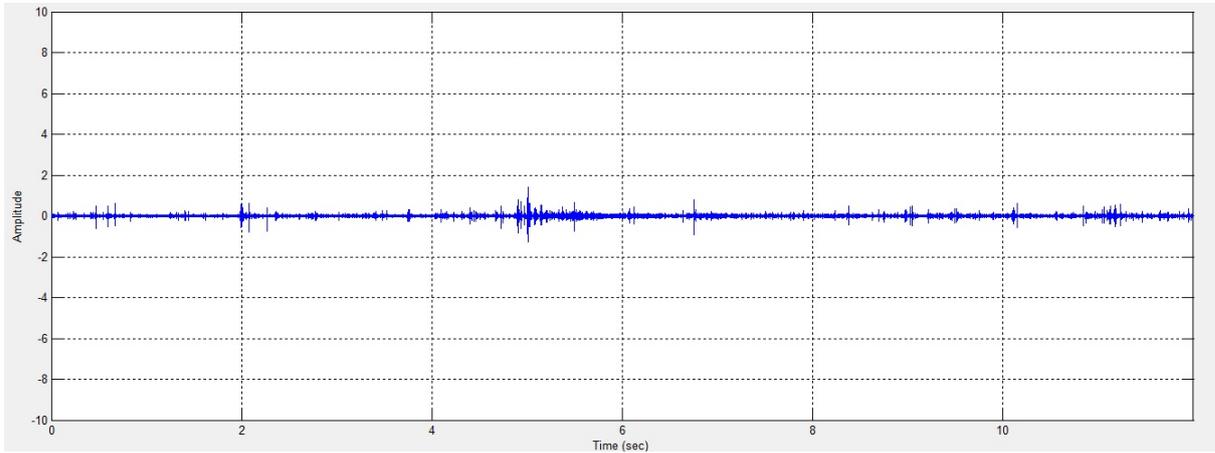
Figure 86: Raw AE waveform with multiple peaks present above the background noise level.

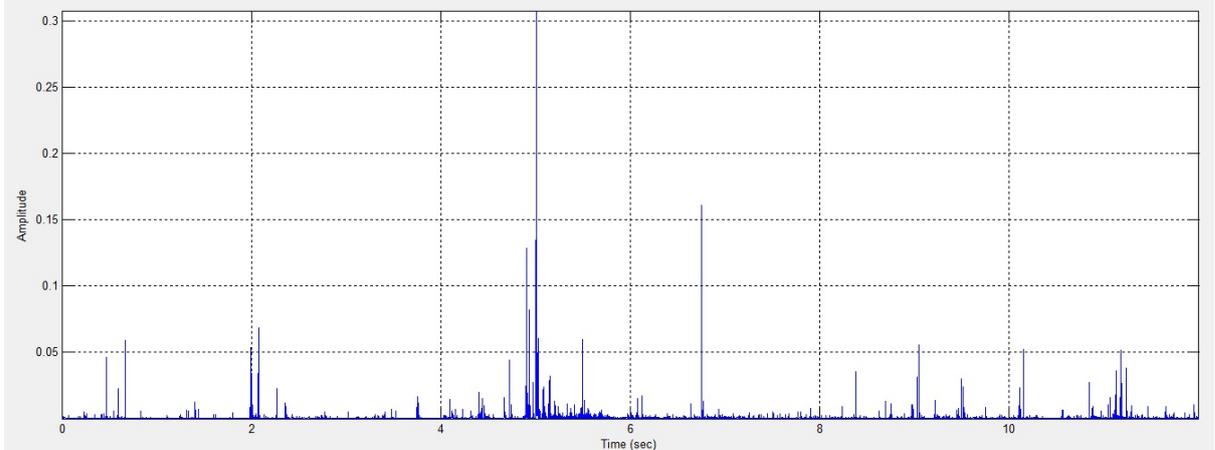
Figure 87: Moving RMS plot with several peaks present. These peaks are clearly associated with the bearing defect present.

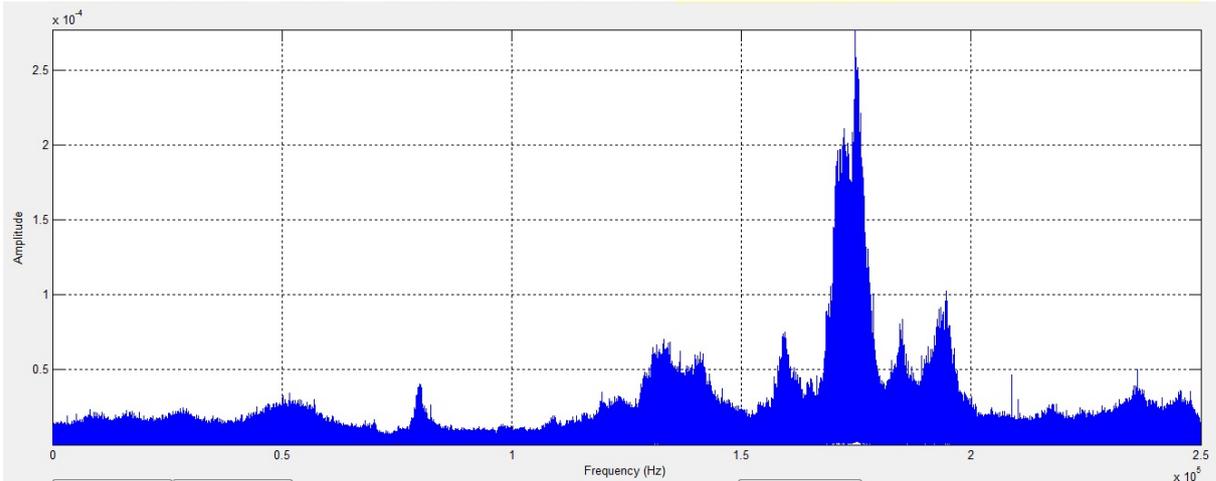
Figure 88: Power spectrum of the AE waveform for the faulty bearing. Notice the rich frequency content of the signal particularly between 130 kHz to 200 kHz in comparison with the power spectrum for the healthy condition.

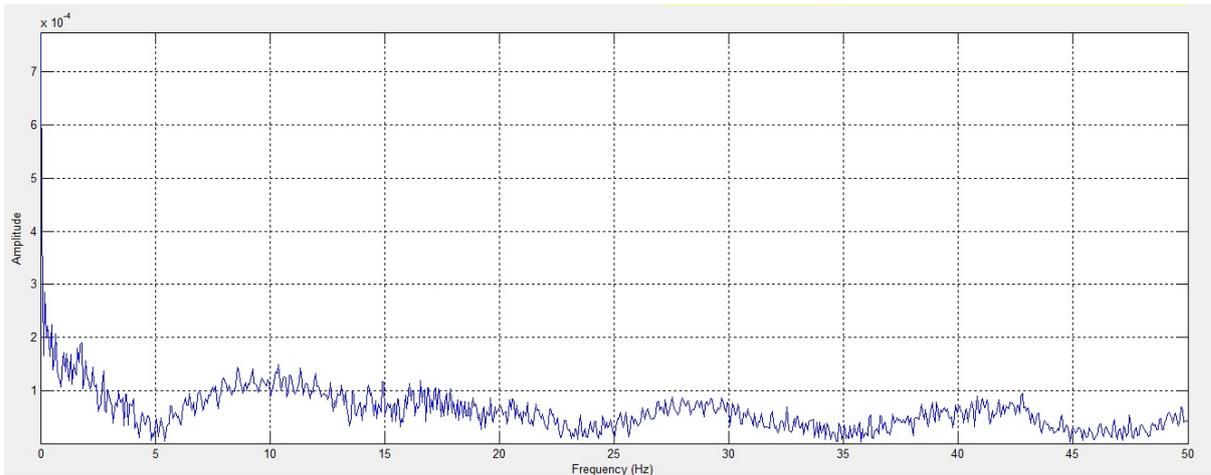
Figure 89: Spike energy plot not showing any useful information in this particular instance.

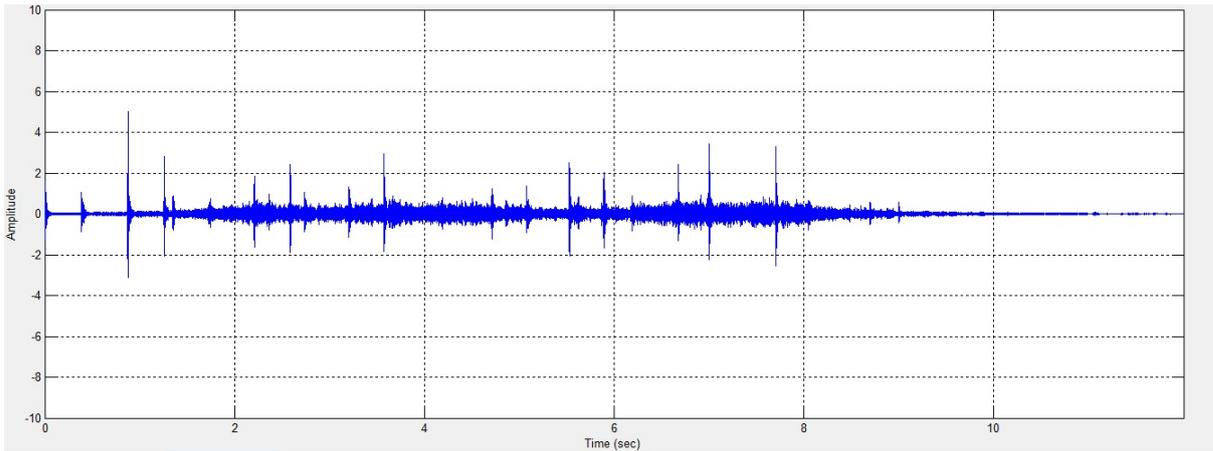
Figure 90: Wayside vibration signal for rolling stock with contaminated axle bearings. Clear peaks above the background noise are detectable.

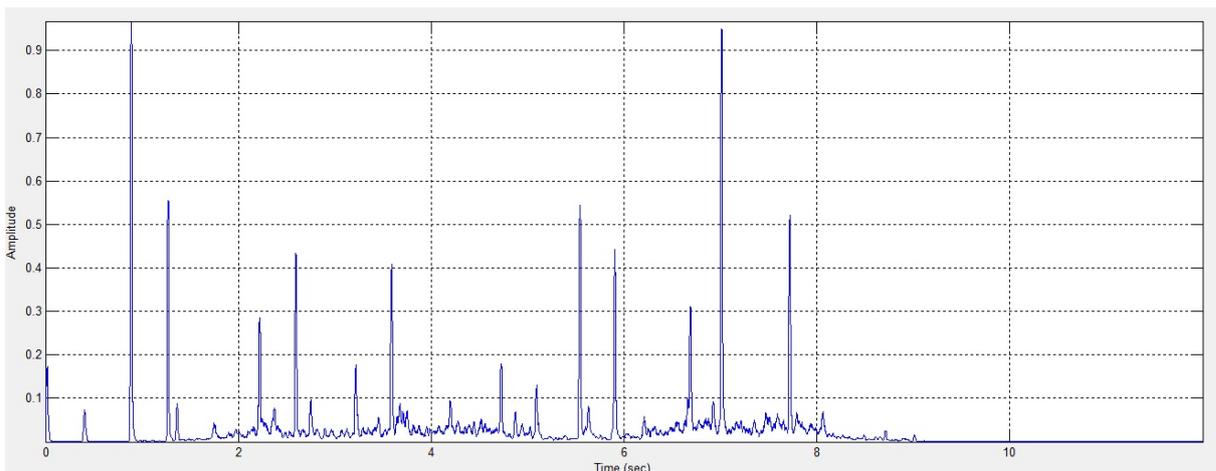
Figure 91: Moving RMS of the vibration signal indicating the high energy content of the peaks observed in the raw AE signal. These are associated with the axle bearing defect as well as the vibrational response to the transition of the wheel trains over each joint along the track section being monitored.

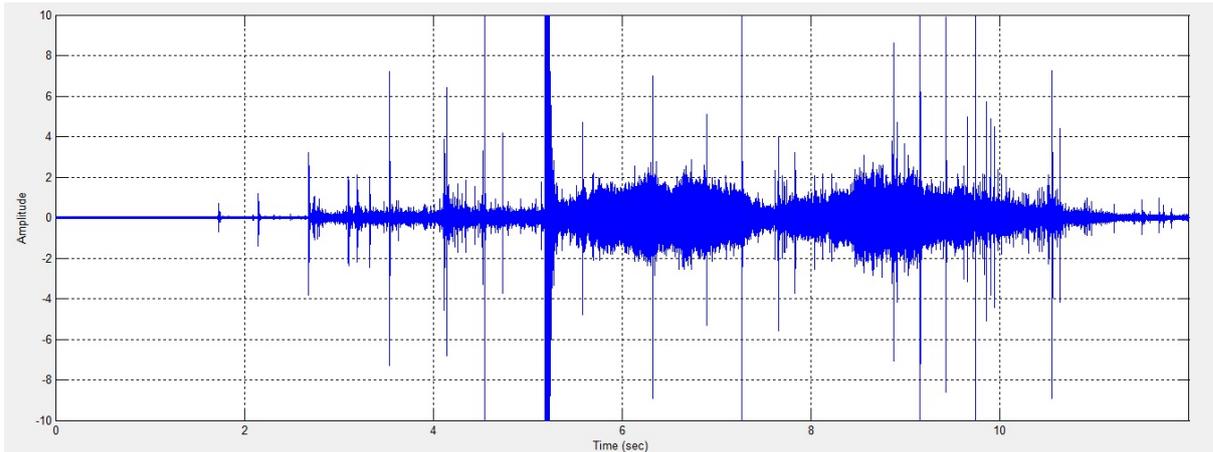
Figure 92: Raw AE waveform taken wayside. Multiple peaks are clearly observed

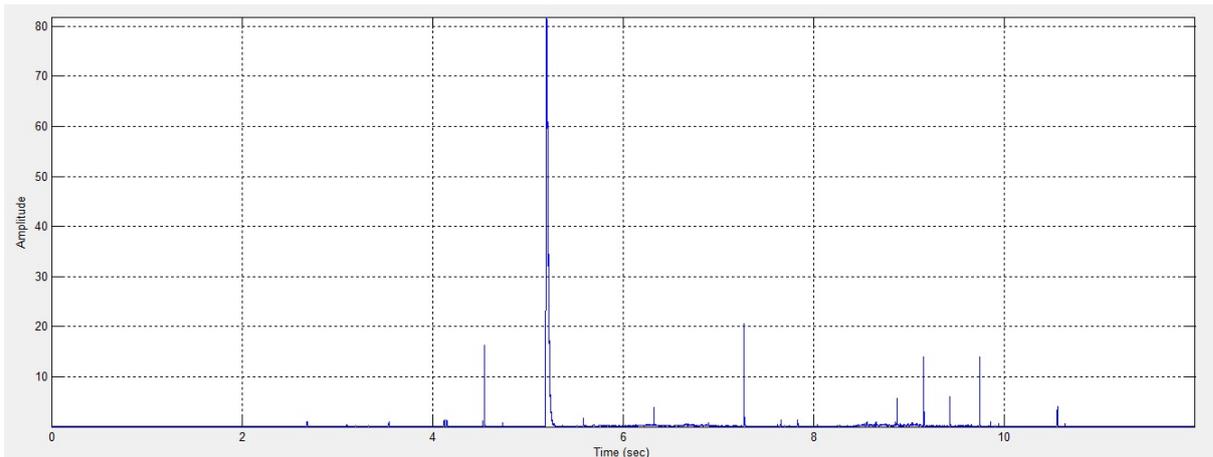
Figure 93: Moving RMS signal showing the presence of the axle bearing defects as well as the presence of the artificially induced flat in one of the wheels of the test train.

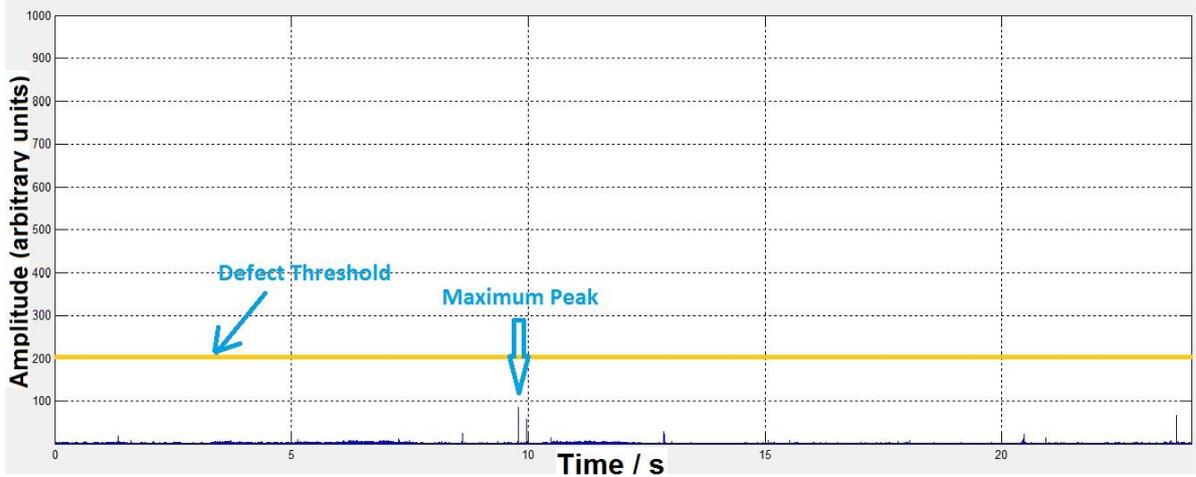
Figure 94: a) Raw AE data acquired from a healthy bearing and b) its moving RMS plot using a filtering time window of 60 points.

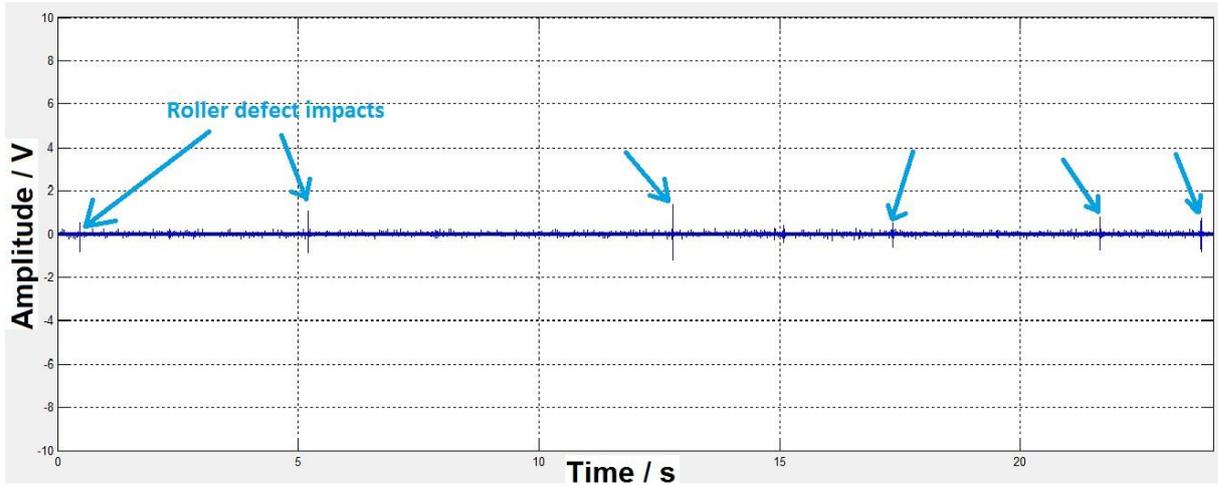
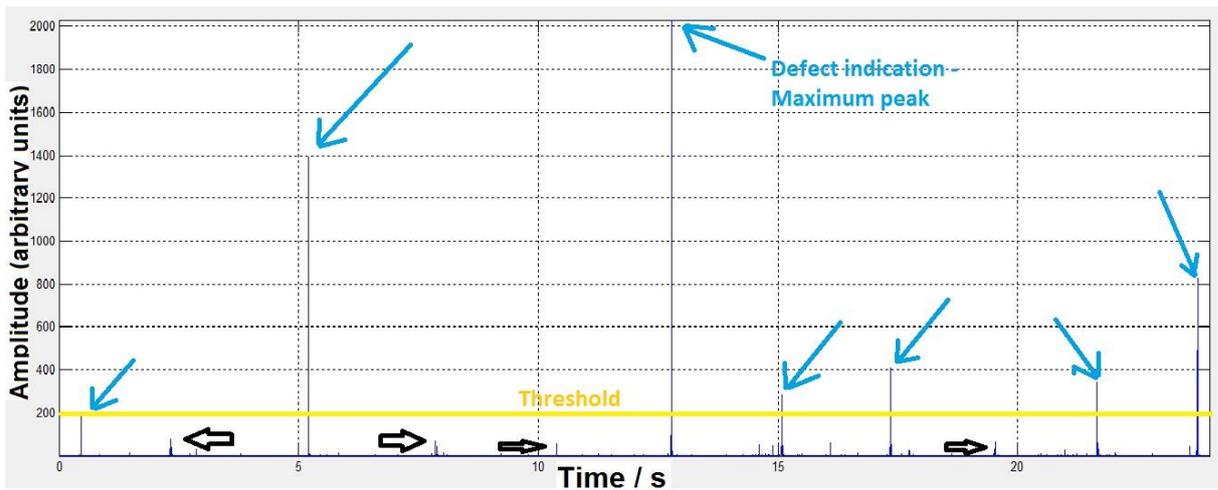
Figure 95: a) Raw AE data acquired from a bearing with a 4 mm roller defect and b) RMS processed results. Notice the amplitude of the strong RMS peaks

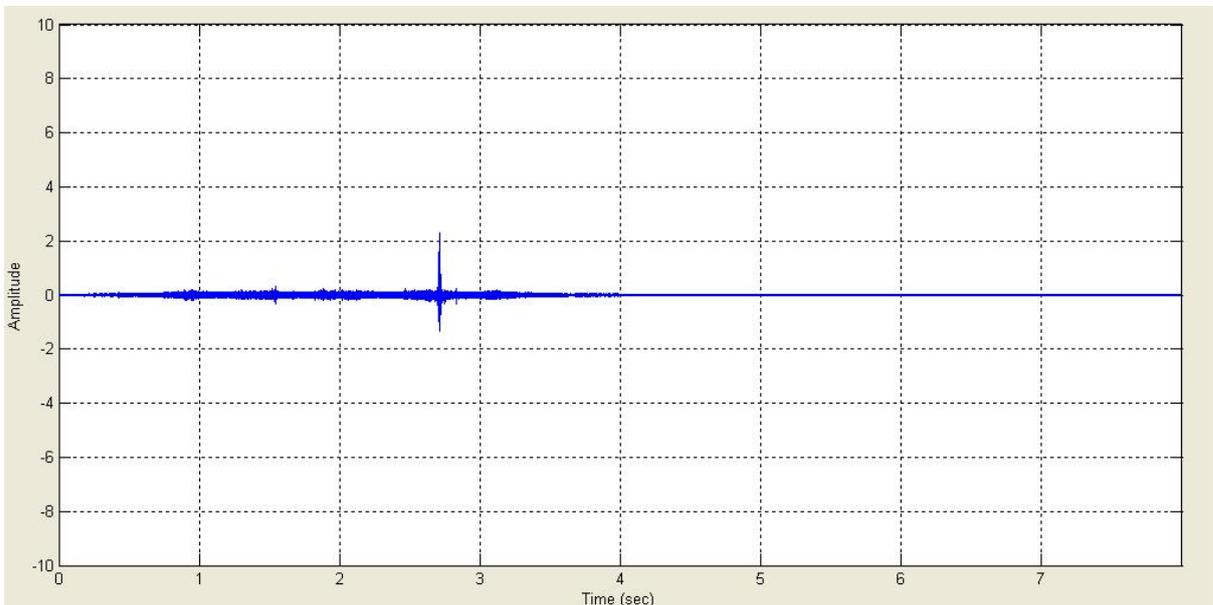
Figure 96: Raw AE signal for passenger train. The peak observed at the end of the signal is associated with a power axle causing sliding of the wheel as it moves along the track, generating additional noise captured by the AE sensor.

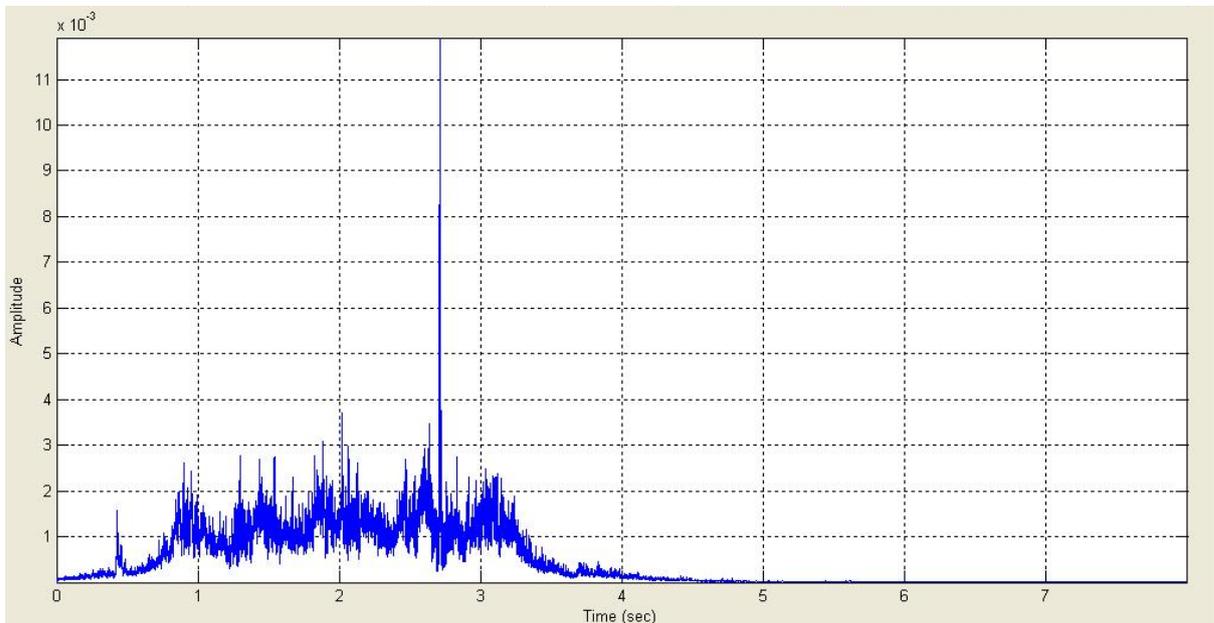
Figure 97: The corresponding moving RMS signal for a passenger train moving over the instrumented site.

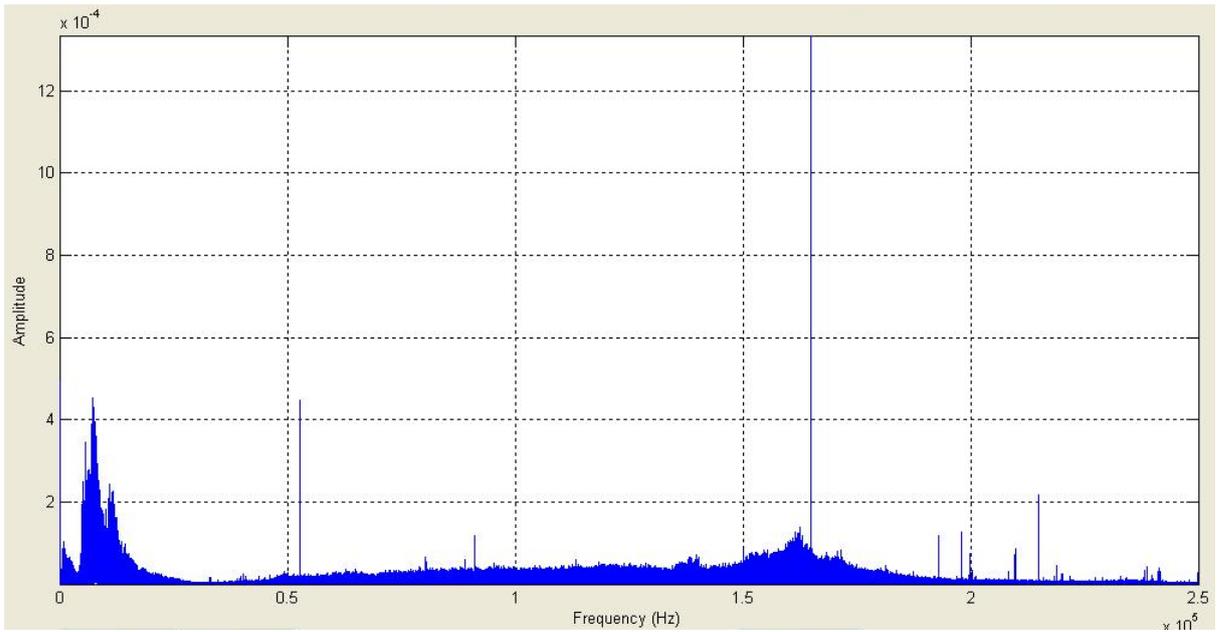
Figure 98: Power spectrum with relatively low amplitude peaks associated with background noise sources alone.

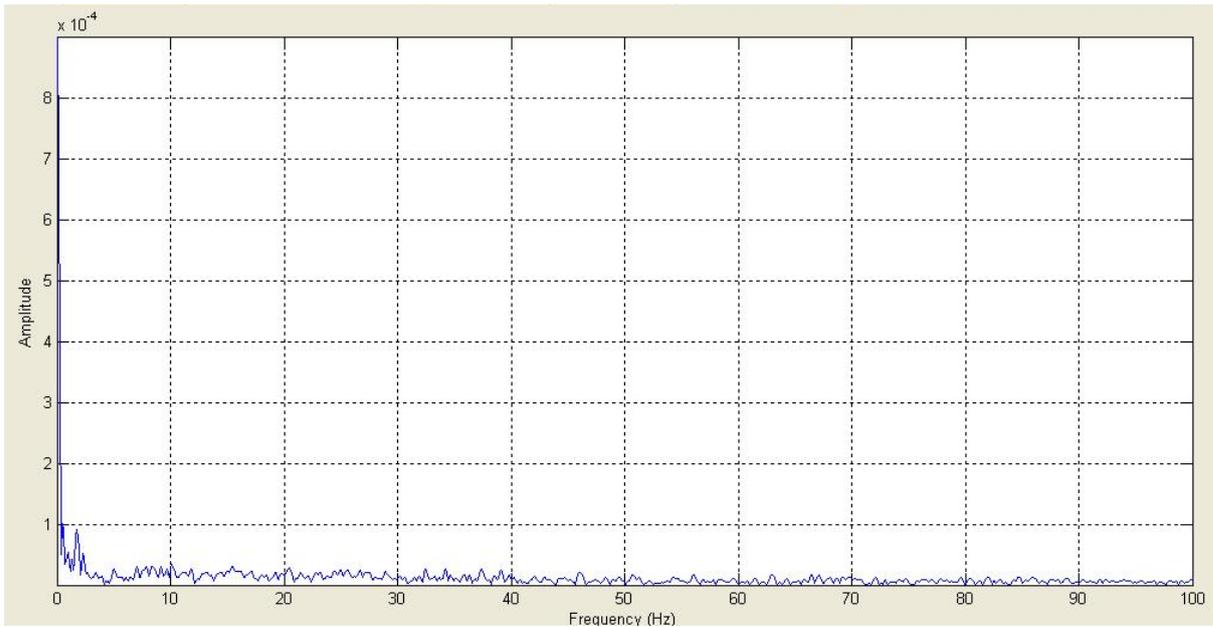
Figure 99: Spike energy plot indicating no wheel or axle bearing defect is present.

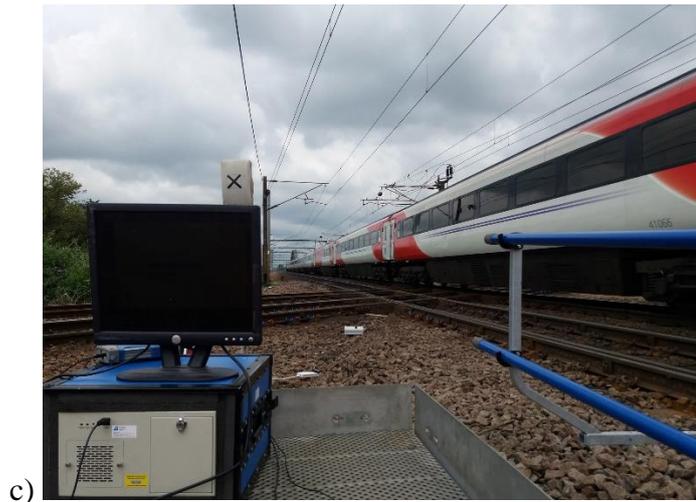
Figure 100: a) Photograph of the Newark flat crossing, b) the installation process of the AE system overnight and c) measurement setup and example rolling stock moving over the crossing at normal operational speed.

Newark flat crossing is located on the East Coast Main Line. The maximum permissible train speeds are 125MPH up (towards Lincoln) and 100MPH down (towards Newark). From East to West the maximum permissible train speeds are 25 MPH and 50 MPH from West to East. The crossing is used by both passenger and freight trains. The photograph's in Figure 100 show the Newark crossing and the measurement setup.

Network Rail had decided to replace the Newark flat crossing after approximately 15 years in service. Before replacing the aforementioned crossing, Network Rail had decided to evaluate the structural integrity while it was still in-service using AE.

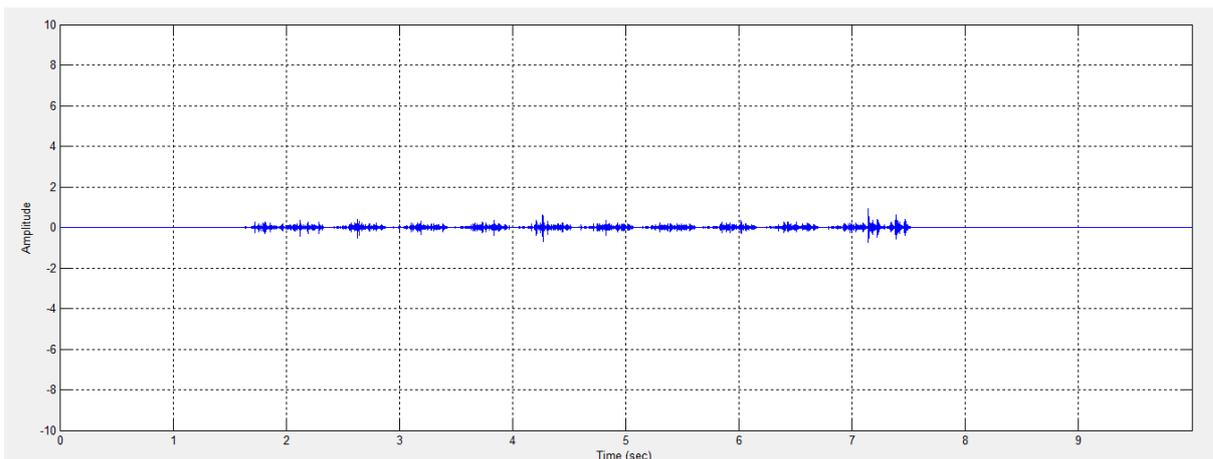
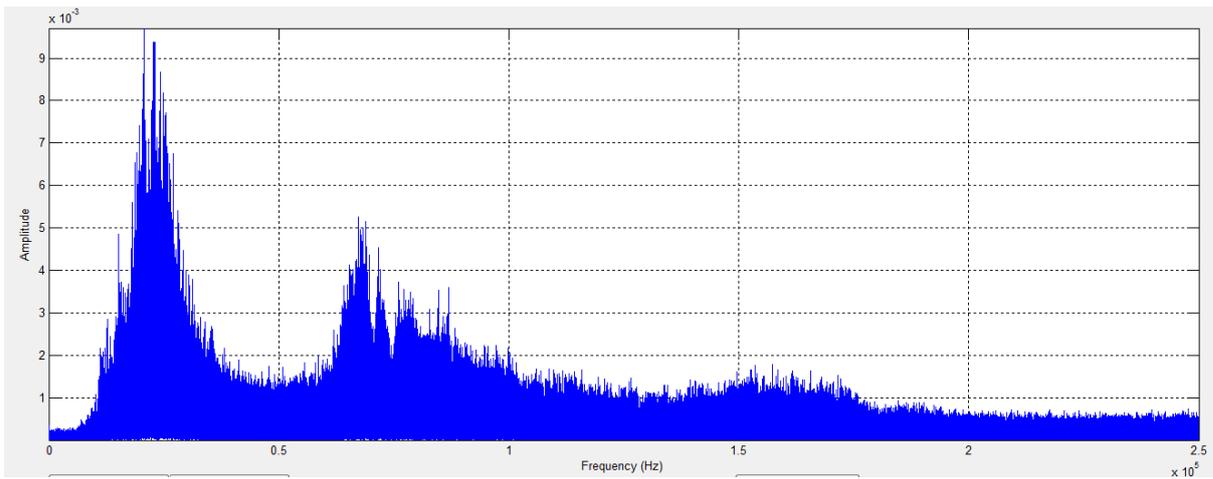
Figure 101: a) and c) raw AE waveforms acquired at Newark flat crossing and b) and d) corresponding power spectra indicating low frequency content above 100 kHz. This suggests that there is no crack propagation occurring which would result in peaks at higher frequencies being clearly observed.

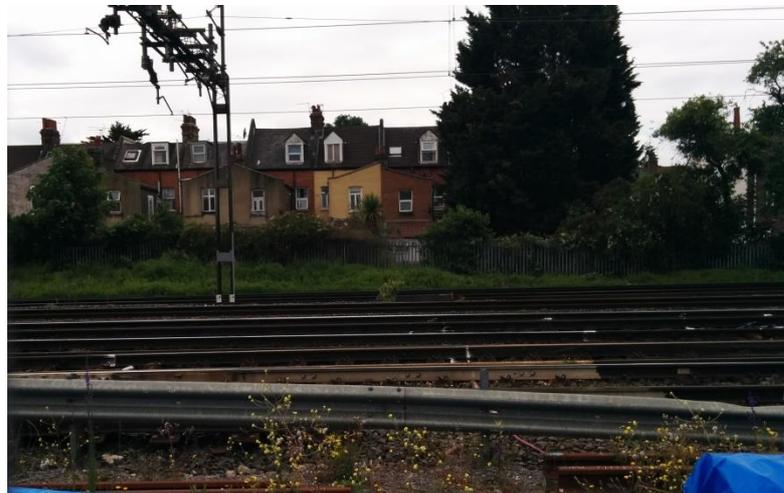
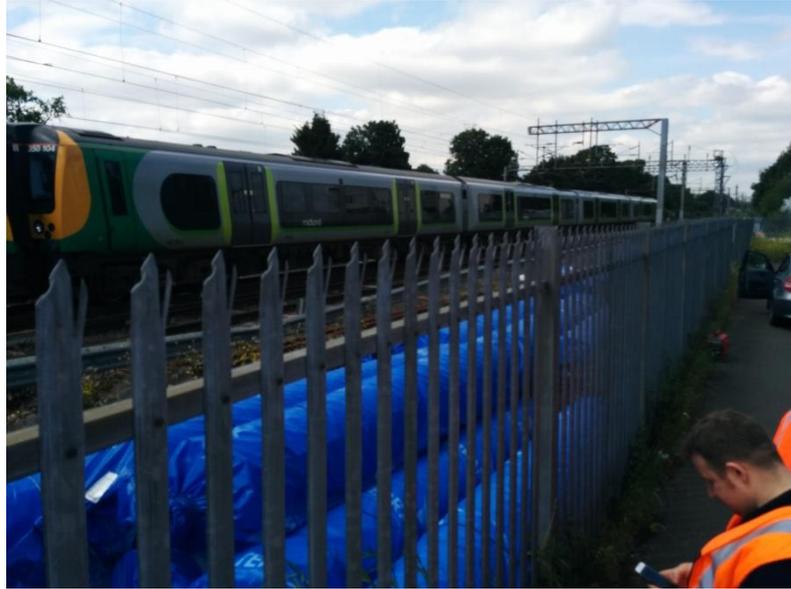
Figure 102: Photographs showing the: a) the crossing measured and b) indicative traffic.

The photographs in Figure 102 show the crossing measured in the area of Wembley, on the West Coast Main Line. The crossing had been recently replaced and hence, no defects were expected to be found. This was also confirmed by the AE measurements. The plots in Figure 103 provide very similar results to those observed for the crossing at Newark. In this particular case the sampling rate has been set at 1 MSamples/s.

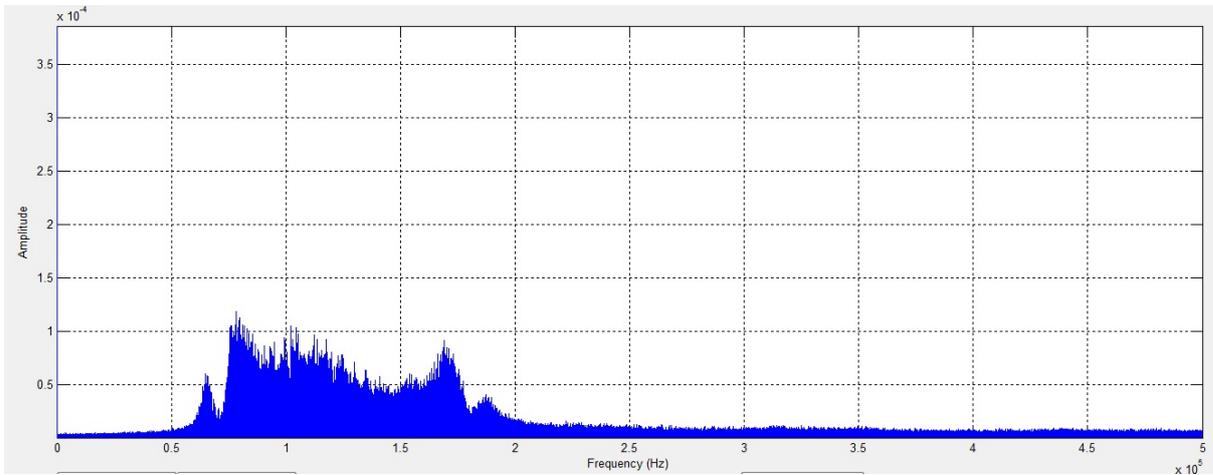
Figure 103: a) and c) raw AE waveforms acquired at Wembley crossing and b) and d) corresponding power spectra indicating low frequency content above 100 kHz. This suggests that there is no crack propagation occurring which would result in peaks at higher frequencies being clearly observed.

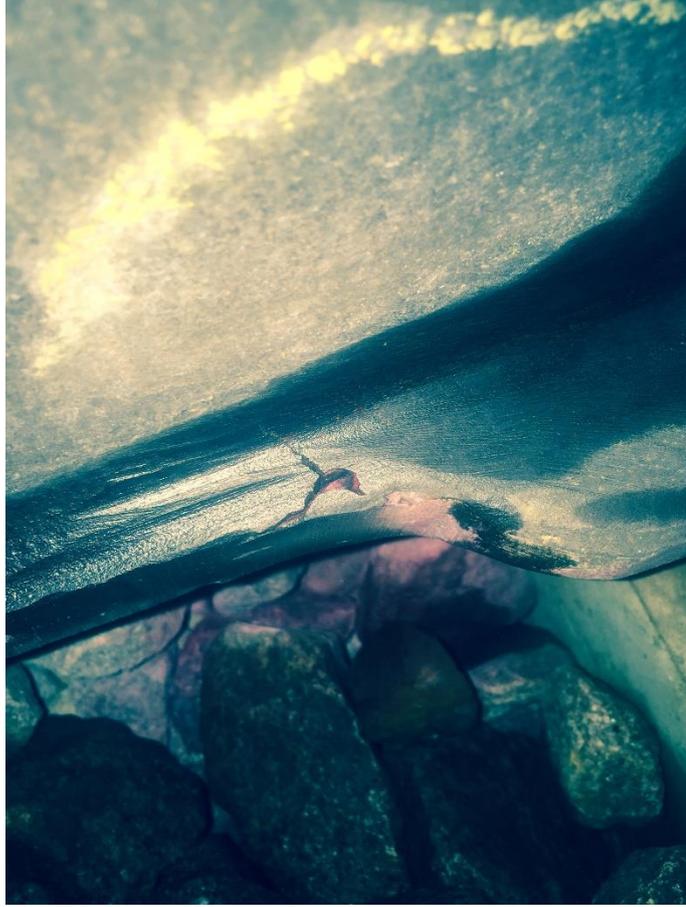
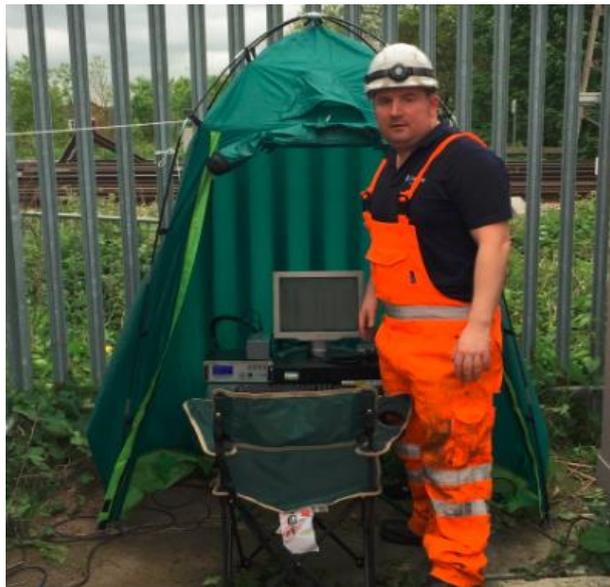
Another crossing measured on the West Coast Mainline in the area of Watford was identified as severely damaged and was due for replacement by the maintainer. There was substantial interest to monitor this particular crossing with AE. The experimental setup and defective crossing in Watford are shown in the photographs in Figure 104. Although passenger trains did not yield any additional damage, when the crossing was loaded by a heavy freight train clear peaks were detected on the AE waveform captured. These peaks and overall signal characteristics were identical to those signals observed for the cast manganese steel samples tested under three-point bending fatigue conditions.
