CRACK GROWTH IN ALLOY 709 AT HIGH TEMPERATURES UNDER FATIGUE, CREEP AND DWELL-FATIGUE LOADS

JIN YAN

A thesis submitted to University of

Crack growth tests were conducted under fatigue (0.25 Hz), dwell-fatigue (1 hour hold time at maximum load) and creep (static) loading using compact tension specimens.

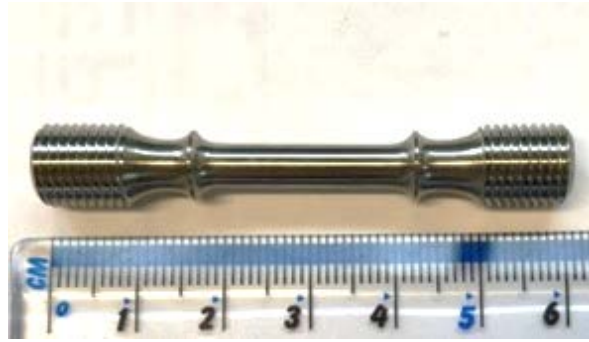
Figure 3.1 Macrograph of the tensile testpiece.

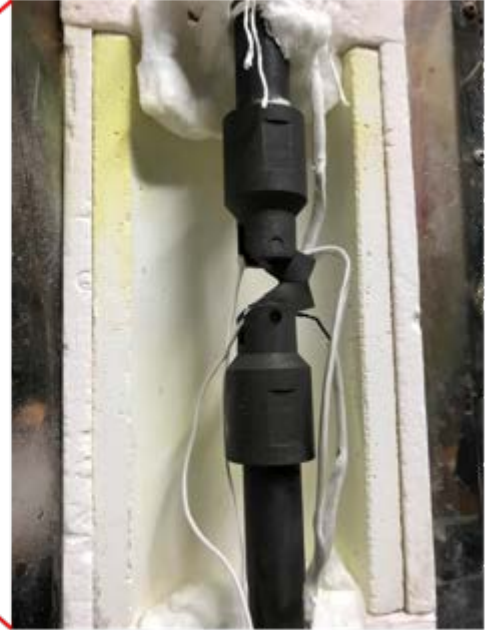
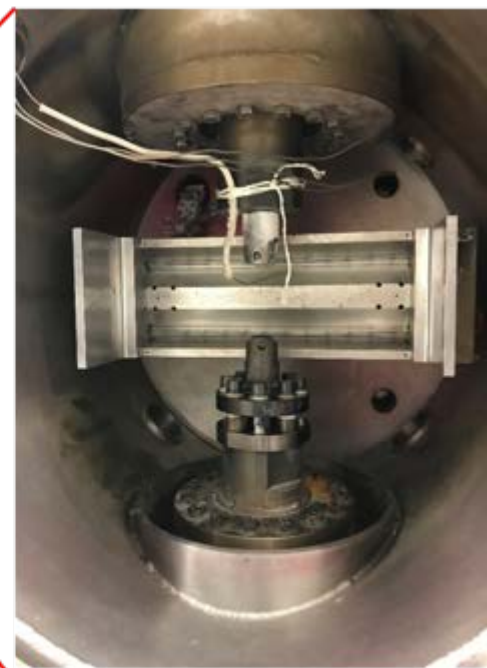
Figure 3.5 (a) and (b) Instron 8501 screw driven testing machine with a ceramic line resistance furnace and d.c.p.d unit; (c) and (d) ESH servo-hydraulic testing machine with a vacuum chamber and d.c.p.d unit.

CT specimens were first fatigue precracked at RT using an Amsler vibrophore machine with a frequency ~50 Hz and an R ratio of 0.1. After precracking, the crack length was normally ~1 mm and the final ΔK value was ~15 MPa \sqrt{m} . For air tests, the CT specimens were transferred to an Intron 8501 screw driven machine (Figures 3.5a and b) with a load cell of 100 kN, which is suitable for the load in this study (8 kN). The testing temperatures used were 550, 650 and 750°C. An ESH servo-hydraulic mechanical test machine equipped with a vacuum chamber was used for the vacuum tests, see Figures 3.5c and d. The heat was provided by four quartz-halogen lamps which are fitted inside the chamber. During the vacuum tests, the vacuum level of $\sim 1.5 \times 10^{-5}$ mbar was achieved in the

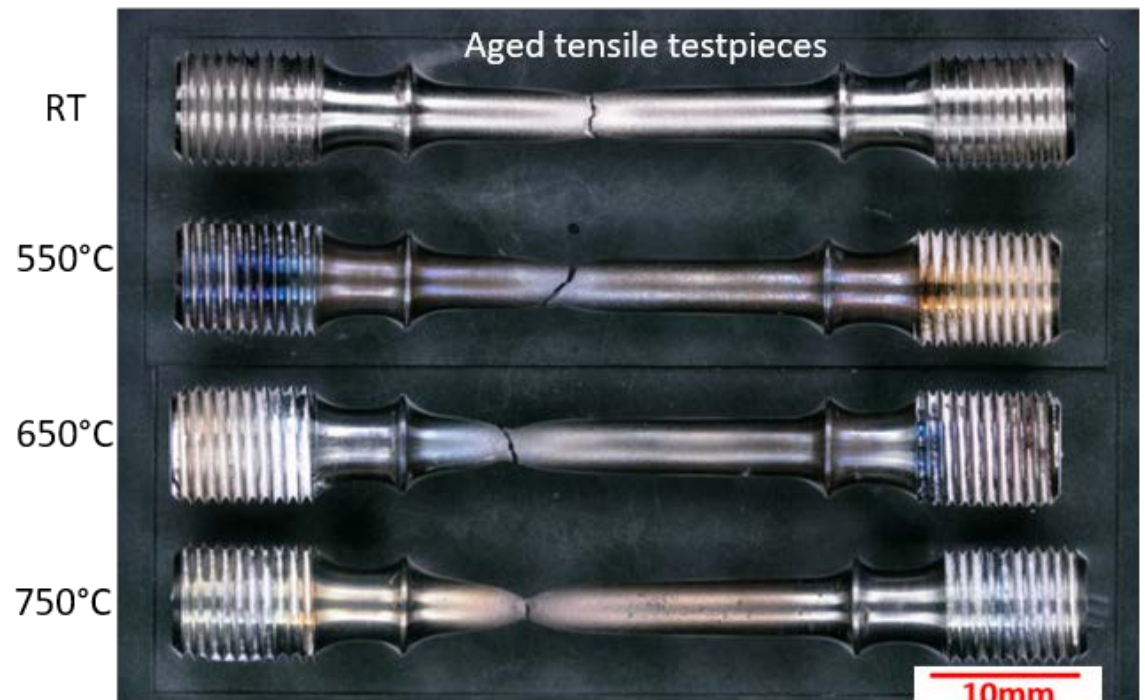
Figure 4.12 Optical images of the fractured tensile testpieces for the (a) as-received Alloy 709, (b) aged Alloy 709 tested at different temperatures, showing the failure mode and necking behaviour.

The optical images of the fractured as-received and aged tensile testpieces are shown in Figure 4.12. To further investigate the failure mechanisms in Alloy 709, the fracture surfaces, as well as their metallographic sections (along sample longitudinal axis) were carefully examined under SEM for testpieces in both conditions. A summary of fractographic and metallographic results of the as-received testpieces tested at different elevated temperatures is shown in Figure 4.13. In general, two zones were observed, the inner zone, where the crack initiated and an outer shear-lip zone which fails last. Such inner and outer fracture zone can be clearly seen for the samples tested at RT and 750°C, giving a typical ‘cup and cone’ appearance (Figures 4.13a and d), also accompanied with

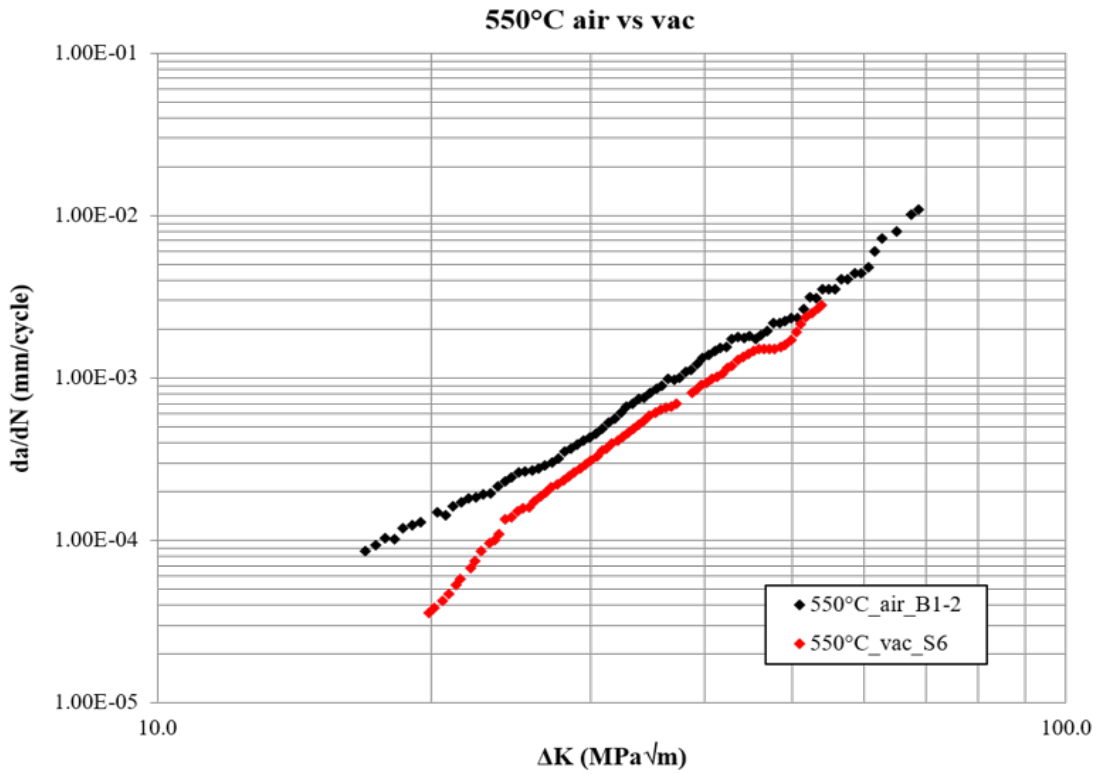
Figure 4.20 Fatigue crack growth resistance curves of the as-received Alloy 709 tested in air and vacuum at 550°C.

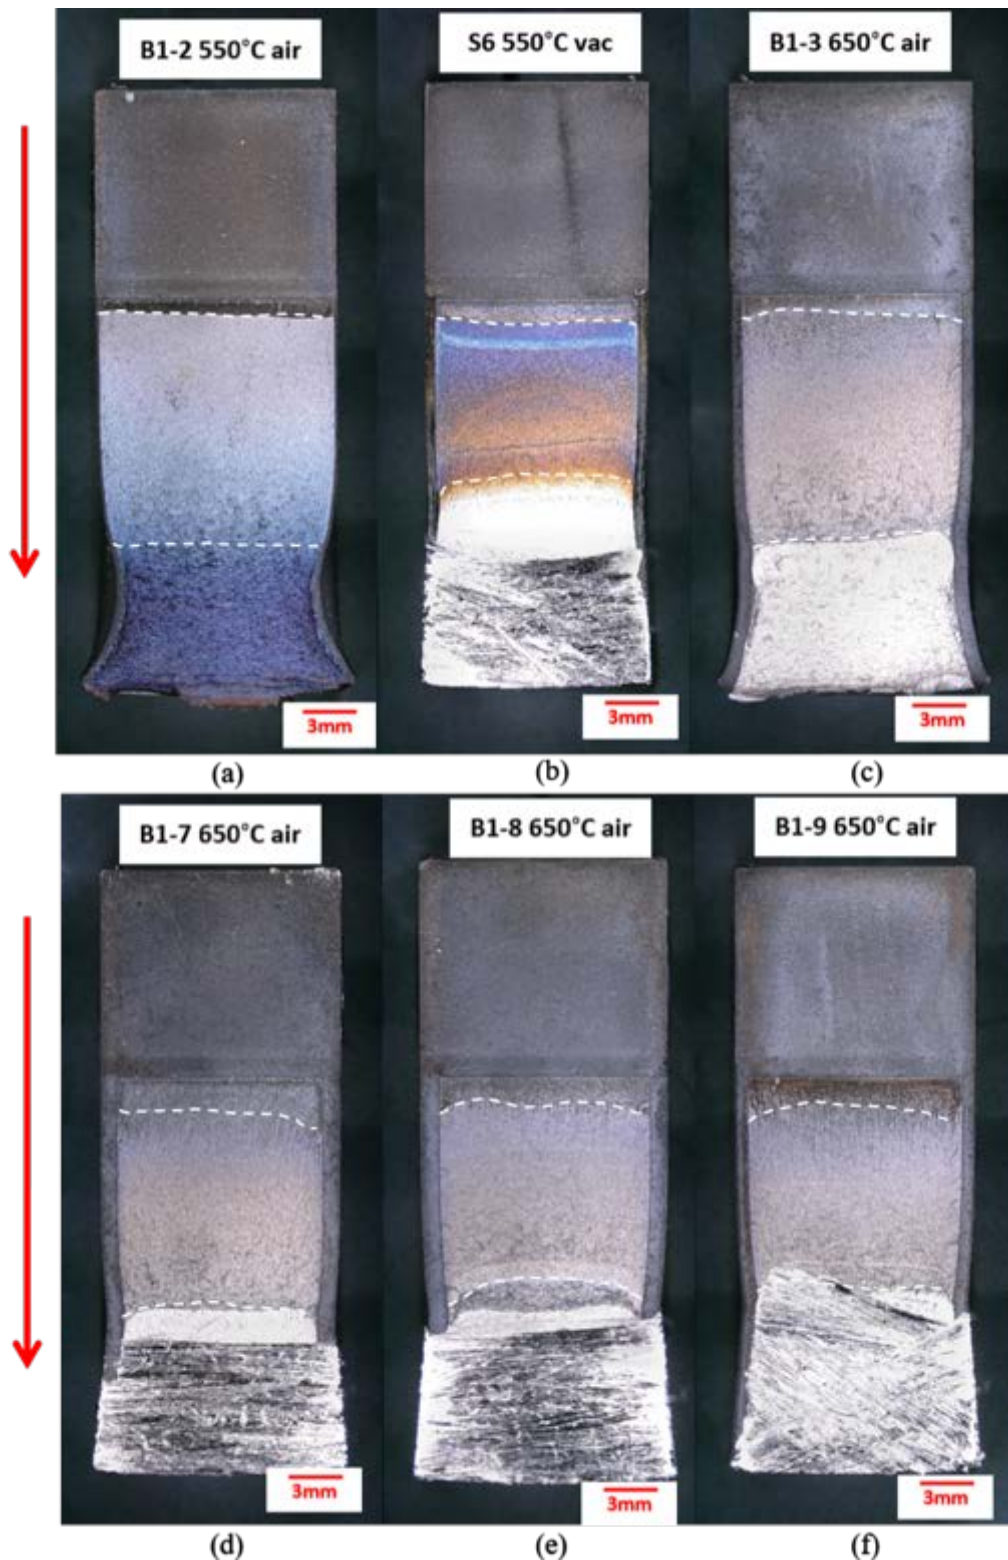
Figure 4.25 Optical fractographs for fatigue crack growth testpieces of the as-received Alloy 709 tested in air at (a), (b) 550, (c) - (f) 650°C, (g) 650°C in vacuum (h) 750°C in air and (i) 750°C in vacuum. Note: Red arrows indicate the direction of crack growth. A back-face notch was applied using a hand saw to facilitate the breaking open of the testpieces. Continued overleaf.

Figure 4.25 Continued. Optical fractographs for fatigue crack growth testpieces of the as-received Alloy 709 tested in air at (a), (b) 550, (c) - (f) 650°C, (g) 650°C in vacuum (h) 750°C in air and (i) 750°C in vacuum. Note: Red arrows indicate the direction of crack growth. A back-face notch was applied using a hand saw to facilitate the breaking open of the testpieces.

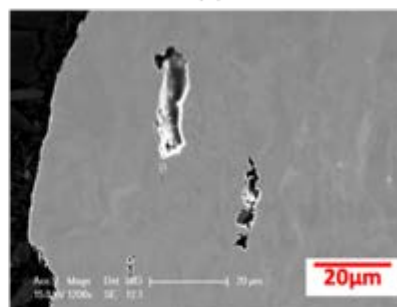
Figure 4.40 (a) BSE images taken from the longitudinal cross-sectioned creep specimens tested at 650°C, (b) microvoids near the fracture surface (a in Figure 4.40a), (c) close-up of Figure 4.40b showing the Nb(CN) particles fractured (white arrow) when the voids formed, (d) and (f) microvoids away from the fracture surface (b and c in Figure 4.40a), (e) and (g) close-up of (d) and (f) showing microvoids formed at grain boundaries.

To investigate the fracture modes for testpieces tested at 650 and 750°C, metallographic sections cut perpendicular to the loading direction were analysed under SEM and the BSE images are provided in Figures 4.40 and 4.41. It should be noted here that the narrower area for the cross-section sample at 750°C is due to the cut not being in the middle of the testpiece. Areas close and away to the fracture surface were analysed. As can be seen from Figures 4.40c and 4.41c that the voids near the fracture surface can be seen to be due to particle cracking. These particles are similar in appearance to the Nb(CN) particles, seen in the microstructure of this material, see Figure 4.4b. However, some microvoids were found at grain boundaries in the area away from the fracture surface, see Figures 4.40e and g and Figures 4.41e, g and h. This indicates that intergranular cracking occurred at the early stage of creep damage. It is also interesting to note that even in the area near the fracture surface, see Figure 4.41b, there are still some grain boundary microvoids formed. This indicates that intergranular cracking formed when ‘necking’ occurred.

presumably relate to early stage of tertiary creep. In the area near the fracture surface, where the stress and the creep strain rate increase, large deformation of matrix and the formation of numerous voids can be seen (Figure 4.40c and Figure 4.41b). This is related to later stage of tertiary creep.

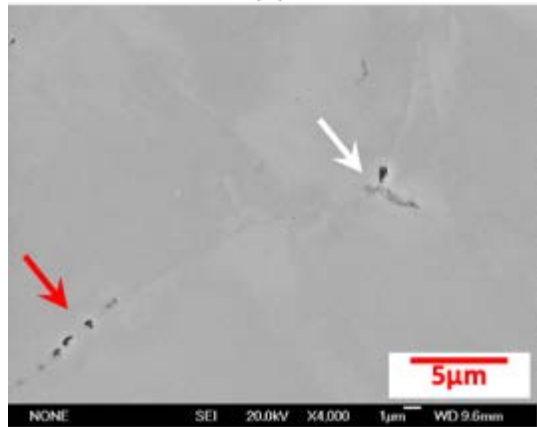
Figure 4.51 (a) SEM images taken from the 2nd CCG on longitudinal cross-sectioned creep crack growth testpiece at 550°C, (b) close-up of Figure 4.51a showing the areas near the crack surface and (c) close-up of Figure 4.51b showing the grain boundary damages associated with the linkage of grain boundary cavities (red arrow) and “wedge” cracks (white arrow).

The fracture mechanisms at 550°C (numbered 'CS1') were confirmed on the side view of the 2nd CCG (K value of ~40 MPa√m), see Figure 4.51. The areas near crack surface were analysed, see Figure 4.51b. Figure 4.51c showing the intergranular damage in the

2nd CCG at 550°C is mainly associated with linkage of grain boundary microvoids (red arrow in Figure 4.51c) and wedge cracking formed at triple junctions (white arrow in Figure 4.51c).

can be detected: the deceleration and then acceleration, or acceleration, depending on the magnitude of mechanical driving force (stress, or K) and temperature. It is observed that an acceleration in crack growth rate, presumably taking the form of the linkage of grain boundary voids and wedge cracks (Figure 4.51c), is related to an increase in load-line displacement rate. This is also suggested in the creep-fatigue crack growth tests in Type 316 stainless steel at 625°C [157] and proposed by Neumann in several plasticity models [158].
