Quantifying the damage of in-service rolling stock
wheelsets using remote condition monitoring

DOCTOR OF PHILOSOPHY

School of Metallurgy and Materials

September 2022

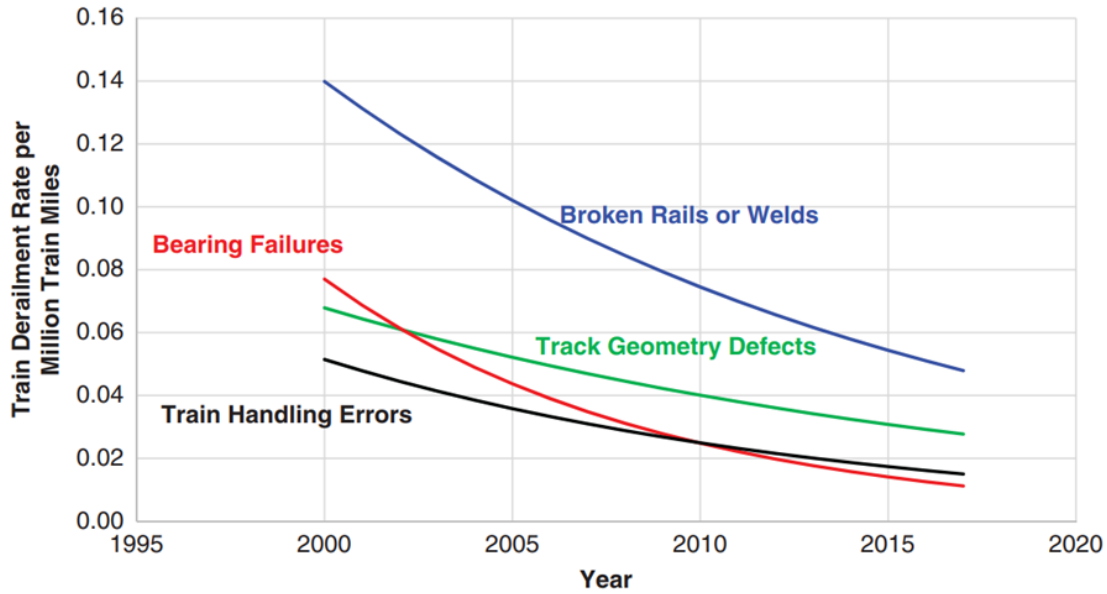
Figure 1-2: Statistical temporal analysis of freight train derailment rate per million train miles by causes (X. Liu, 2015).

The analysis performed by Liu (X. Liu, 2015) revealed a trend of temporal derailment rate per million train miles as displayed in Figure 1-2 based on their model evaluation using time parameter as a predictive variable. Liu studied the data of freight train derailments of four Class 1 railroads measured by million train miles from 2000 to 2012. The model used in the parameter estimation of their study focused on the temporal trend of train derailment rate. Obviously, the rate of freight train derailment by any cause has been decreasing in recent years.

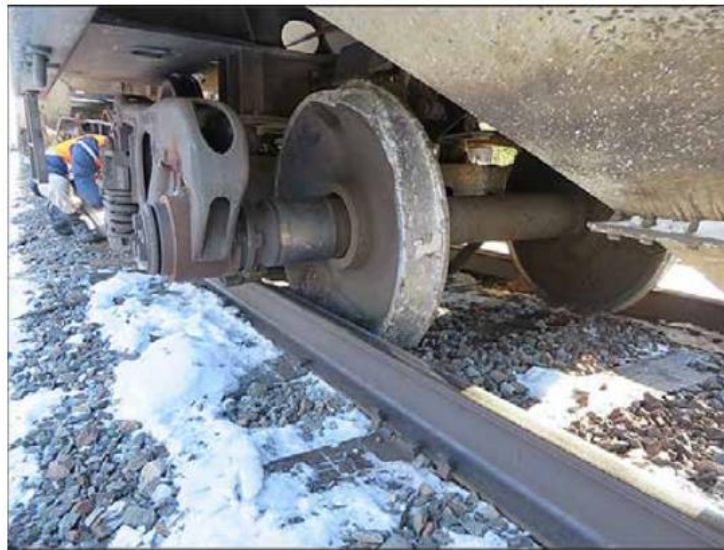
Figure 1-4: The manufacturing defects of the wheel cause the derailment in Canada
(Transportation Safety Board of Canada, 2015).

A wheel failure could result from various types of defects including cracking on the wheel surface. A derailment accident report from the Transportation Safety Board of Canada revealed that the reason for the freight train's derailment on 7 January 2014 was caused by shattered rims as seen in Figure 1-4 (Transportation Safety Board of Canada, 2015). The root cause was determined as a large porosity under the wheel surface which contributed to fatigue cracking. According to the investigation, the porosity formed during the casting of the wheel in 1991. However, the ultrasonic inspection (UT) during the manufacturing process and reprofiling did not detect the large porosity. Figure 3 displays how the left wheel of car CRDX 15109 caused the derailment when it finally failed from the crack initiating from the porosity. A missing part of the wheel caused the wheel to fracture and come off the rail causing the train to derail.

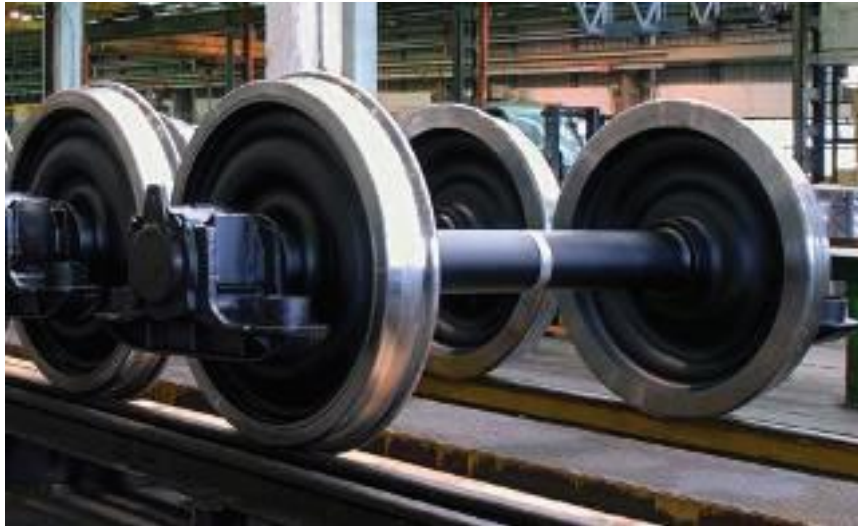
Figure 2-1: Wheelsets for rolling stocks (Bracciali, 2016a).

A trailing wheelset consists of an axle that rotates, two wheels that are attached to the axle through wheel seats cut into the axle, two external axleboxes, and rolling bearings installed on the axle journals. Figure 2-1 shows the wheelset for freight wagons which relies on the tyred wheel design although most freight and passenger rollingstock nowadays uses monobloc wheels. This old-fashioned design was introduced with the traditional tread-based braking system at the beginning of the rolling stock age (Bracciali, 2016a).

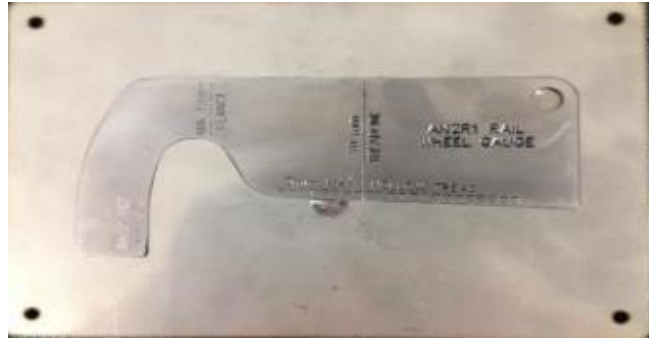
Figure 3-1: Steel wheel measuring gauge (Laing O'Rourke, 2020b).

Visual inspection is generally a simple approach for evaluating the surface condition of the wheel, bearings, and axle. The use of specially designed measuring tools helps identify parameters of interests as defined in the relevant standard. For example, wheel inspection may use a steel measuring gauge to evaluate a number of important parameters, such as flange width, flange height, flange angle, rim thickness, and tread profile (Laing O'Rourke, 2020a).

According to the inspection standard, visual inspection can also be used for the evaluation of tapered roller bearings. The axle end cap should be the first location to be inspected as there could be missing parts, i.e., lubrication plugs, cap screws, and set screws in the axle boxes. These parts are related to the tightness of the bearings. The end cap should be inspected for damage or wear caused by a misplaced adapter. It is necessary to inspect axle boxes or package units for loose backing rings and excessive wear on the boxes, adaptors, or mating faces on the side frames. Any seals might be missing or broken, and excessive grease surrounding a seal could indicate damage. (Laing O'Rourke, 2020b). Figure 3-1 shows the gauge used for the wheel inspection.

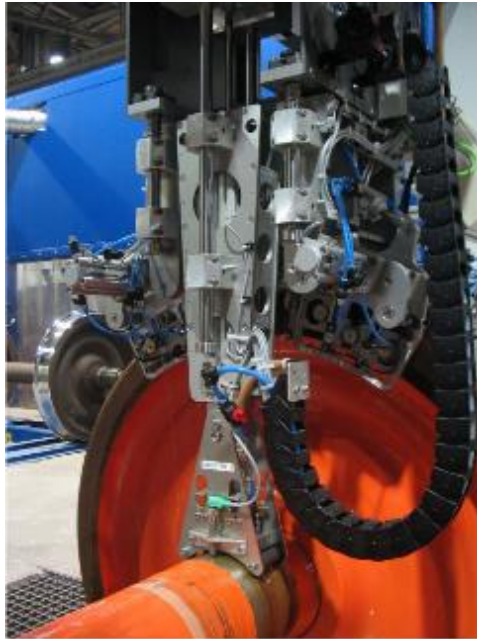
Figure 3-9: Probe system carriers for wheel and axle inspection by GE company (Kappes et al., 2007).

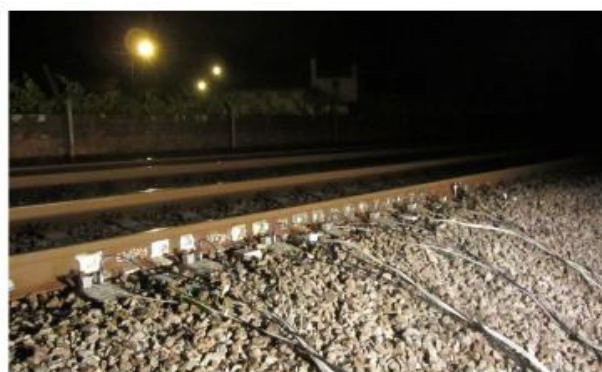
Figure 3-19: The actual site containing accelerometers and strain gauges (Meixedo et al., 2015).

The straight track sections on a ground level were chosen because of the cancellation of external stresses from the curved track sections. The detection of wheel flats was based on a periodic change in strain. As a result, the monitoring results contains the acceleration and the direction of the train, as well as the quantity of axles. The monitoring system combined the use of accelerometers and strain gauges. The designed system is a competitive, flexible, and resilient wayside device capable of detecting wheel impacts and weighing a moving train. Figure 3-19 depicts the installation of all sensors along the measurement rails.

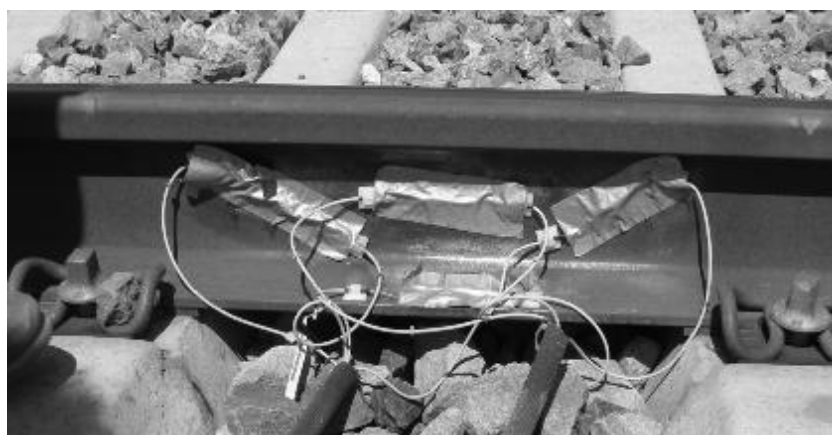
Figure 3-22: The actual condition of section 1 in Figure 20 (Filograno et al., 2013).

The second section applied the same concept as the first without using the temperature measurement. In the third section, vertical and bending sensors are added to each sleeper. Figure 3-22 shows the actual area of strain gauges at the installation point.

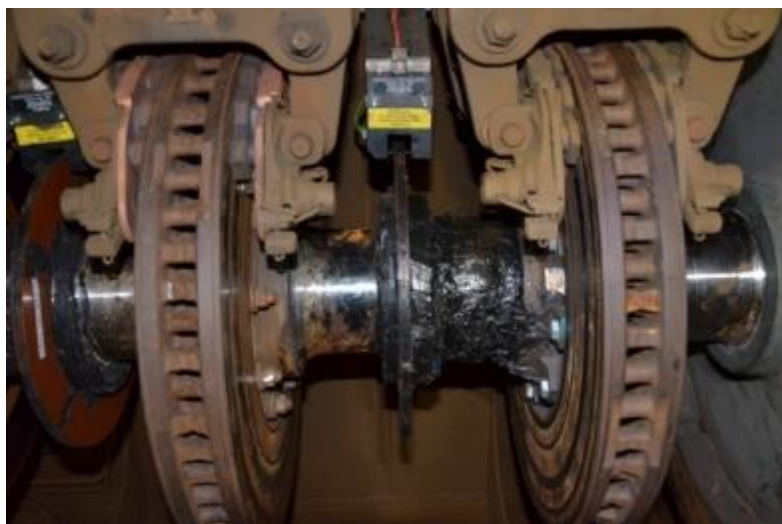
Figure 3-32: Specially designed auxiliary brackets for wireless signal transfer system (J. Wang et al., 2021).

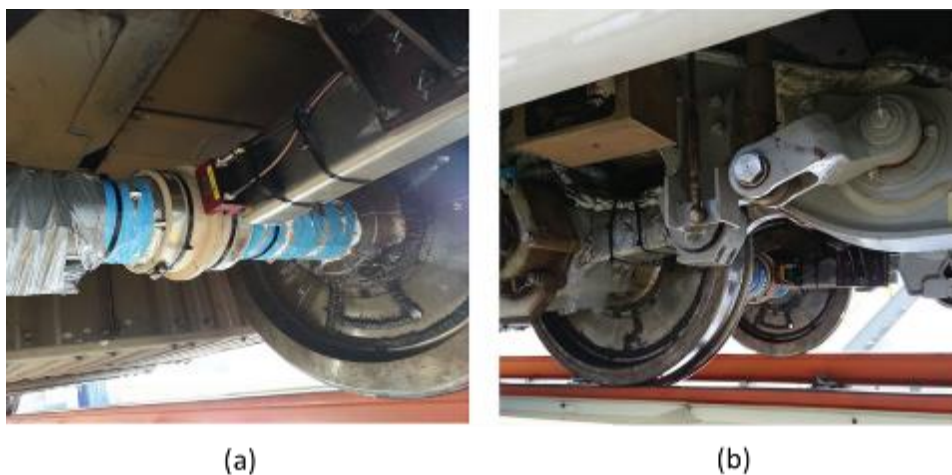
Figure 3-33: The wheels mounted under high-speed train model CRH6 in China (a) antenna unit (b) instrumented wheelset (Jin, 2020).

EN 14363 specifies online reference procedures for measuring wheel-rail contact forces and axle stresses to demonstrate vehicle safety. The related parameters include the (Y/Q) max (or Nadal's coefficient), the guiding forces Y_{max} , and the maximum vertical force Q_{max} (Jin, 2020). Figure 3-33 demonstrates (a) an antenna unit and (b) instrumented wheelset of the high speed train

The following strategies are primarily used to increase signal quality and minimise noise. Using full bridges of strain gauges, the shortest cable layouts by optimisation of the connecting path on the wheelset, the usage of twisted-pair wires with anti-electromagnetic tinfoil, the high insulating resistance between strain gauge and wheelset measuring bridges and the signal amplification on the wheelset.

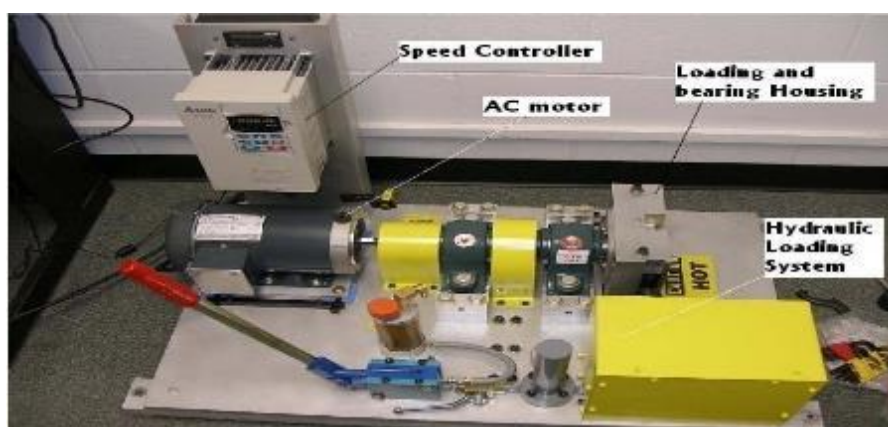
Figure 4-1: The ceramic bearing test rig (He et al., 2011).

(He et al., 2011) researched AE bursts for complete ceramic bearing defect detection and diagnosis. They experienced the effectiveness of their experiment based on bearings with five different conditions: healthy bearing, inner race defect, outer race defect, cage damage, and ball defect. The test relied on full ceramic bearings coupled with the motor shaft controlled at 600rpm. The AE signals were retrieved at a 5 MHz sampling rate and collected in a total number of 400 AE bursts. The AE burst data was collected using two wide bands (WD) type AE sensors and a PCI-2 data collecting board. AE sensors were attached to the bearing housing with special adhesive. Bearing seeded fault tests were performed on a modified bearing test rig, as shown in Figure 4-1. However, the system used in this experiment still requires other related devices for a better quality of output signals, for example, a pre-amplifier. Further analysis based on the extraction of three AE features using an empirical mode decomposition (EMD) revealed that the greatest condition indicator combination is the group average of Root-Mean-Square (RMS) and the group standard deviation of RMS, which provide the classification accuracy of 93%. In contrast, the group average of kurtosis individually performed the lowest classification error among three AE features (RMS, peak value, and kurtosis).

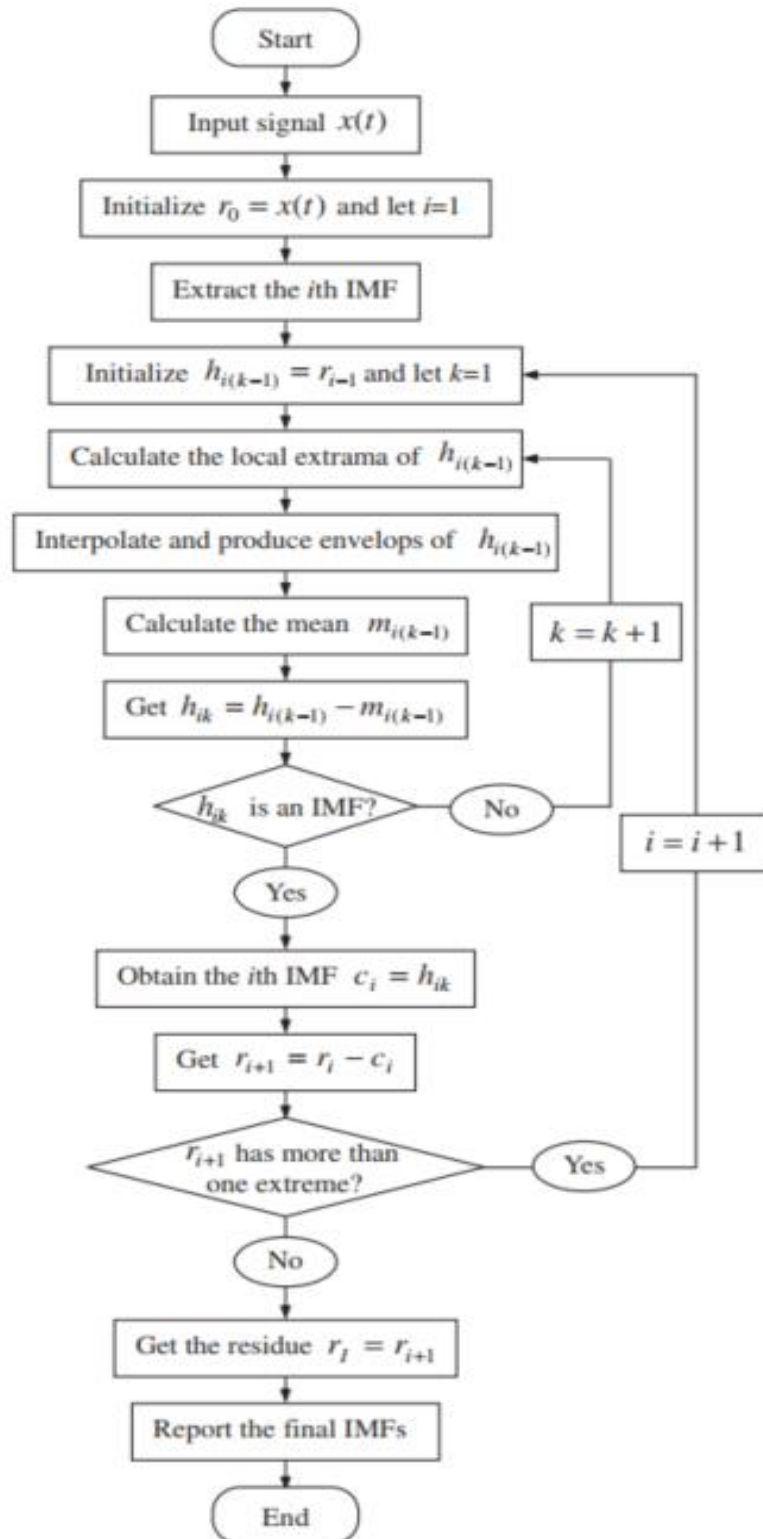
Figure 4-23 Flow chart of EMD process (Lei et al., 2013).

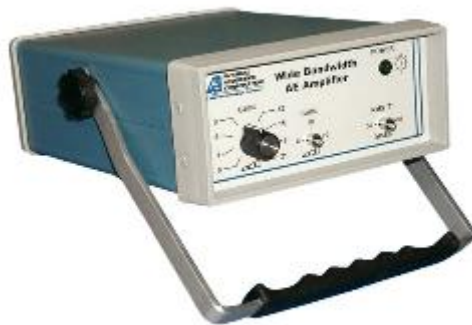
Figure 5-6: Amplifier from PAC model AE2A (PAC, 2004).

The main amplifier from Physical Acoustics Corporation (MISTRAS) model AE2A is chosen as it is a low noise, high-performance and wide bandwidth systems for AE sensors. It is displayed in Figure 5-6. The bandwidth of PAC AE2A ranges from 3 kHz – MHz while it is capable of internal gain between 0 and 61dB in 3dB steps.

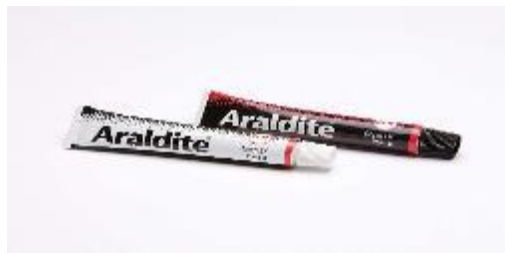
Figure 5-7: Araldite A0002 Rapid Epoxy (Lawson H.I.S. Ltd, 2022).

Magnetic hold-downs were selected for experiments in this study as all samples are ferrous substances. However, the wayside measurement on cast manganese crossings used the glue type via Araldite adhesive instead of magnetic hold-downs. Rapid and easy setting epoxy provides the sufficient strength to the coupling between AE sensor and the monitoring samples. It should be noted that applying light pressure to the contact until set via a tape between 20 minutes and 2 hours allows the full strength. Figure 5-7 displays Araldite A0002 Rapid Epoxy.

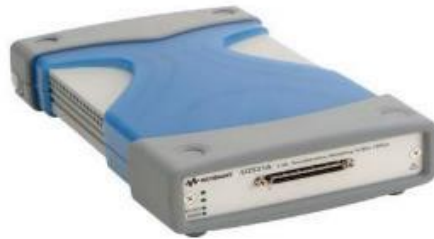
Figure 5-8: DAQ U2531A (KEYSIGHT Technology, 2019).

There are two DAQ units providing a series of data in this study. The first is Agilent (Keysight) U2531A which extract the AE and vibration signals acquired during the experiments. Figure 5-8 shows the actual DAQ unit used in this study. This was connected to the computer via Universal Serial Bus (USB) cable. When operated in single-channel mode, it can acquire data at the sampling rate up to 2 MS/s (per each channel) with 12-bit resolution according to the

technical data sheet from Keysight. It also allows simultaneous sampling of data per each channel through dedicated Analog-to-digital.

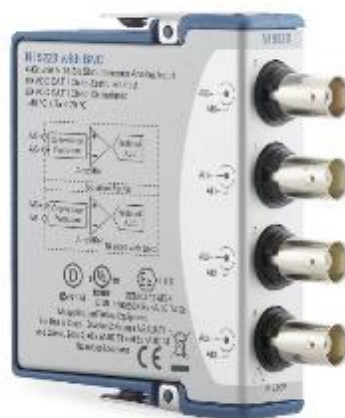
Figure 5-9: DAQ NI 9223 (NATIONAL INSTRUMENTS, 2016).

Another DAQ unit comes in a small form factor from National Instruments (NI) model NI-9223 as shown in Figure 5-9. The connection was made through the USB type enclosure which also provide the LED status of the DAQ unit. The maximum sampling rate is 1 MS/s (per each channel) with 16-bit resolution according to the technical data sheet from NI. ADCs are embedded inside the DAQ unit to provide the capability on measuring the impact and best wave testing. Each channel's input signals are buffered, conditioned, and sampled by an ADC. An independent signal path for each channel in conjunction with separated ADC enable the simultaneous measurement for all channels.

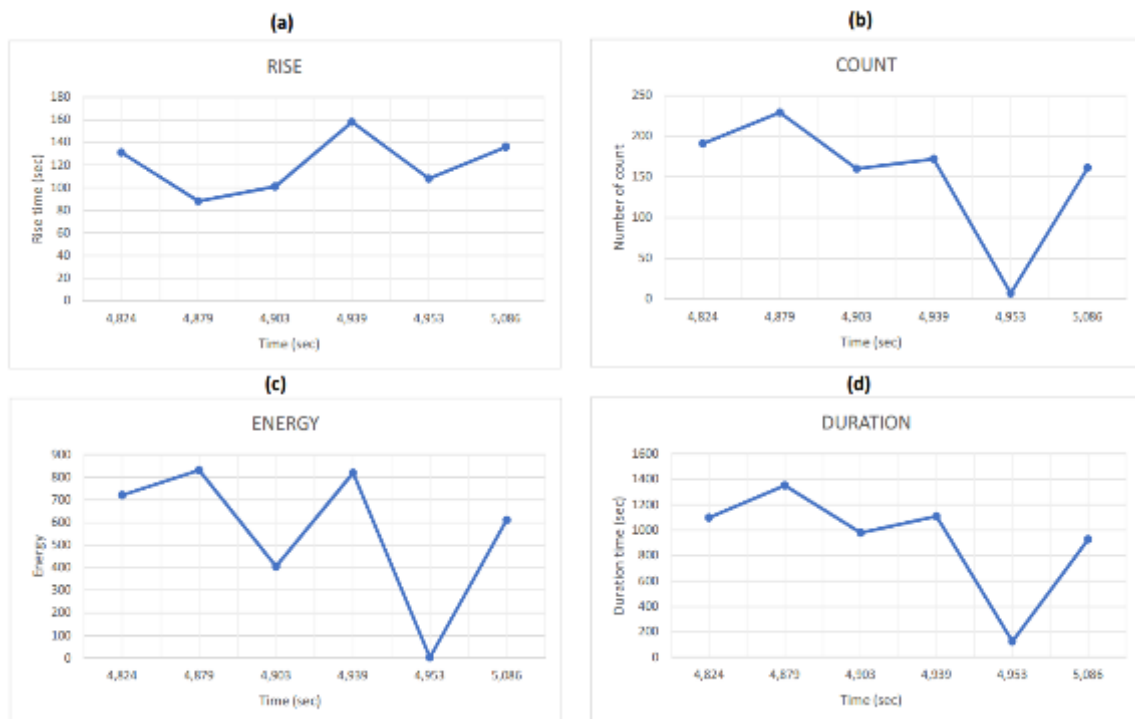
Figure 5-19: AE parameters of related hits.

There are 6 hits discovered above the threshold (50 dB) as shown in Figure 5-18. Each hit had different value of parameters. Because of the longer detected signals, increasing the rise dramatically increases the number of counts and energy as illustrated in Figure 5-19.

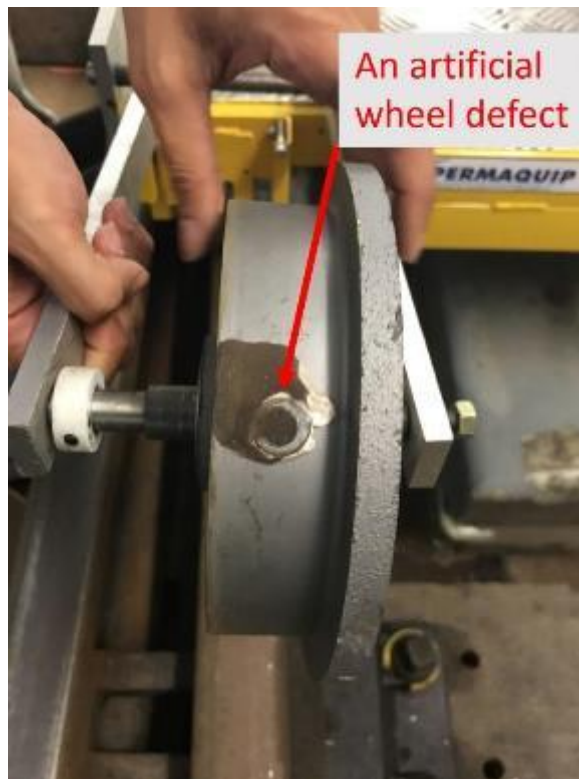
Figure 5-22: A faulty wheel used in the trolley.

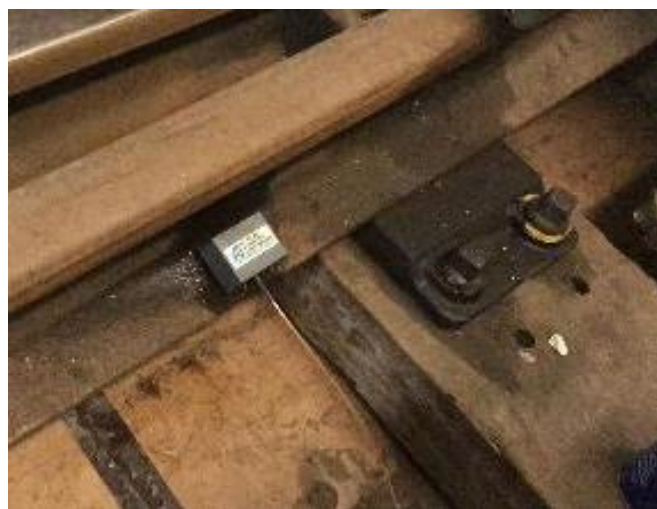
Figure 5-23: AE sensor installed by a magnetic hold-down.

The trolley was pulled by hand, allowing the wheels to rotate at 1m/s. AE signals were amplified with a 40-dB preamplifier and 18-dB amplifier. Figure 5-22 shows a piece of metal welded to a reduced scale wheel to simulate a wheel flat problem. A magnetically powered AE sensor was placed on the rail for the wayside inspection in Figure 5-23. The detailed picture represents a piece of magnetic adapter for the installation of the AE sensor is displayed in Figure 5-24.

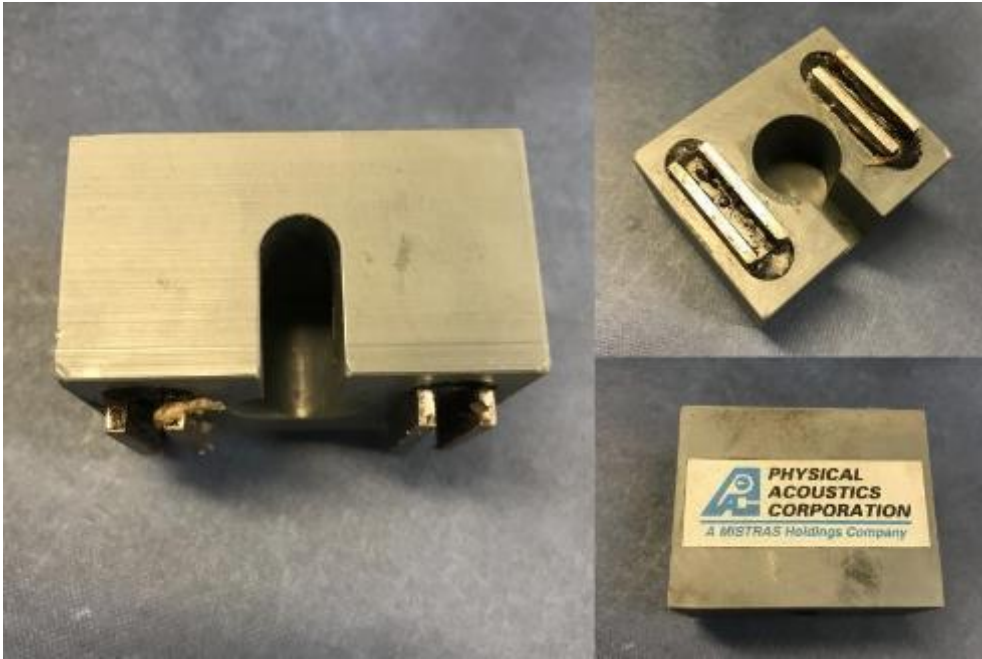
Figure 5-24: A magnetic adapter for the placement of AE sensor on the wayside measurement.

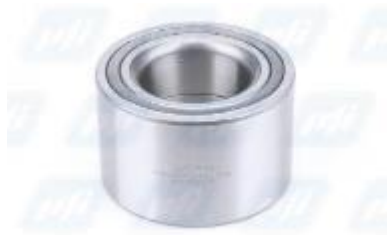
Figure 5-26: Bearing model PW29530037CSHD made by PFI.

In addition to the wheel and rail interface investigation, the experiment using a bearing test rig was designed to study how the bearing with range of conditions generate AE and vibration signals. Healthy bearings and bearings with several artificially induced defects were used for a series of experiments, which include different operating speed and loading conditions. Automotive wheel bearing samples were chosen as representatives of tapered roller bearings which are installed in the rolling stock wheelset. The bearing model PW29530037CSHD made by PFI has the dimensions of 29 x 53 x 37 mm. Figure 5-26 displays the bearing sample used in the laboratory rig test.

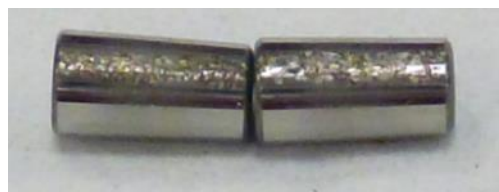
Figure 5-28: Rollers with artificial defects.

Heathy and damaged bearings which contain artificially induced roller defects and lubricant contamination were included as the samples for this laboratory experiment. The severity of roller damage was assessed through 10% and 50% fault size when compared with the circumference. Figure 5-28 displays the rollers with artificially induced defects. Disassembly of the test bearings allow the introduction of artificially induced defects before they are enclosed and installed on the test rig. Modified test rigs rotated bearings from 100 to 1000 RPM. In addition to speed variations, a range of loading conditions was added to the test.

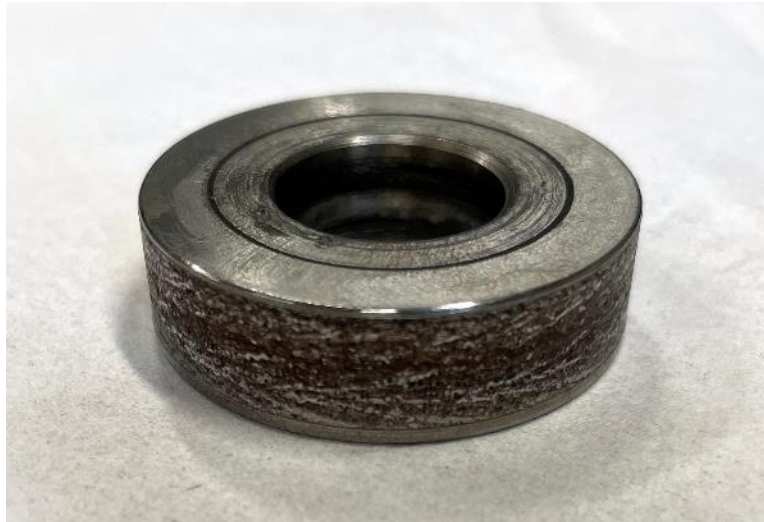
Figure 5-29: A healthy EN24T sample.

The first lab experiment used the Amsler machine to study the integration of AE sensors with a compact DAQ unit and other components (section 5.2). The DAQ unit from National instrument Co. Ltd. used in this experiment is 4-channel with the maximum sampling rate of 1 MS/s. A pair of samples made from EN24T steel was selected as refer to a twin discs model, which leading to the study of AE signals from material conditions. There are healthy and artificially damaged samples which are illustrated in Figure 5-29 and Figure 5-30 respectively.

EN24T (817M40T) is a nickel chromium molybdenum through hardening steel with a wide range of strengths that may be heat treated. EN24T is widely utilised in heavy-duty applications that need hardness, wear resistance, and tensile strength because to its hardenability characteristics. Based on nitriding or flame induction processes, its surface hardness would be extended to 60 RC.

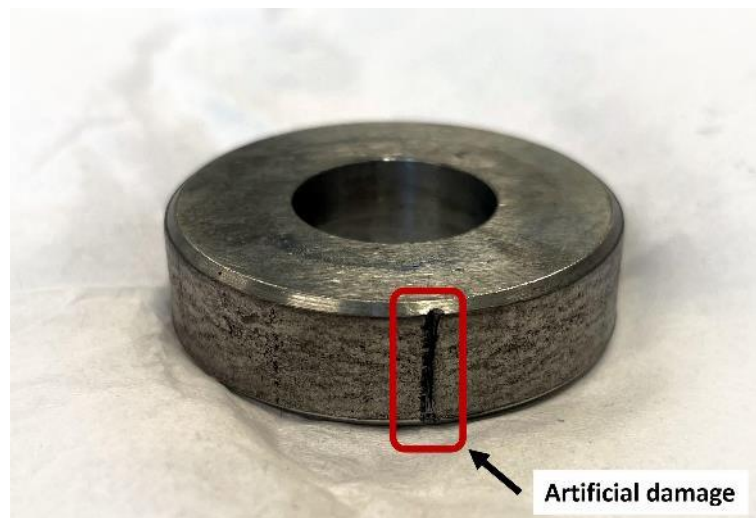
Figure 5-30: A damaged EN24T sample.

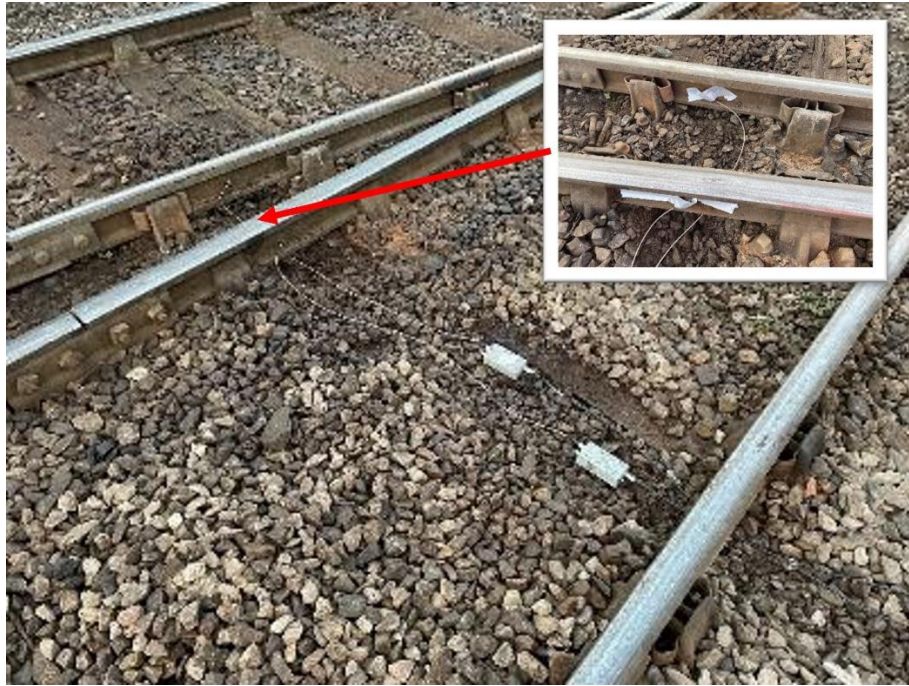
Figure 6-2: AE measurement system and the installation of two AE sensors

The freight wagons with a class 08 Number 08670 locomotive used in the experiments travelled along a straight track. Two AE sensors were installed on each side of the rails using Araldite A0002 Rapid Epoxy as mentioned earlier in Chapter 5. Both sensors link by flexible wires to a pre-amplifier and main amplifier before sending data to DAQ NI 9223. This experiment demonstrates how the wayside measurement works as a designed RCM of railway rolling stock wheelset which will be further described in detailed for both AE and vibration data. Figure 6-2 shows the location where two AE sensors are placed.

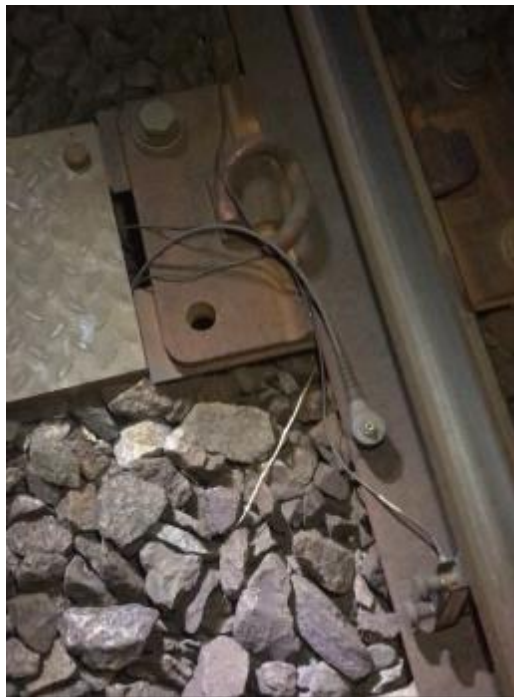
Figure 6-6: An AE sensor installed on one side of the rails.

Figure 6-5 shows the screenshot of the customised program which was used for the data collection. Figure 6-6 shows one of the track's AE sensors.

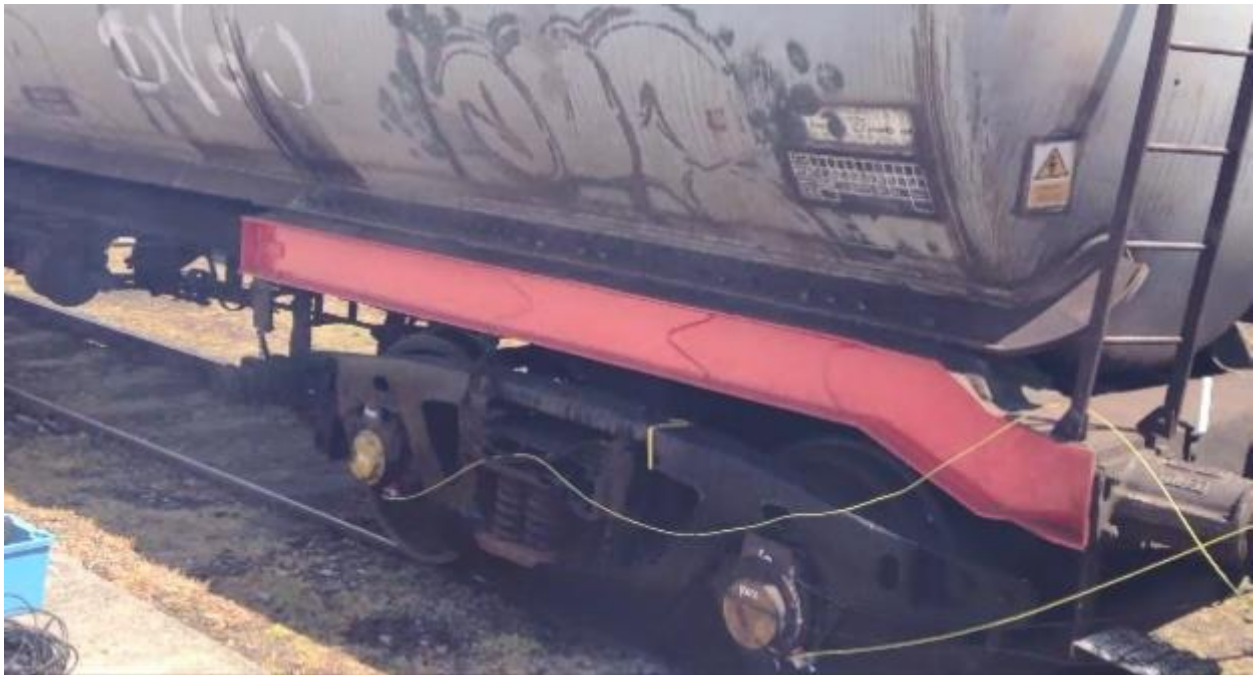
Figure 6-7: Onboard measurements of axle bearings with roller defects on the wagon tanker.

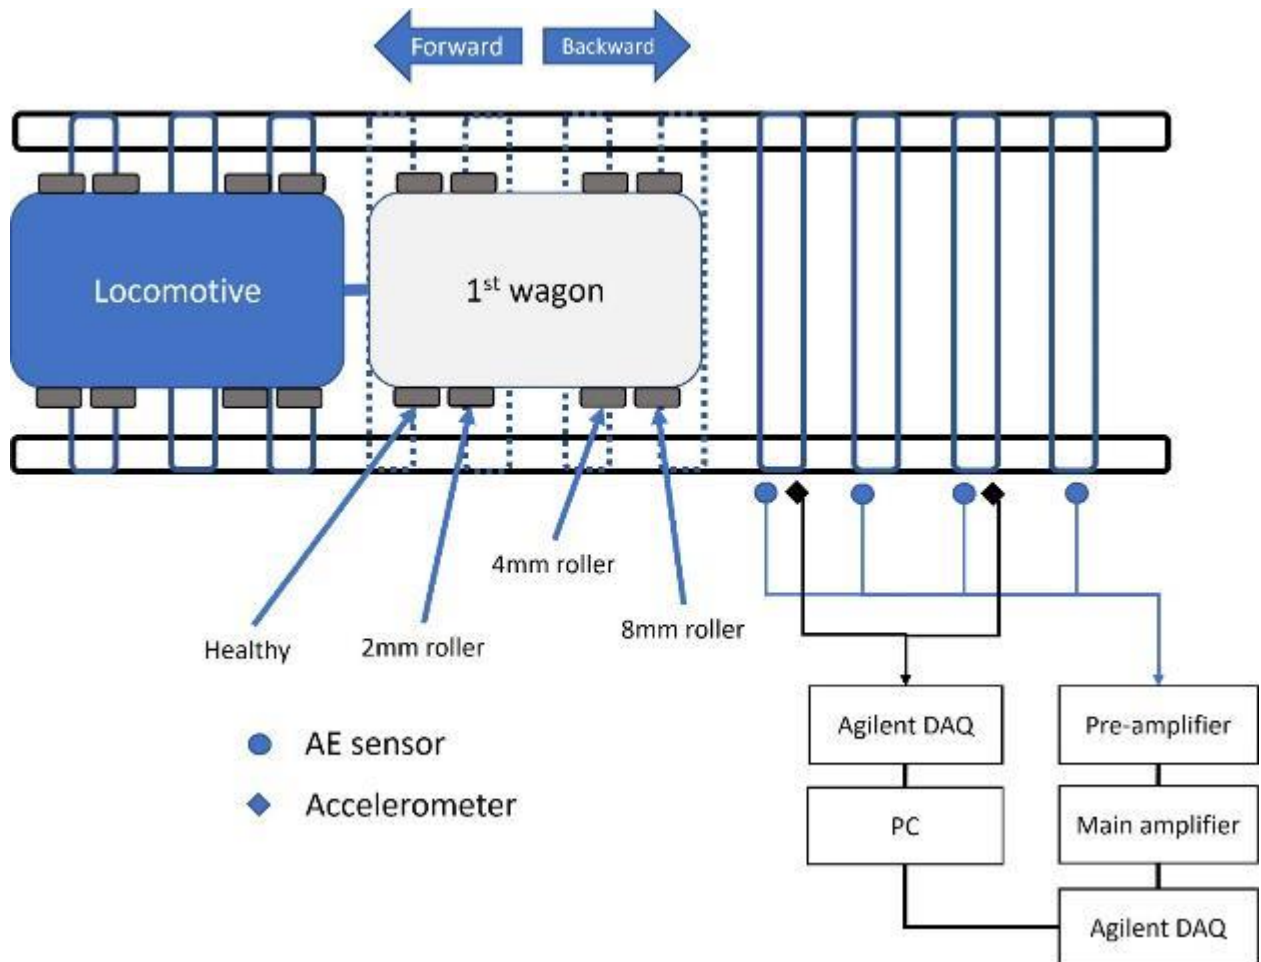
Figure 6-8: Diagram of the installation of the wayside RCM system with AE sensors and accelerometers at Long Marston.

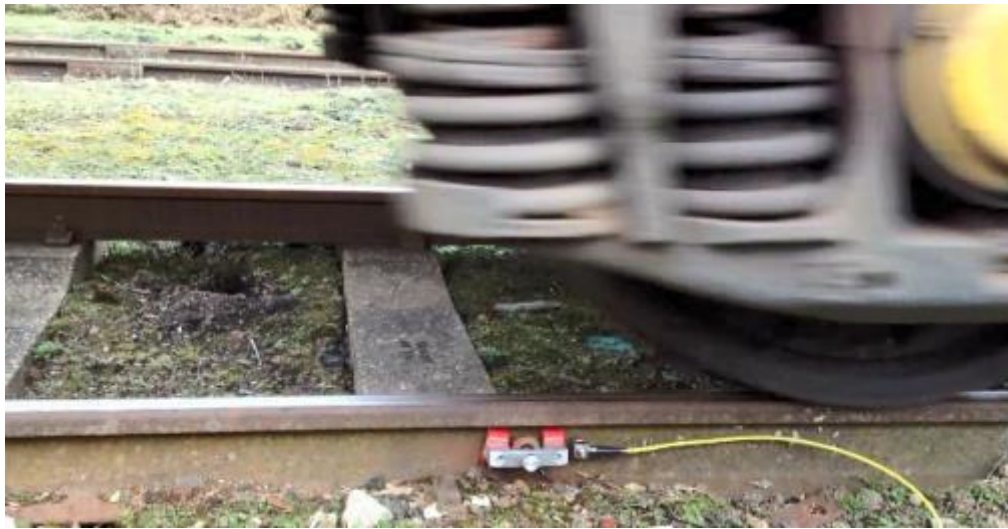
Figure 6-9: Wayside accelerometers and AE sensors.

The installation of AE sensors and accelerometers was conducted on the rail using magnetic couple as shown in Figure 6-9. The pre-treatment of rail surface at the sensor location was done by grounding to provide the better contact. The sensor position should be less impacted by rail movements. AE sensors and accelerometers were mounted above sleepers to reduce rail noise
