CHARACTERISATION OF IN718 FASTENERS FOR AERO-ENGINE APPLICATIONS

A thesis submitted to The University of Birmingham for the
degree of

DOCTOR OF PHILOSOPHY

School of Metallurgy and Materials

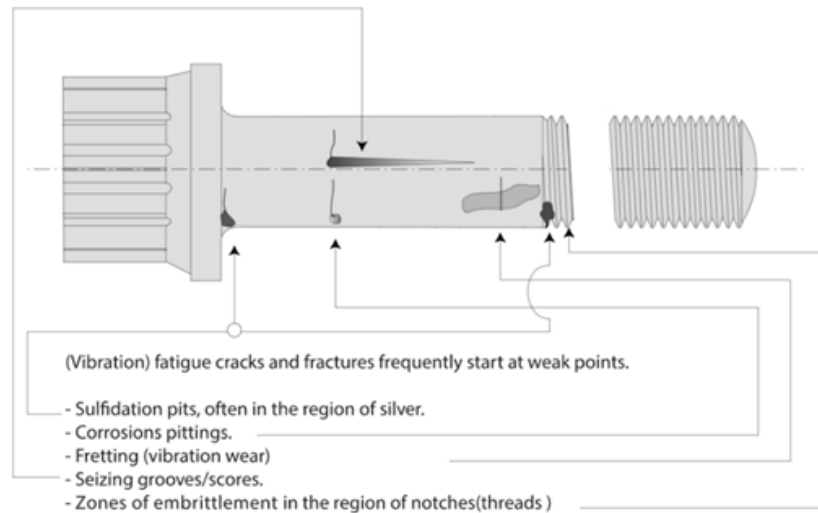
Figure 2-5 The failures or fractures initiation locations of an aero-engine bolt during the operation [95]

mechanical fracture of the aero-engine bolts potentially occur at the indicated locations in Figure 2-5 [95], and the locations of bolted joints in the turbofan engine is shown in Figure 2-6.

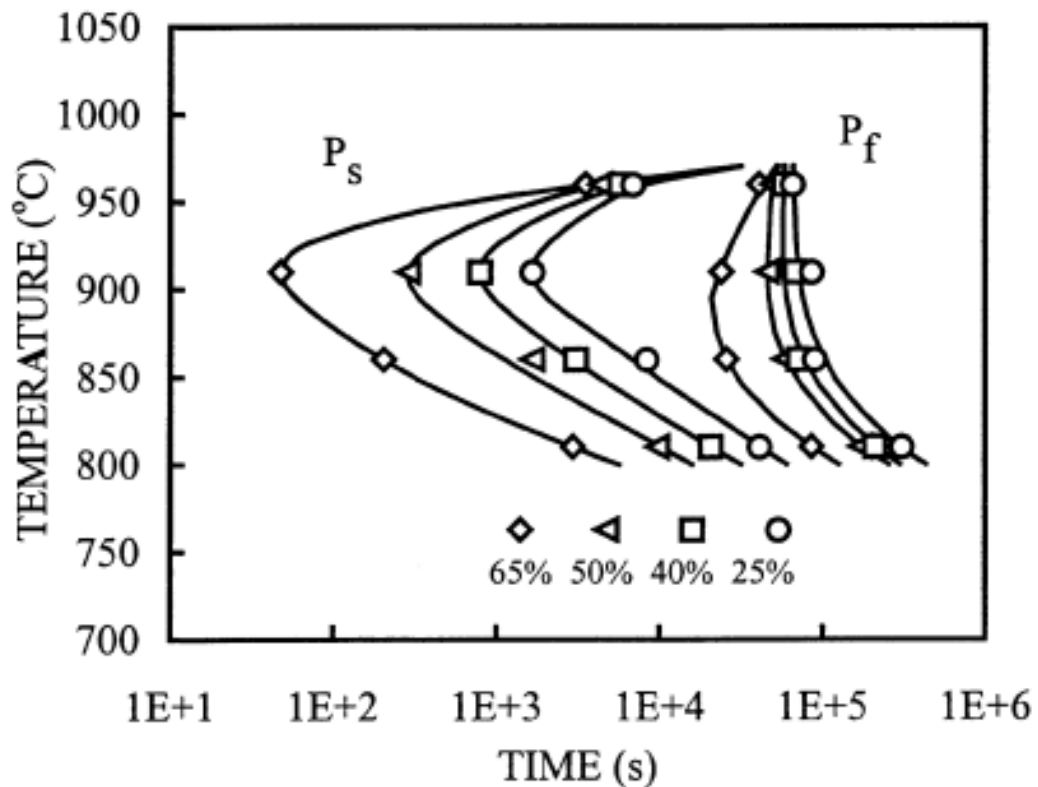
Figure 2-9 The time-temperature-transformation diagram of IN718 with different cold work reduction, P_s (δ phase) is the starting precipitation and P_f is the finishing precipitation.

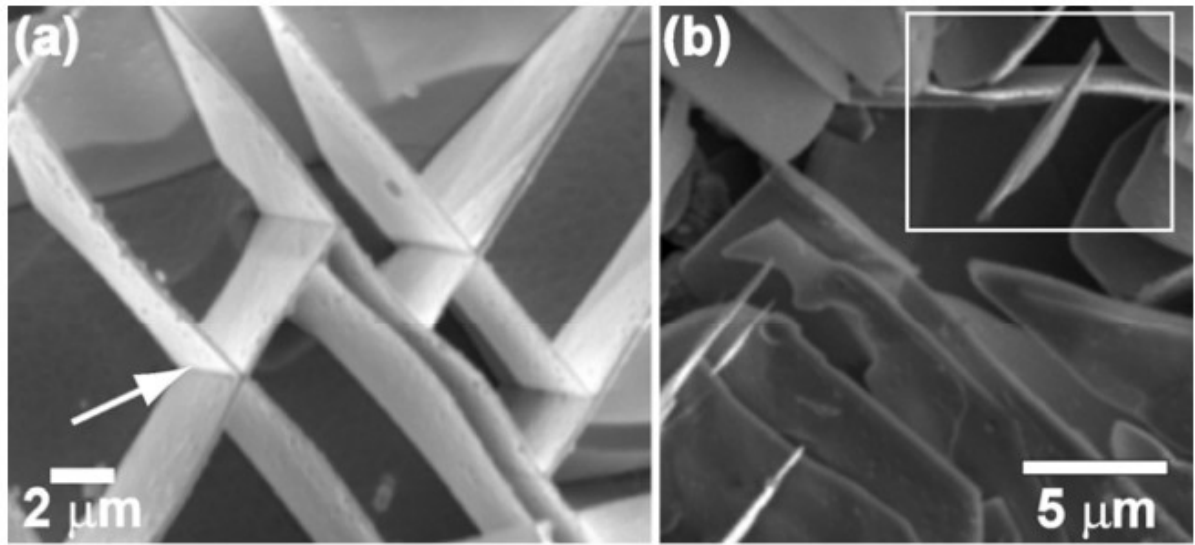
Figure 2-10 Plate-like δ phase with intersecting growth presented by SEM in etched IN718 [87].

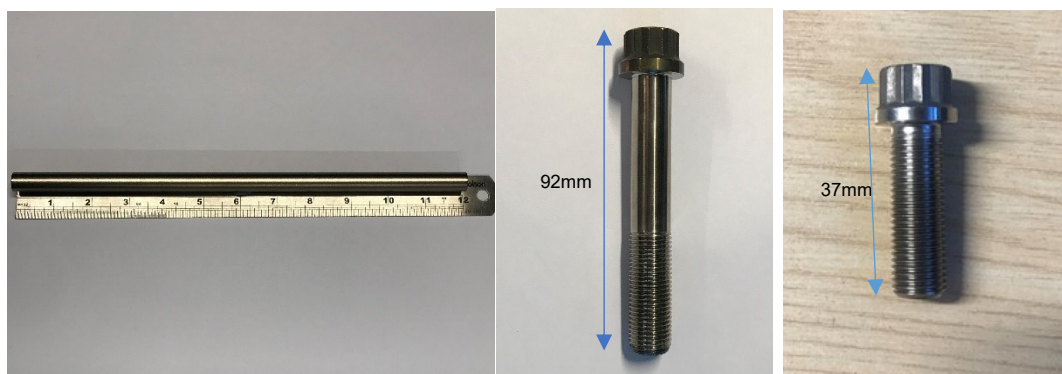
Figure 3-1 Twelve inches long as-received IN718 bar, IN718 large bolt and IN718 small bolts from left to right
The manufacturing process of the as-received IN718 bars follows the AMS (Aerospace Material Specification) 5662M of SAE (Society of Automotive Engineers) International group, summarised in chart (Figure 3-2). The composition and the weight percentage are shown in table 3-1 from AMS 5662M. The alloy multiple melting practice requires

The IN718 alloy used in this project was supplied by Arconic Manufacturing (GB) Limited in two forms. These were nineteen hot rolled bars which were 12" long with finishing diameter of $\frac{1}{2}$ " and a batch of $\Phi \frac{1}{2}$ " large bolts, as shown in Figure 3-1. Nine $\Phi \frac{3}{8}$ -inch IN718 bolts were also provided by Rolls-Royce plc. for microstructure characterisation only, named IN718 small bolts in this project.

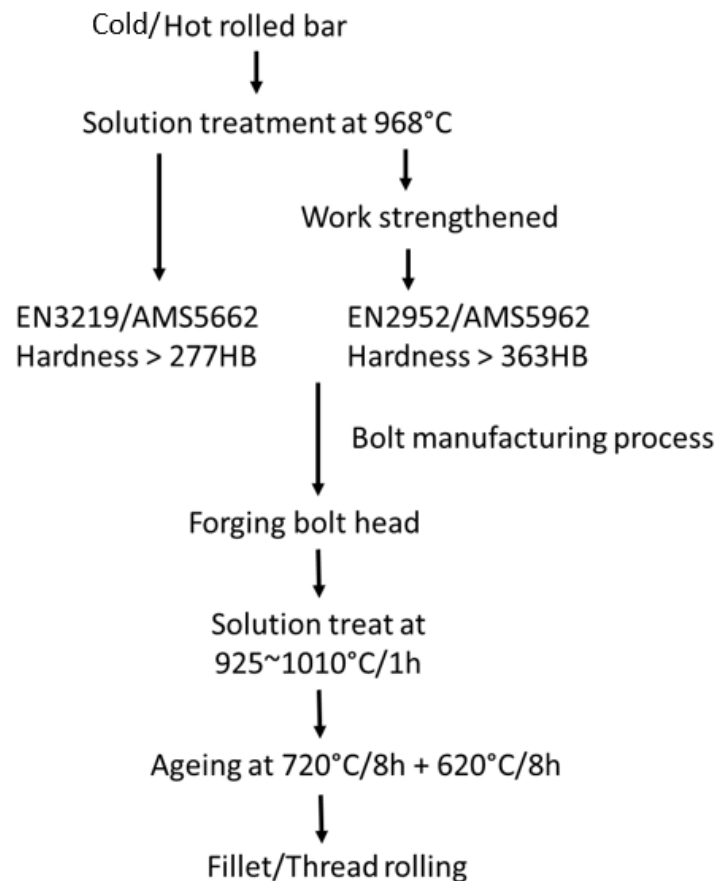
Figure 3-3 Flowchart of manufacturing IN718 aero-engine bolts

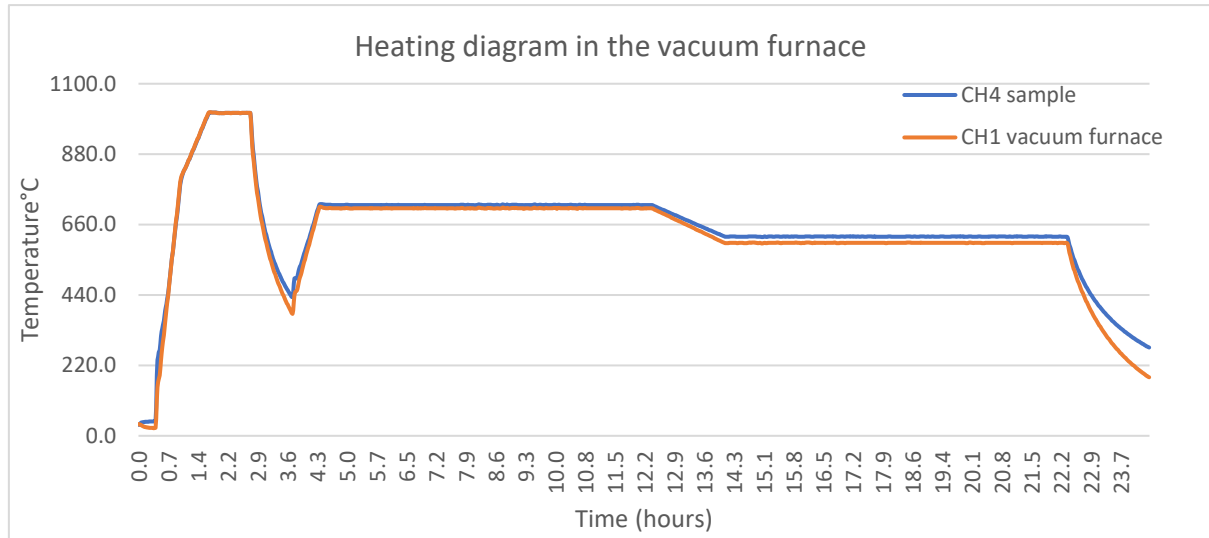
Figure 3-5 An example of a heating diagram (HT3 condition)

furnace, Camco G1600, an initial cooling rate of $14^{\circ}/\text{s}$ was achieved from the solution heat treatment temperatures. A typical heating diagram in the furnace is shown in Figure 3-5.

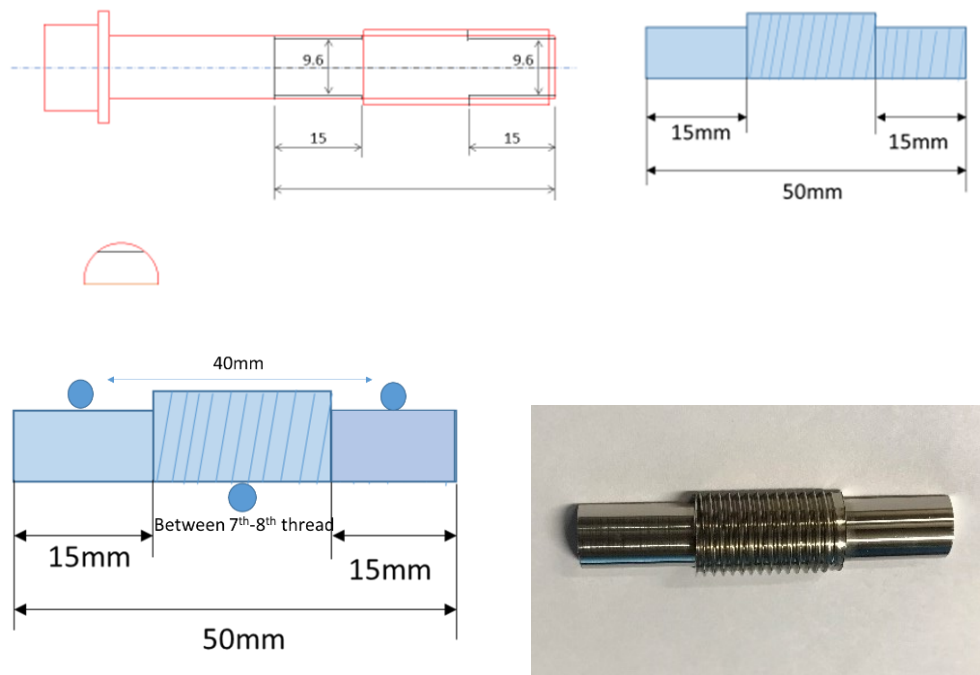
Figure 3-8 Schematic and photo of half-cut large bolts for three-point bending fatigue tests

To conduct bending fatigue tests on a threaded section of IN718 bolts, test pieces which retained some threads were designed as shown in Figure 3-8. The half-cut test pieces were machined from the as-received IN718 large bolts. The total length of the test piece is 50mm, with a 20mm thread section in the centre and 15mm smooth sections at both ends. Bending test pieces were subjected to the heat treatment before the bending tests to achieve the cold work free microstructure at the thread area (Section 2.1.2.2).

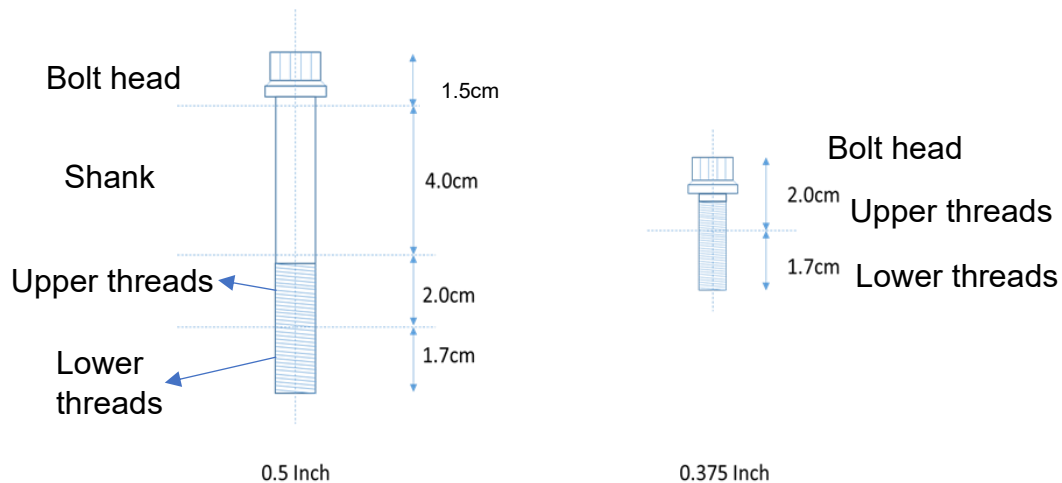
Figure 3-11 Illustration of local areas in IN718 bolts

Due to the complex geometry, several manufacturing processes are required to produce different parts of a bolt. This leads to a variation in microstructure in different parts of the bolt. The large and small bolts were longitudinally sectioned and divided into different pieces named “Bolt head”, “Shank”, “Upper threads” and “Lower threads” as shown in Figure 3-11. The samples were mounted and polished and tested for micro-hardness.

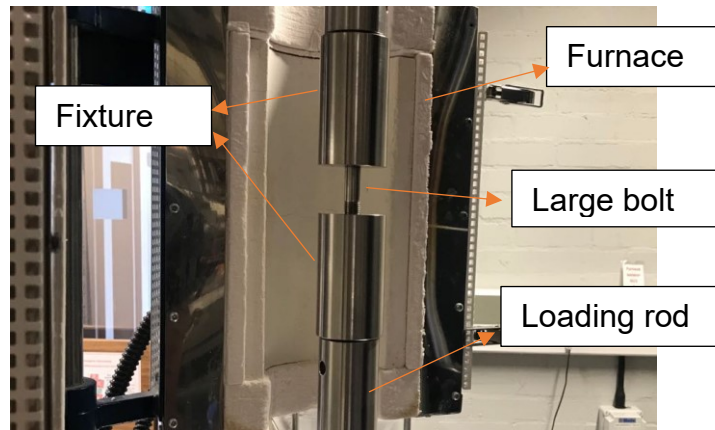
Figure 3-12 Group C IN718 large bolt installed in the testing machine by the customised fixture in the middle

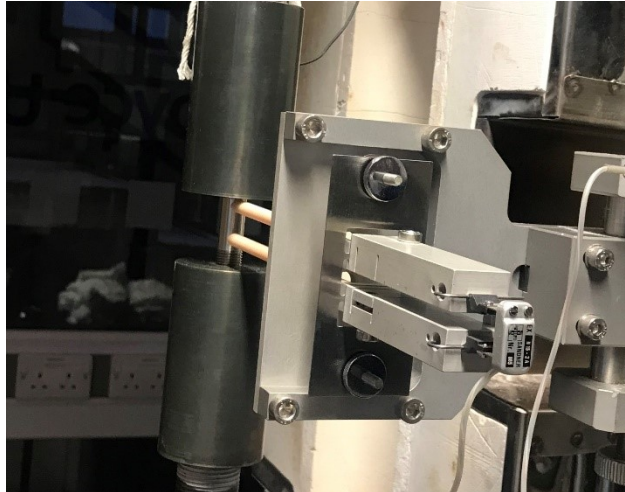
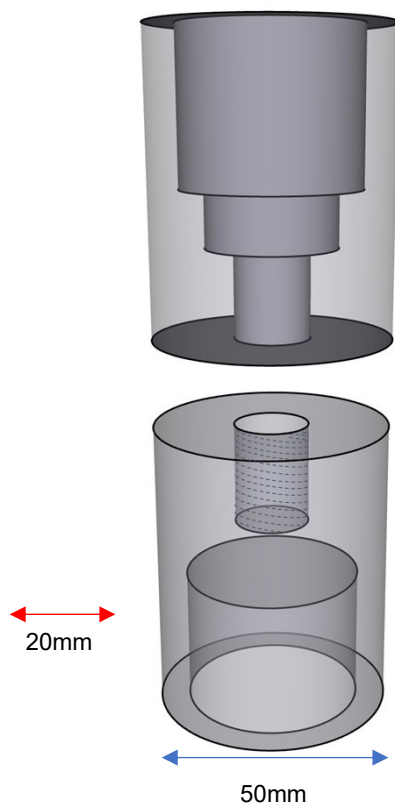
Figure 3-16 Axial tensile-fatigue testing setup and the special fixture used for fitting the IN718 large bolts

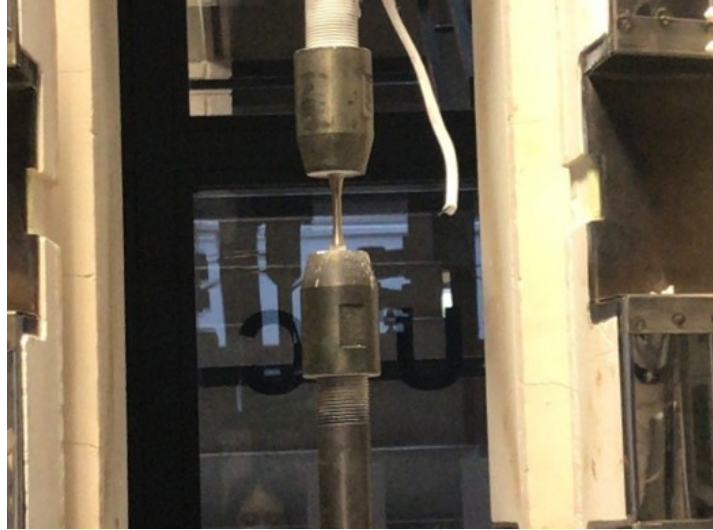
Figure 3-17 HT sample installed on ESH hydraulic testing machine

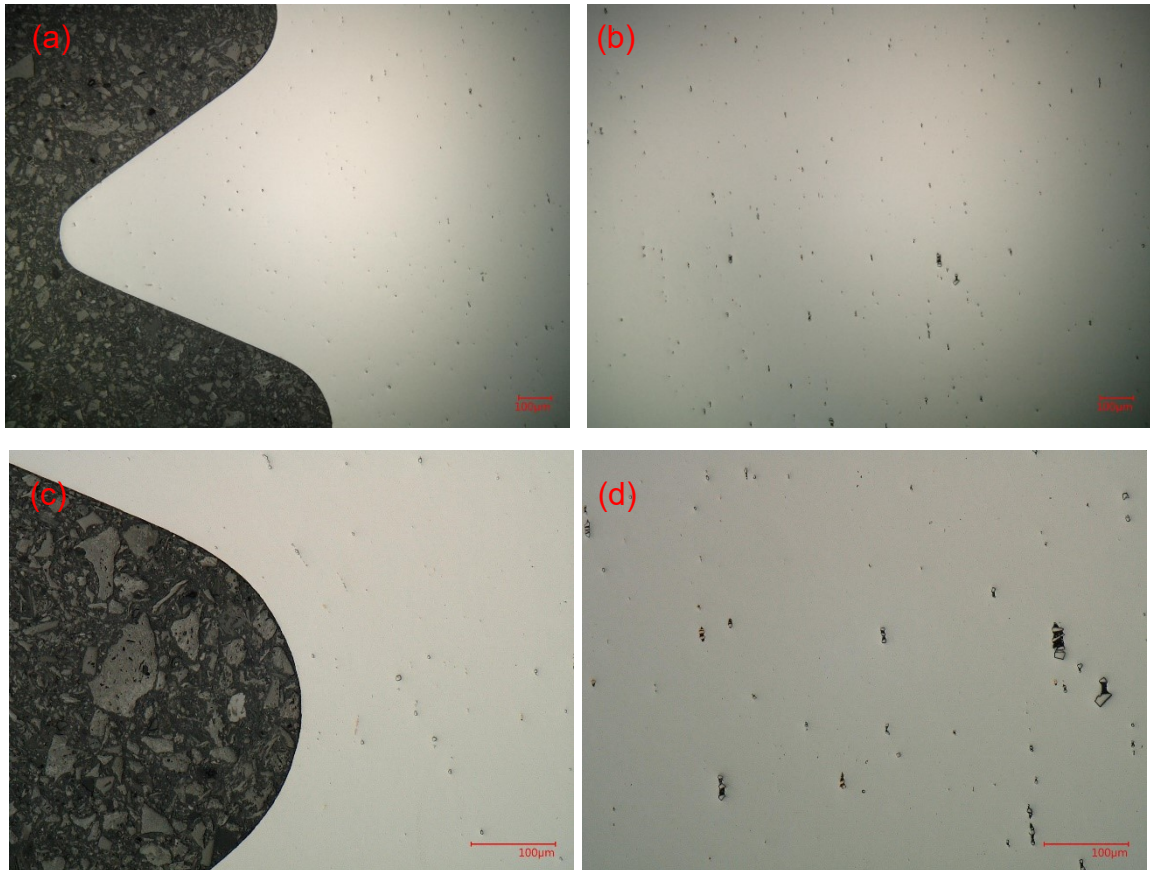
Figure 4-2 As-received large bolt in the polished condition. (a) and (b) were taken at the threads and the centre of thread section under 200 magnifications, (c) and (d) were taken at the thread root and the centre of thread section under 500 magnifications.

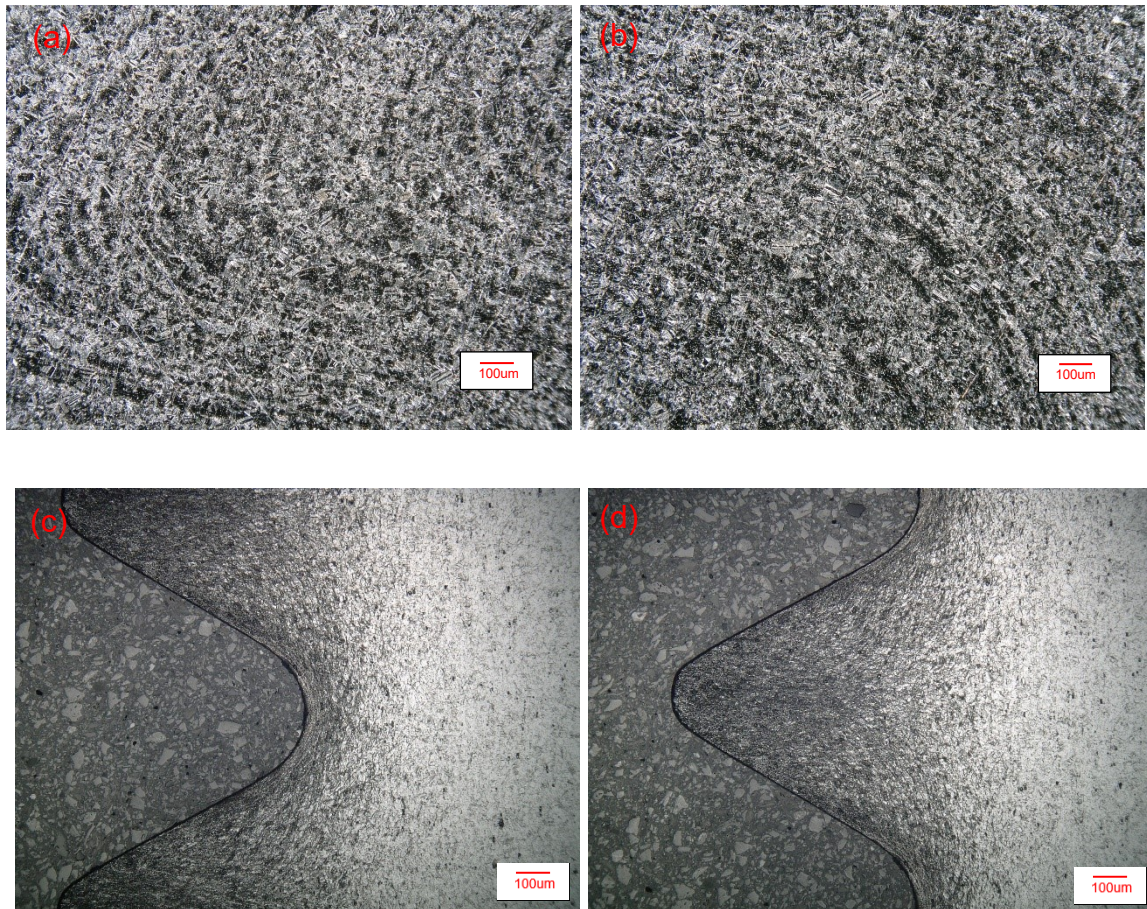
Figure 4-3 As-received large bolt in the etched condition under 200 magnifications. (a) and (b) show the clear deformation flows at the bolt head, (c) and (d) show the cold-rolling deformation at the threads.

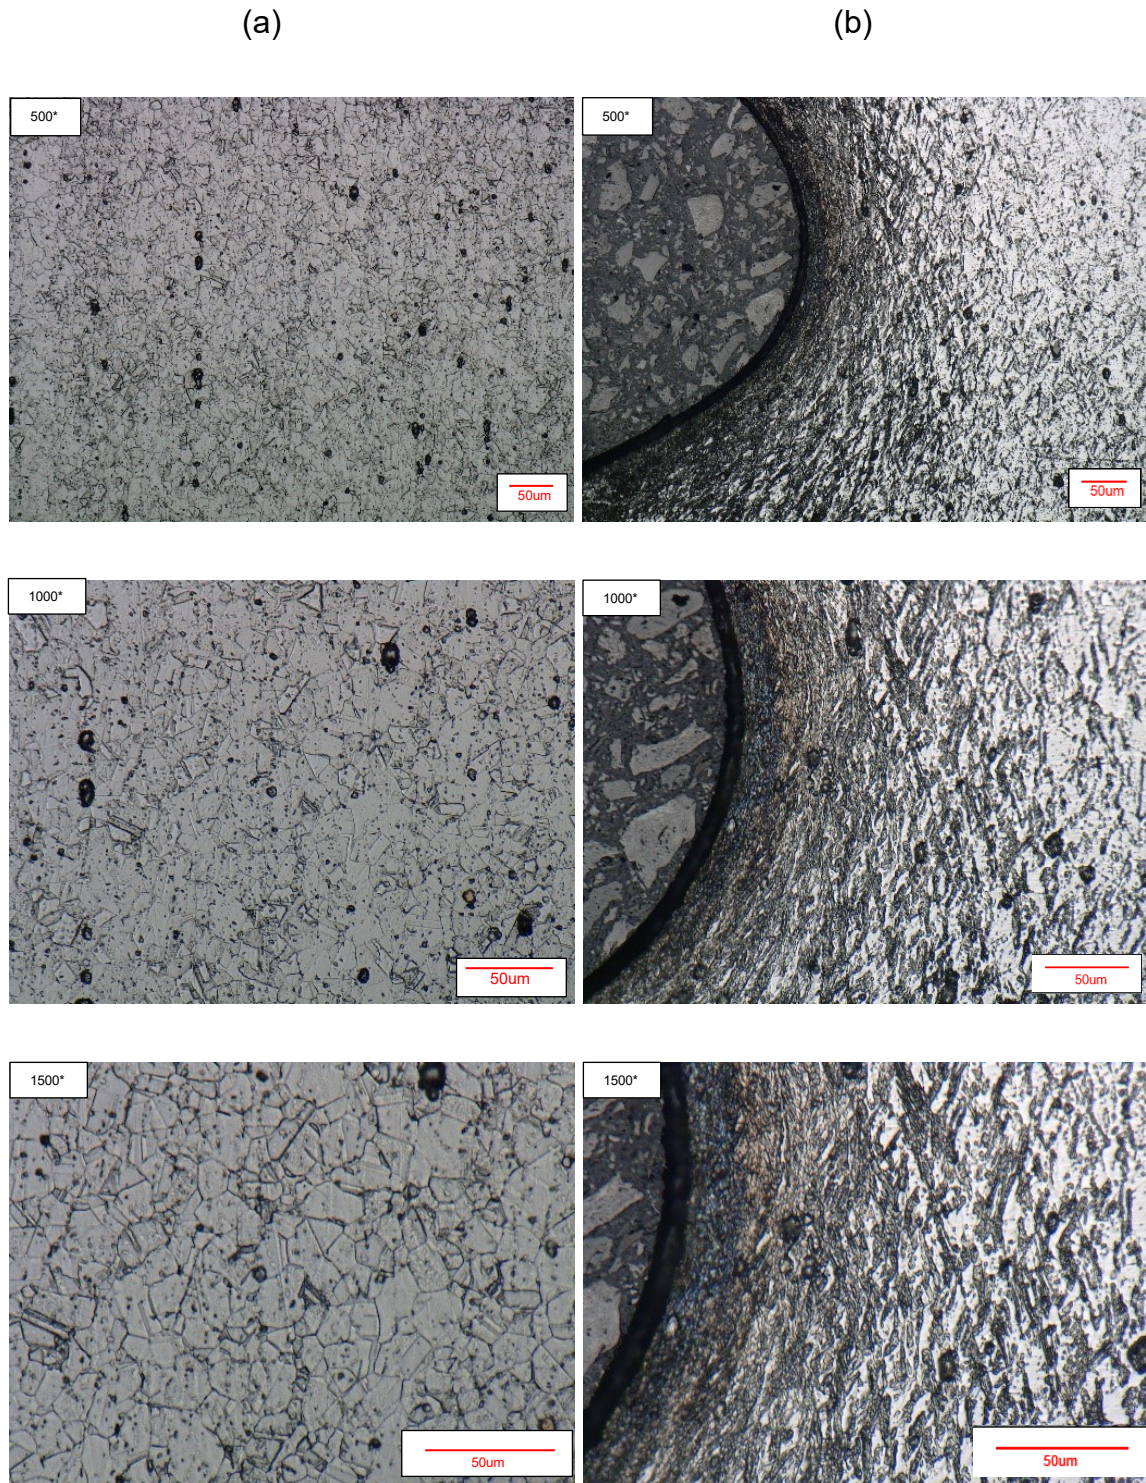
Figure 4-4 Optical micrographs of the shank (a) and thread root (b) in the as-received large bolt.

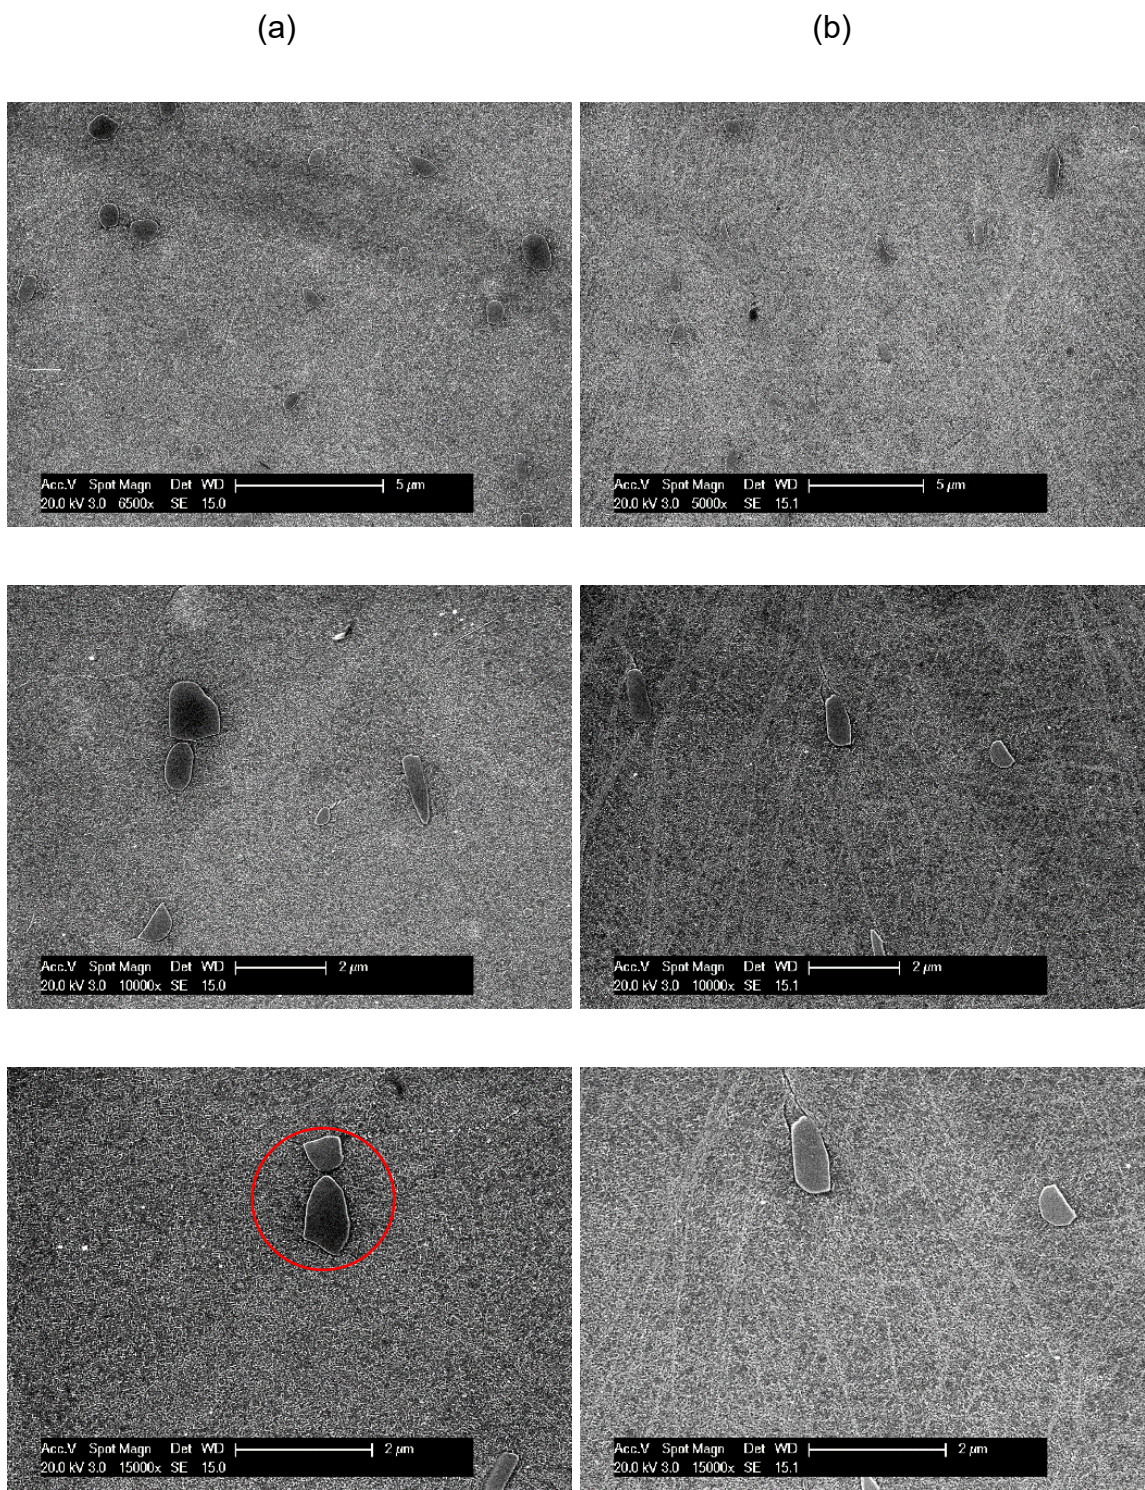
An as-received large bolt was polished and etched by electro-phosphoric acid to reveal the precipitates. In Figure 4-5, only few δ precipitates are detected in the shank or the thread root. Unlike the HT conditions (Figure 4-16), δ precipitates (circled in red) are mainly short and blocky in the bolt instead of long and needle like.

Figure 4-5 (a) Shank and (b) thread root in the as-received large bolt under the SEM

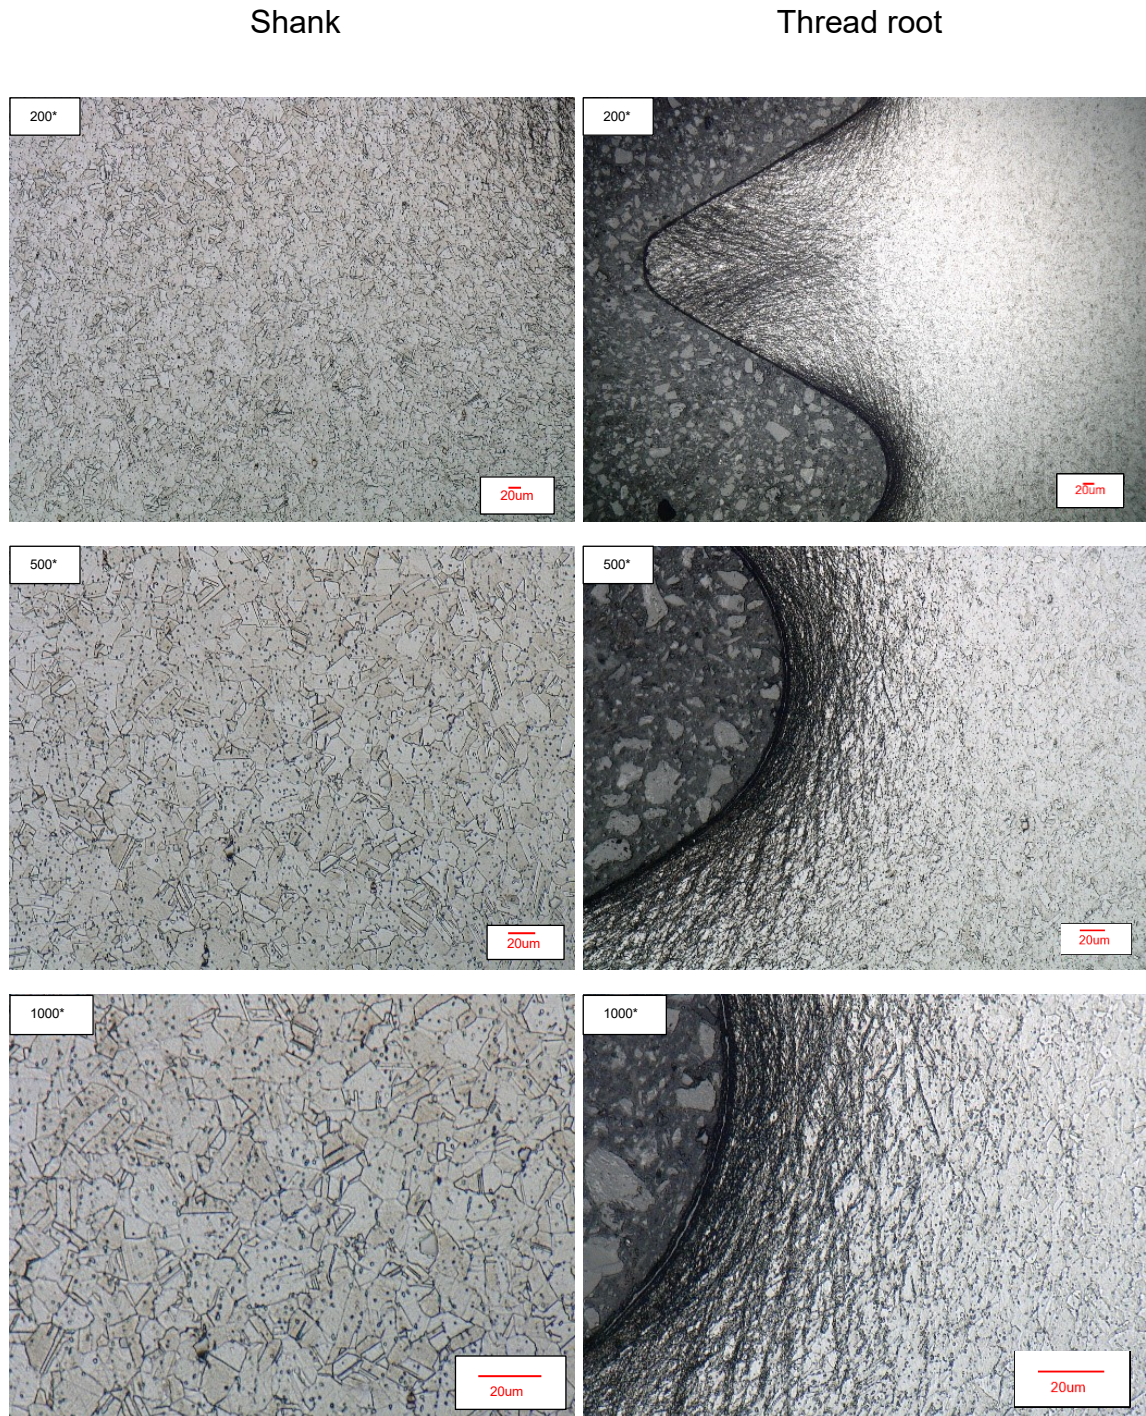
Figure 4-10 Optical micrographs of the shank and thread root areas of the Group C large bolts

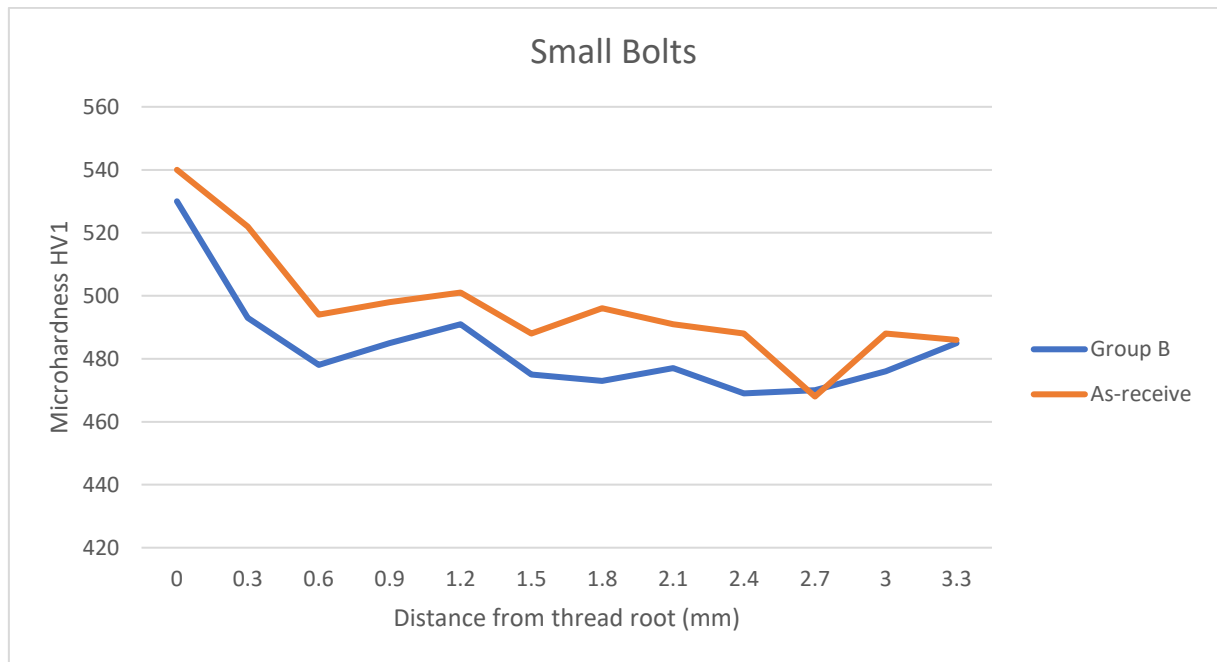
Microhardness testing from the thread root to the centre area was carried out on as received and Group B Small bolts. Figure 4-13 shows the comparison. It can be seen that the results of both conditions share the key features that the peak hardness appears at the thread root and rapidly drops towards the centre area of the bolts. Unlike the large bolts, the microhardness tends to decrease slightly overall after the heat treatment (Group B small bolt), and the difference is smaller moving closer to the centre.

Figure 4-13 Microhardness of As-received small bolts and Group B small bolts

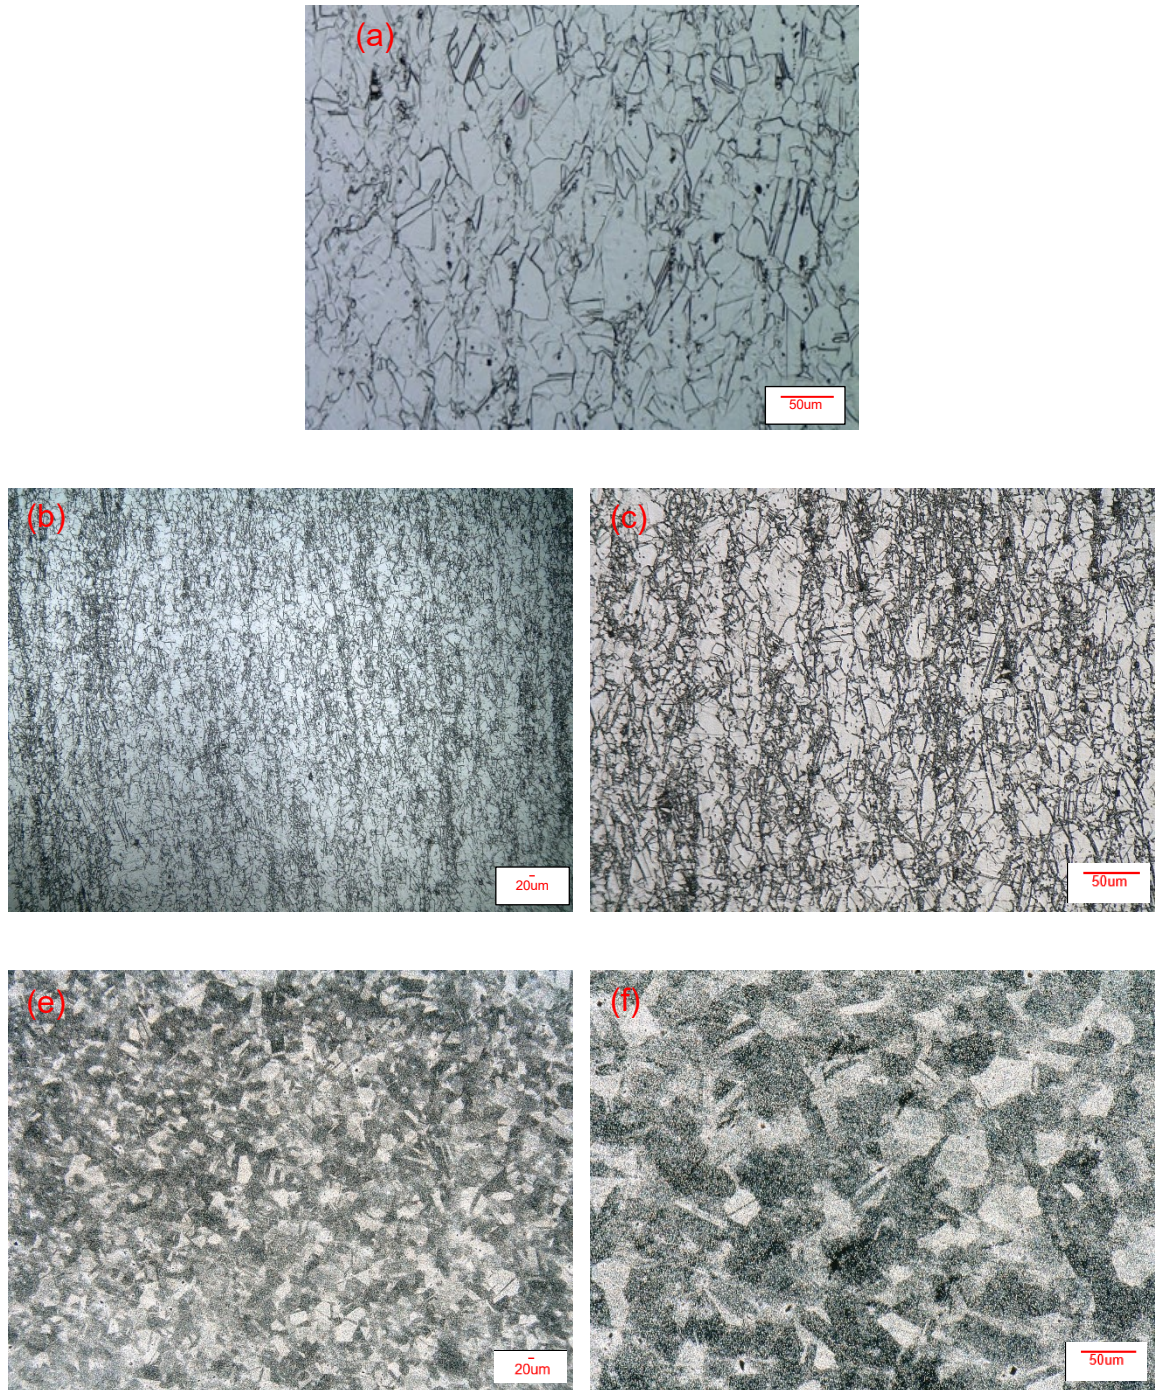
Figure 4-14 Optical micrographs of etched HT0 HT1 and HT3 samples in the longitudinal direction. (a) is HT0 at 500 magnifications, (b) and (c) are HT1 at 200 and 500 magnifications, (e) and (f) are HT3 at 200 and 500 magnifications.

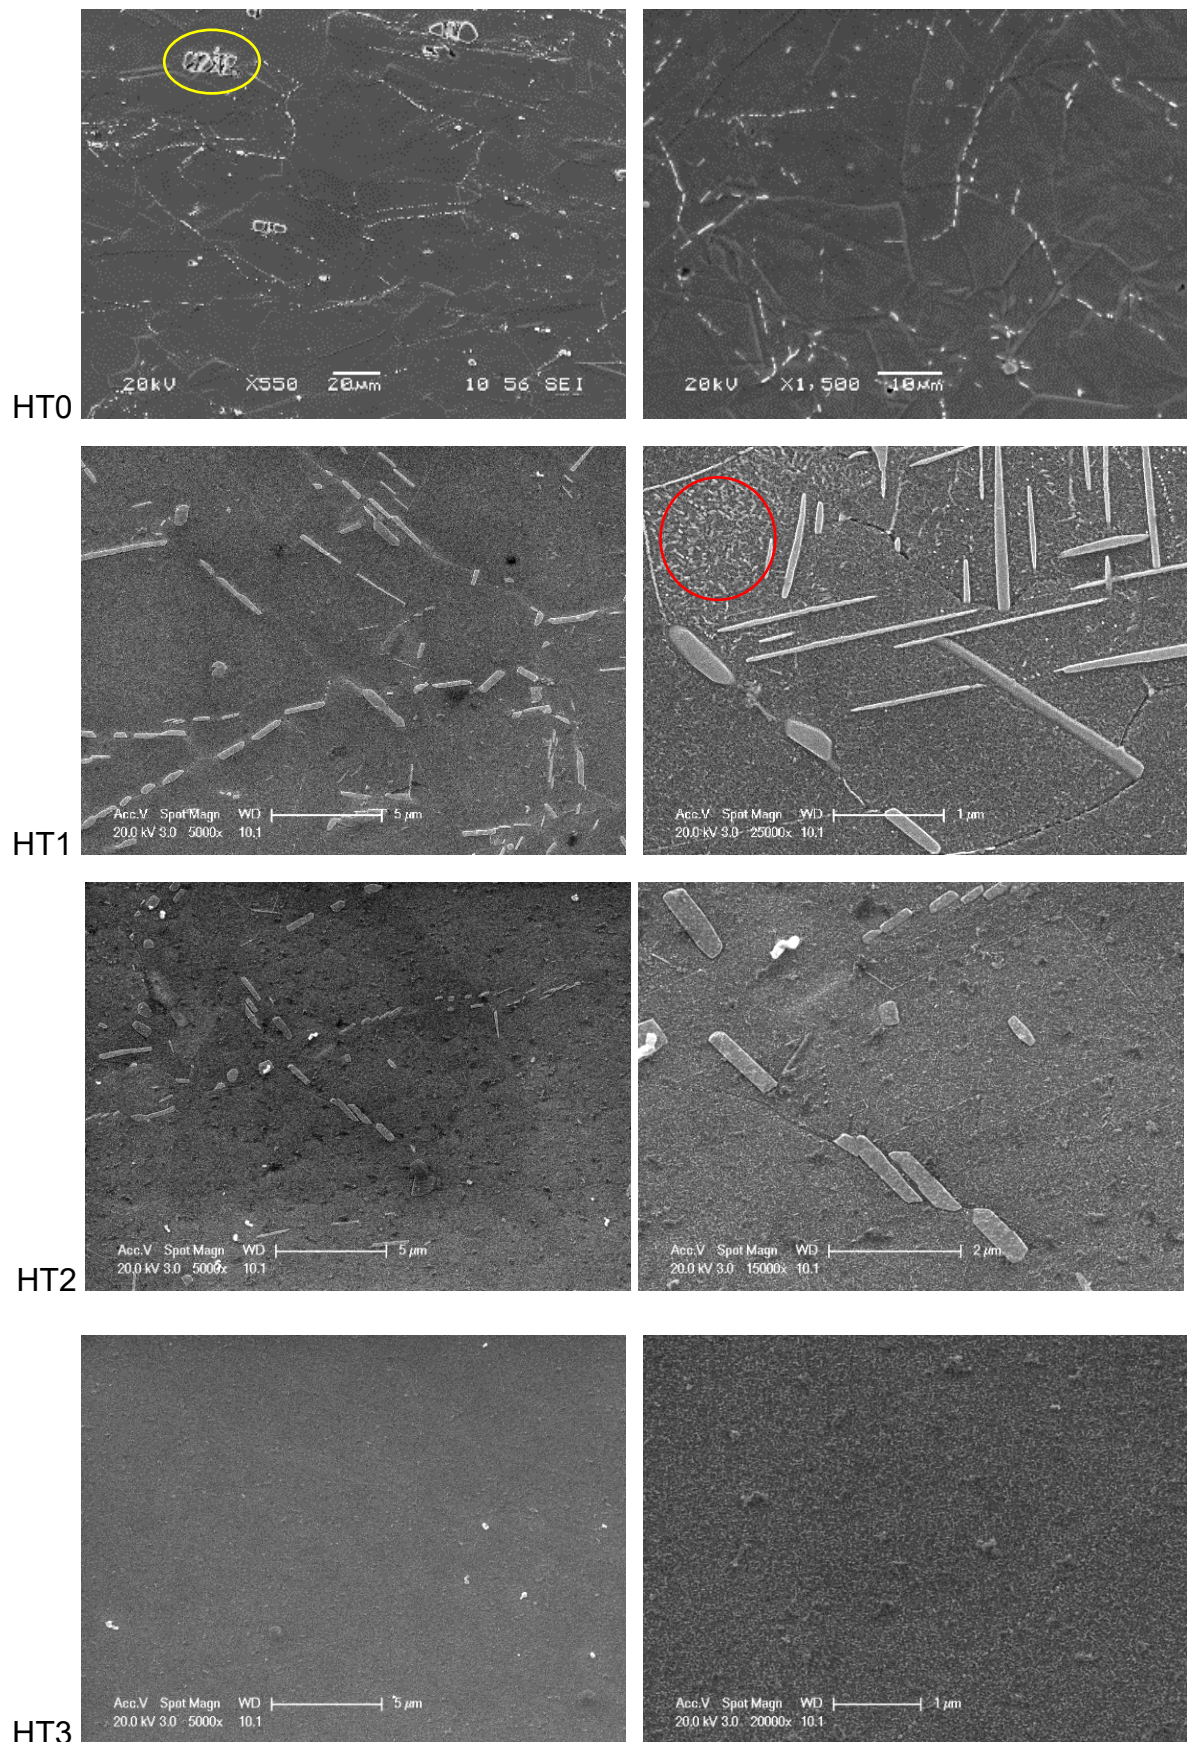
Figure 4-16 SEM images of HT0, HT1, HT2 and HT3 for δ phase observations

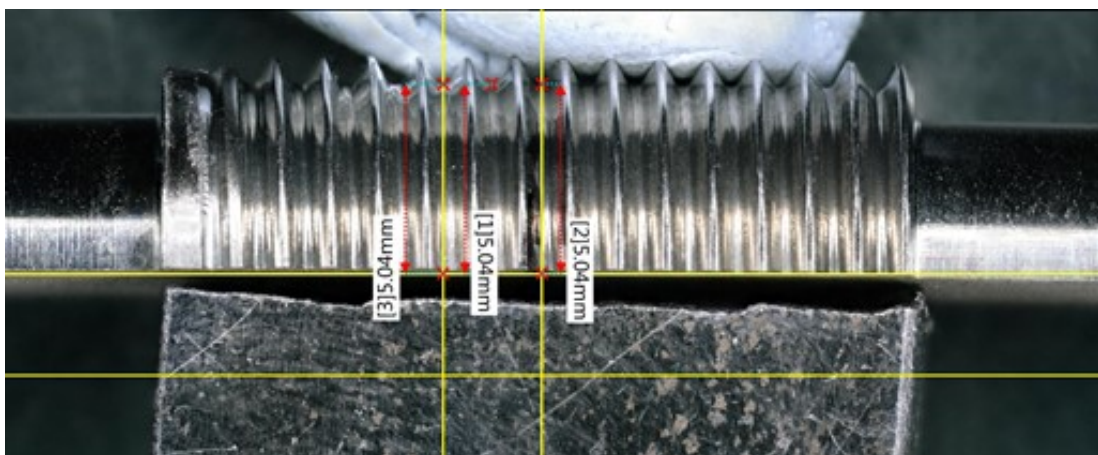
Figure 4-19 Width measurements of the bending samples

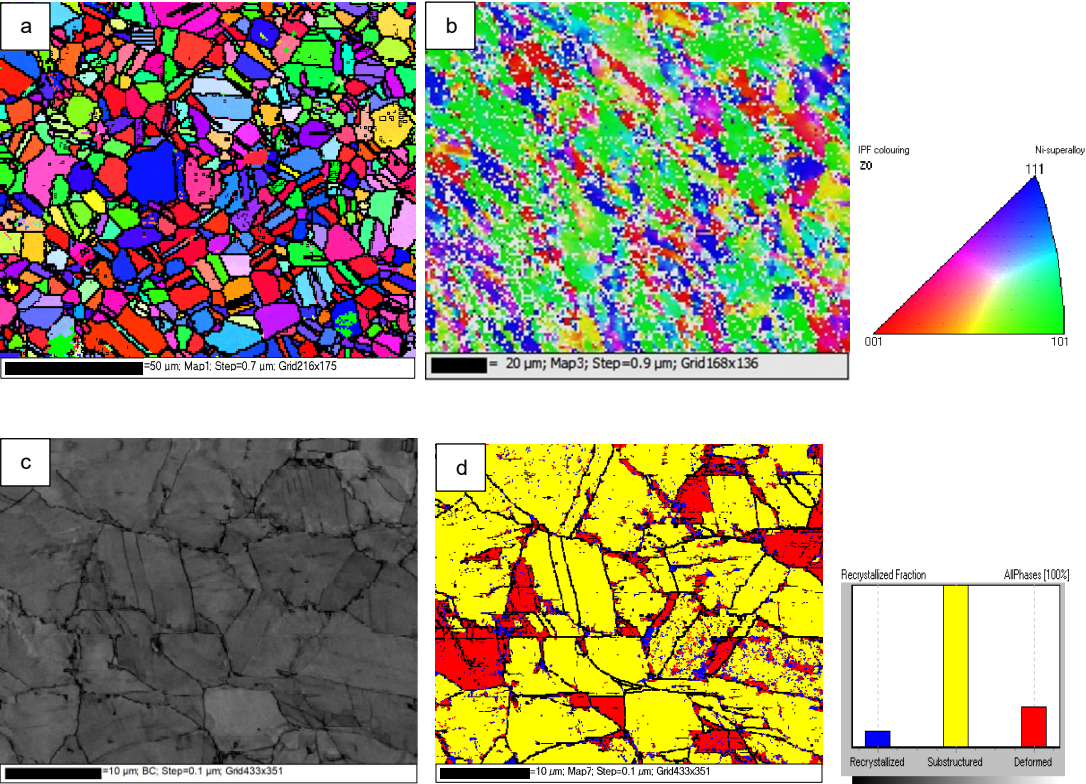
Figure 4-21 IPF mapping of (a) CWF and (b) CW samples at the threads; (c) band contrast and (d) deformation analysis of CW sample at a depth of 250µm below the threads root surface.

A fine step-size EBSD mapping (band contrast) was taken at a further depth near the thread-root area in the CW sample in Figure 4-21 (c) and (d). This is to detect if the cold work still exists beyond 250µm from the thread-root surface. Figure 4-21(c) shows that the grain boundaries are very slightly distorted. However, by analysing the recrystallisation-deformation map in figure 4-21(d), some areas of heavy coldwork, shown in red zone can still be seen to exist, and the rest of the area is covered by sufficient cold work in yellow as the substructure. From the EBSD results, cold rolling heavily affects the threads and thread root surface to a depth of at least 250µm, and the remaining cold work still can be detected beyond the depth where the grains appear only slightly deformed. The following testing results investigate the influence of thread rolling on high-temperature fatigue performance, as well as the microstructural evolution under the dwell fatigue testing.

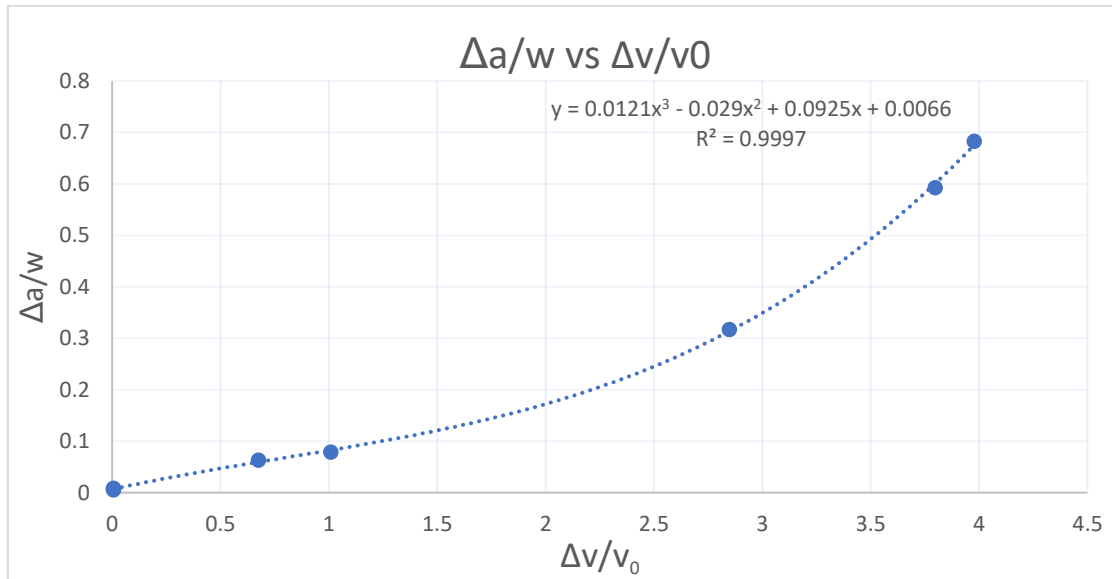
Figure 4-22 The calibration relationship between p.d. ($\Delta V/V_0$) and crack growth rate ($\Delta a/W$) of the bending test pieces

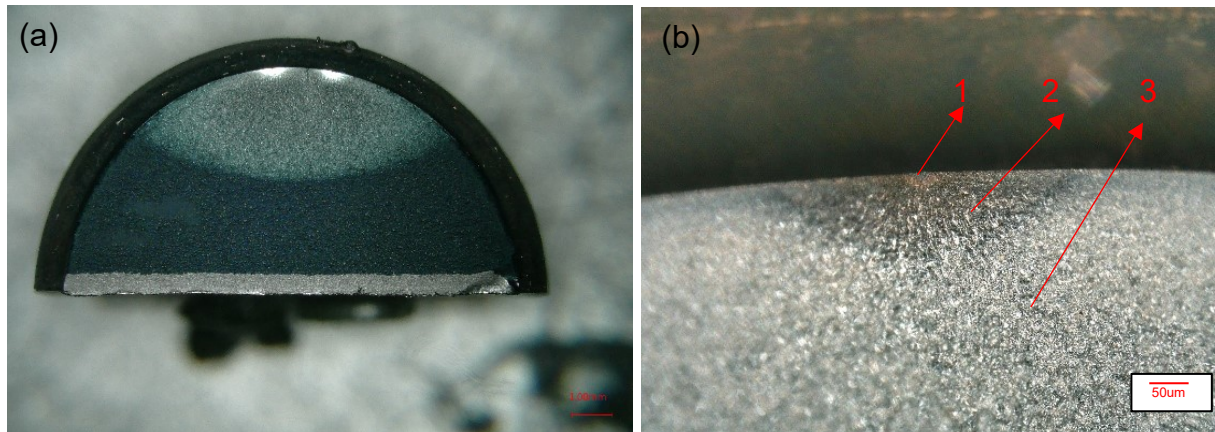
The large dark blue area in Figure 4-23 (a) is the overload zone that occurred during final failure, and the bottom silver line is caused by manually separating the sample after testing.

Figure 4-23 Optical images of (a) the fracture surface of the trail sample and (b) the three fatigue zones.

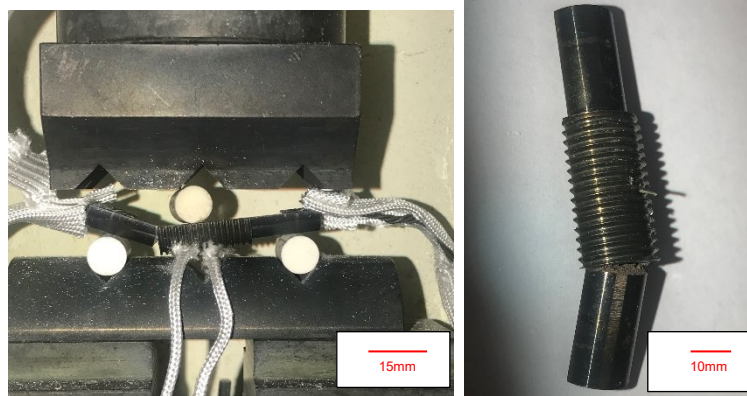
Figure 4-25 The tested CWF sample failing at the threads edge
