CHARACTERISATION OF IN718 FASTENERS FOR AERO-ENGINE APPLICATIONS

A thesis submitted to The University of Birmingham for the
degree of

DOCTOR OF PHILOSOPHY

School of Metallurgy and Materials

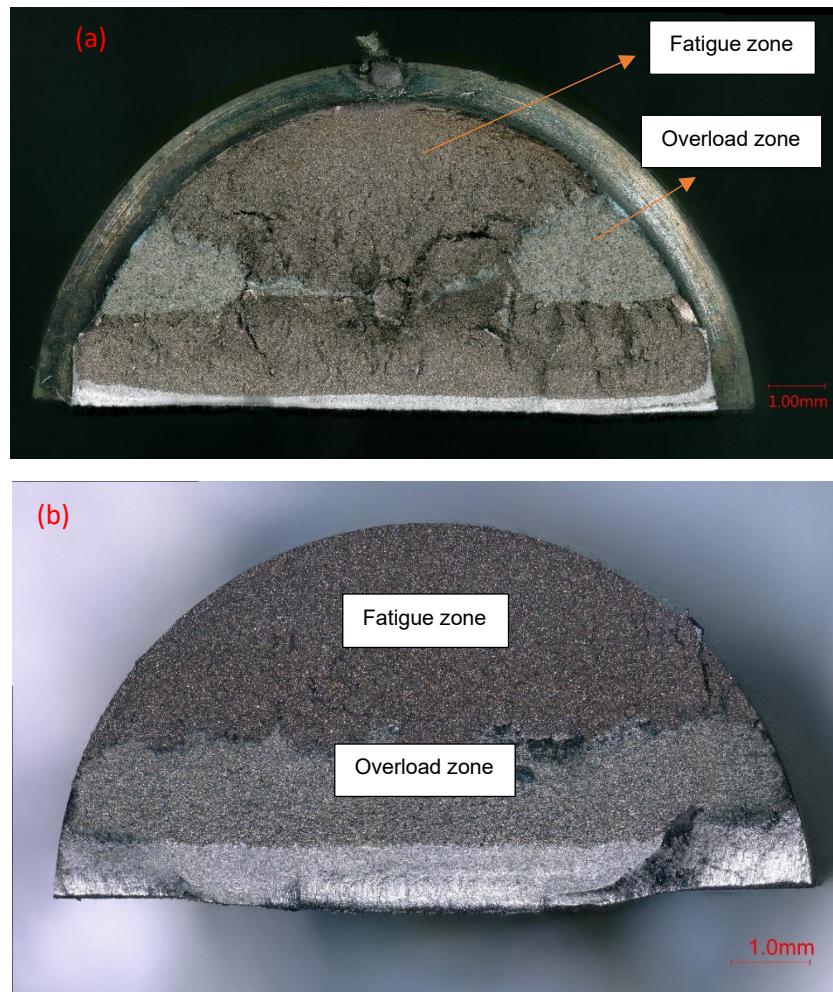
The fracture surfaces of CW and CWF samples were examined at the lower-magnification SEM. The optical images (Figure 4-26) show that both fracture surfaces consist of fatigue and overload areas, and a closer observation was carried out by SEM from the crack origin to the centre zone in Figure 4-27. Within 200 μ m from the origin in Figure 27 (a), the CW sample shows a flat fracture surface overall, especially within 30 μ m no grains can be observed. The crack growth mechanism then gradually becomes a mixture of intergranular and transgranular. The CWF sample shows bumpy intergranular failure with a small amount of transgranular behaviour from the crack origin to the end of the fatigue zone (see Figure 4-27 b). Due to the heat treatment on CWF sample, the recrystallisation layer at a depth of 60 μ m from the surface can be seen in Figure 4-27 (b).

Figure 4-26 Optical images of the fracture surfaces of (a) CW and (b) CWF

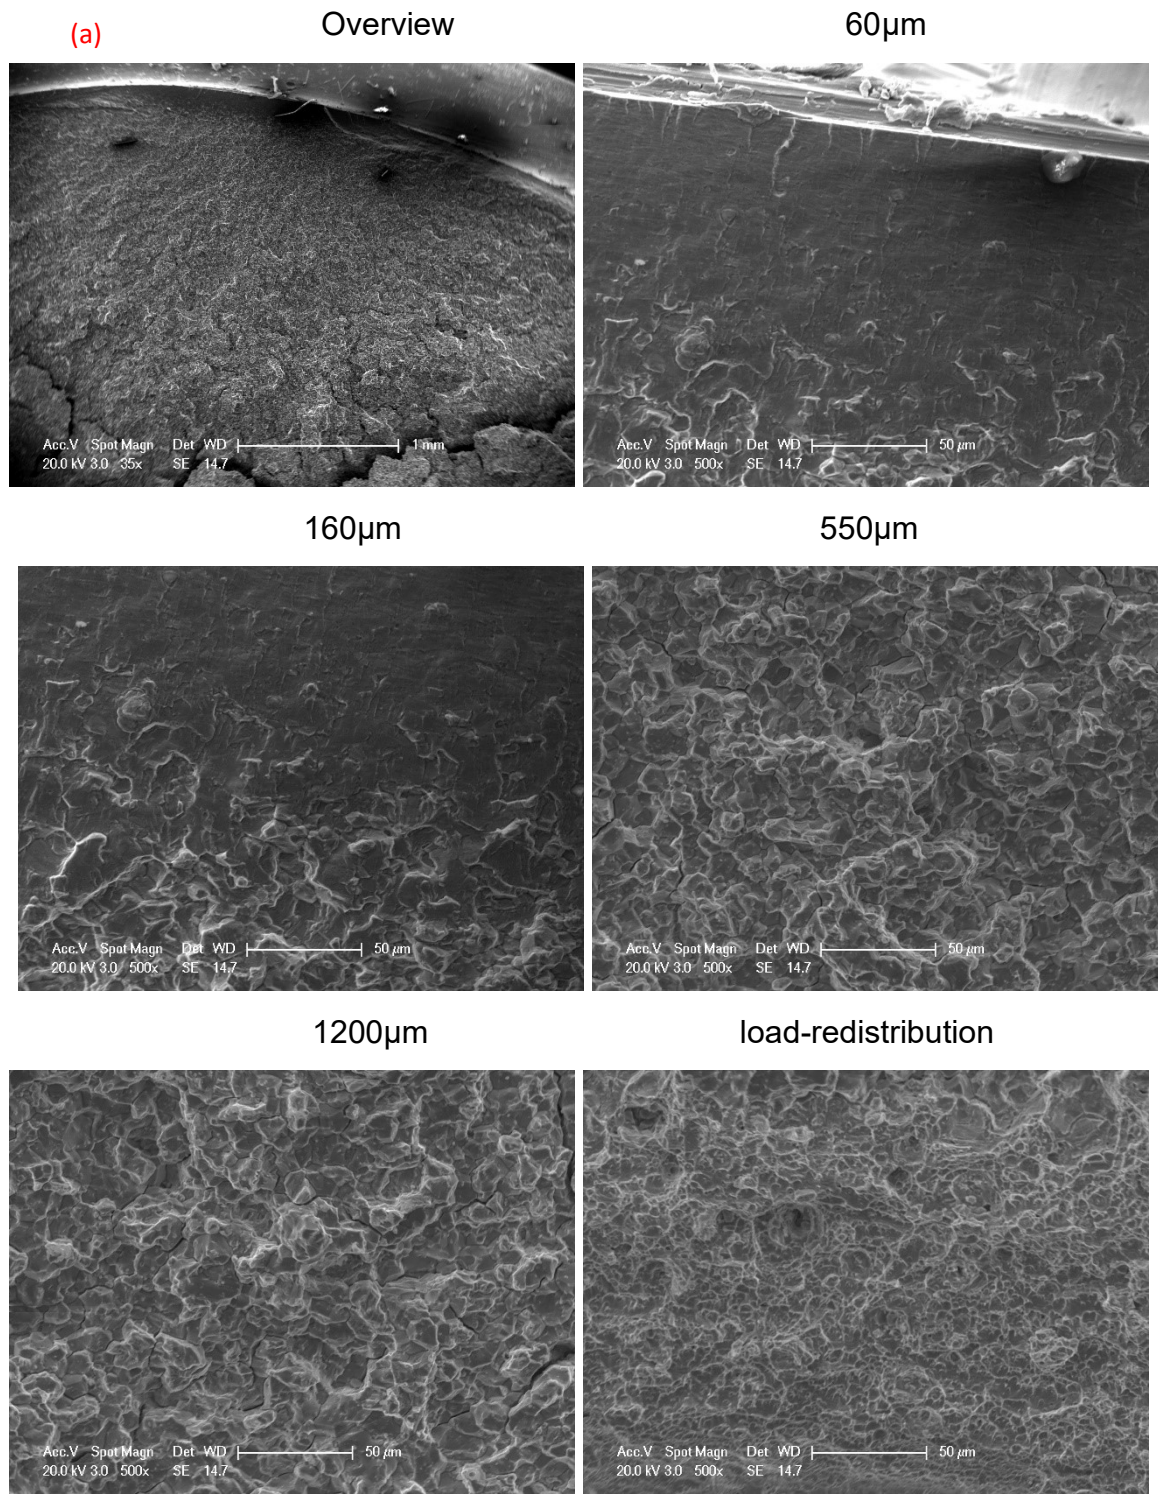
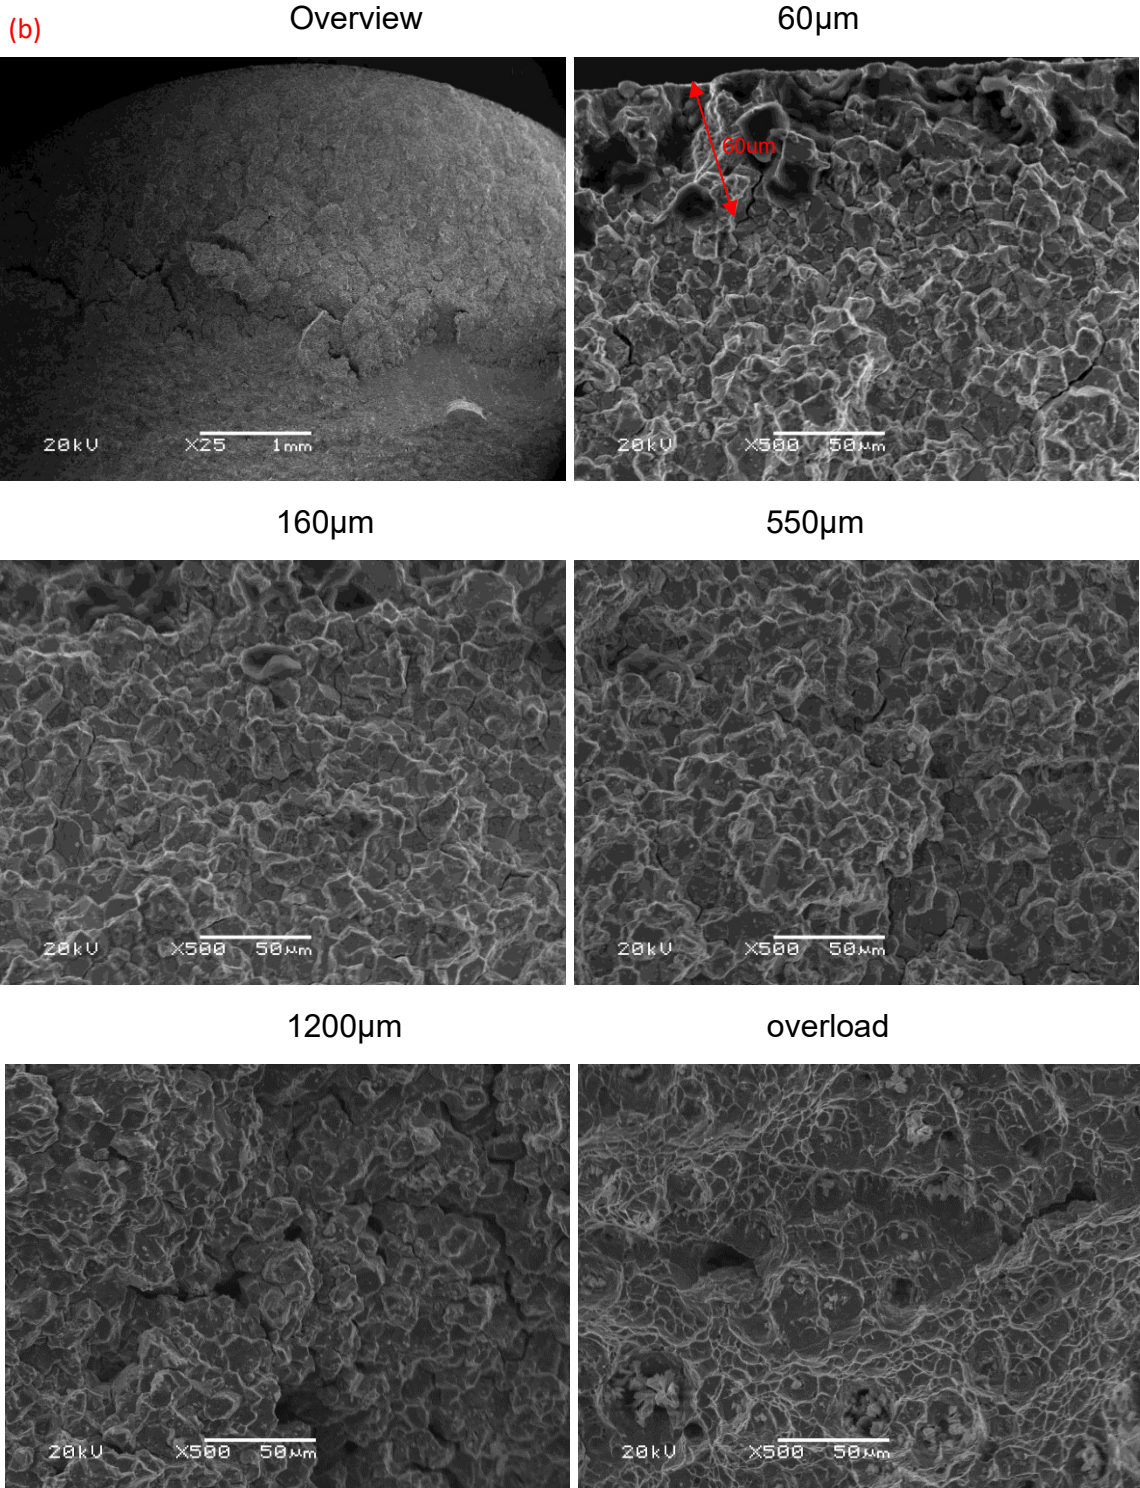
Figure 4-27 SEM images of the fracture surfaces of (a) CW sample and (b) CWF sample at different depth from the thread root surface

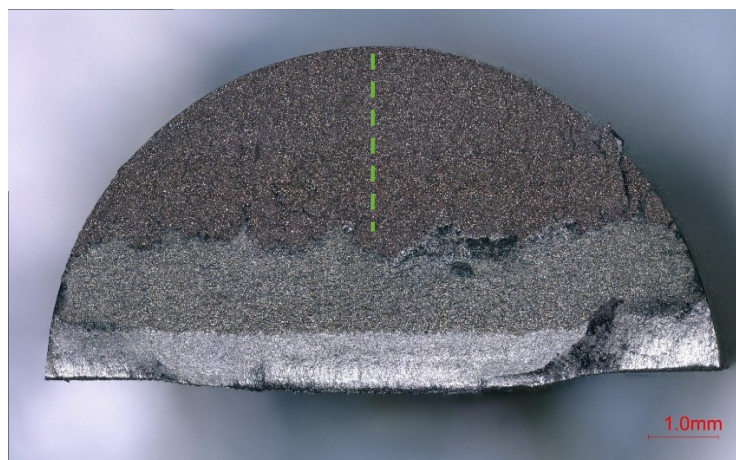
Figure 4-28 Preparation of cross-sectional microstructure on the CWF sample

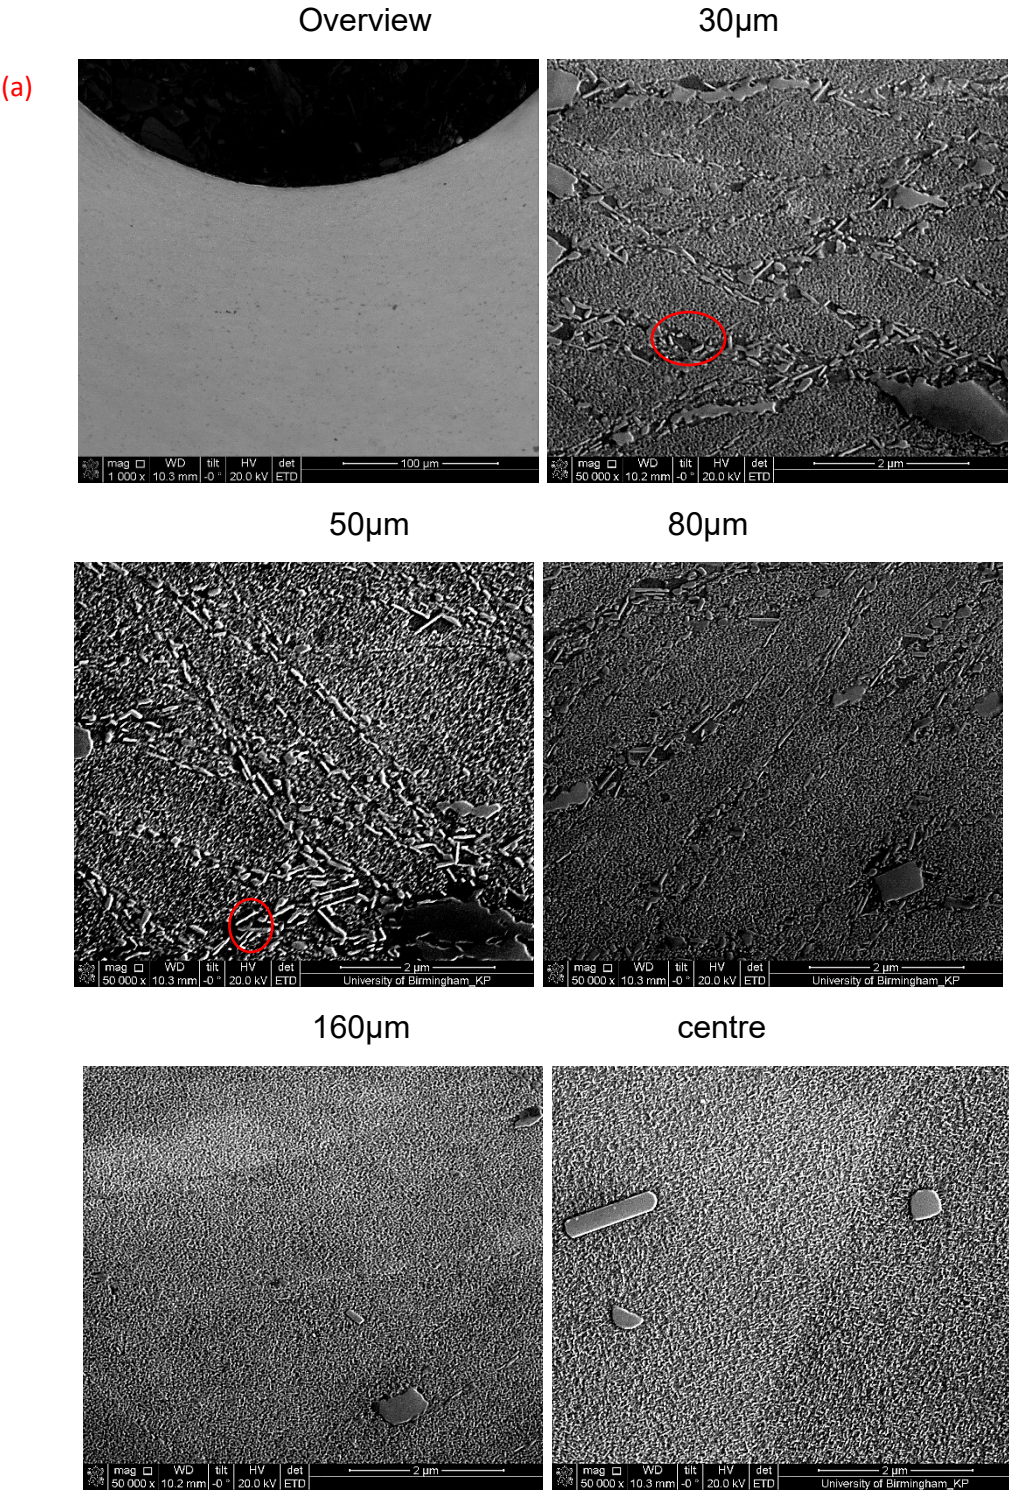
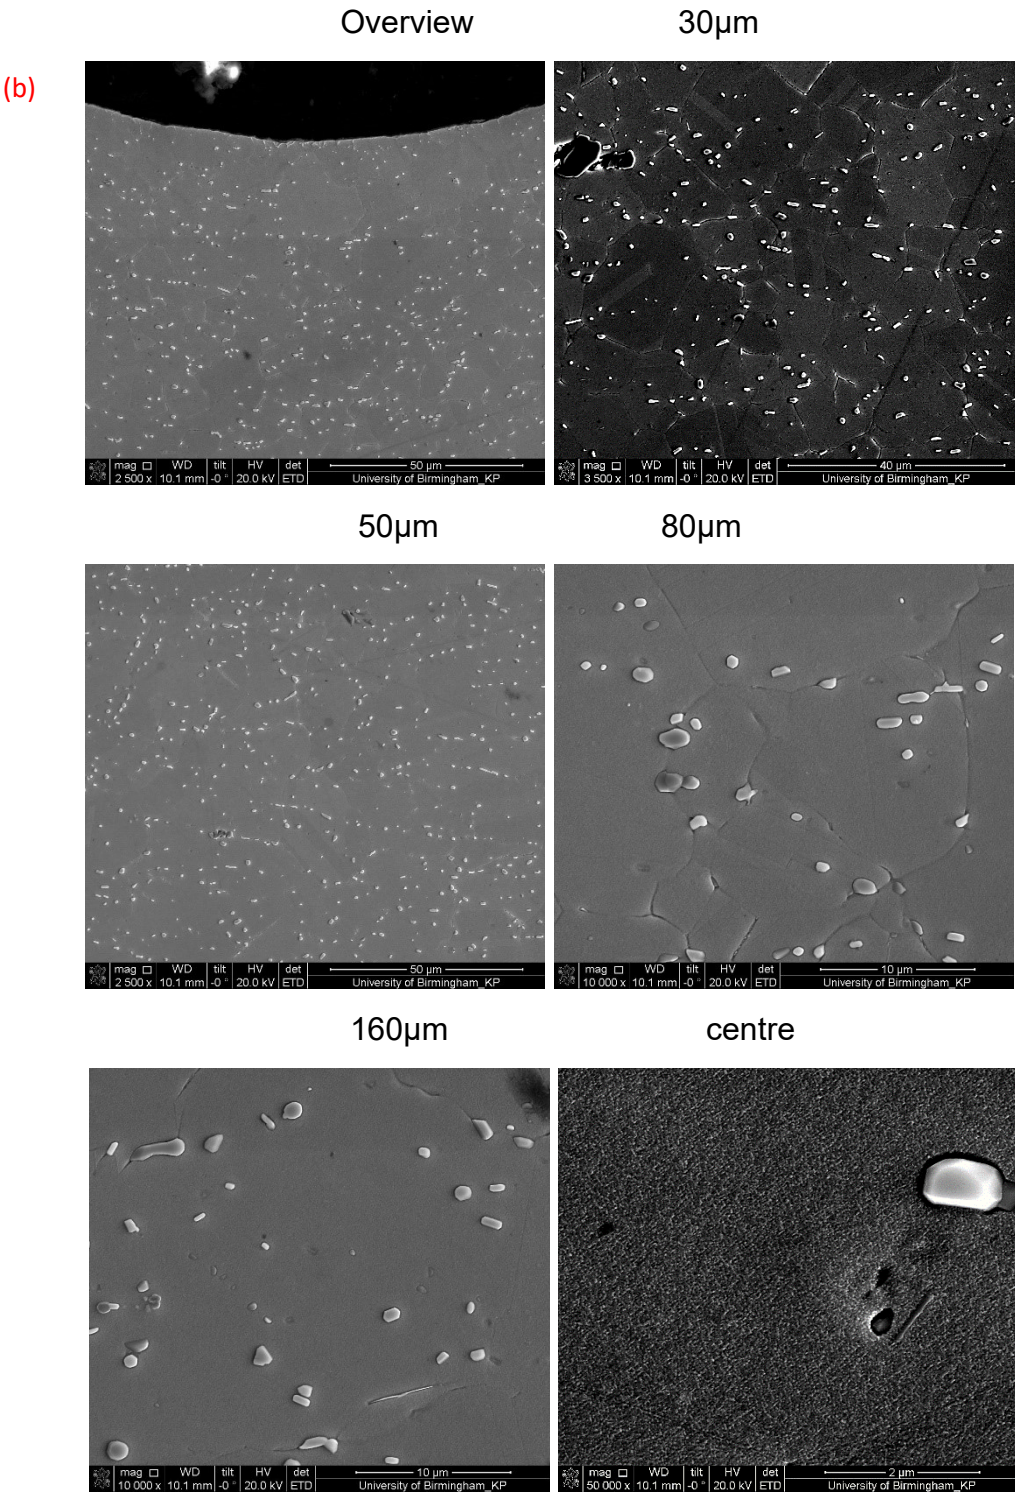
The characteristics of the CWF sample differs from those of the CW. Both δ phase and γ'' phase are evenly distributed throughout the CWF sample. Additionally, the number of δ precipitates increases in the CWF sample at the thread area after the heat treatment in Figure 4-29 (b).

Figure 4-29 SEM images of cross-section profiles of the (a) CW and (b) CWF samples at the thread root.

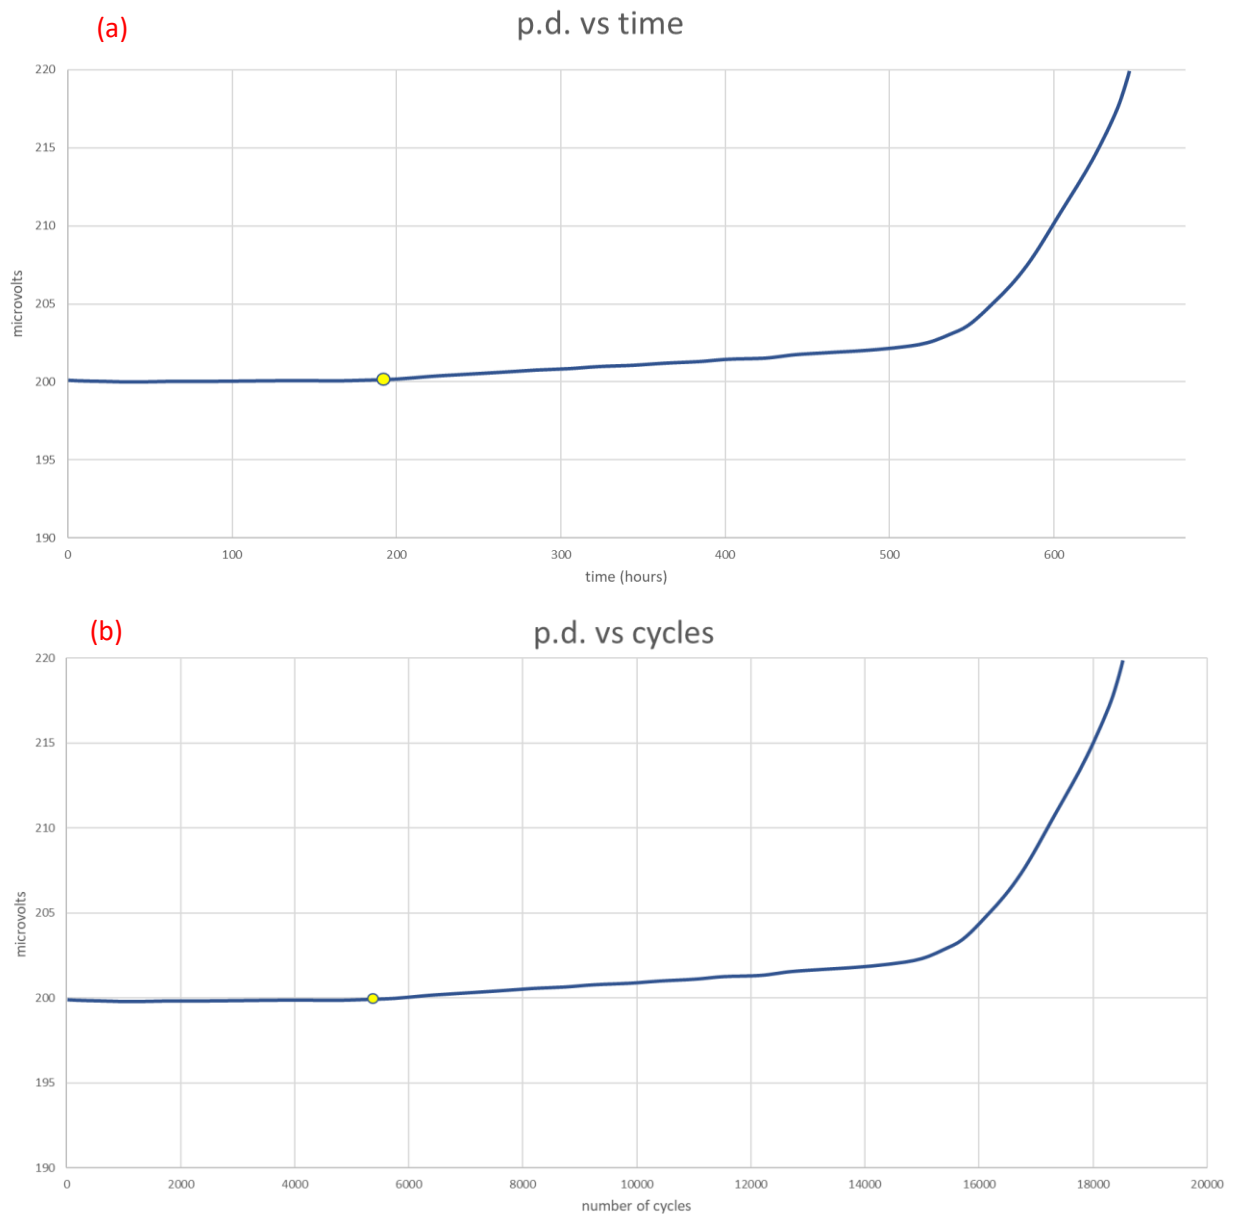
Figure 4-32 The dwell fatigue testing results of the CWF sample presented by p.d against (a) time and (b) cycles.

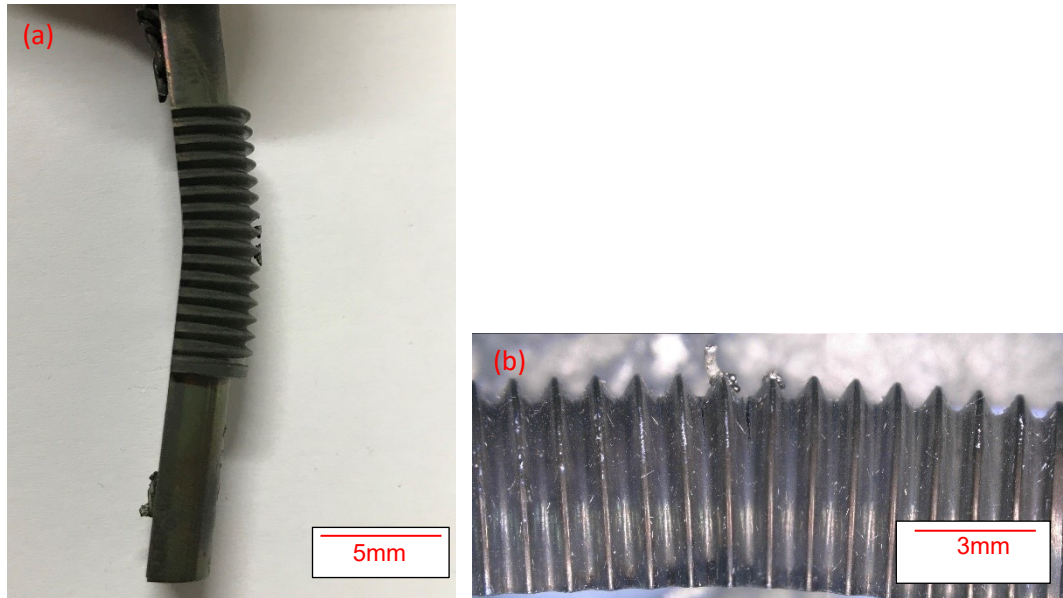
Figure 4-33 The bent CW (a) and CWF (b) samples after dwell testing

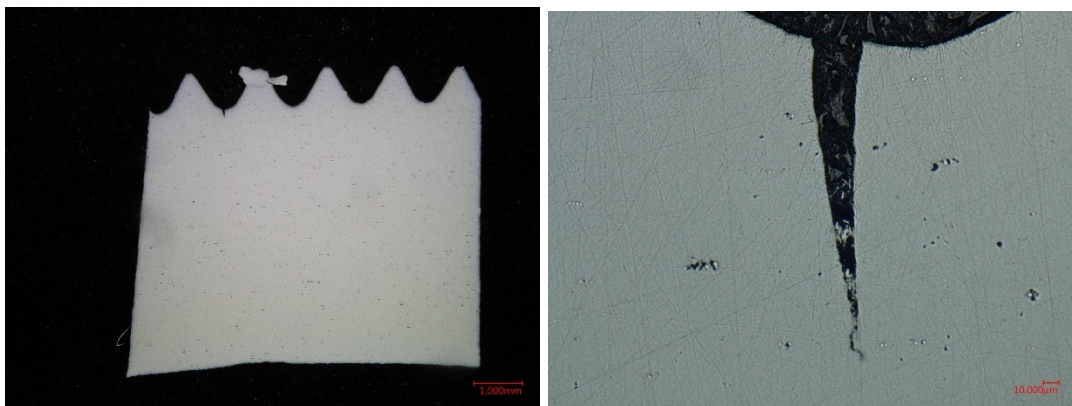
Figure 4-34 Optical images of the CW cross-sectional microstructure for crack observation at 200 and 300 magnifications.

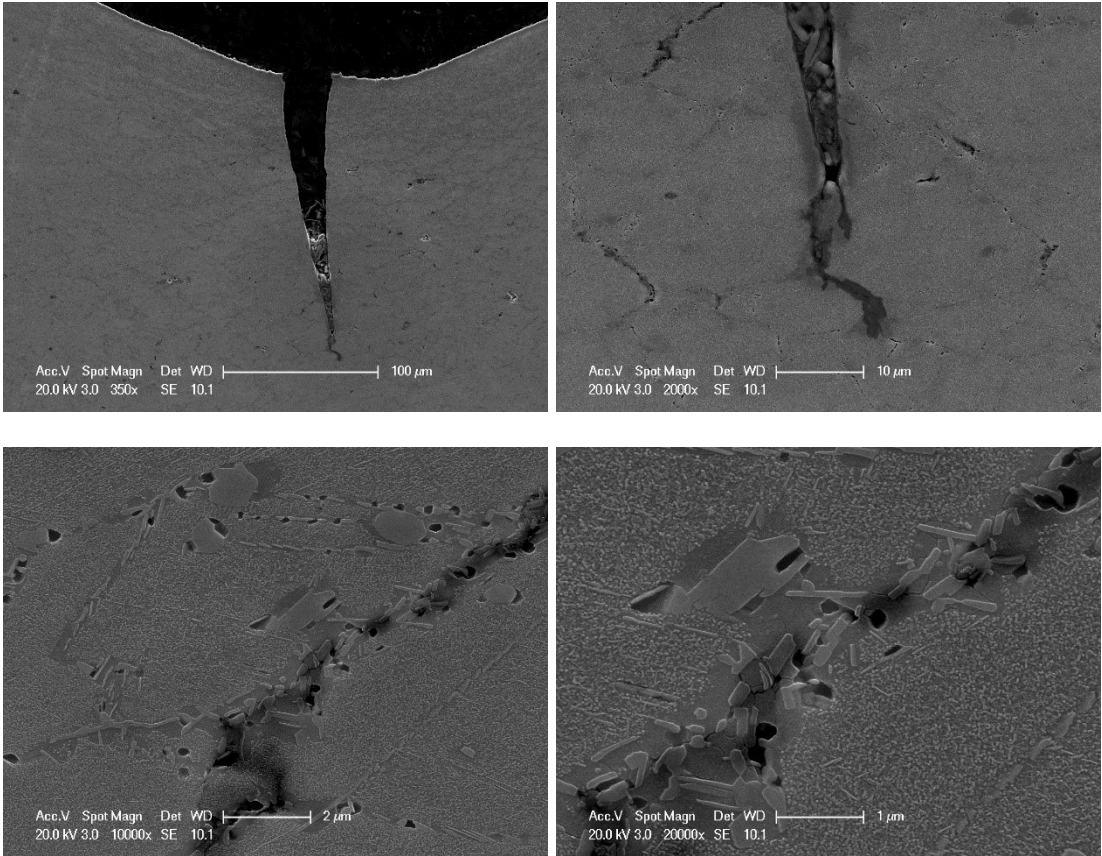
Figure 4-35 (a) SEM images of the crack and crack tip in the CW sample

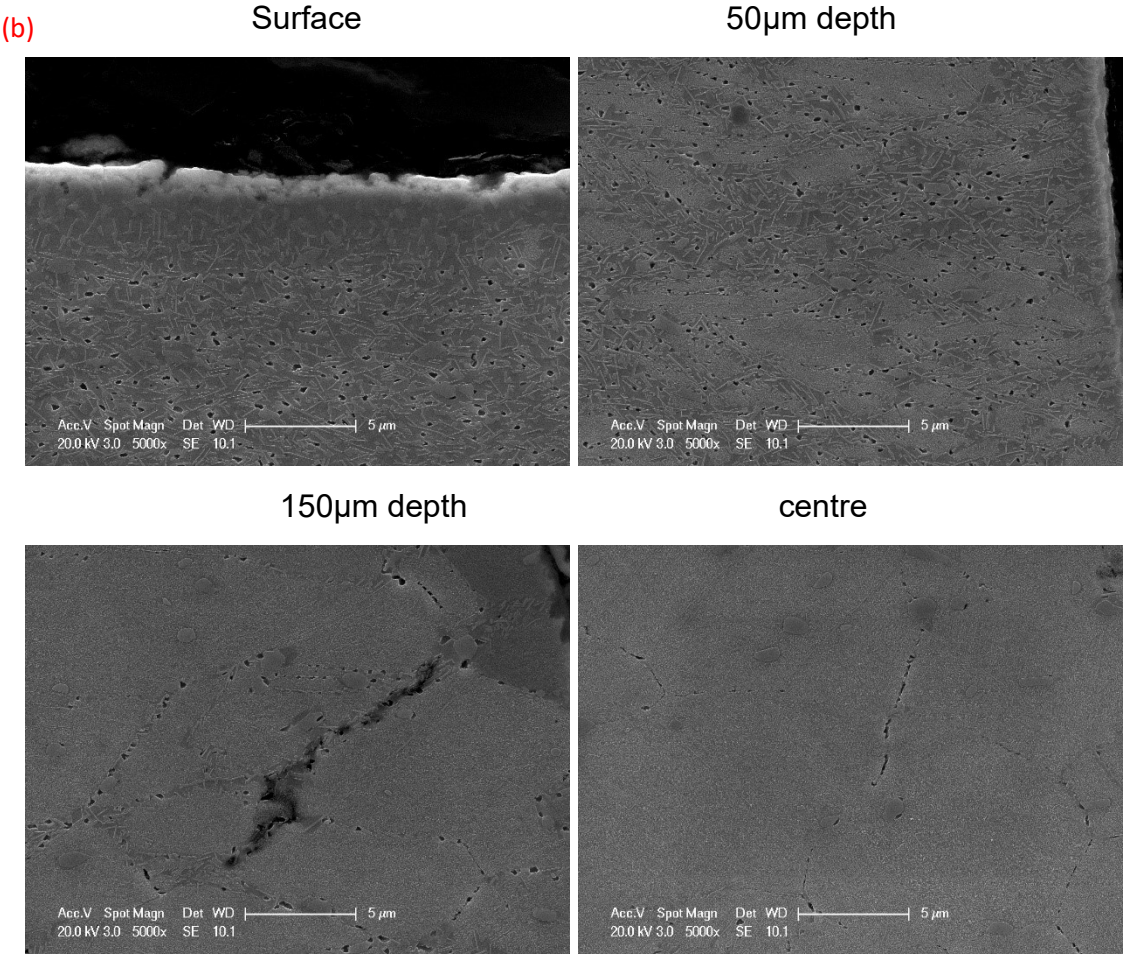
Figure 4-35 (b) Microstructure in the CW sample near the thread root and centre

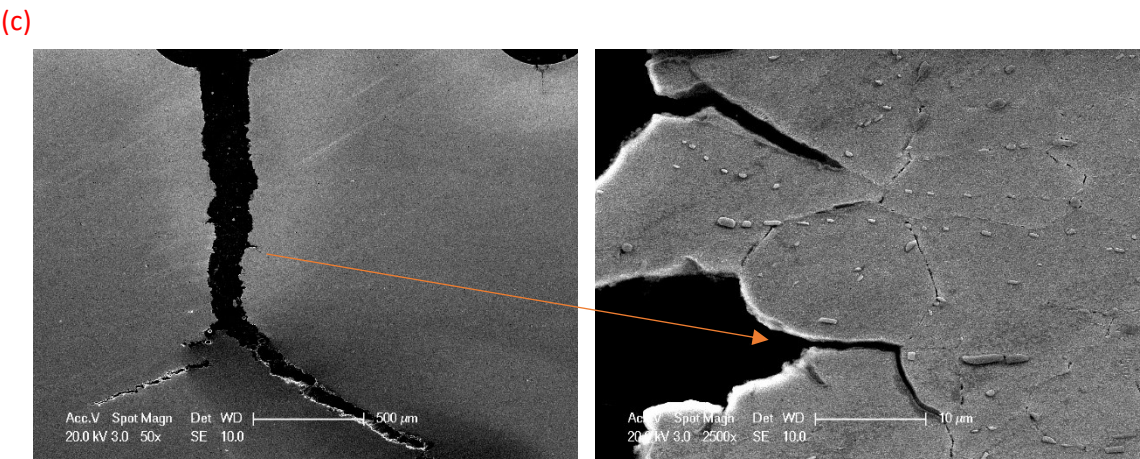
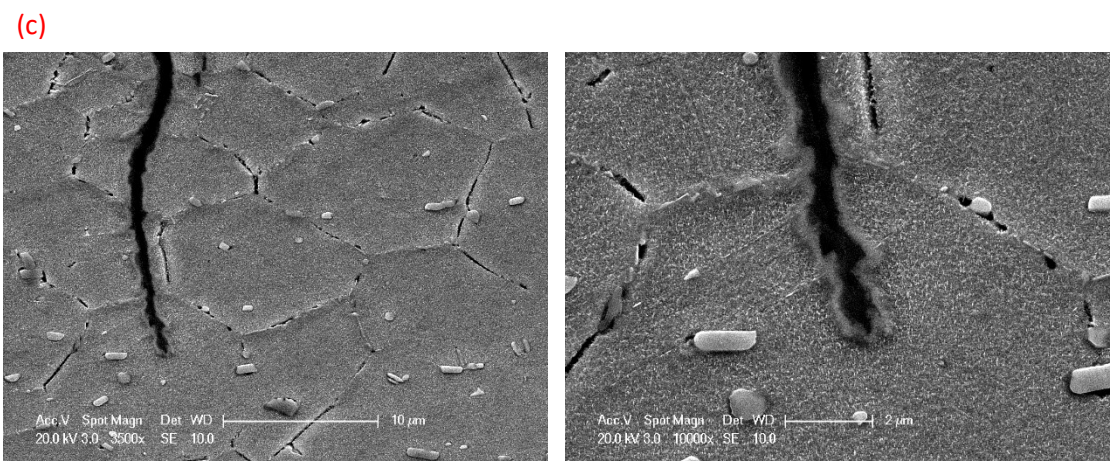
Figure 4-35 (c) SEM images of the crack and crack tip in the CWF sample

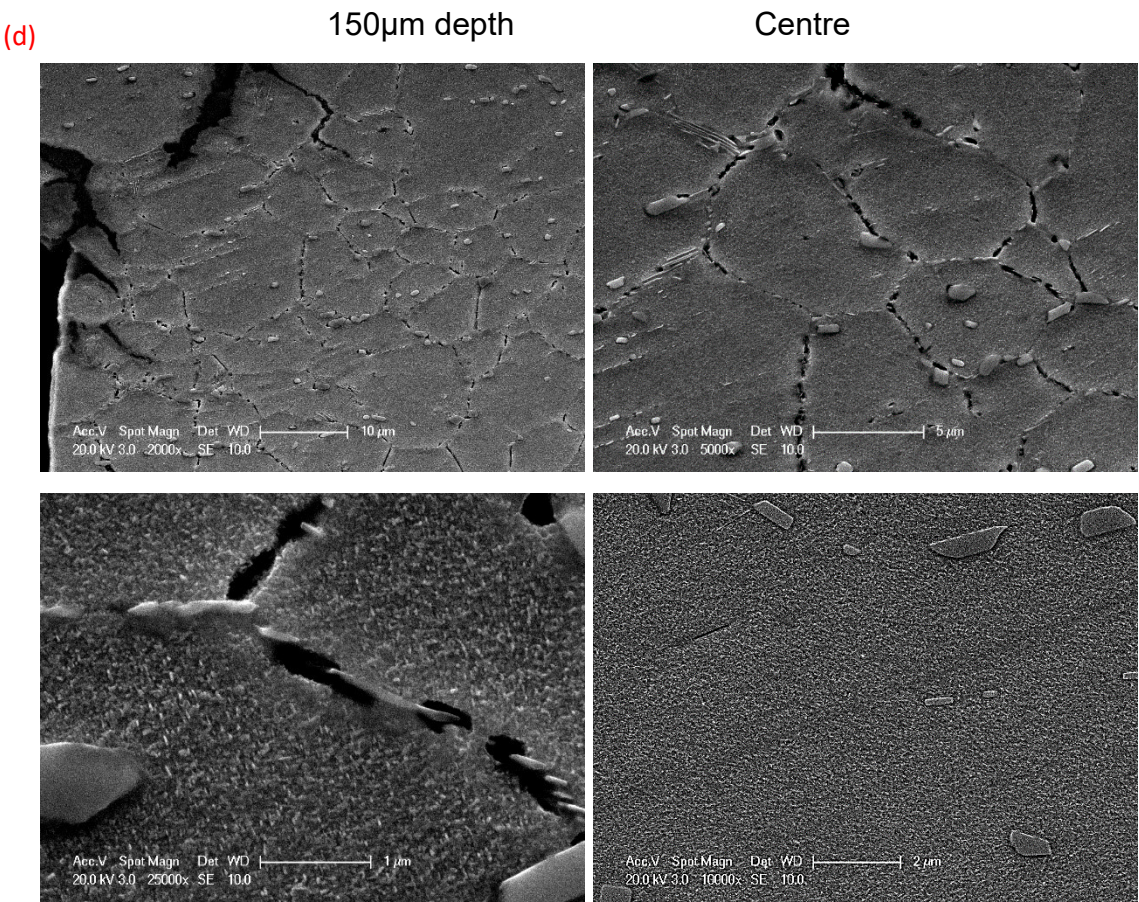
Figure 4-35 (d) Microstructure in the CWF sample near the thread root and centre

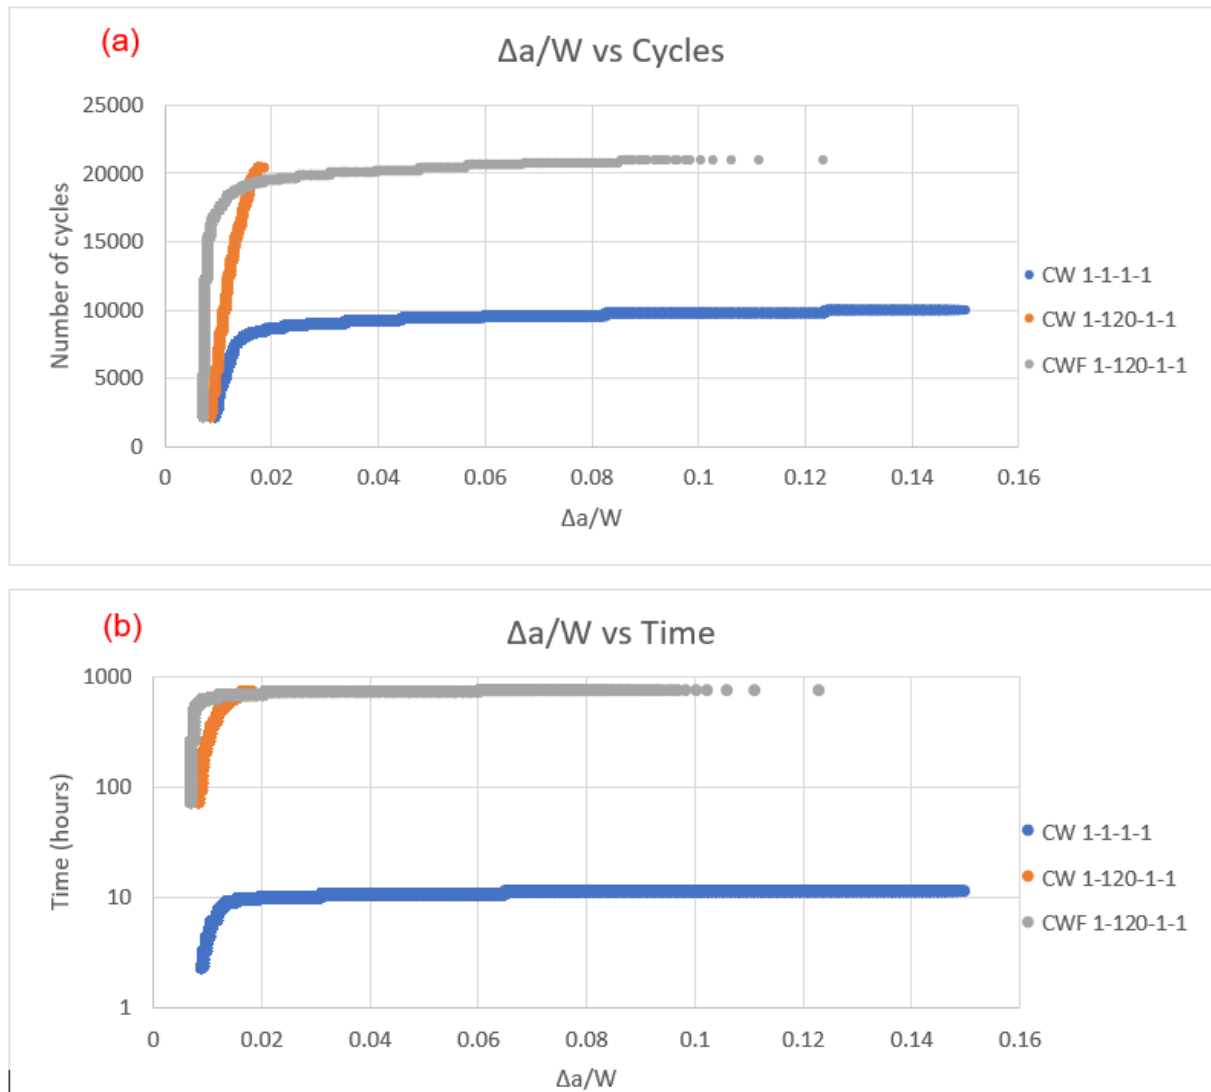
The crack length against number of cycles and time was determined using the calibration of p.d. vs crack growth of the bending samples (see 4.3.2 above). Three bending tests with valid data were fitted in the calibration and are presented in Figure 4-36. Under the maximum stress 1500MPa, the bending sample in the baseline (1-1-1-1) fatigue frequency needs fewer cycles to develop a crack of equal length compared to the sample in the dwell fatigue mode (1-120-1-1). Moreover, the samples also display a different crack growth situation with cold work. Excluding the initiation life, at the beginning illustrated in Figure 4-36, CW requires nearly twice as many cycles to propagate the crack compared to CWF. It should be noted that the Y axis shows the number of cycles or time for a better demonstration of the trends. As the CW sample stopped the crack propagation, the valid data is limited for acquiring the crack growth rate in this situation.

Figure 4-36 The crack growth vs number of (a) cycles and (b) time in different tests

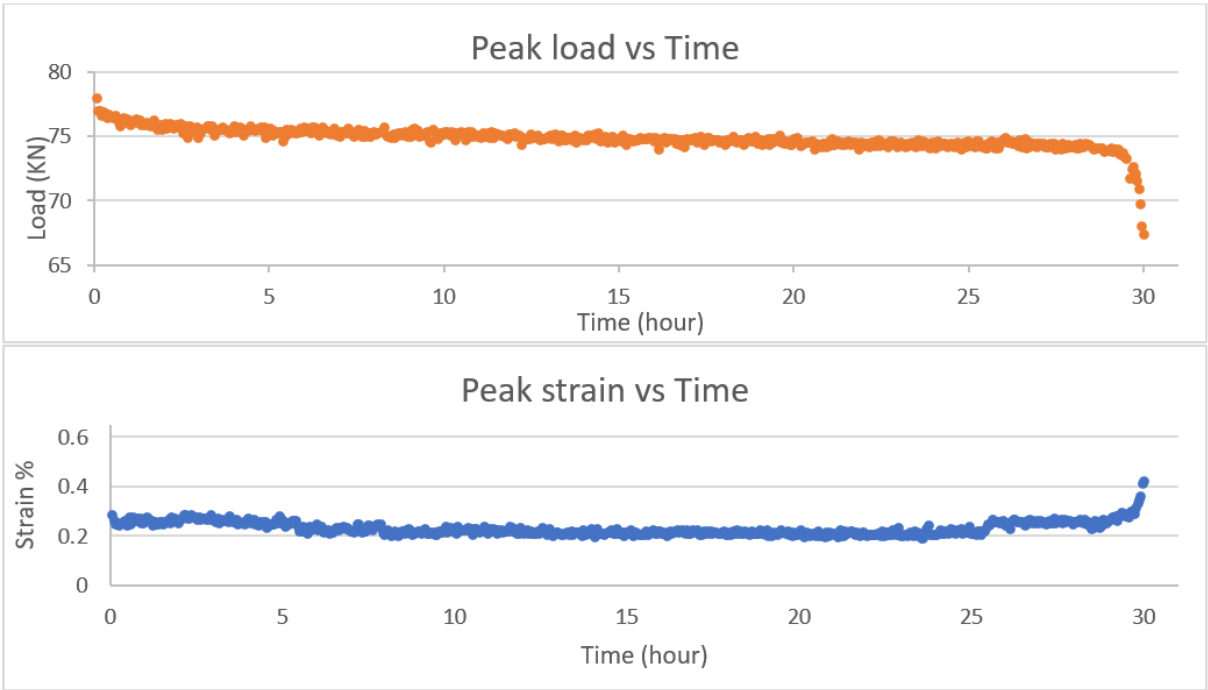
Figure 4-37 The results of baseline trial test on the partially screwed bolt

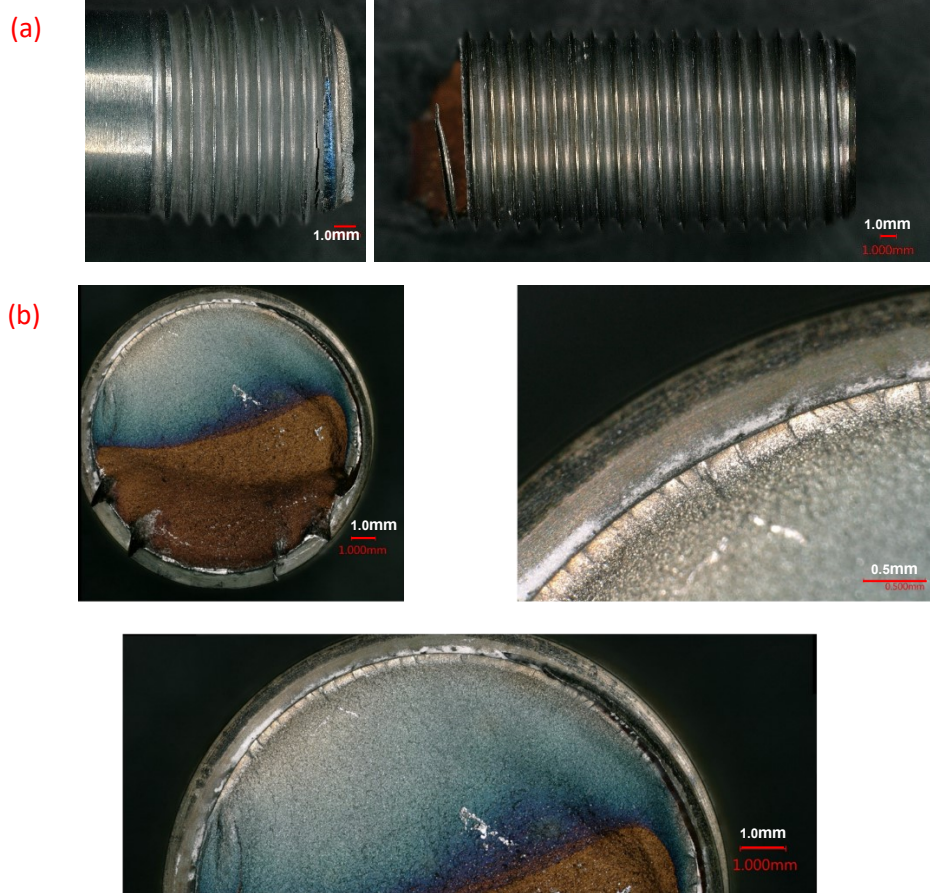
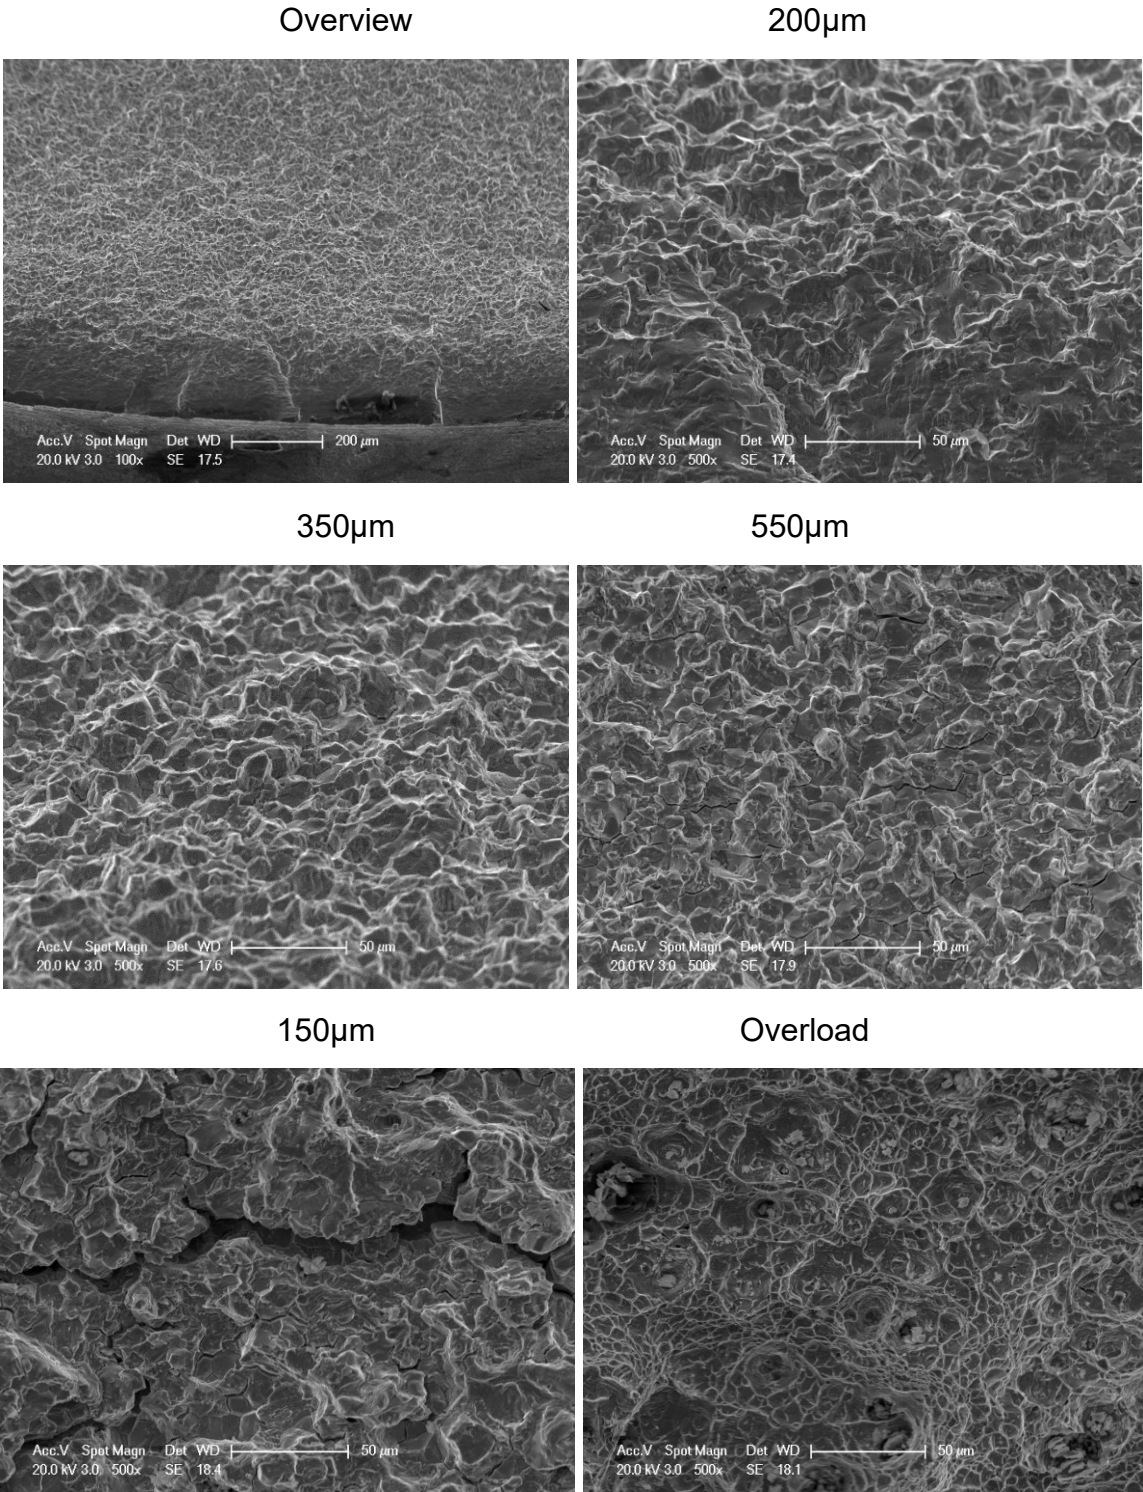
Figure 4-39 SEM fractographies of the fracture surface of trial sample

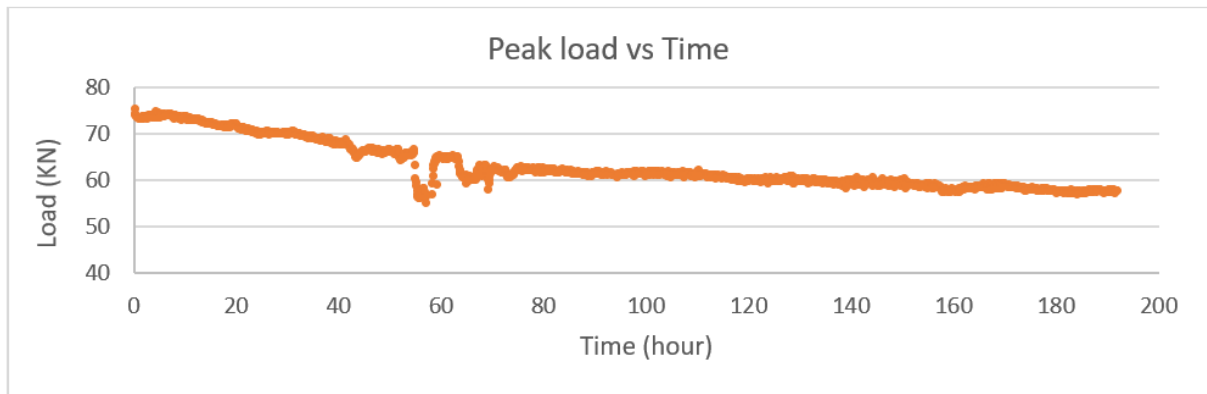
Figure 4-40 The results of a dwell fatigue test on a partially screwed bolt

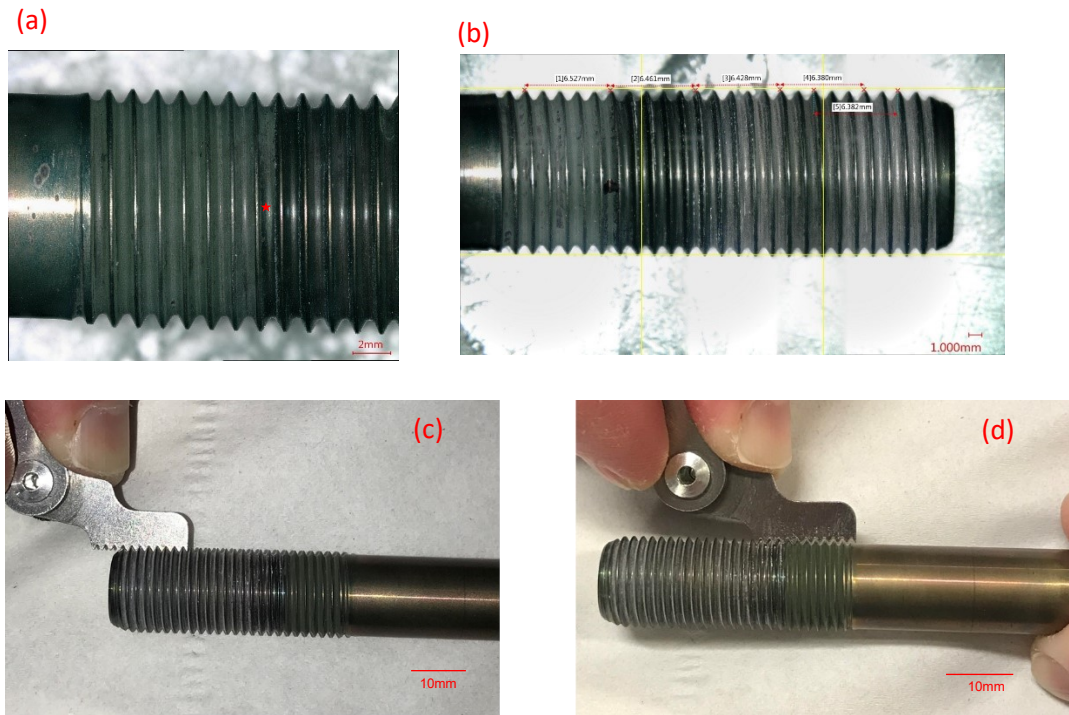
Figure 4-41 (a) and (b) show the optical measurements of a tested bolt, the thread gauge at the engaged threads (c) and the exposed threads (d).

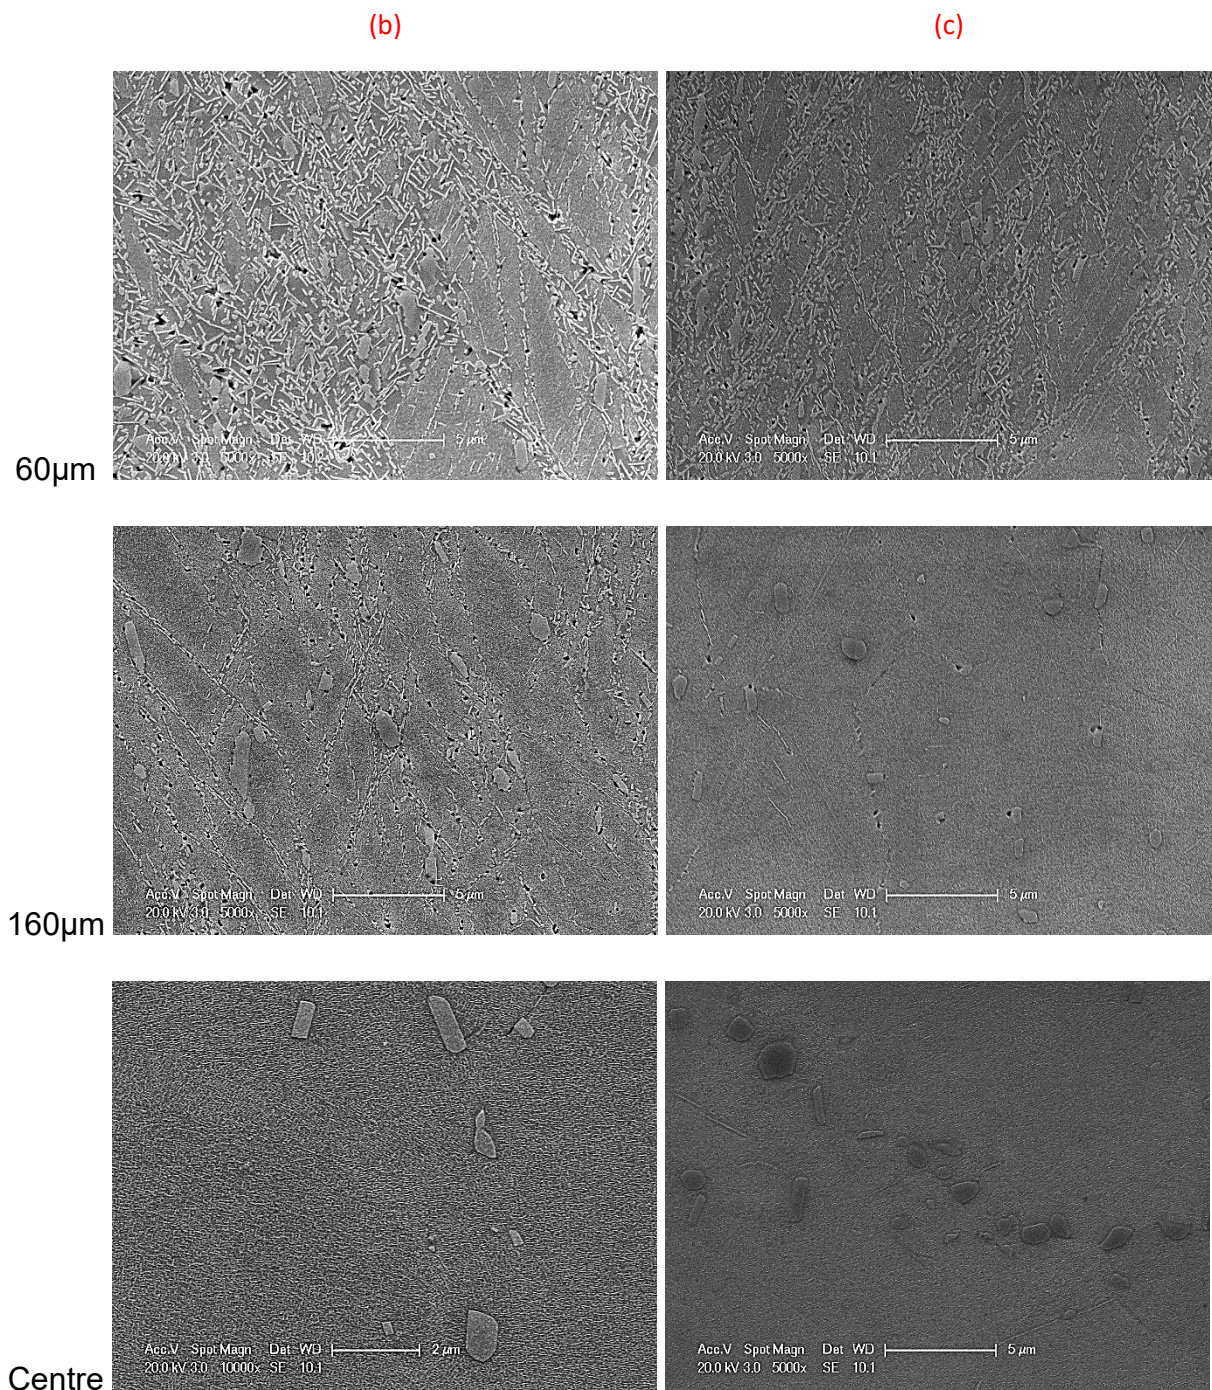
Figure 4-42 (b) and (c) Cross-sectional microstructure of (b) the upper exposed threads root and (c) the lower engaged threads root.
