CHARACTERISATION OF IN718 FASTENERS FOR AERO-ENGINE APPLICATIONS

A thesis submitted to The University of Birmingham for the
degree of

DOCTOR OF PHILOSOPHY

School of Metallurgy and Materials

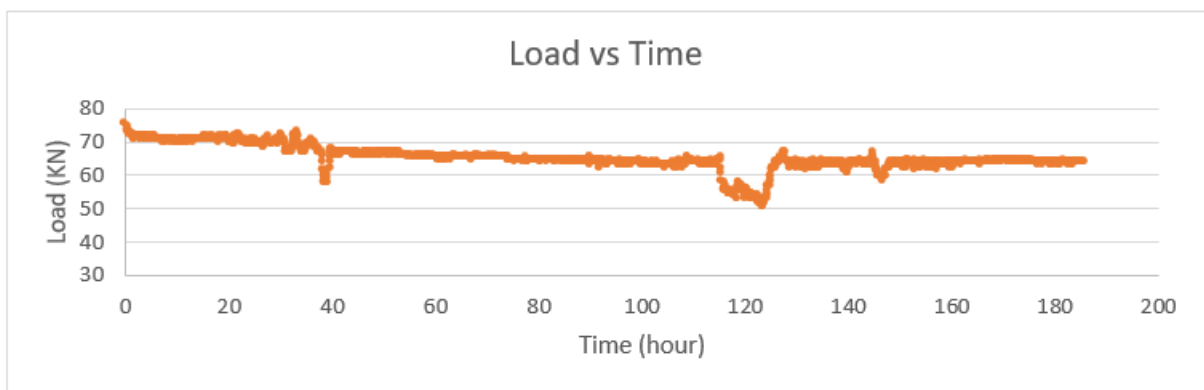
Figure 4-43 The results of stress-relaxation test on a partially screwed bolt

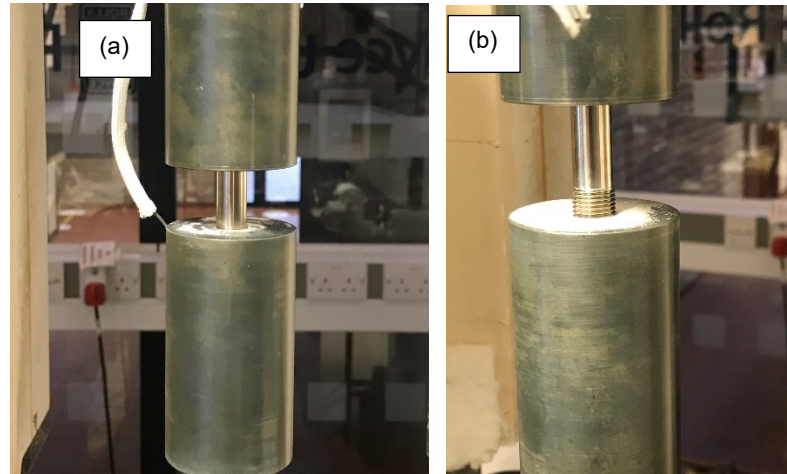
Figure 4-44 (a) Fully screwed bolt and (b) partially screwed bolt on the fixture

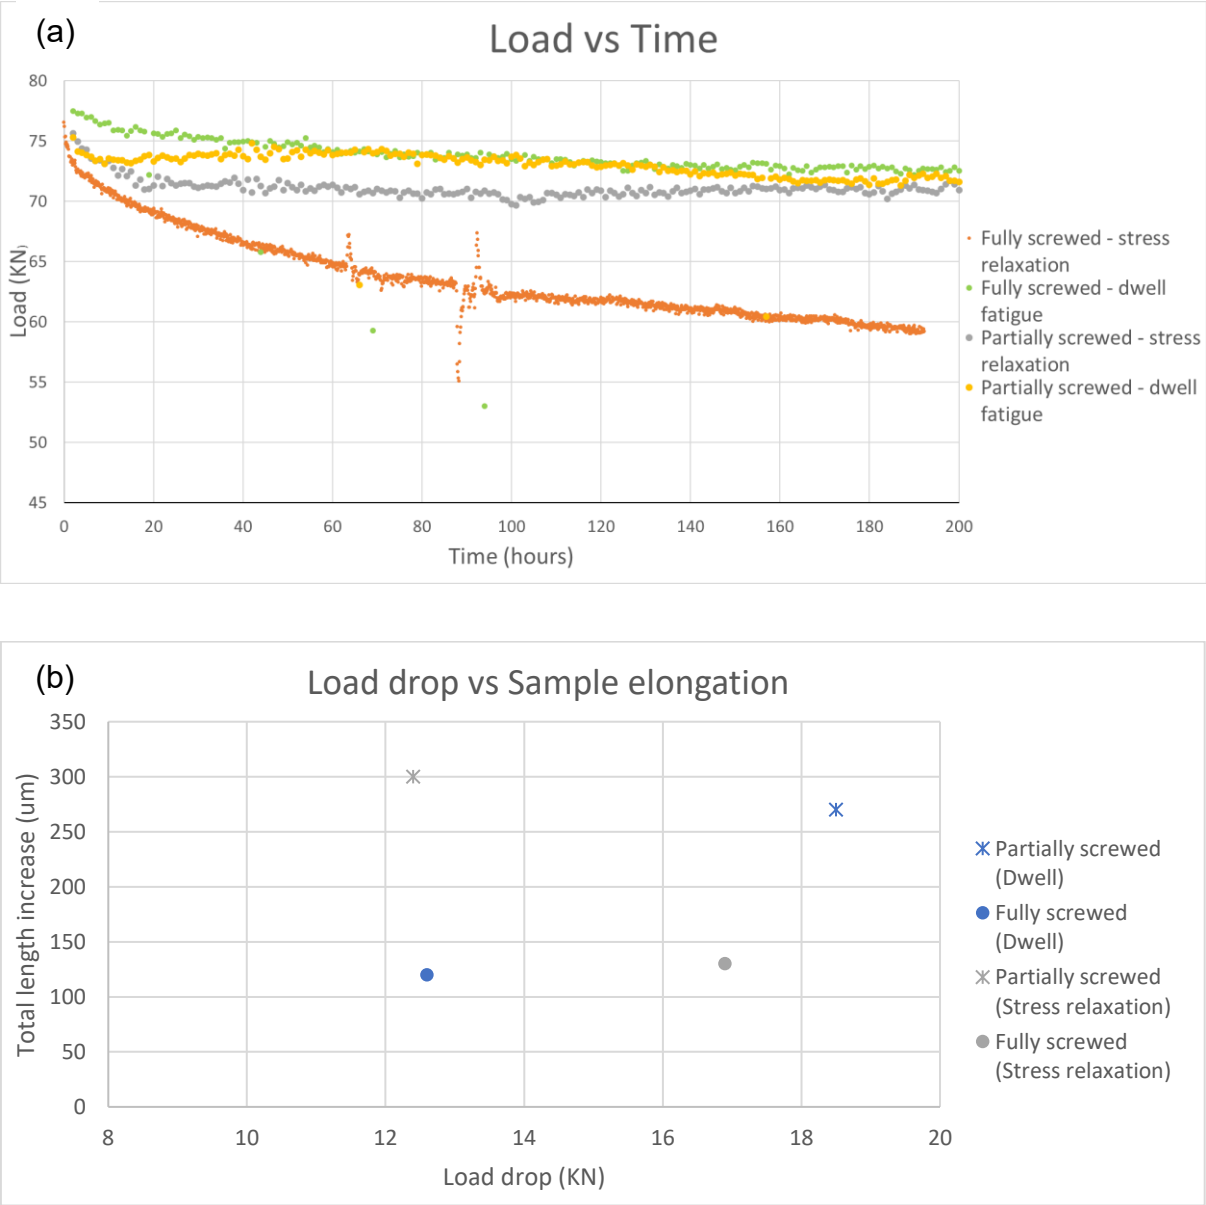
Figure 4-47 Summary of (a) load against time and (b) load drop against sample elongation in different tests

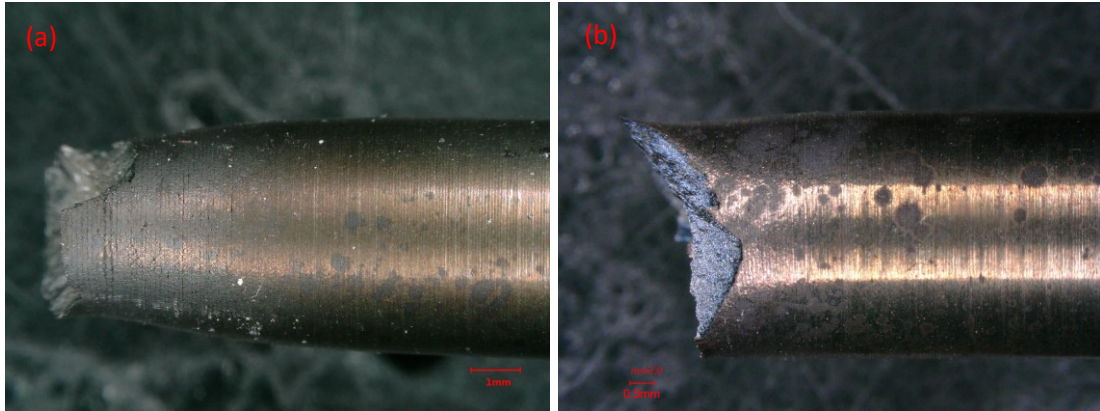
Figure 4-49 The necking sections close to the fracture surface of (a) HT2P and (b) HT3P samples.

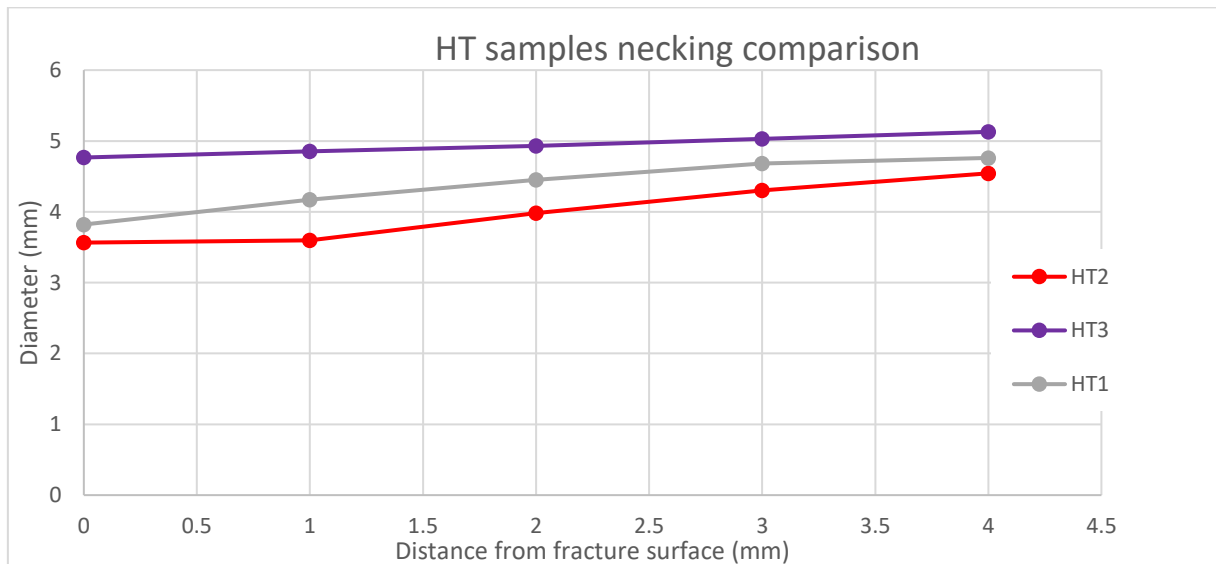
Figure 4-50 Comparison of necking in HTP samples

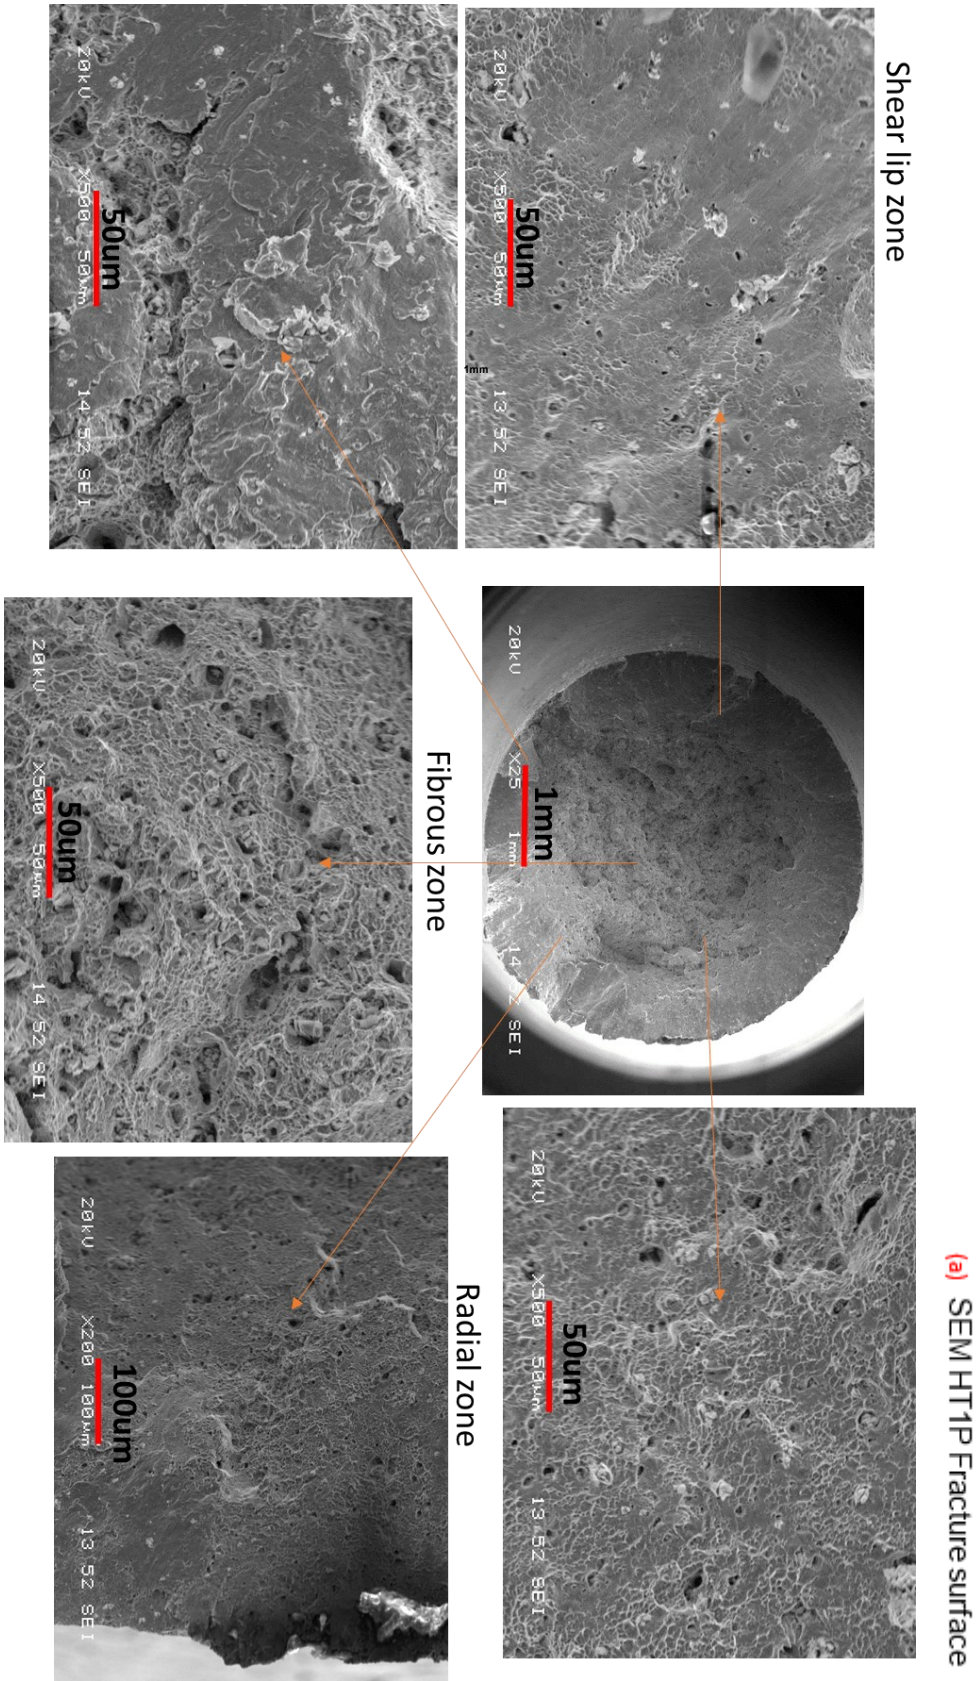
Figure 4-51 (a) Fracture surfaces of HT1P at different locations.

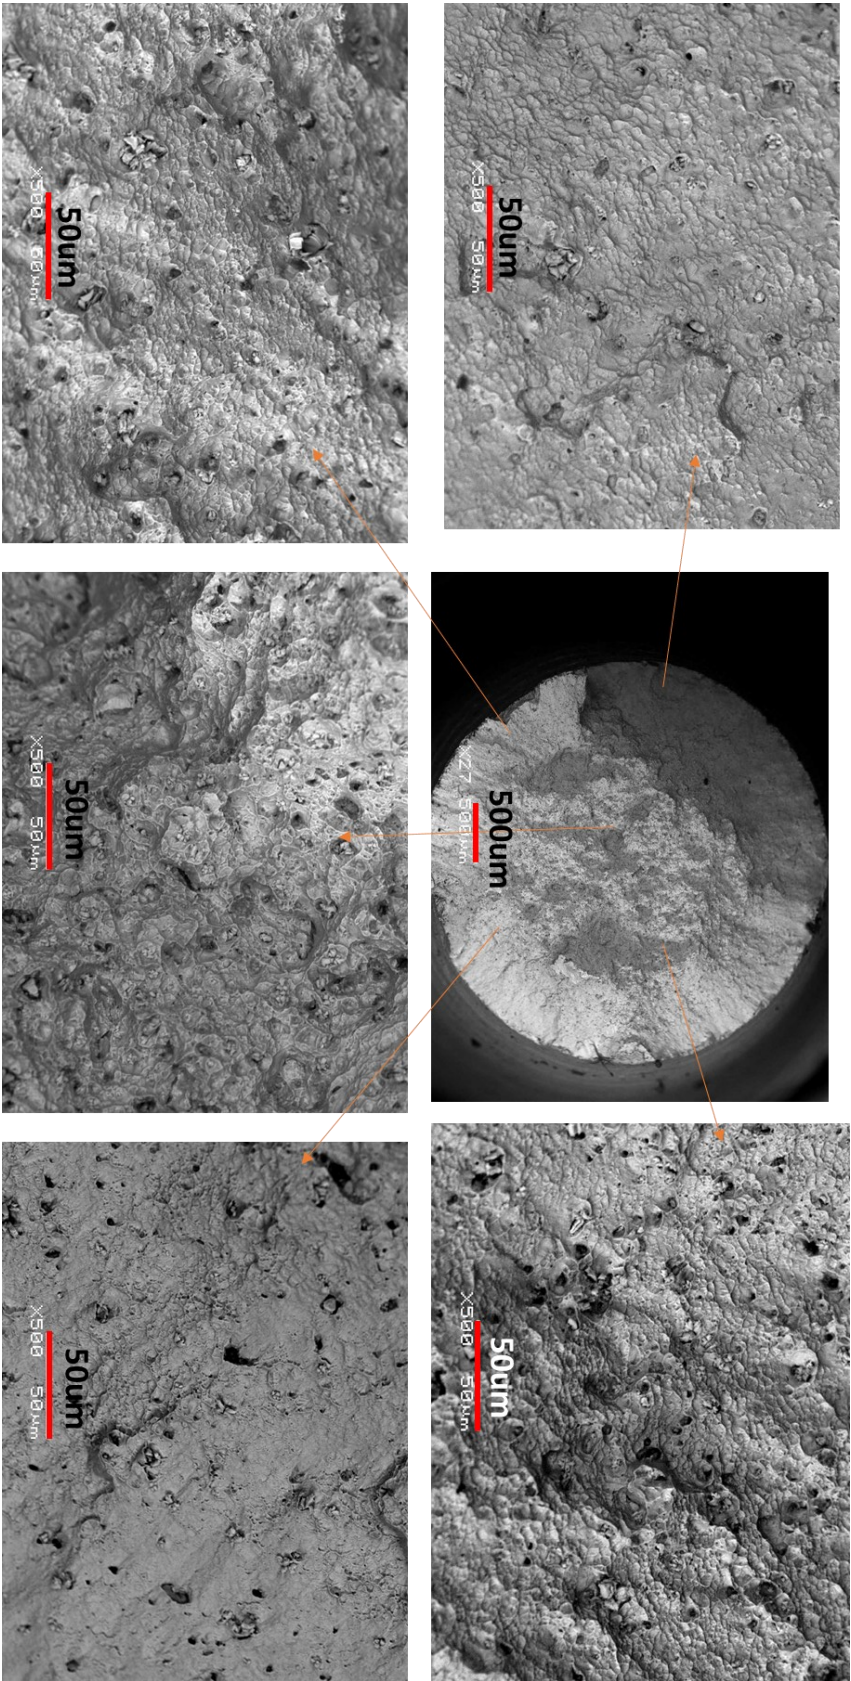
(b) SEM HT2P Fracture surface

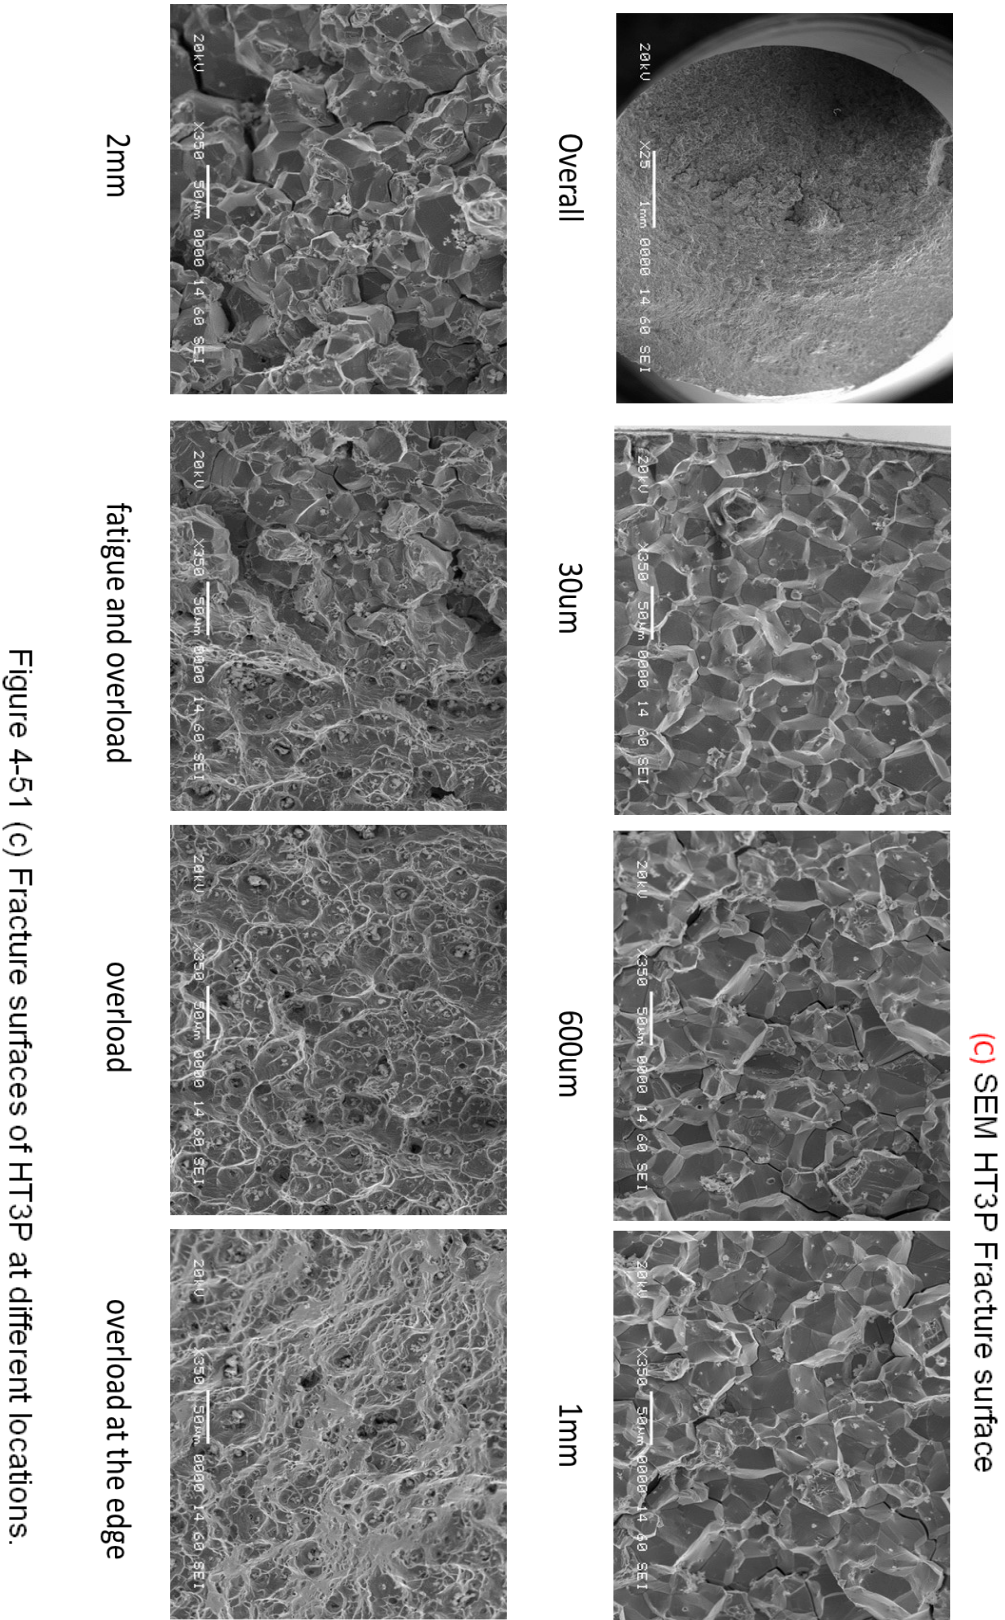
Figure 4-51 (c) Fracture surfaces of HT3P at different locations.

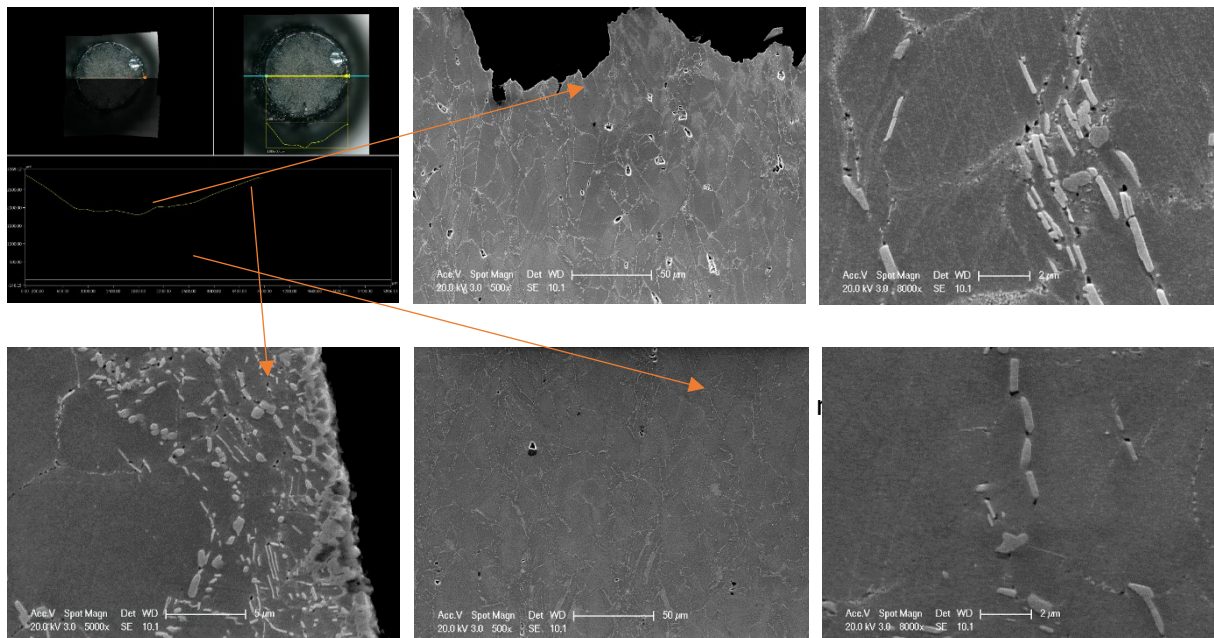
Figure 4-52 (a) Cross-sectional microstructure of the tested HT1P

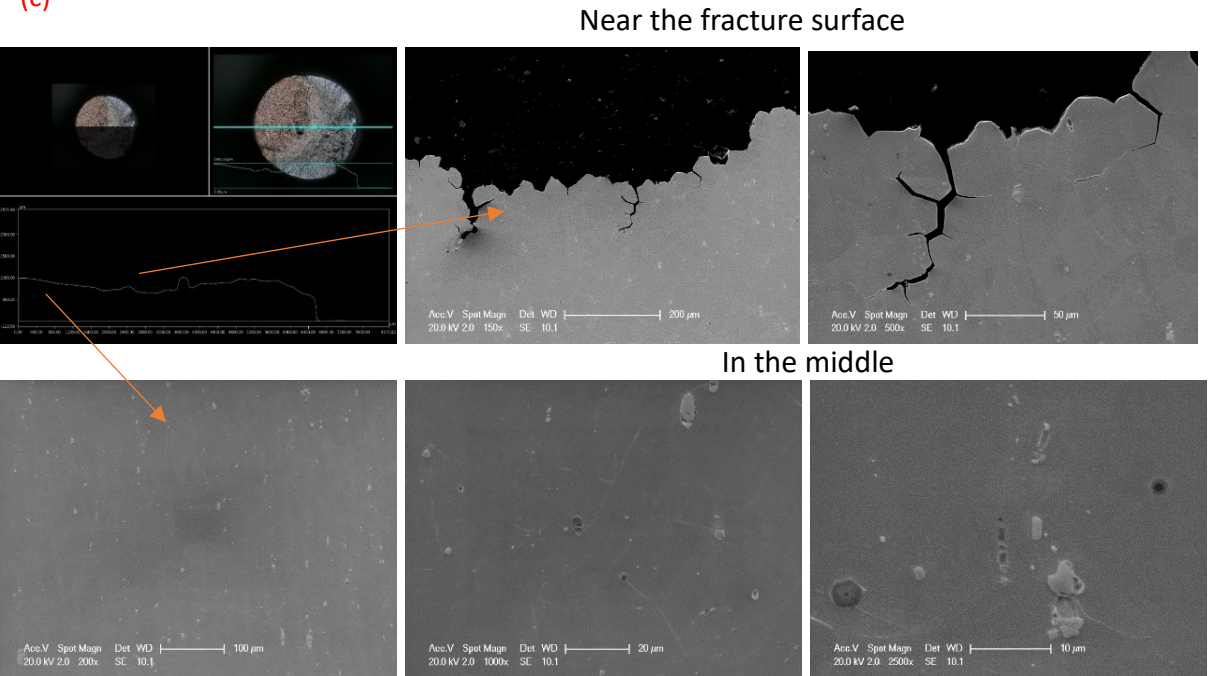
Figure 4-52 (b) and (c) Cross-sectional microstructure of the tested HT2P and HT3P.

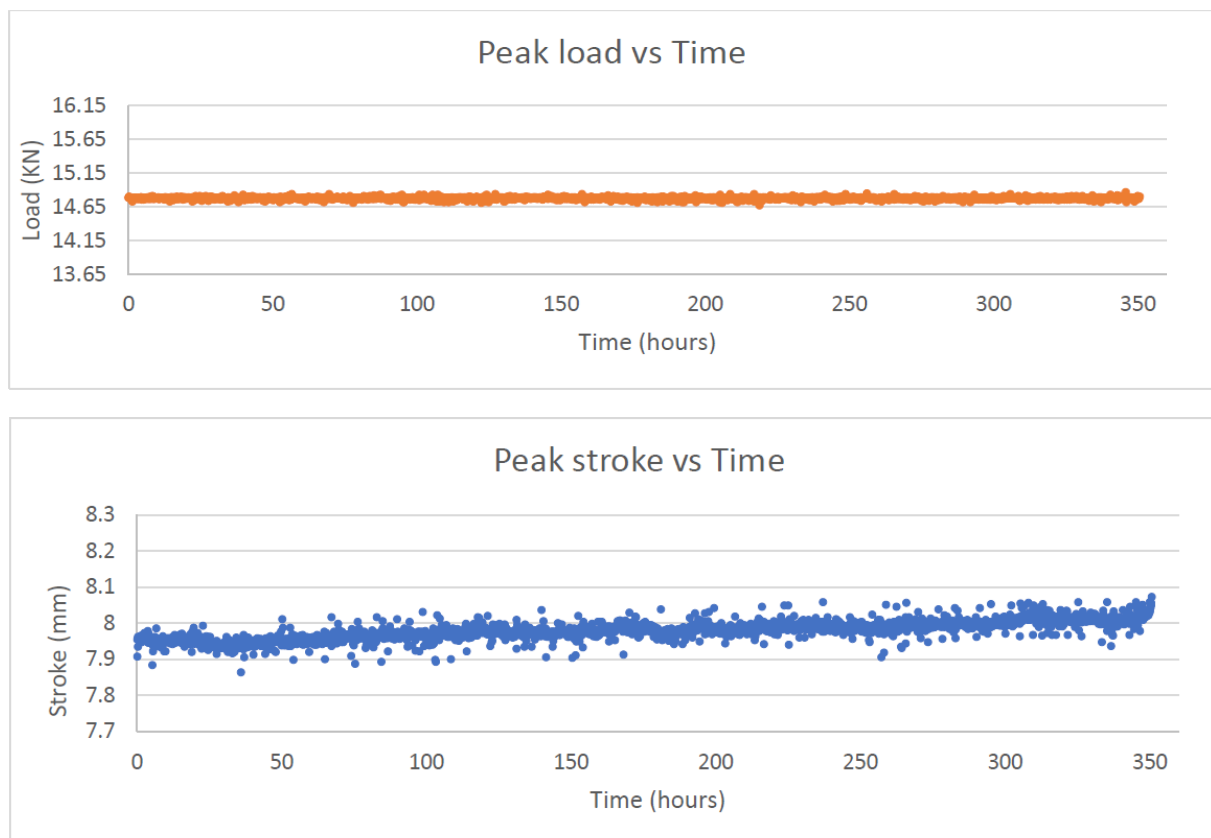
Figure 4-53 (a) The results of HT1 notched sample on dwell fatigue testing

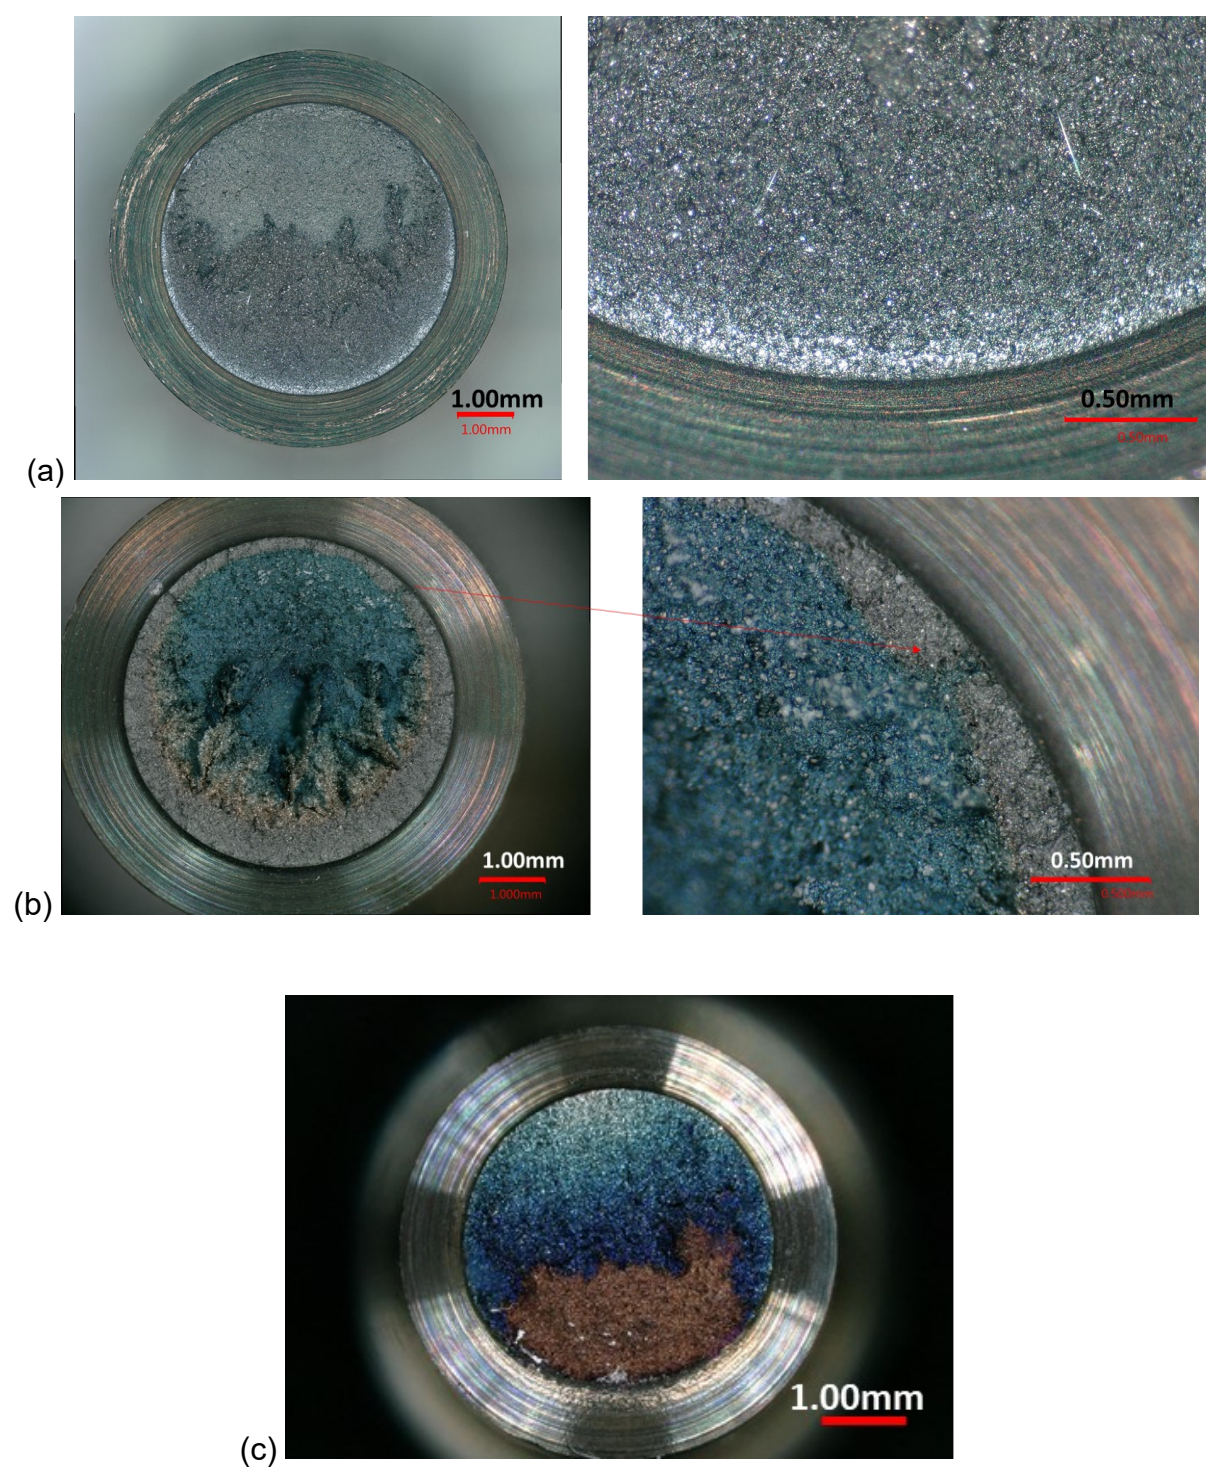
Figure 4-54 Fracture surface of (a) HT1 (b) HT2 and (c) HT3 notched sample under the optical microscope

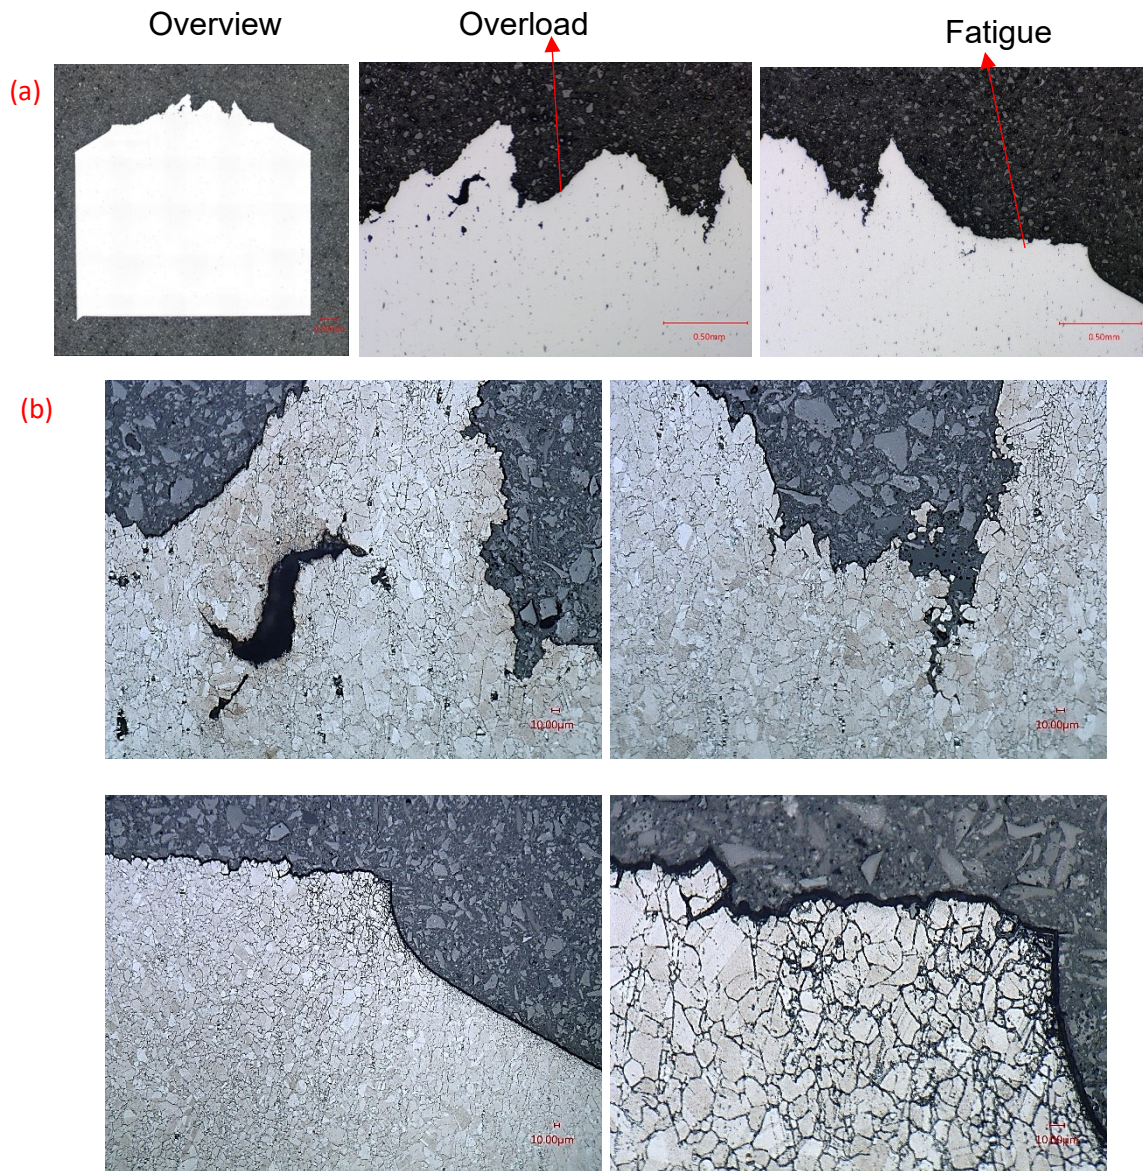
Figure 4-57 Cross-sectional microstructure of sample HT2N (a) as-polish condition and (b) etched condition

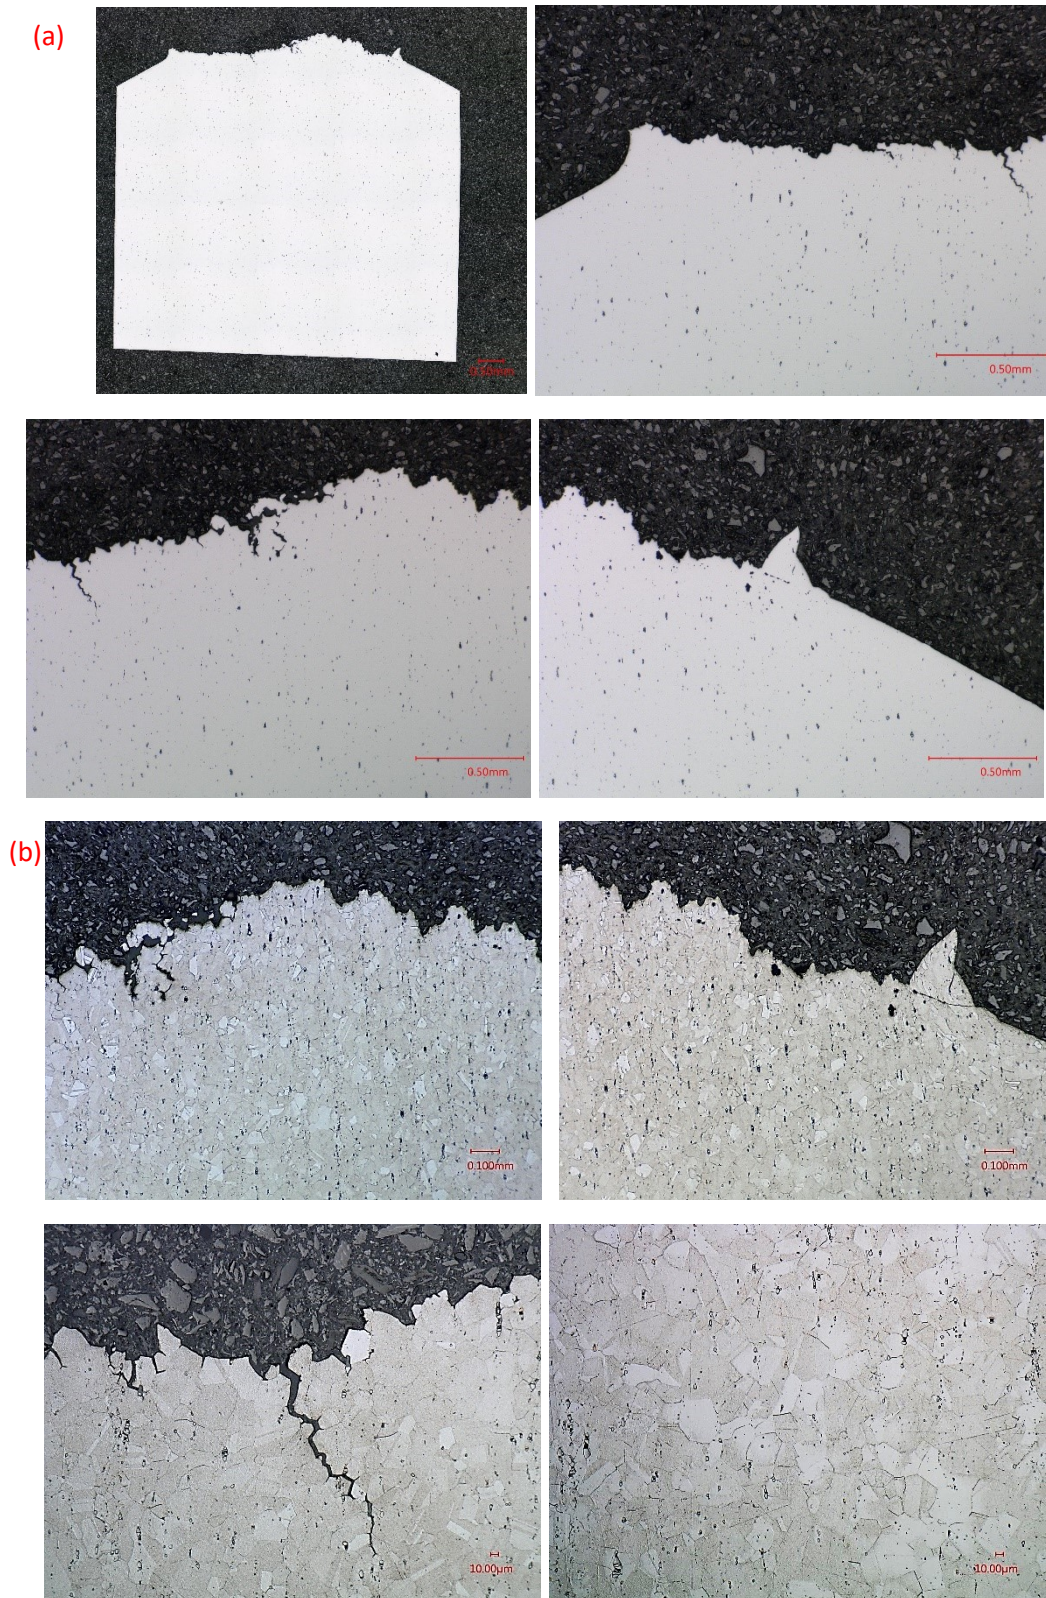
Figure 4-58 Cross-sectional microstructure of sample HT3N (a) as-polish condition and (b) etched condition.

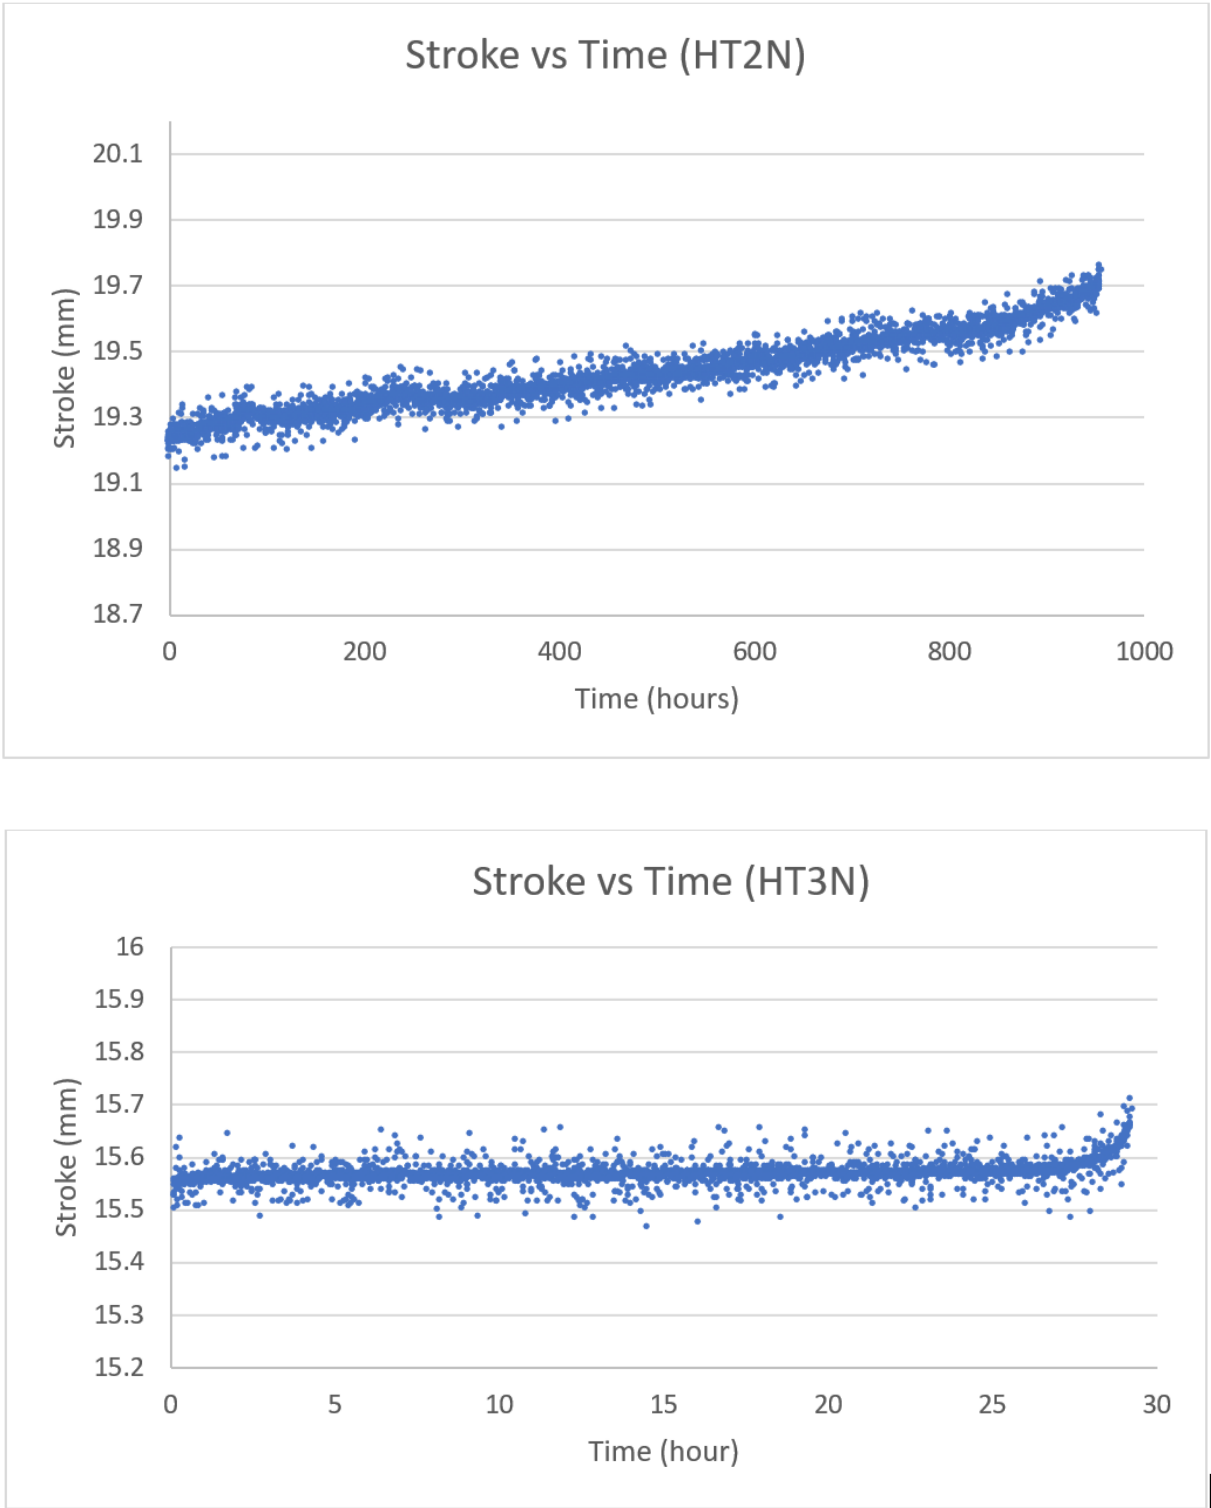
Figure 4-59 The results of HT2 and HT3 notched samples on the stress-rupture testing

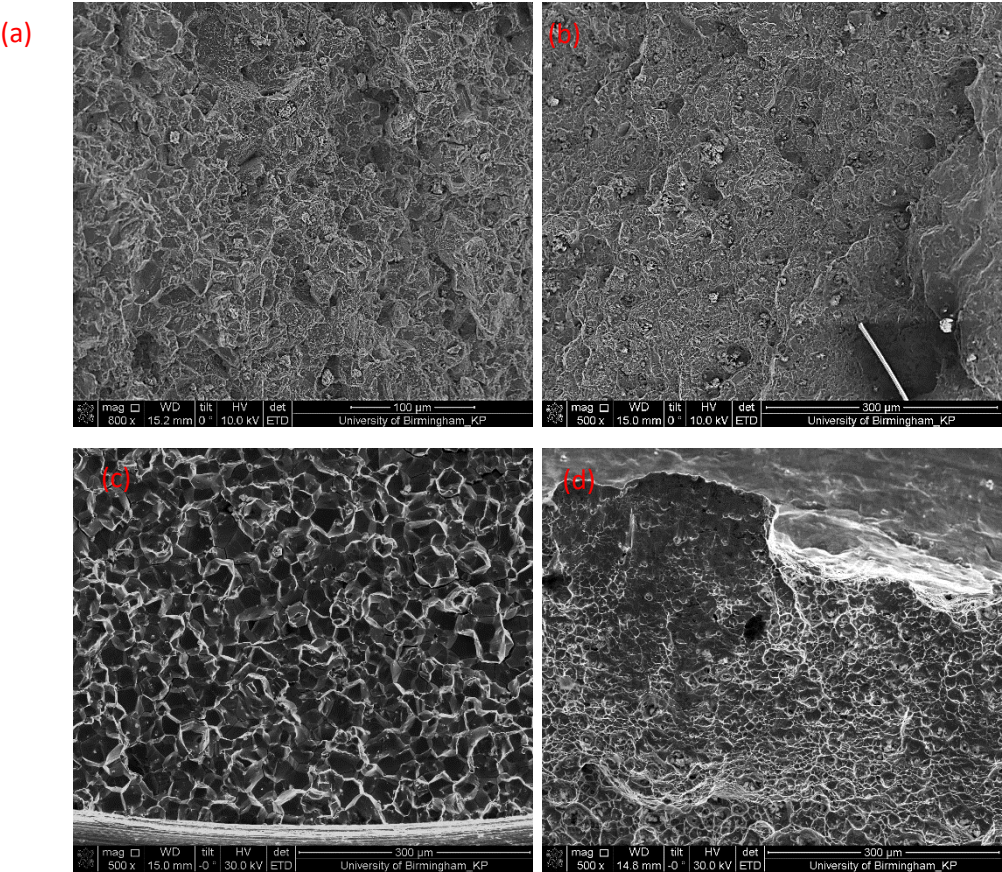
Figure 4-60 Fracture surfaces of (a) (b) HT2 notched sample, and (c) (d) HT3 notched sample

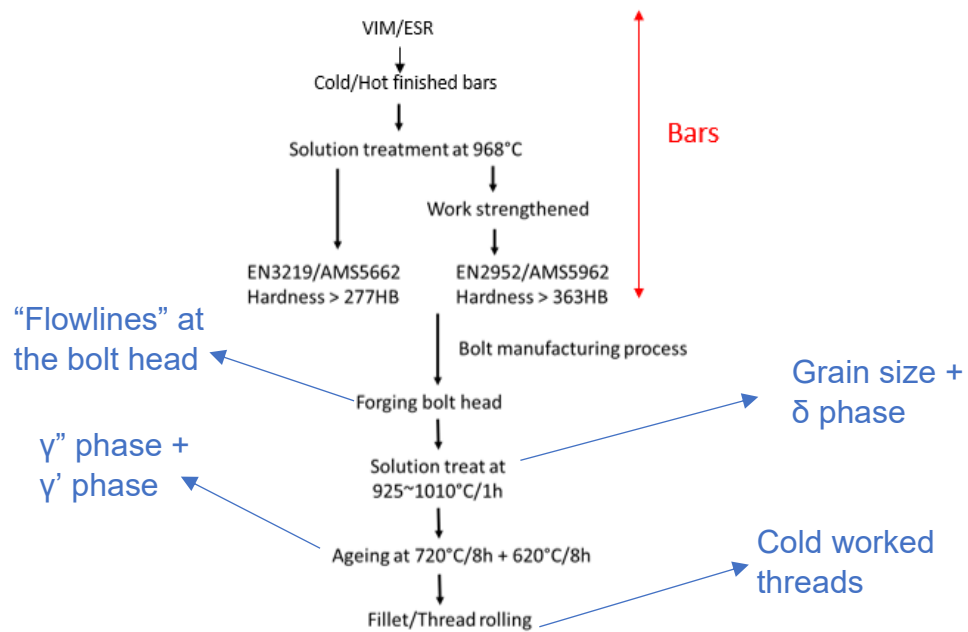
Figure 5-1 the manufacturing process of IN718 aero-engine bolts

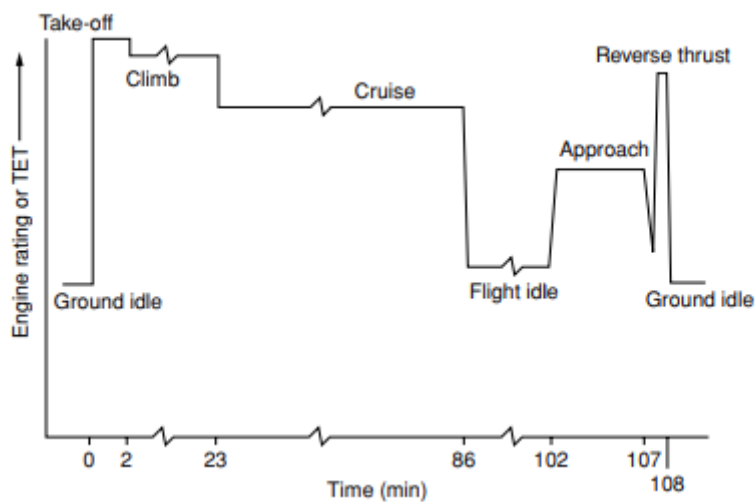
Figure 5-2 Changes in TET during a civil flight cycle [8].

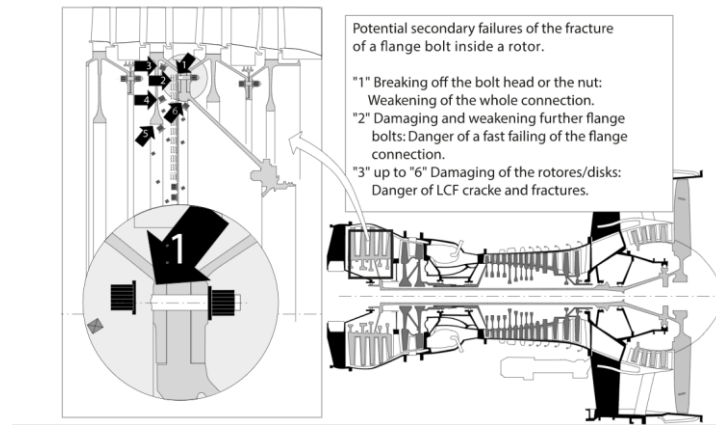
Figure 5-3 The possible outcomes of bolt fracture inside the aeroengine and the subsequent dangers [126].

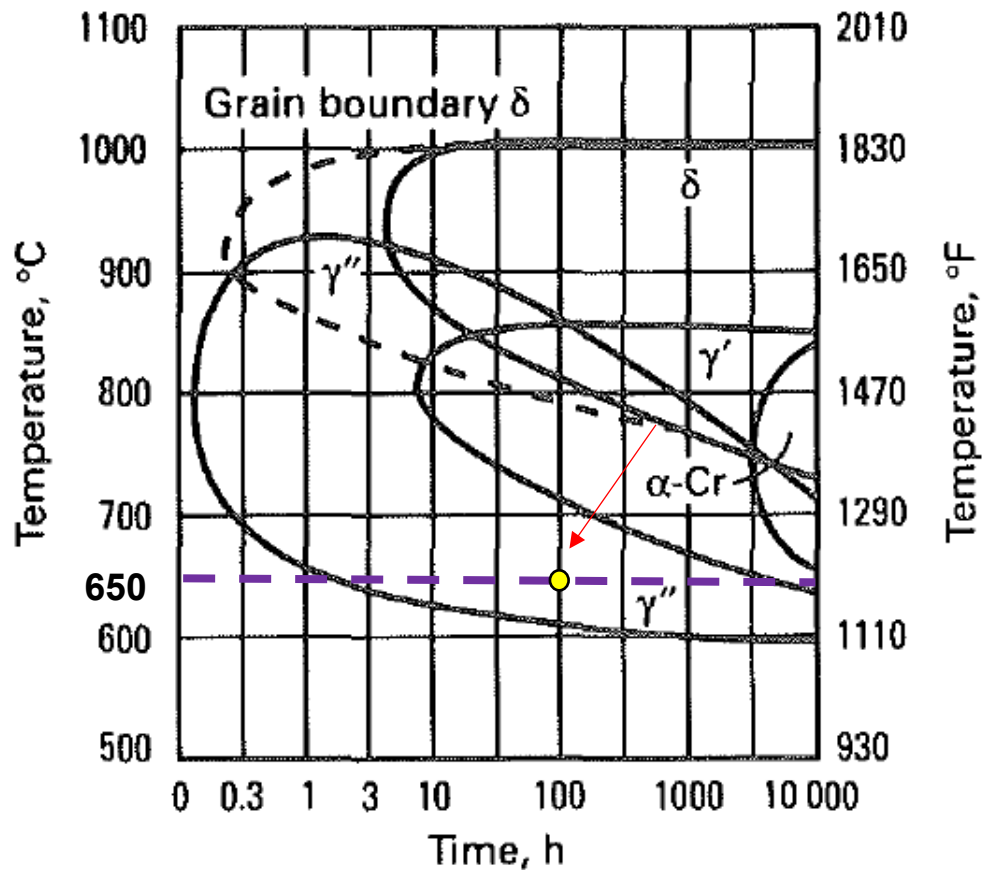
Figure 5-4 original TTT diagram [133]. In this work, the yellow dot indicates the appearance of δ phase under such conditions at the heavy cold-work zone.
