DEVELOPMENT OF AN IMAGE BASED SYSTEM FOR ROUTINE VISUAL INSPECTION OF UK HIGHWAYS BRIDGES

A thesis submitted to the
University of Birmingham
for the degree of
DOCTOR OF PHILOSOPHY

School of Civil Engineering
College of Engineering and Physical Sciences
University of Birmingham
August 2015

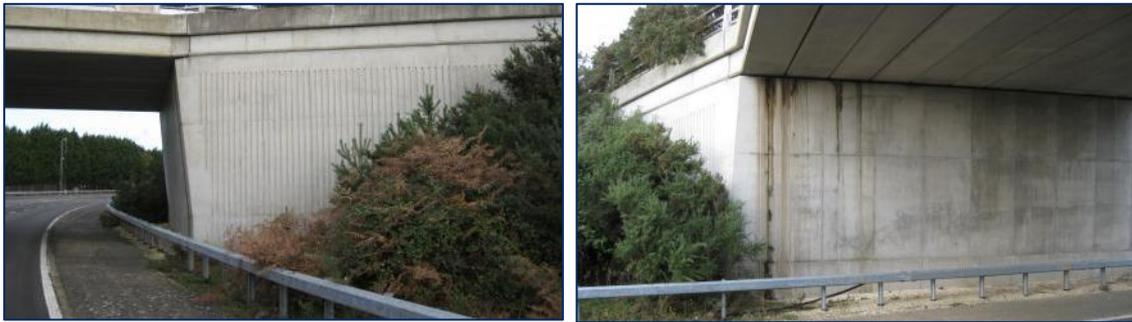
Figure 36: Images taken from 12m from bridge to illustrate what a 12m viewing distance can show.

the structure. In terms of inspection distances, a distance of 12m is probably the upper limit of what might be deemed acceptable. An inspector would try to get closer to the bridge than this wherever possible, but in cases where there are obstructions or impediments this may be as close as they can get: wingwalls up overgrown embankments may be hard to access; to observe a parapet 6m above the pavement avoiding oblique viewing may require the inspector to stand 10m back, which produces a viewing distance of 12m (examples shown in Figure 36).

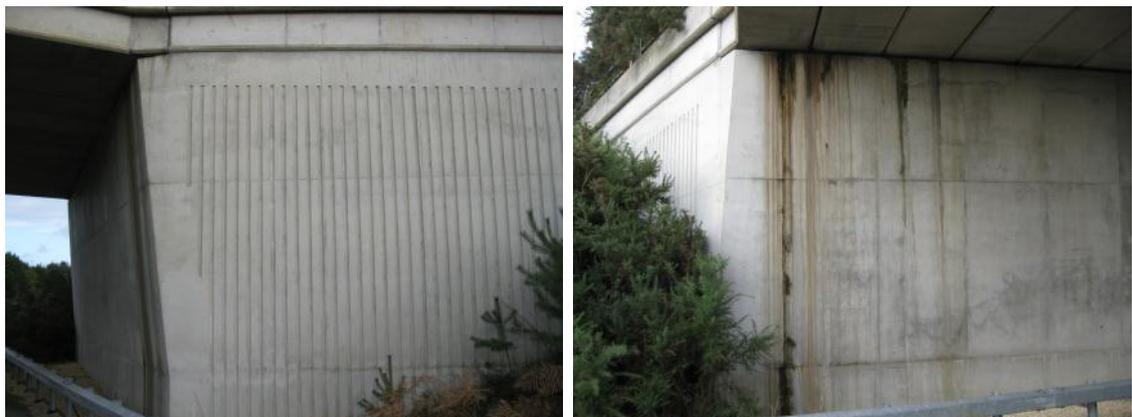
Figure 37: Images taken from 6m from bridge to illustrate what a 6m viewing distance can show.

A 6m inspection distance (Figure 37) may be experienced when inspecting the soffit of a structure, particularly when looking at the part of the soffit above the carriageway from a viewing position on the footway.

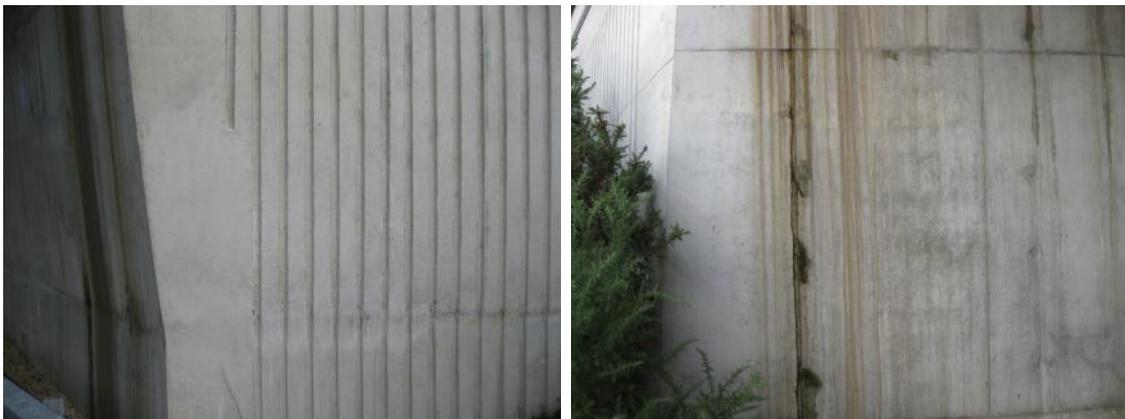
Figure 38: Images taken from 3m from bridge to illustrate what a 3m viewing distance can show.

Even in cases where the access to the bridge is good a 3m inspection distance (Figure 38) will be used frequently. If the clearance of the bridge is 5m, which is common on many highways bridges, then the inspectors head is unlikely to ever be closer than 3m to any part of the soffit, or to the upper parts of the abutment. Even on lower bridges it will be difficult to get closer than 3m to many parts of the bridge such as the soffit above the carriageway, parapets, wingwalls, or the upper part of abutment.

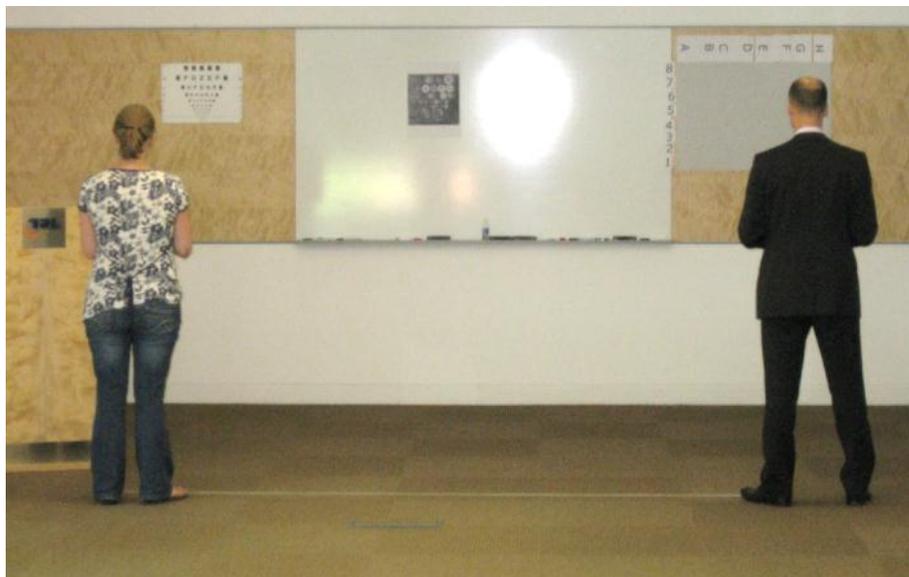
Figure 43: View of room set up for collection of acuity and image resolution data.

The room was set up as shown in Figure 42, and Figure 43. Lines were marked on the floor at positions P_0 , P_1 , P_2 and P_3 . These were measured to be distances D_0 (3m), D_1 (12m), D_2 (6m) and D_3 (3m) from the targets (Table 9).

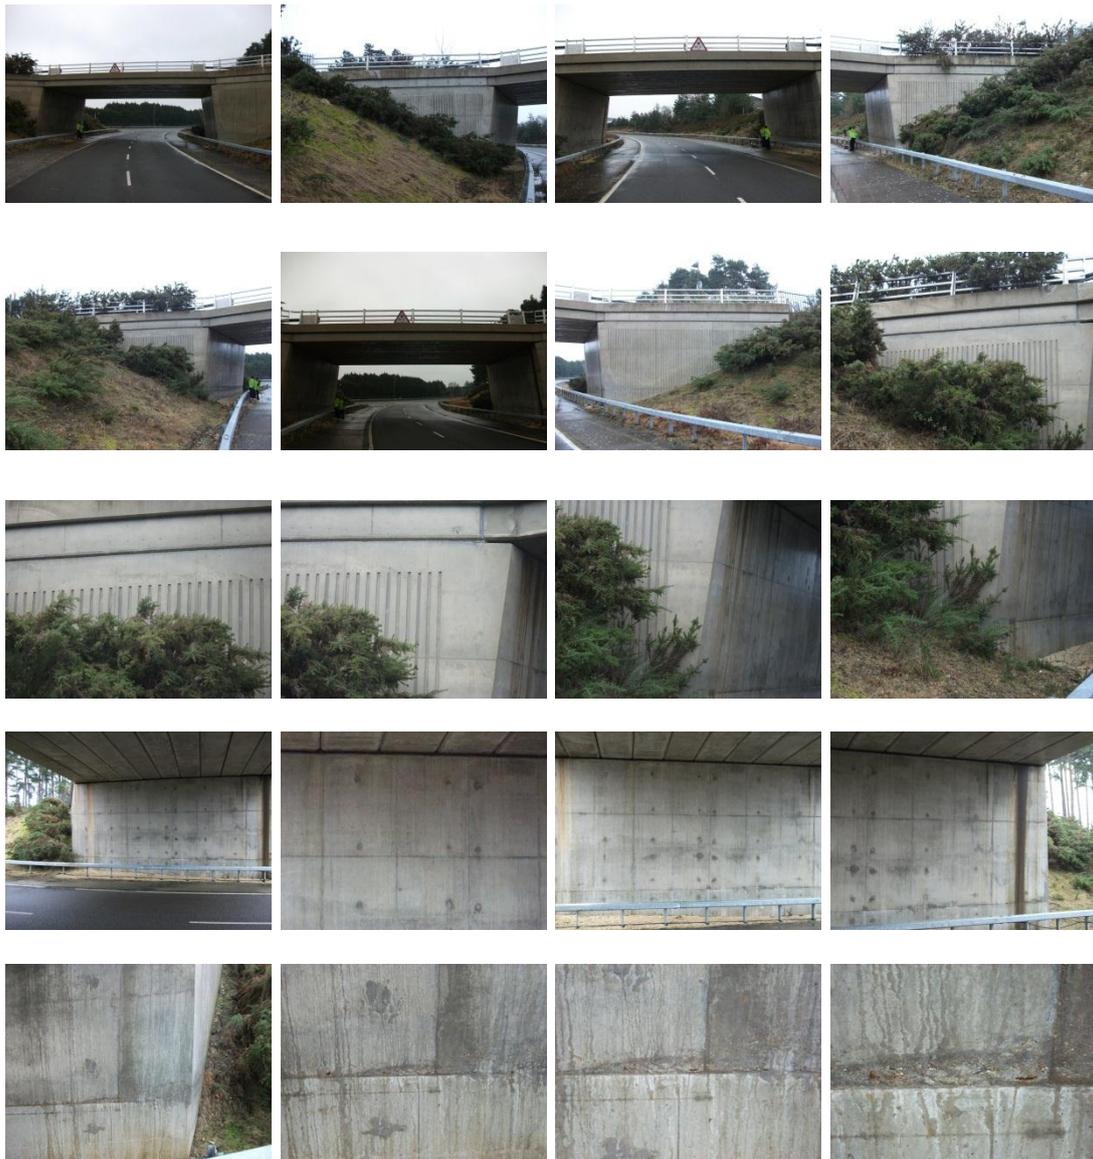
Figure 50: A selection of images of a bridge taken with a hand-held camera with only guidance provided to operator to ensure full coverage.

Figure 50 presents a series of images collected using a hand-held camera. These were taken by simply walking around the structure and photographing each face at progressively closer distances, with specific defects and features being photographed from close range.

Each image shows a portion of the surface of the bridge, but viewed as a series of individual images, they are hard to interpret. Inspectors found it hard to keep track of where they were looking at on the bridge, and the changes in viewing angle and the size of the area imaged made it hard to determine the scale of feature seen, or how it compared to other features elsewhere on the bridge.

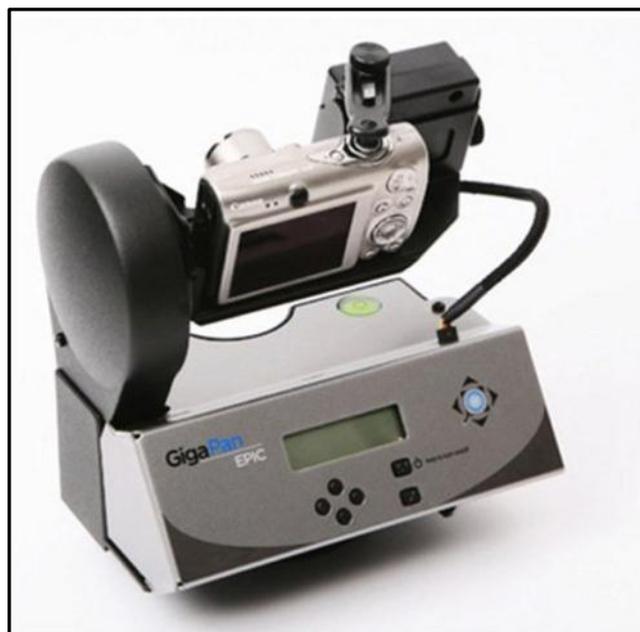
Figure 53: GigaPan Epic, with camera attached.

The GigaPan Epic robotic mount consists of a camera mounting plate, a control panel and electronics, two motors to control vertical and horizontal rotation of the camera, and a robotic 'finger' which presses the camera shutter button (Figure 53).

The system takes a few minutes to set up for each camera/lens combination, to ensure that the field of view of the images is known, in order to calculate the amount by which the camera orientation must change between images to produce a series of images with adequate overlap. The camera orientation for each individual image is not directly recorded, but it is possible to estimate this later using outputs from the stitching and processing software. Unfortunately this does not always produce accurate results (discussed later in Section 7.2.1).

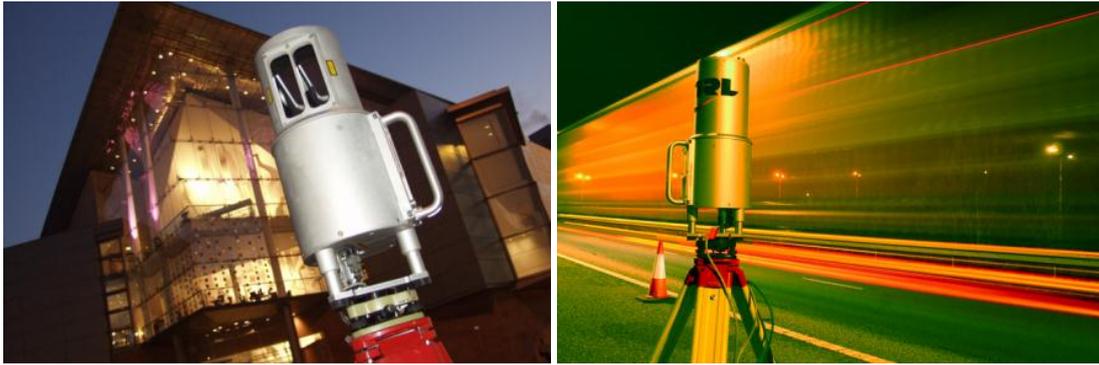
Figure 54: Riegl LMS-Z360i laser scanner as operated by TRL.

TRL own and operate a Riegl LMS-Z360i laser scanner (Figure 54). This system is predominantly used to collect data at collision incidents. The system can create 3-D models from the point cloud data it records.

The system uses a Class 1 laser, meaning no traffic management or closures are required, and has a quoted measurement range of approximately 200m with an accuracy of $\pm 12\text{mm}$. Experience within TRL suggests that it is possible to achieve higher accuracies by combining multiple scans at a single location.

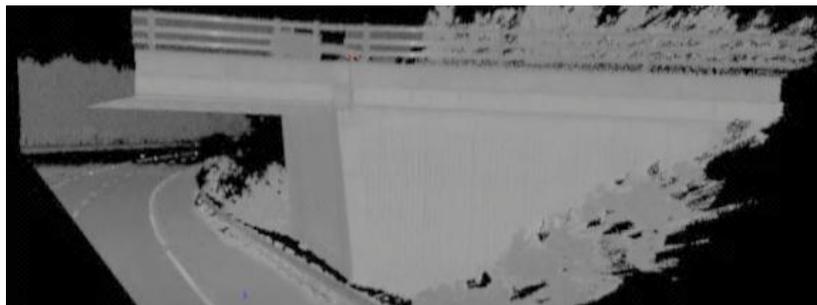
Figure 58: Scan of a section of the bridge from scan position 2 and a resolution of 0.035°.

Resolution setting	Number of points	Time to scan	Data shown in...
0.2°	810000	90 seconds	Figure 57 (left)
0.1°	3240000	6 minutes	Figure 57 (right)
0.035°	3183404	11 minutes, 29 seconds	Figure 58
0.01°	6269575	12 minutes, 20 seconds	Figure 59

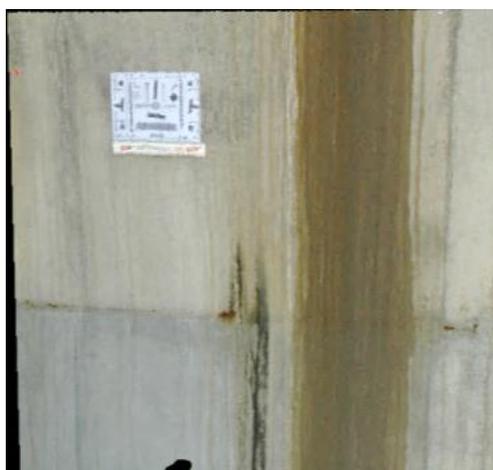
Figure 59: High resolution scan at scan position 5 of a section of abutment.

The target sheet visible in Figure 59 was fixed to the abutment to help gauge the scanners ability to record detailed features. In addition to the A4 sheet, a 30cm ruler was also attached to the abutment. The image on the left of Figure 60 shows an enlarged view of the target as recorded, the image on the right shows the same target imaged with a normal camera at a resolution of 1mm per pixel.

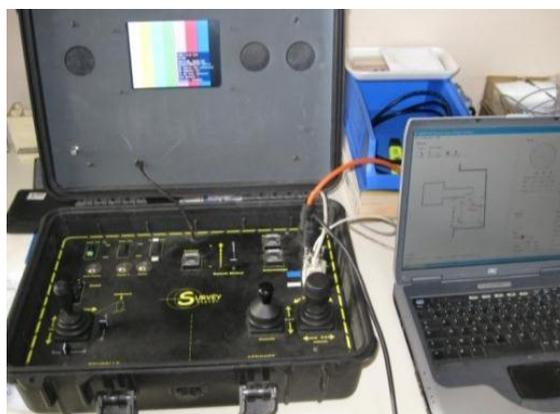
Figure 63: Control station for system.

The system is controlled from a suitcase control system, and a laptop, as shown in Figure 63, and can be flown in three modes:

Flying the drone manually requires high levels of expertise, however the assisted control mode allows the system to translate simple **commands of 'up', 'down', 'left', 'right', etc. into full control commands for the flight systems.** This can be done with relatively little training. Flight in the fully automatic mode relies on the production of a flight plan which uses GPS data to store the positions and flight routes of the drone. Using an aerial imaging system means that views of structures can be obtained which would otherwise be impossible, or very difficult to get, and which would require specialist access arrangements and equipment.

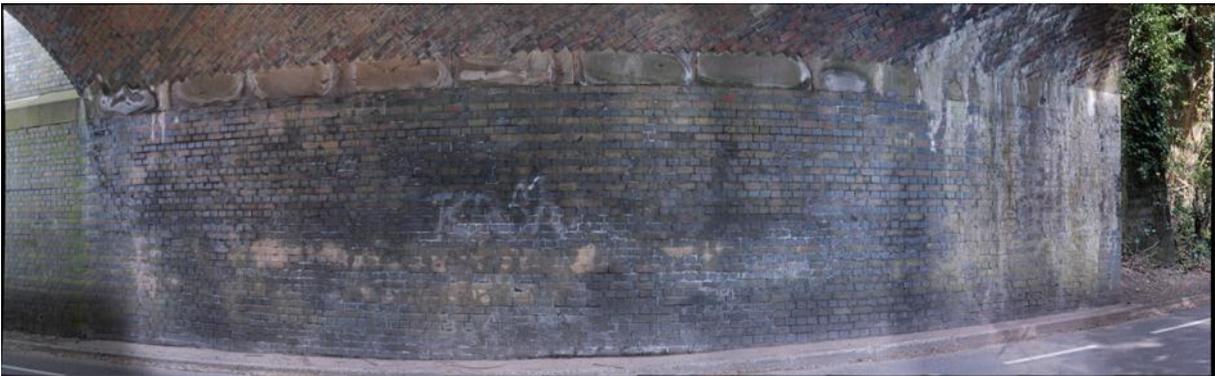
Figure 64: Display of 60 individual images and resulting panoramic display produced with GigaPan Stitcher.

This type of software attempts to take a series of images of a scene and merge them to produce a single output image. Examples of this include the GigaPan Stitcher software, and Microsoft ICE (Image Composite Editor). Figure 64 shows example of a series of images, and the resultant panoramic image produced using GigaPan Stitcher version 2.3.0307.

The software works by defining features within images, and then identifying other images exhibiting similar feature patterns. The matching feature patterns are then aligned and the images blended to produce a single output image with no visible seams.

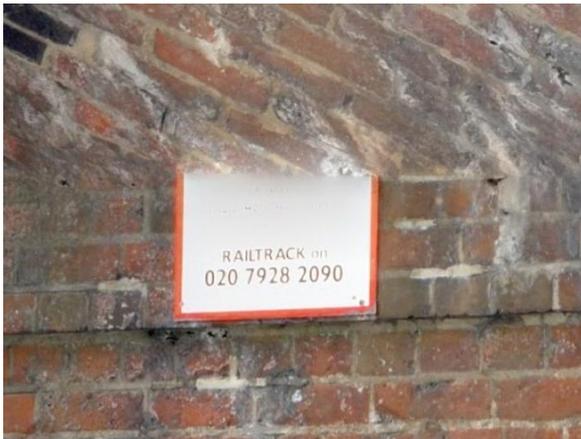
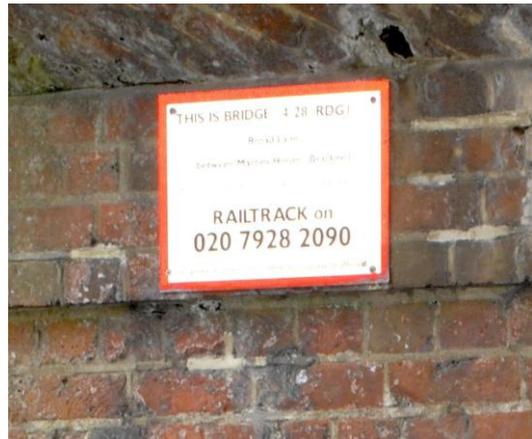
Figure 65: Panoramic image produced by GigaPan Stitcher, with close-ups highlighting mis-stitching of images (left), and showing actual appearance of surface (right).

However, it can go wrong as illustrated in Figure 65 and Figure 66. Mis-stitching errors like these have a number of potential causes, such as the inability to detect enough identifiable and unambiguous features in a scene. This can be a result of there being too little (for example wide expanses of blank uniform concrete), or too much (for example repeating patterns as found on good condition masonry surfaces) information in the scene. In these cases the system can struggle to decide which instance of a feature matches another instance of the feature, and makes mis-stitching errors.

Mis-stitching errors such as those shown above can be hard to detect without carefully scrutinising output images, and even then, in the absence of identifiable features and obvious mistakes it can be hard to identify when things go wrong.

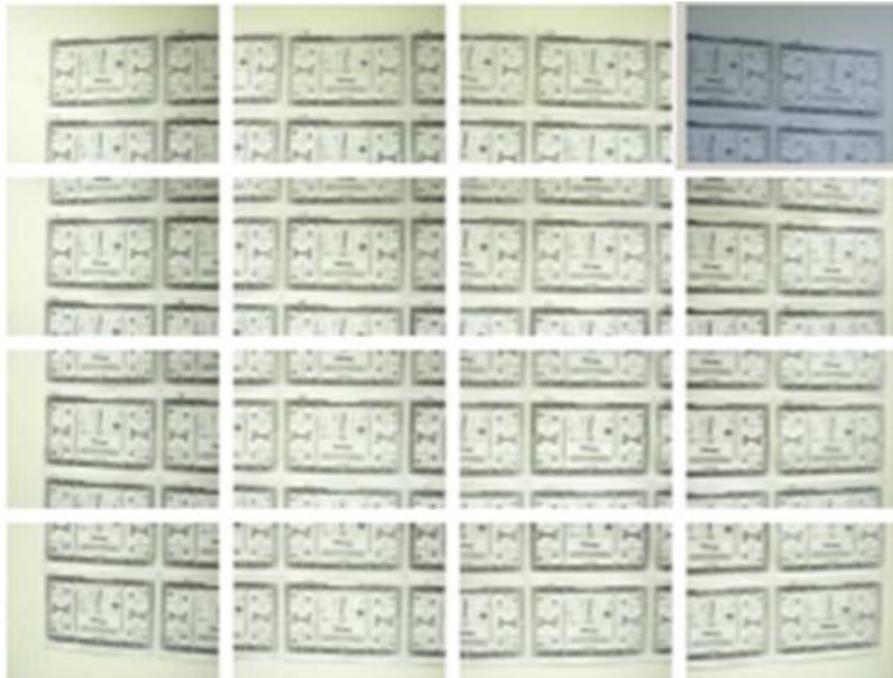
Figure 68: Sixteen individual images of test targets used to test alignment.

Sixteen A4 sized targets were fixed to a wall and imaged using a Nikon D60 mounted on a GigaPan Epic. The individual images collected are shown in Figure 68.

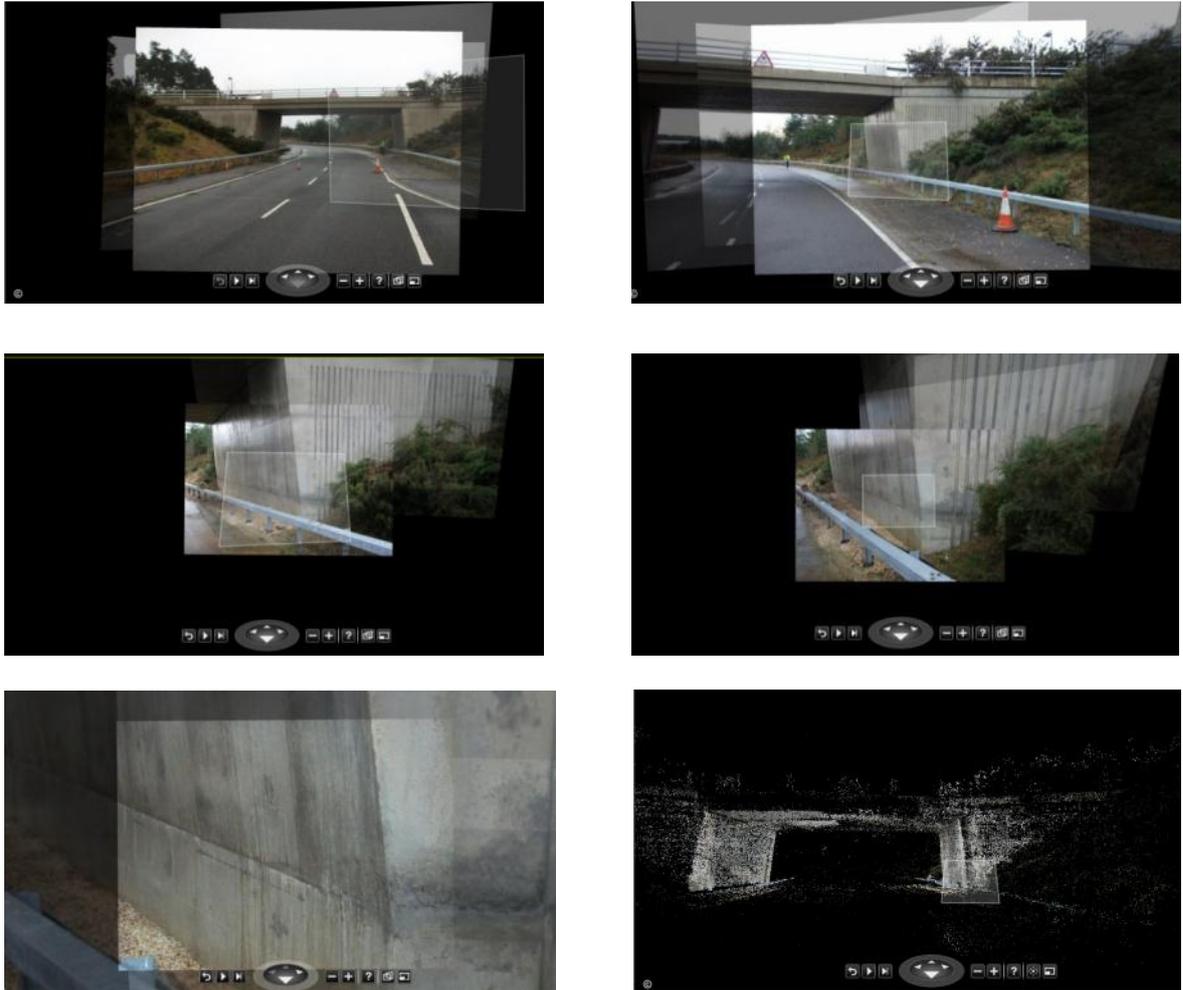
Figure 70: Series of images, displayed in Photosynth browser window, moving progressively closer to part of east end of north abutment. Also shown is the point cloud of the bridge.

Figure 70 shows some of the images presented within the Photosynth application. The images present progressively closer and more detailed images of the north east corner of the bridge, and within each display the main image can be seen, as can other images showing the same, or similar overlapping parts of the scene. Selecting these neighbouring images changes the display to focus on these images instead, and presents a new set of similar alternative images and views. This demonstrates how the images can be viewed and manipulated to see both contextual and detailed views of the structure. Figure 71 shows a plan view of the point cloud of the bridge, created using image pixel data alone.

To test the potential usefulness of the system a test was undertaken. A standard point and shoot digital camera was used to take 347 photos of a bridge following the advice on the Photosynth website, imaging out from the middle of the road under the bridge in a circle, then in from the edges of the bridge, then filling in gaps on the east and west approaches to the bridge. The image collection took approximately 45 minutes. The images were then supplied to the stitching software, which took several hours to process them and produce the output model.

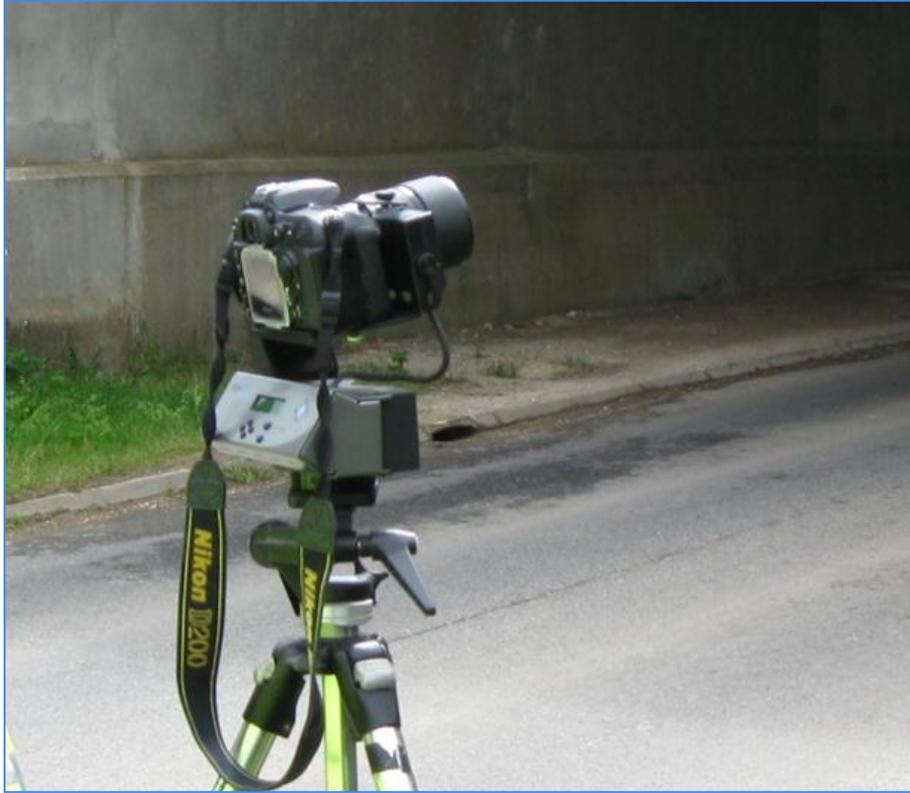
Figure 73: Prototype image collection system showing camera mounted on GigaPan automated pan-tilt unit.

collection of the first sets of bridge images was performed using the GigaPan Epic, as shown in Figure 73.

However, the GigaPan Epic was limited in its effective payload, and the range of compatible cameras was also restricted. These restrictions stemmed from the motors used in the system and also the image-triggering mechanism used in the GigaPan Epic.

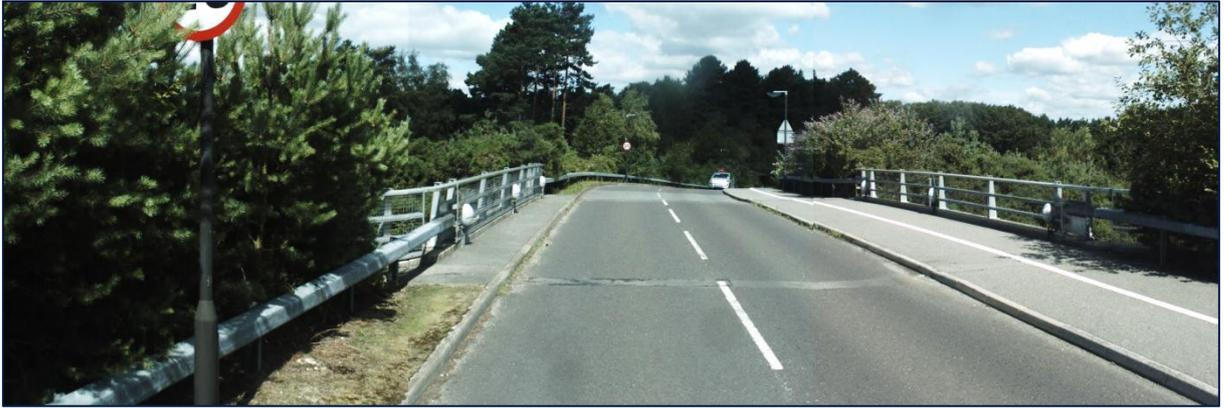
Figure 81: Forward facing image as collected by pavement condition survey vehicle.

downward (Figure 80) and forward (Figure 81) facing images of the road surface. Combining these images with IBIS images and inspection software enables inspectors to see the condition of the bridge deck, and to record the locations and types of defects seen.

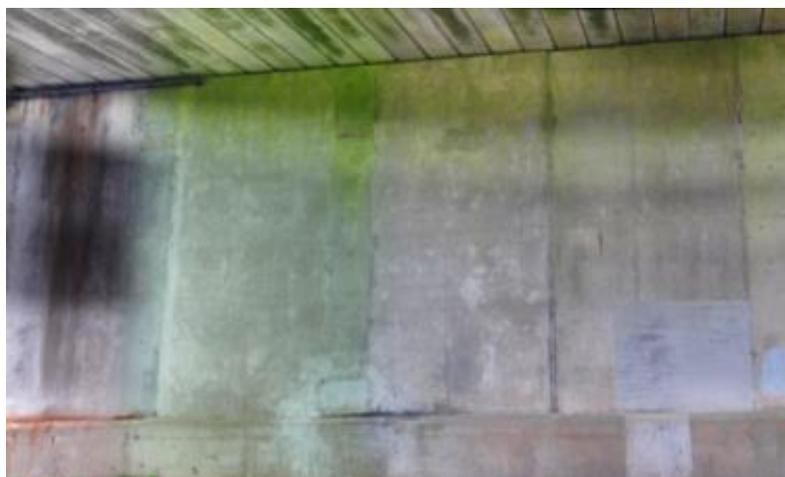
Figure 92: Example of tessellated images showing large colour and intensity differences due to changing illumination conditions (GigaPan).

This is not a simple issue, and even professionally developed image blending and stitching software has problems in coping with large changes in image illuminations, as illustrated by the example shown in Figure 92, showing the same images as in Figure 91, but this time stitched using GigaPan Stitcher software.

Here, although most of the images are smoothly blended into one another, there are still obvious differences in some locations where the input image illumination differed from its neighbours – the dark area on the left remains, as does the green

tinge to some of the image, and although less dramatic than in Figure 91, the changes in image brightness from the top to the bottom of images can still be seen to give the upper right part of Figure 92 a somewhat stripy appearance.

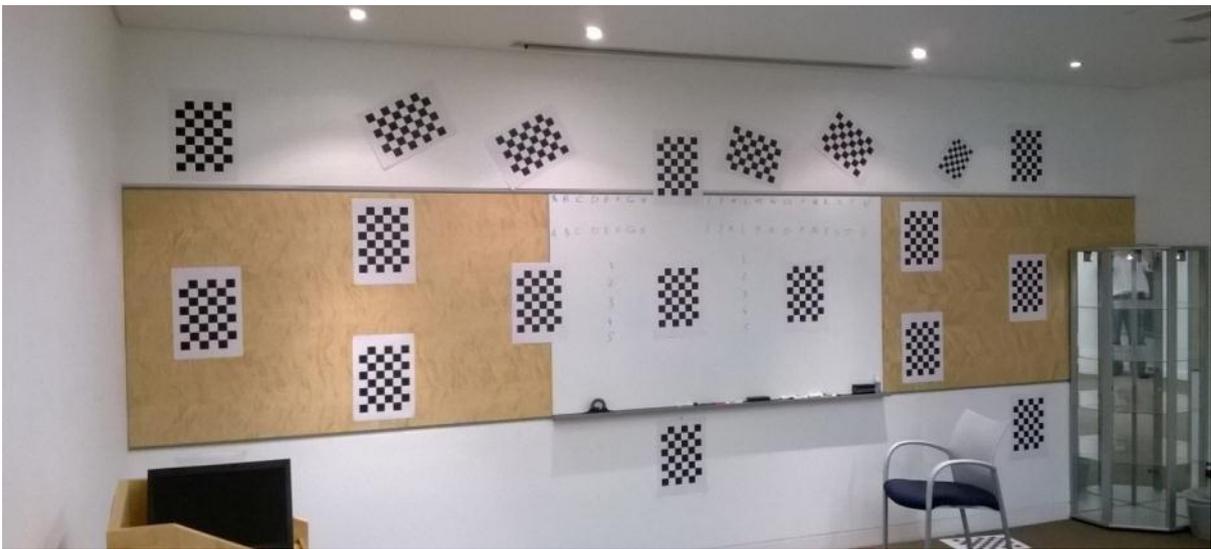
Figure 100: Experimental set up for demonstration of reprojection.

The experiment used a series of targets with known properties, which were fixed to a wall. The camera was set up 5m perpendicularly from the centre of the wall, with a 100mm focal length lens. Figure 100 shows the experimental set up.

A plumb line was used to ensure that the targets were aligned as accurately as practically possible.

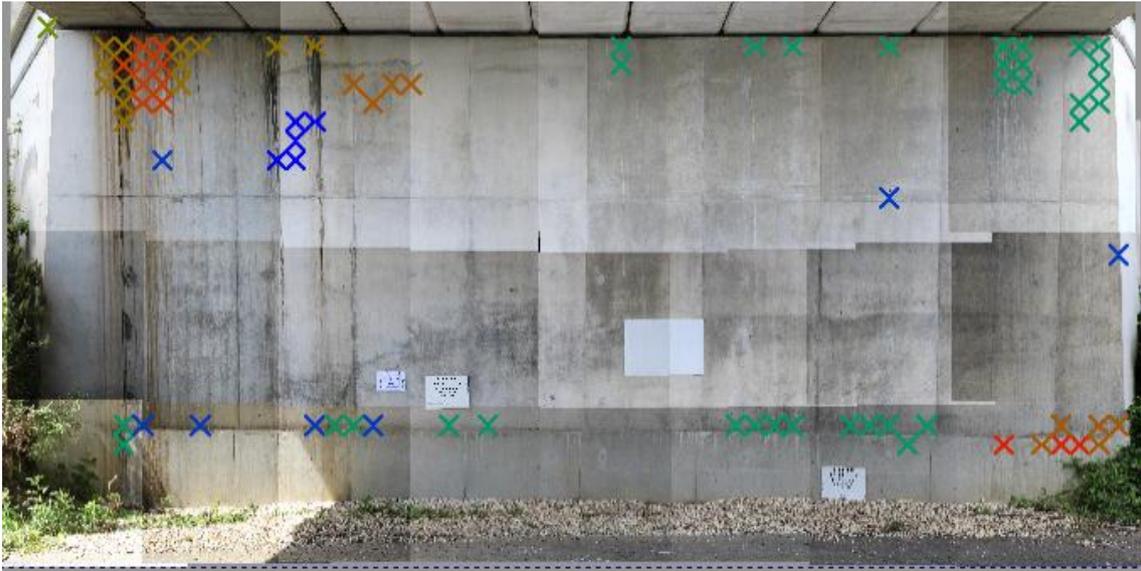
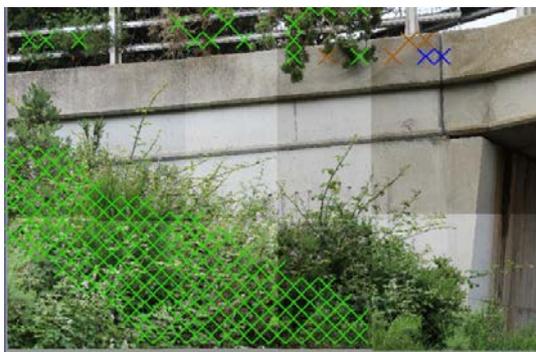
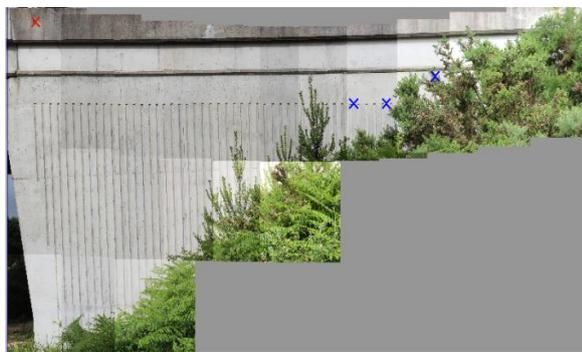
Figure 102: Example of defect maps created during IBI procedure.

To consider the use of IBIS data and tools specifically when completing a GI report experienced bridge inspectors were supplied with a set of IBIS images, the modified ChartCrack software, and were asked to undertake a GI using these. Figure 102 shows some examples of the IBIS images, overlaid with defect maps produced by the inspectors while undertaking this task. The complete set of defect maps is provided in Appendix D.

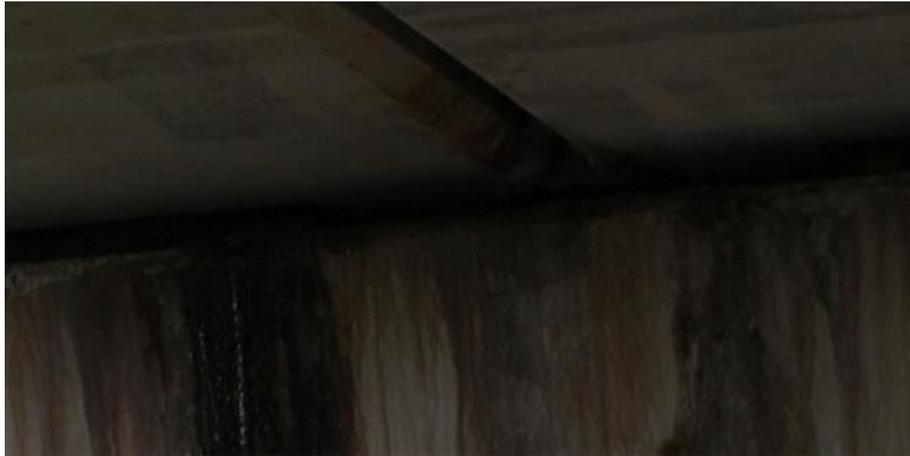
Figure 103: Portion of underexposed image of top of a bridge abutment (top); same image following image processing (below).

Figure 103 shows an example of an underexposed image before and after application of image processing techniques to highlight and present details which were originally difficult to see.

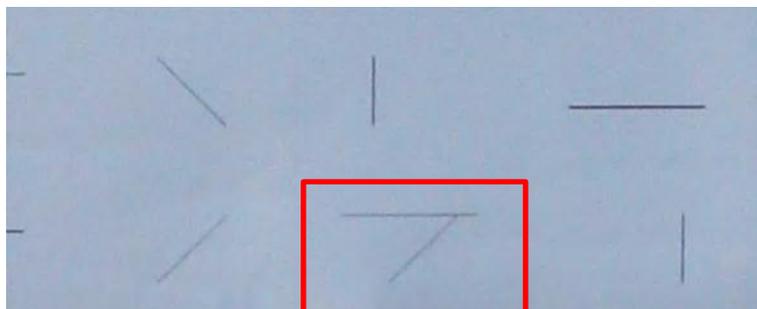
Figure 107: Close up of location where inspector's answer was incorrect in image shown in Figure 105, showing presence of 2 lines in box.

It can be seen comparing Figure 105 (showing the inspectors recorded line orientations on target T_A) and Figure 106 (showing a zoomed in portion of the actual image containing T_A) that the inspector made one mistake in identifying the orientation of the lines in the visual acuity target. On the bottom row of the target they labelled a cell as containing a single diagonal line, when in fact it also contained a horizontal line, as can be seen in the zoomed in view of Figure 106, shown here as Figure 107.

It is unclear whether the inspector did not see the horizontal line, or simply failed to mark it on the results sheet. However, because of the image record being available it is possible to look again at the image and determine it was there. This would not be possible in a traditional inspection. The thickness of the missed line was 0.14mm. This is thinner than the minimum required crack width determined in the consultation of 0.4mm, so failure to detect this is acceptable. The results shown in Figure 108 compare well with those from the experimental work (Figure 49), which showed that inspectors sometimes failed to detect lines of this thickness even at 3m.

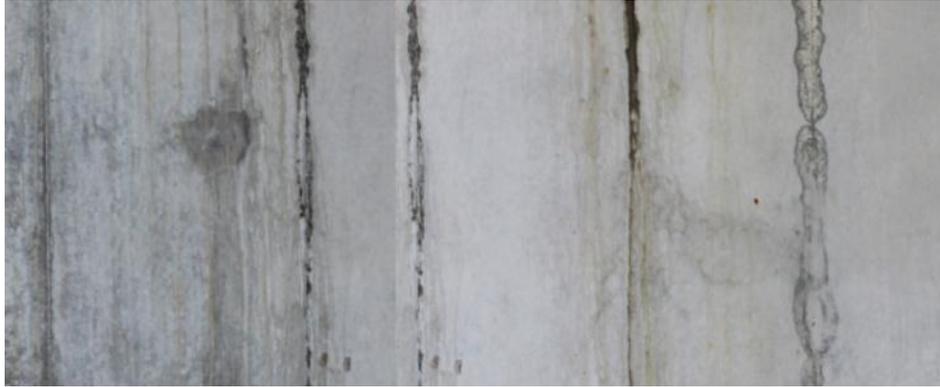
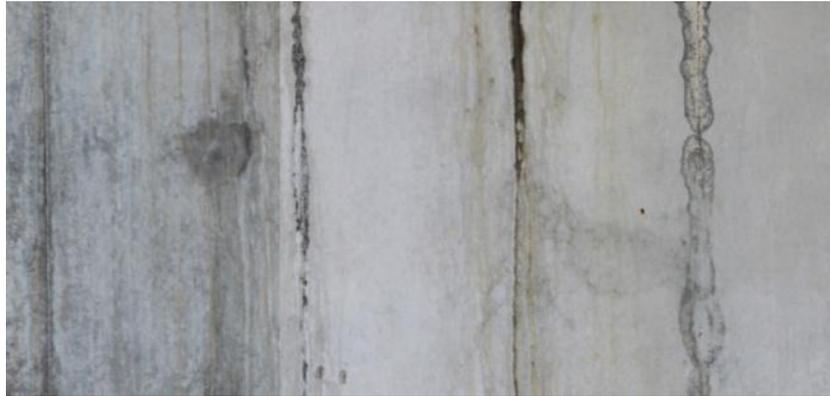
Figure 111: Images aligned using bearing and elevation data only (top) and with image cross-correlation information (bottom).

Figure 111 shows images which have been aligned using only camera orientation information (top), and with the hybrid camera-orientation/cross-correlation approach (bottom). The duplication of features in the top image can be clearly seen. This has been removed in the lower image, which has been produced using the hybrid alignment method. In the top image, the horizontal misalignment shown is approximately 220 mm, in the lower image the misalignment is now less than 10mm.

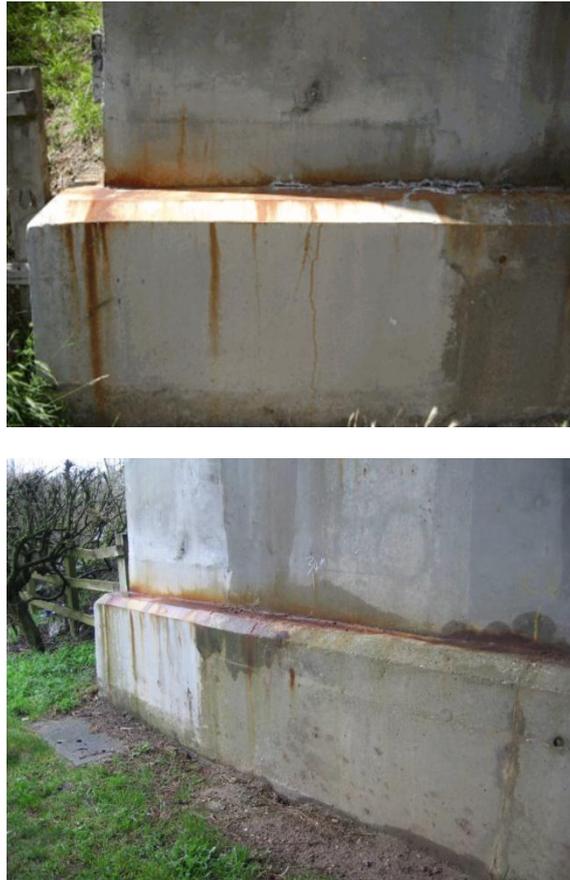
Figure 113: Images of same part of bridge collected during different survey visits using traditional GI methods.

Although both images in Figure 113 show the same part of the bridge, and are illustrating the same defects, the way in which the images have been taken and presented makes it difficult to judge the progression of the defect. The way in which the IBIS images in Figure 112 are presented makes it much easier to judge and assess changes in the bridge condition.

Figure 112 shows images of part of a bridge, taken with the IBIS during three different inspections. Figure 113 shows images provided as part of traditional General Inspection reports undertaken in different years.

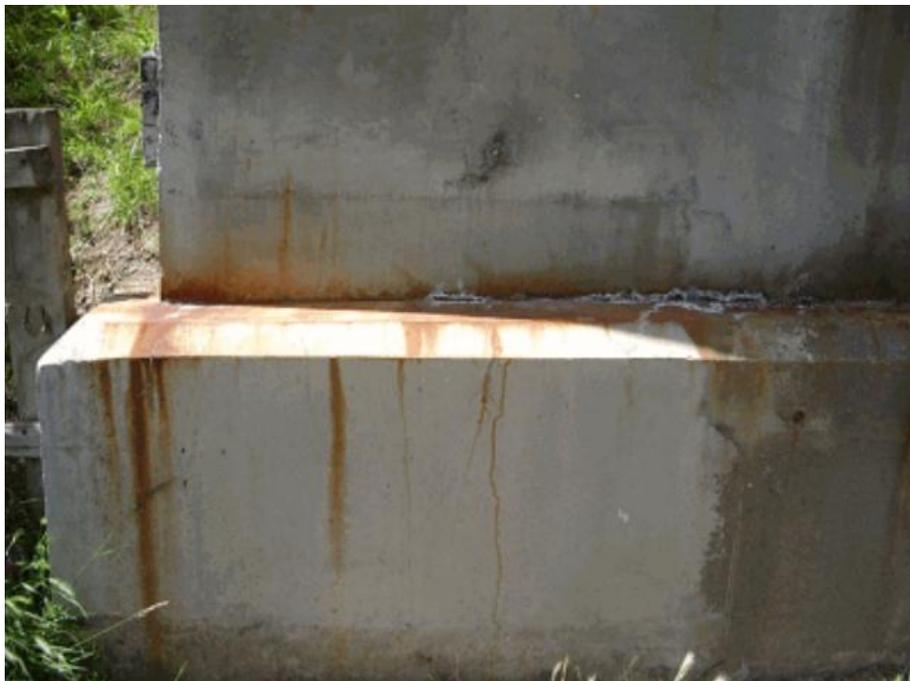
Figure 121: Image of south end of west abutment taken in 2008 as part of scheduled General Inspection.

The following photographs (shown in Figure 121 to Figure 125) were taken during 2 General Inspections performed 2 years apart on the same bridge carrying the M4 over a local road. One was the normal General Inspection performed for the Highways Agency in 2008; the other was performed as part of this research in 2010.

The first three images show a portion of the southern end of the west abutment. Figure 121 shows the image taken in 2008 as part of the scheduled General Inspection on behalf of the Highways Agency, Figure 122 and Figure 123 show the images taken in 2010 by the inspector undertaking the General Inspection commissioned specifically for this research. Although there are sufficient features within the images to be confident that the images show the same general part of the structure the way that they have been taken, with no control over exactly what is imaged makes it very difficult to determine whether any of the defects shown have grown or changed over time.

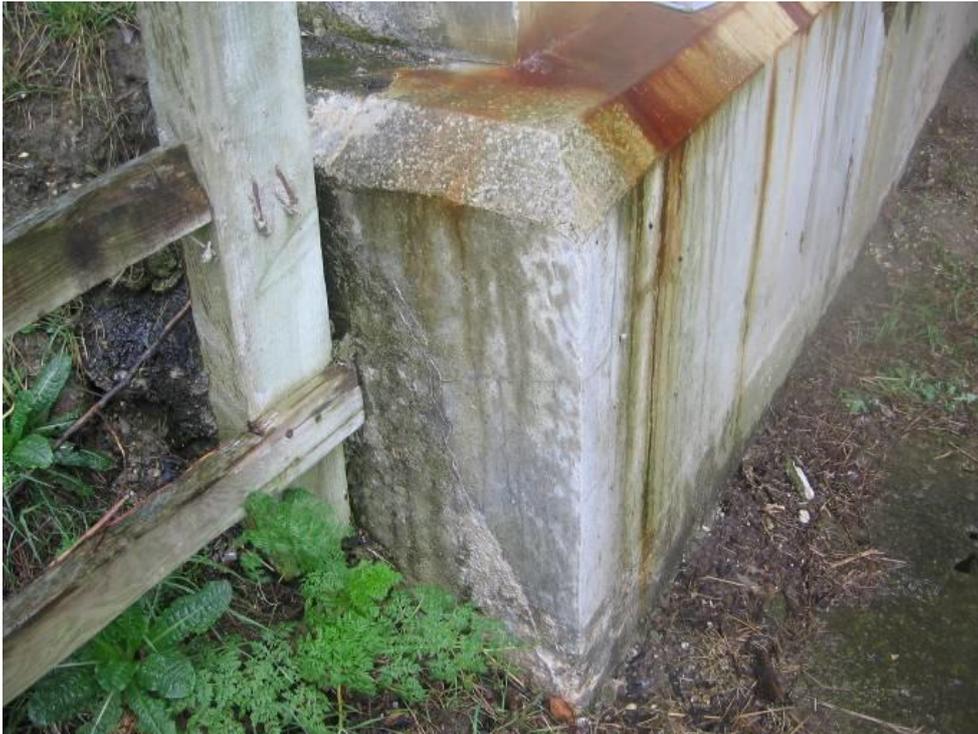
Figure 122: Image of south end of west abutment taken in 2010 as part of research General Inspection.

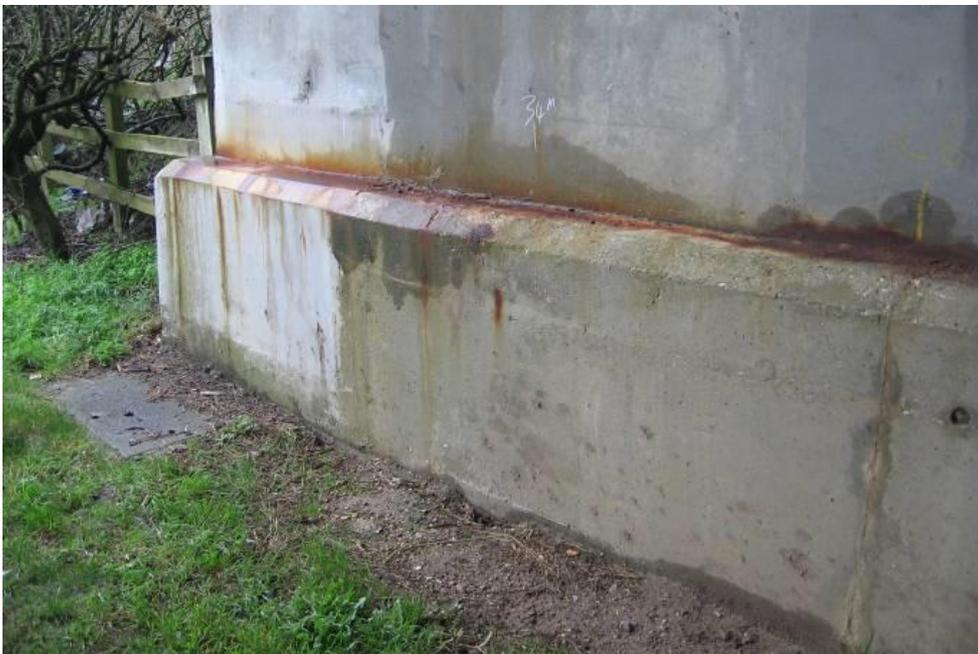
Figure 123: Image of south end of west abutment taken in 2010 as part of research General Inspection.

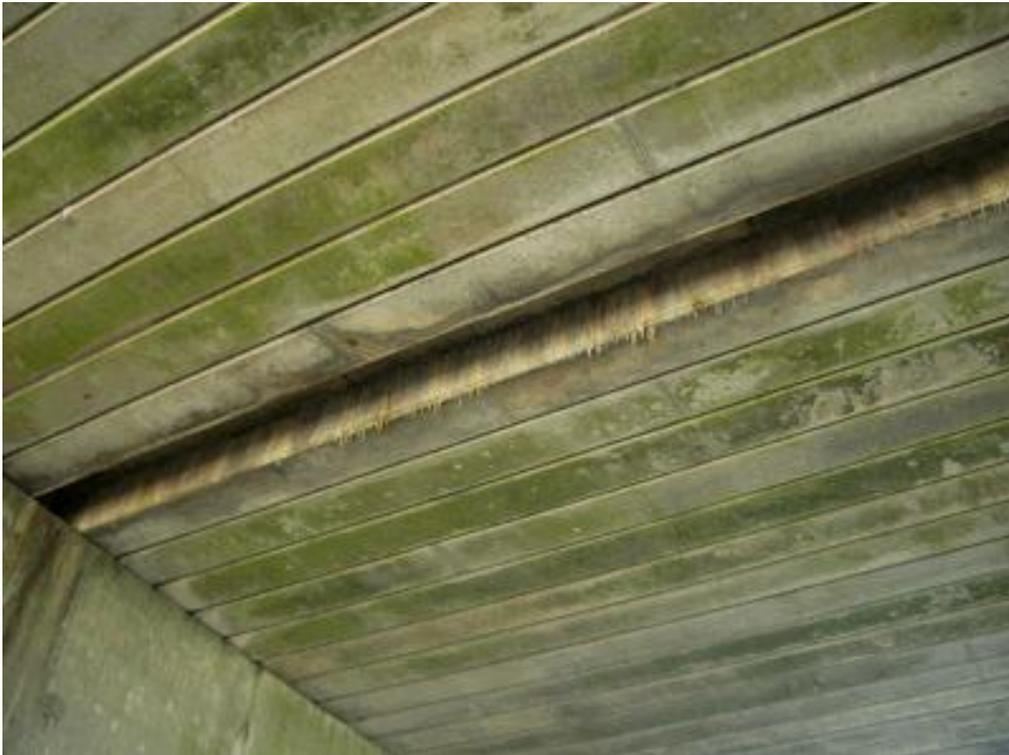
Figure 124: Image of central portion of west end of soffit beams taken in 2008 as part of scheduled General Inspection.

Figure 124 and Figure 125 show images of part of the soffit taken during successive General Inspection visits. Because of the different angles at which the photographs were taken, the regular beam pattern in the images, and the appearance of a wet area in Figure 125 it is not immediately obvious that the images do show the same part of the bridge. Both images obviously show soffit beams, but the images must be looked at quite closely to pick out features that are definitely the same in the two images, before any comparison or trending of defects can take place.

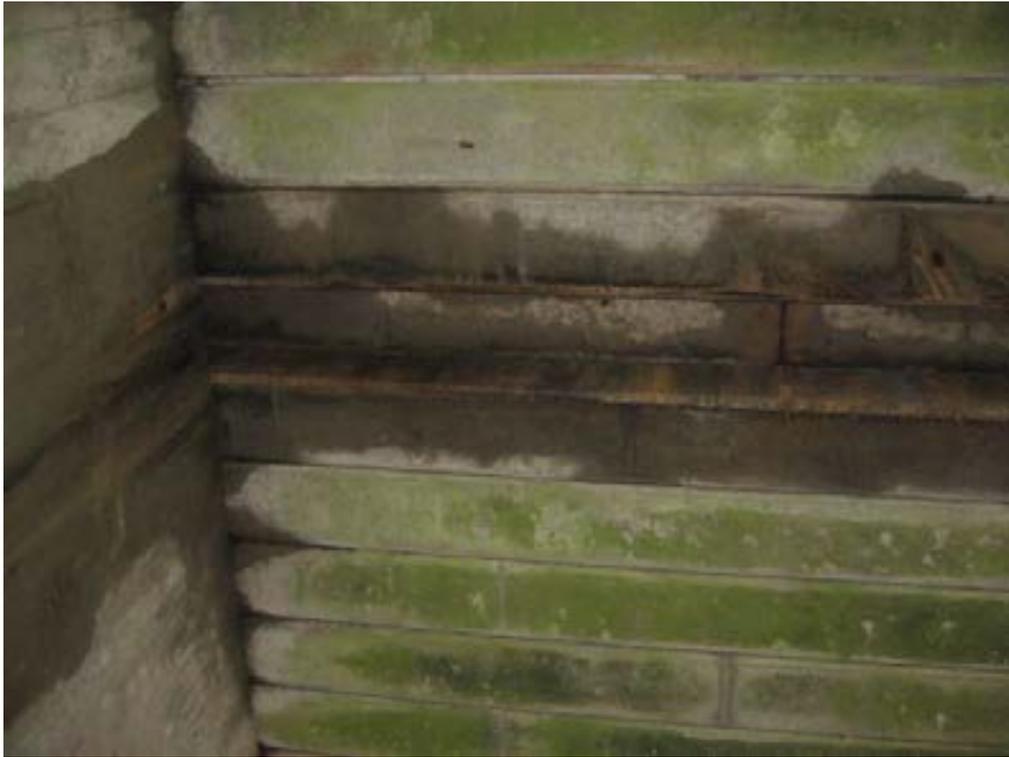
Figure 125: Image of central portion of west end of soffit beams taken in 2010 as part of research General Inspection.

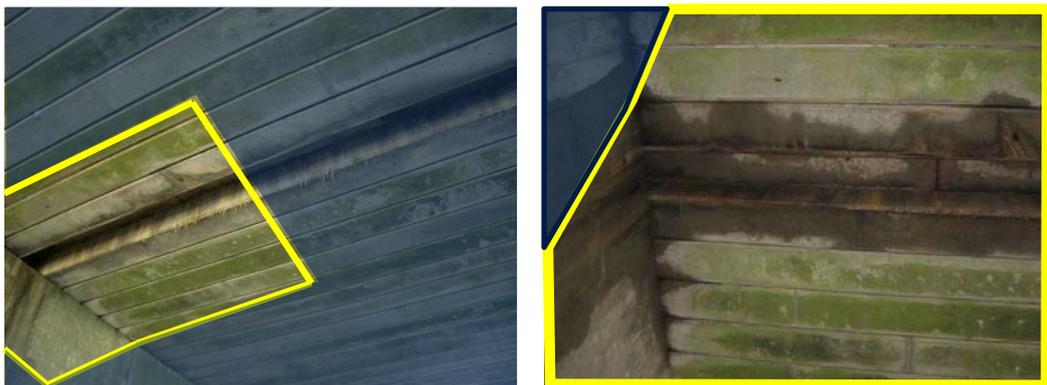
Figure 126 is an attempt to illustrate which part of Figure 124 is visible in Figure 125, and how the viewing angles have changed.

Figure 126: Highlighted areas show part of bridge common to both Figure 124 and Figure 125.

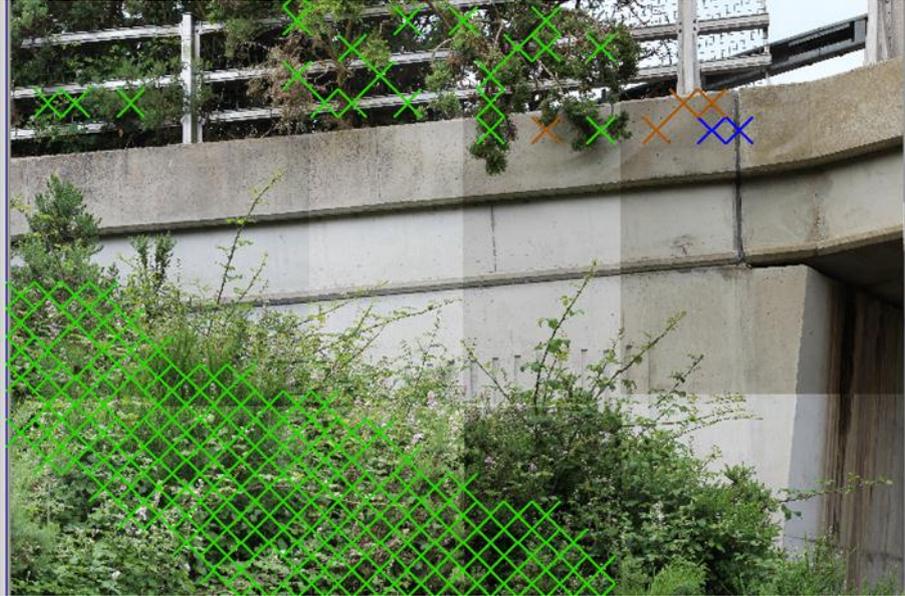
Figure 129: Defect map overlaid on tessellated imageset from IP3.

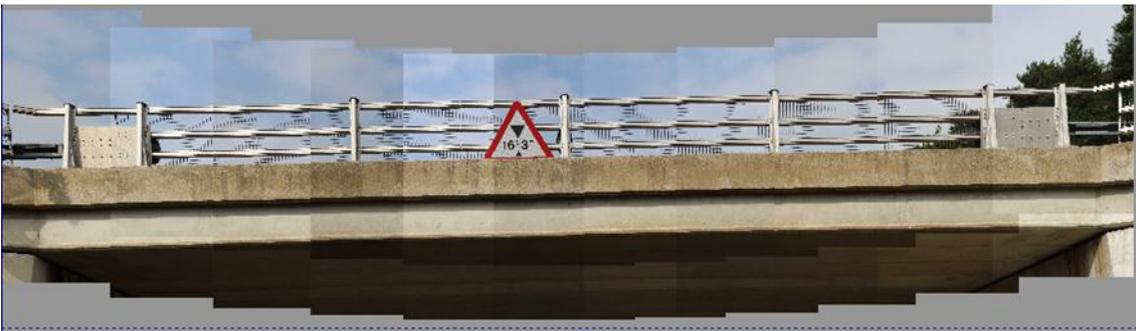
Figure 130: Defect map overlaid on tessellated imageset from IP4.

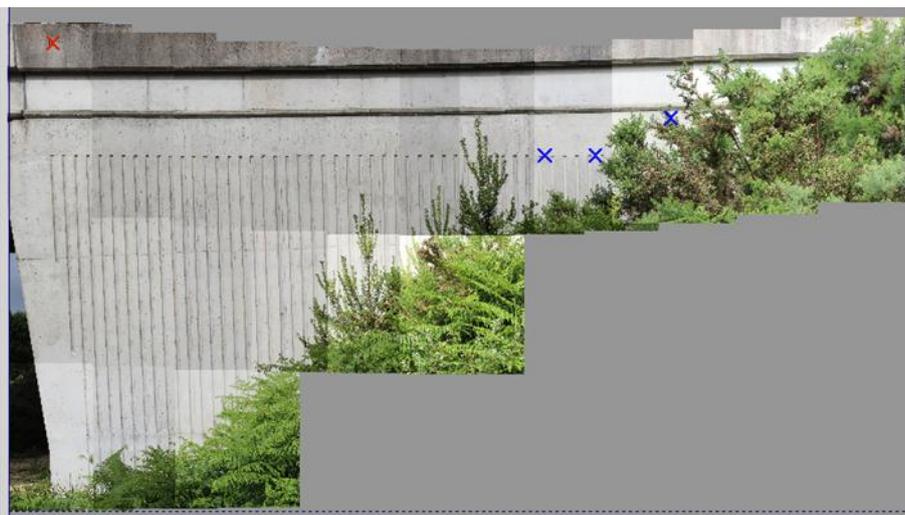
Figure 131: Defect map overlaid on tessellated imageset from IP5.
