DEVELOPMENT OF AN IMAGE BASED SYSTEM FOR ROUTINE VISUAL INSPECTION OF UK HIGHWAYS BRIDGES

A thesis submitted to the
University of Birmingham
for the degree of
DOCTOR OF PHILOSOPHY

School of Civil Engineering
College of Engineering and Physical Sciences
University of Birmingham
August 2015

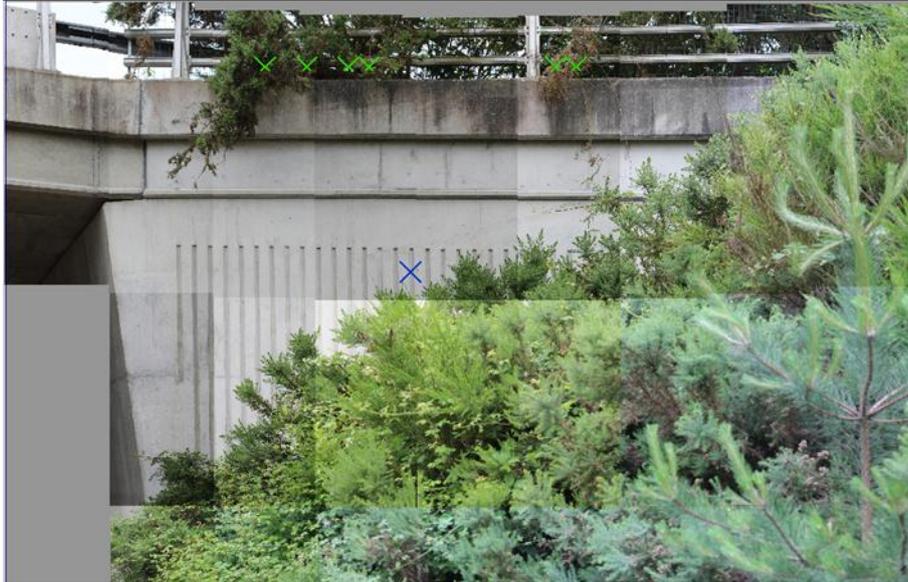
Figure 132: Defect map overlaid on tessellated imageset from IP6.

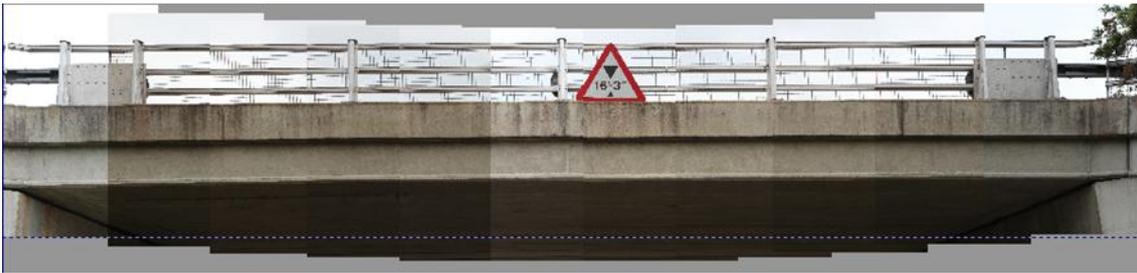
Figure 133: Defect map overlaid on tessellated imageset from IP7.

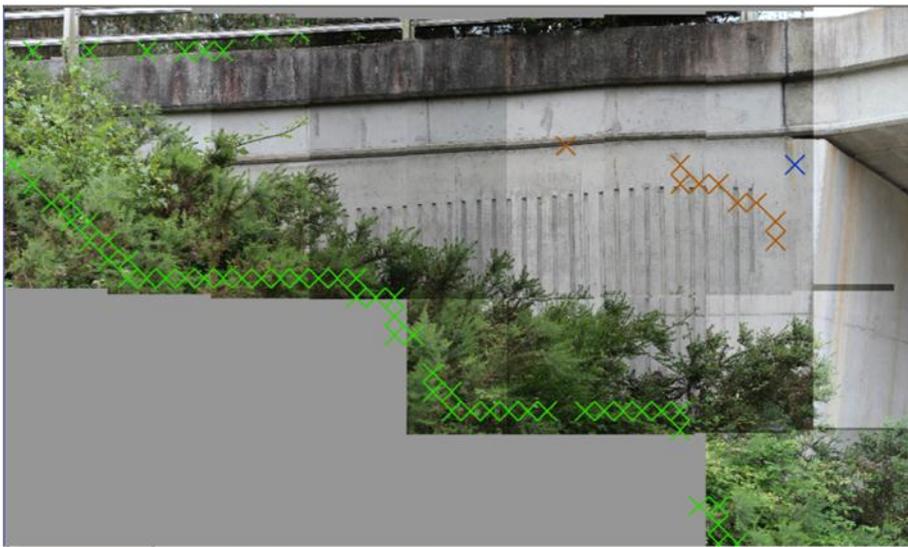
Figure 134: Defect map overlaid on tessellated imageset from IP8.

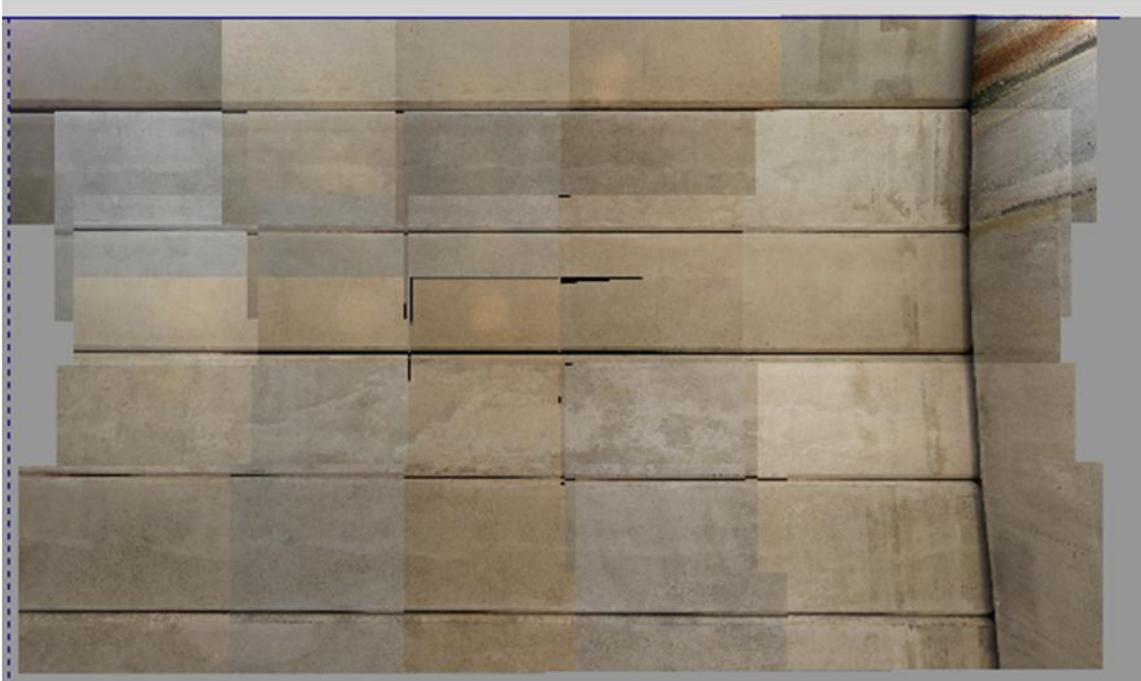
Figure 135: Defect map overlaid on tessellated imageset from IP9.

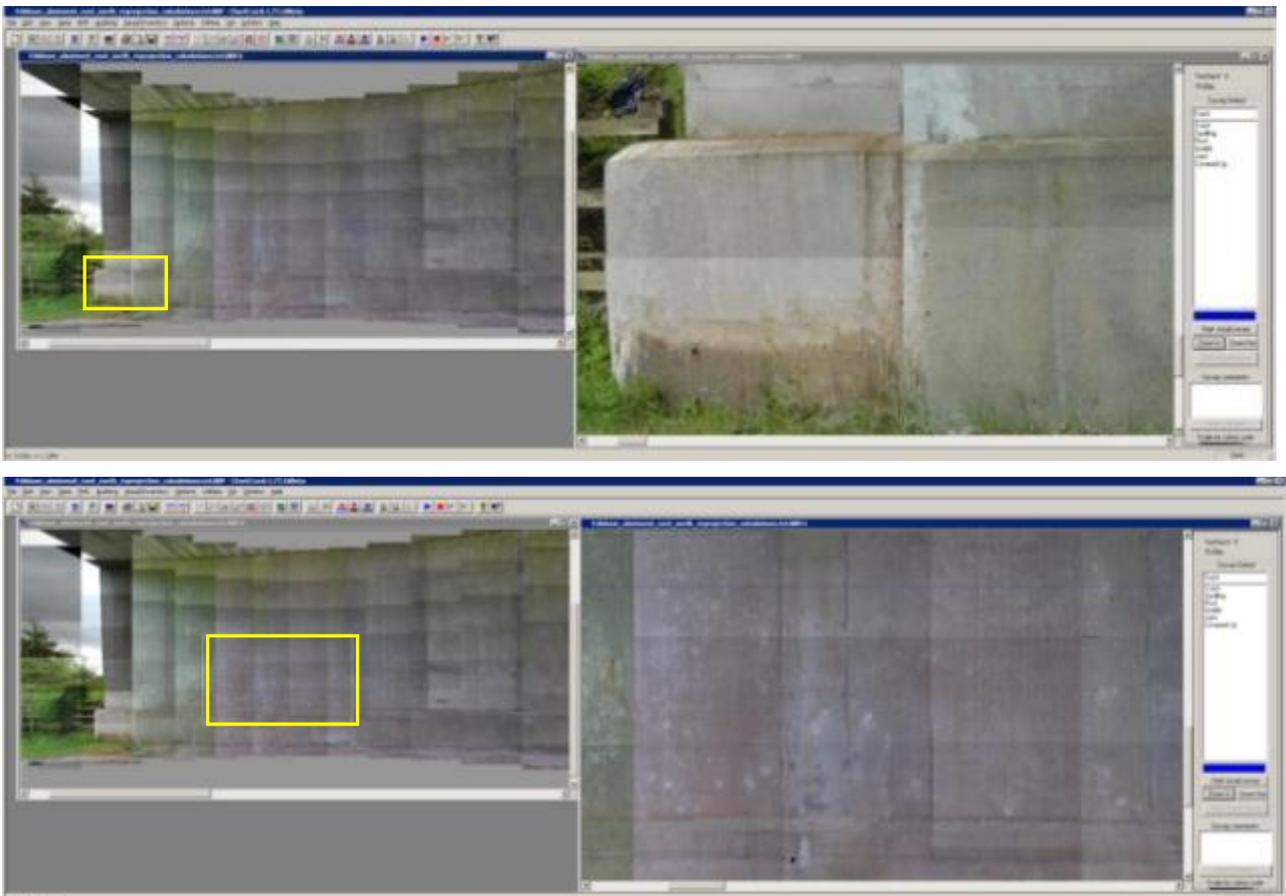
The extent of the images that are shown in the current inspection view is shown as a yellow rectangle in the thumbnail view, as shown in the left hand side of the above screenshots.

Zooming in, out, or moving around within the inspection window will move the yellow rectangle in the other window, meaning that you should always be sure which part of the bridge you are looking at.
