**SCHOOL OF METALLURGY AND
MATERIALS**

**ON THE CHARACTERISATION AND
DETECTION OF ROLLING CONTACT
FATIGUE (RCF) TYPE CRACKS IN
RAILWAY VEHICLE WHEELS USING AN
ALTERNATING CURRENT FIELD
MEASUREMENT (ACFM) TECHNIQUE**

**A THESIS SUBMITTED FOR THE DEGREE
OF**

2017

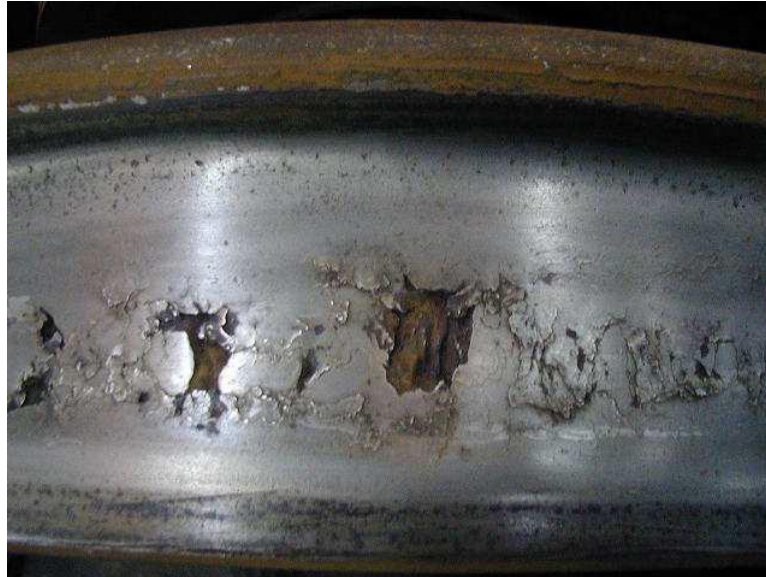
Figure 3.2 shows the presence of shelling and cavities on the wheel tread surface (the original of the above photographic image is shown in reference [11] and has been reproduced and appropriately referenced here for the purpose of this PhD thesis).

Shelling (figure 3.2 [ref. 11]) is a cavity defect due to a local loss of material on the wheel and believed to be the result of RCF. Shelling [12, 18, 89] refers to all sub-surface cracks manifesting as flakes of material that is lost from the tread of a rail wheel. Such defects are primarily caused by excessive vertical wheel/rail contact forces with respect to the wheel diameter. However, it is difficult to distinguish between the phenomena of spalling and shelling simply by visual inspection.

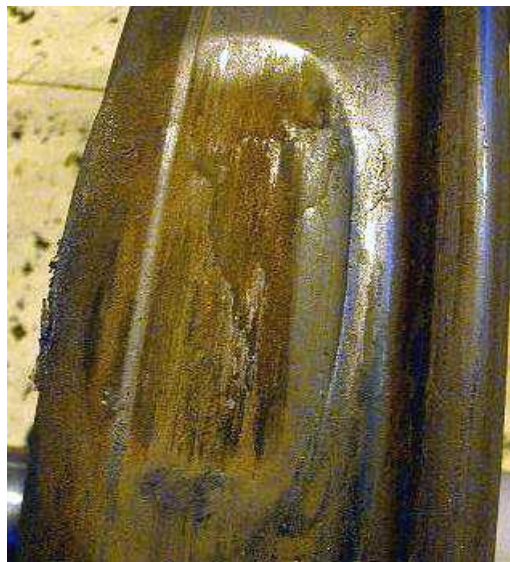
Figure 3.4 shows a wheel flat (the original of the above photographic image is shown in reference [11] and has been reproduced and appropriately referenced here for the purpose of this PhD thesis).

Wheel flats occur as a result of the sliding of the wheel on the rail without rolling and are primarily caused by the very high braking force in relation to the wheel/rail friction. Common causes for this are poorly adjusted, defected or frozen brakes and/or the incidental and local reduction in wheel/rail friction due to the presence of ice or leaves on the railway line.

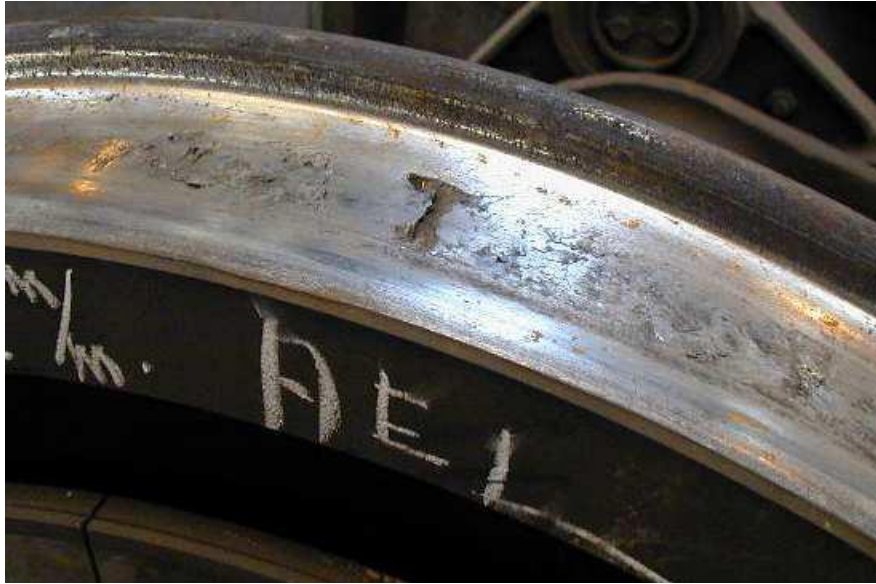
Figure 3.5(b): Figures 3.5(a) and (b) show a schematic and photograph, respectively, of local tread collapse in a railway wheel (the originals of the above schematic and photographic image are shown in reference [11] and have been reproduced and appropriately referenced here for the purpose of this PhD thesis).

Circulatory defects result in the shape of the wheel tread contact patch becoming permanently changed, for example, resulting in the local collapse of the wheel tread (see figures 3.5(a) and (b)) or polygonisation (figure 3.6) that causes defects to occur on the circumference of the rail wheel. Shelling is evidently present in the central region of the collapse in the tread. The occurrence of local tread collapse damage is due to premature wheel tread turning which, in turn, is the result of wear, which includes flange wear, and the presence of thermal damage as a result of wheel slide in conjunction with tread braking mechanism. Furthermore, geometric defects occur at the flange tip and flange face and are usually discrete or continuous defects being caused by the flow or loss of material from the flange.

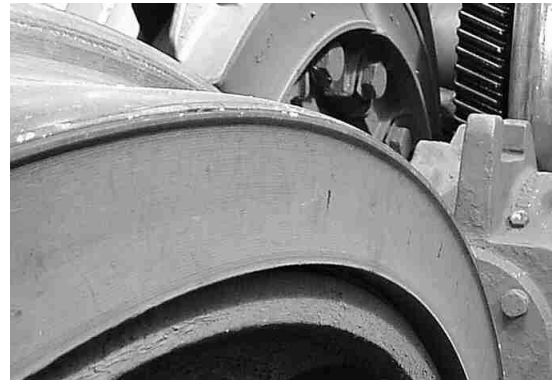
Figure 3.7 shows a schematic and a photograph of wheel tread roll-over (the originals of the above schematic and photographic image are shown in reference [11] and have been reproduced and appropriately referenced here for the purpose of this PhD thesis).

Wheel tread roll-over (figure 3.7) is extruded material that has formed on the outer rim of the wheel during service by plastic deformation and is a continuous defect [50]. This defect is not expected to extend beyond 5 mm from the face of the wheel rim; neither should there be any cracks present. However, cracks that have initiated in the rolled over region of the material can readily propagate into the wheel rim with the potential for wheel fracture [119].

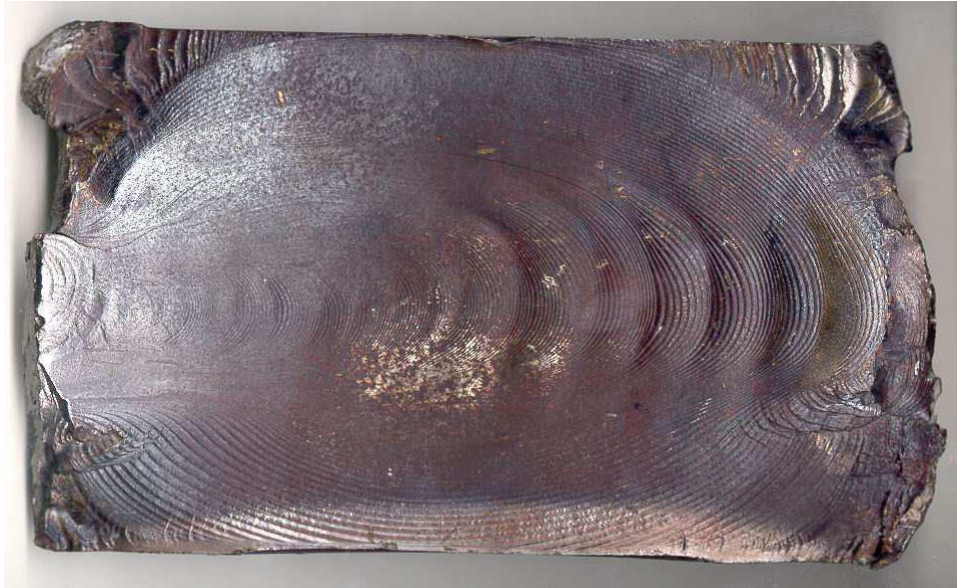
Figure 3.8 shows deep sub-surface tread defect (the original of the above photographic image is shown in reference [11] and has been reproduced and appropriately referenced here for the purpose of this PhD thesis).

Defects that are specific to monobloc wheels include deep sub-surface tread defects (figure 3.8) which tend to grow parallel to the tread. Fatigue damage related rail wheel failures are characterised as either surface or sub-surface induced. The former is initiated due to gross plastic deformation of the material in close proximity to the wheel's surface as a consequence of increased loading and/or lower strength material in this near surface region of the tread, thus, leading to the growth of cracks in this region which extend within the material for several millimetres before returning to the surface and, subsequently, causing material to be detached from the tread surface. The latter type of failures occur below the tread surface and can initiate from the presence of macroscopic defects within the material or in defect free zones where the local stress might be extremely high. These defects can grow to a greater depth in the material, typically to a depth of about 30 mm beneath the tread surface before again returning to the surface and, thus, resulting in the loss of large amounts of material from the tread which can be very serious and, thus, become a potential safety hazard requiring the immediate removal of the wheel from surface for safety reasons. Furthermore, overheating can affect the transition between the rim and defects, thus, defects can form as a result of thermal contact with the web (figure 3.9).

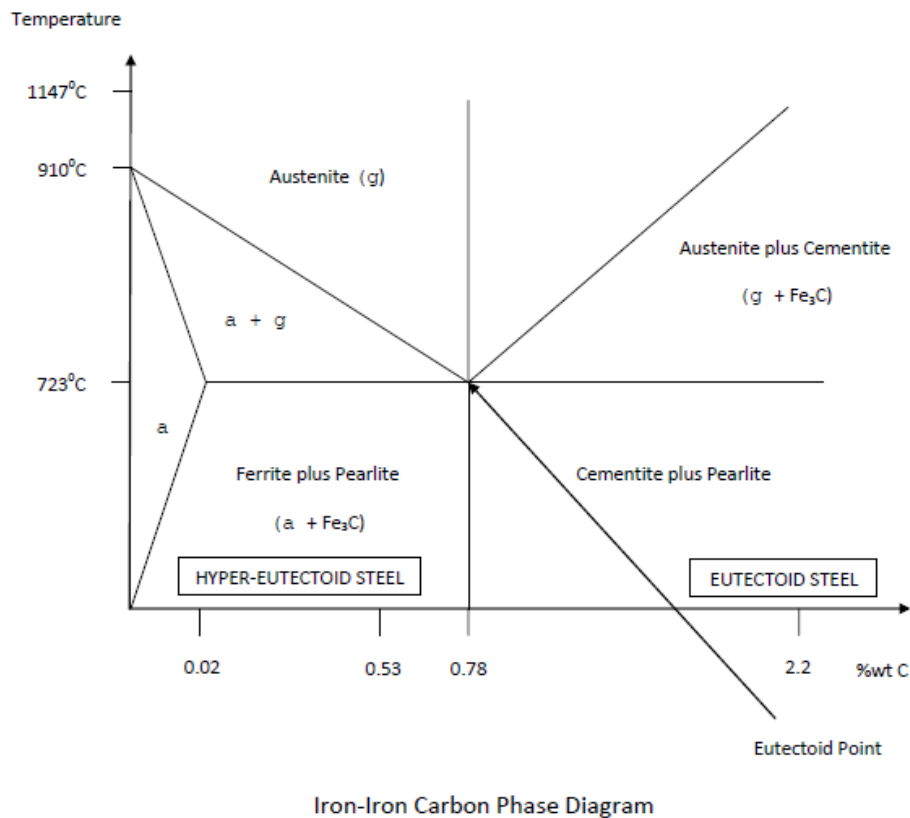
Figure 3.10 shows the Iron-Iron Carbon Phase Diagram.

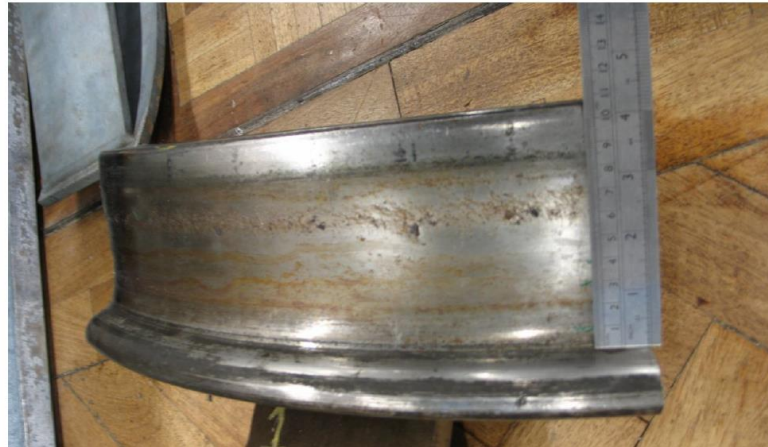
Figure 6.1 railway wheel HSR1 at the minimum run-out tread position.

RCF band, which as observed in wheels HSR1 and HSR2 to extend from the central region of the tread to the field side, the results show an increase in surface hardness (see section 6.3.3 below) and the presence and concentration of a greater number of surface breaking and deeper RCF cracks (see figures 6.1-6.4 incl.). This is caused by the leading wheel contacting the inner rail on curves whilst simultaneously the opposite wheel makes direct contact with either the flange face or the route of the flange. Thus, under these conditions the frequency of contacts made are considerably less, nevertheless, the stresses are much higher and, thus, results in higher material hardness and an increase in the level of surface damage, as observed in these worn rail wheels, as well as an increase in the concentration and severity of RCF-type cracks present in this region of the wheel tread. Furthermore, as seen from this work, cracks in this region can be angled as observed in the HSR1 rail wheel, however, the cracks can also be oriented almost circumferentially, i.e. close to 90^0 along the running direction, as observed in wheel HSR2 due to the occurrence and influence of traction forces.

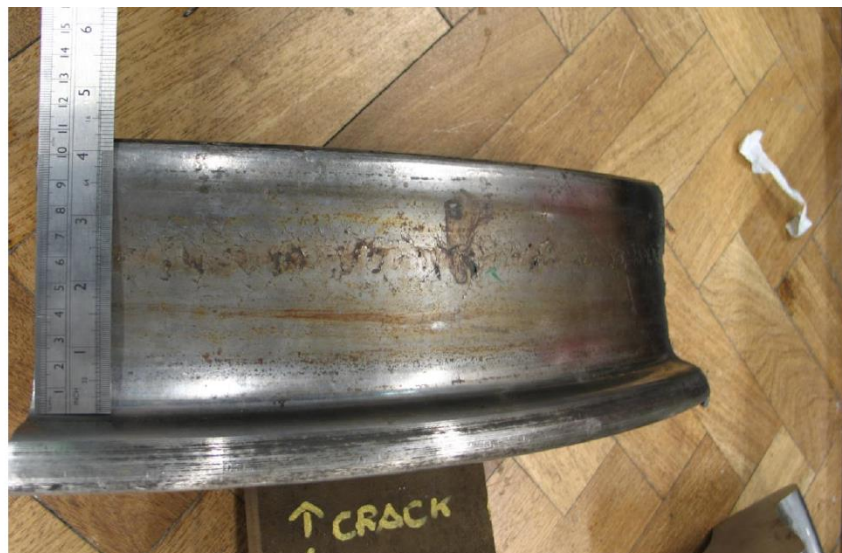
Figure 6.2 railway wheel HSR1 at the maximum run-out tread position.

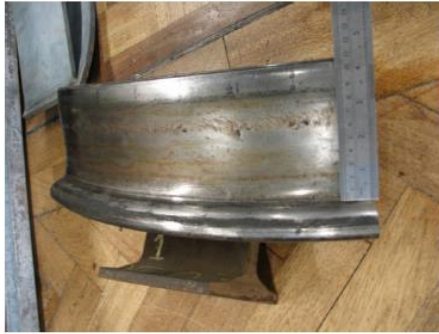
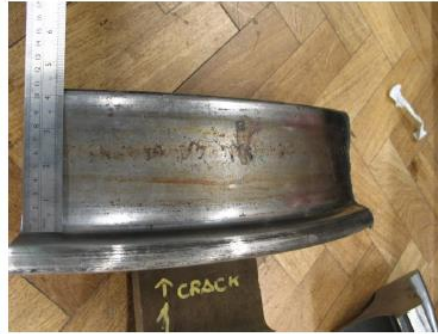
Figure 6.3 photograph of the HSR1 railway wheel tread surface at the maximum and minimum run-out tread position segments A and B, respectively.

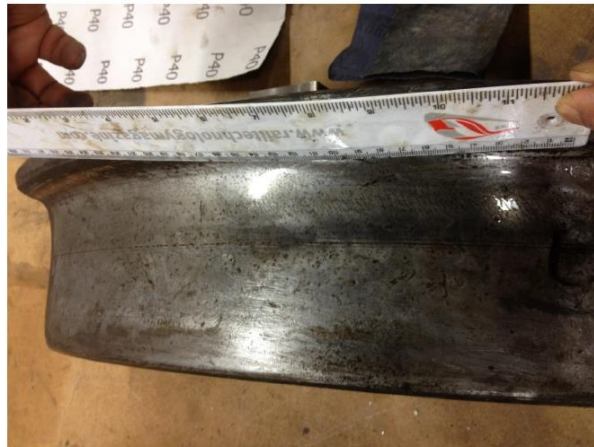
Figure 6.4 photograph of the HSR2 railway wheel tread surface showing the two circumferential bands of RCF cracks: first band consists of shallow and fine cracks oriented at approx. 60° to the circumferential direction of the tread found near the flange and the second circumferential band of cracks are oriented almost perpendicular ($90^{\circ} \pm 0.5^{\circ}$) to the circumferential direction of the tread and are found at approx. 3 cm from the non-flange end of the tread.

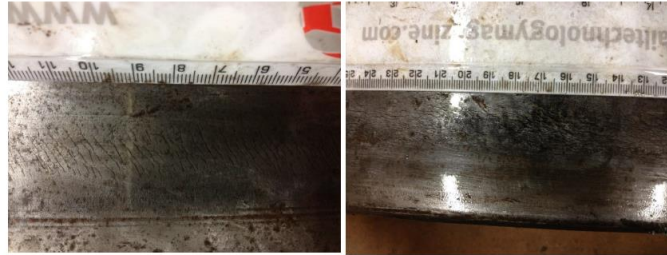
Cracks at 60 degrees to circumferential direction near flange end

Cracks at approx. 90 degrees (+/- 5) at about 3 cm from non-flange end

Figure 6.5 high magnification photographs of the HSR2 railway wheel tread surface showing the two circumferential band of RCF cracks: first band consists of shallow and fine cracks oriented at approx. 60° to the circumferential direction of the tread found near the flange and the second circumferential band of cracks are oriented almost perpendicular ($90^{\circ} \pm 0.5^{\circ}$) to the circumferential direction of the tread and are found at approx. 3 cm from the non-flange end of the tread. These two bands of RCF cracks are regions of interest for the 3-D reconstruction of cracks using the multi-sectioning in conjunction with optical metallography approach and ACFM scans across these cracks as presented in chapters 4 and 6, respectively.

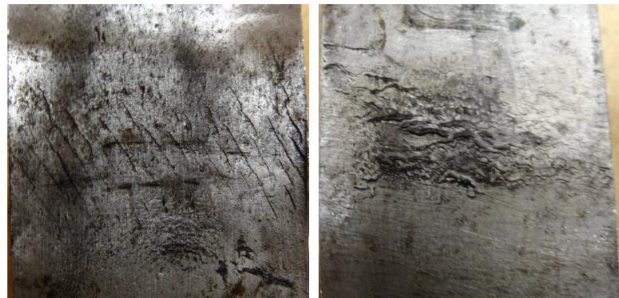
Figure 6.6 another high magnification photographs of the HSR2 railway wheel tread surface showing the two circumferential band of RCF cracks: first band consists of shallow and fine cracks oriented at approx. 60° to the circumferential direction of the tread found near the flange and the second circumferential band of cracks are oriented almost perpendicular ($90^{\circ} \pm 0.5^{\circ}$) to the circumferential direction of the tread and are found at approx. 3 cm from the non-flange end of the tread. These two bands of RCF cracks are regions of interest for the 3-D reconstruction of cracks using the multi-sectioning in conjunction with optical metallography approach and ACFM scans across these cracks as presented in chapters 4 and 6, respectively.

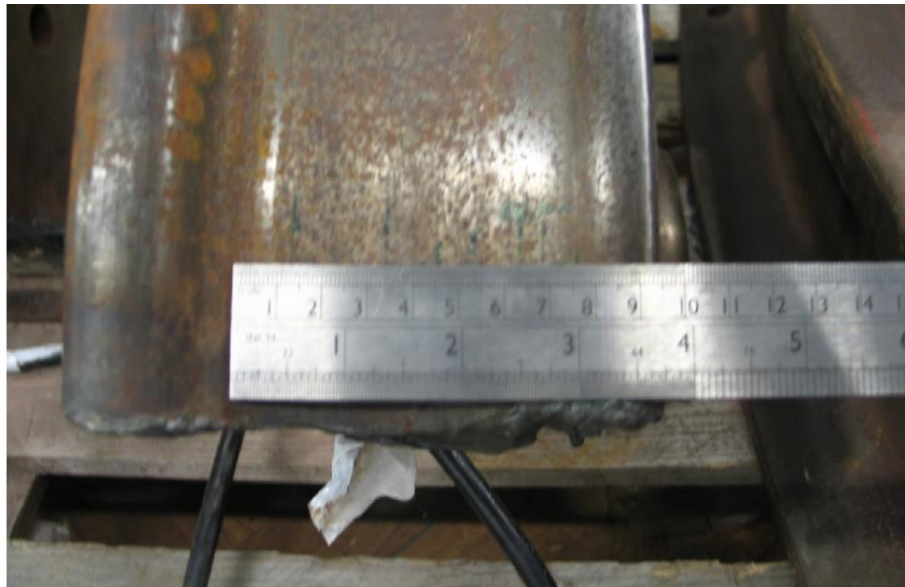
Figure 6.7 railway wheel HSR3 (wheel without visible defects).

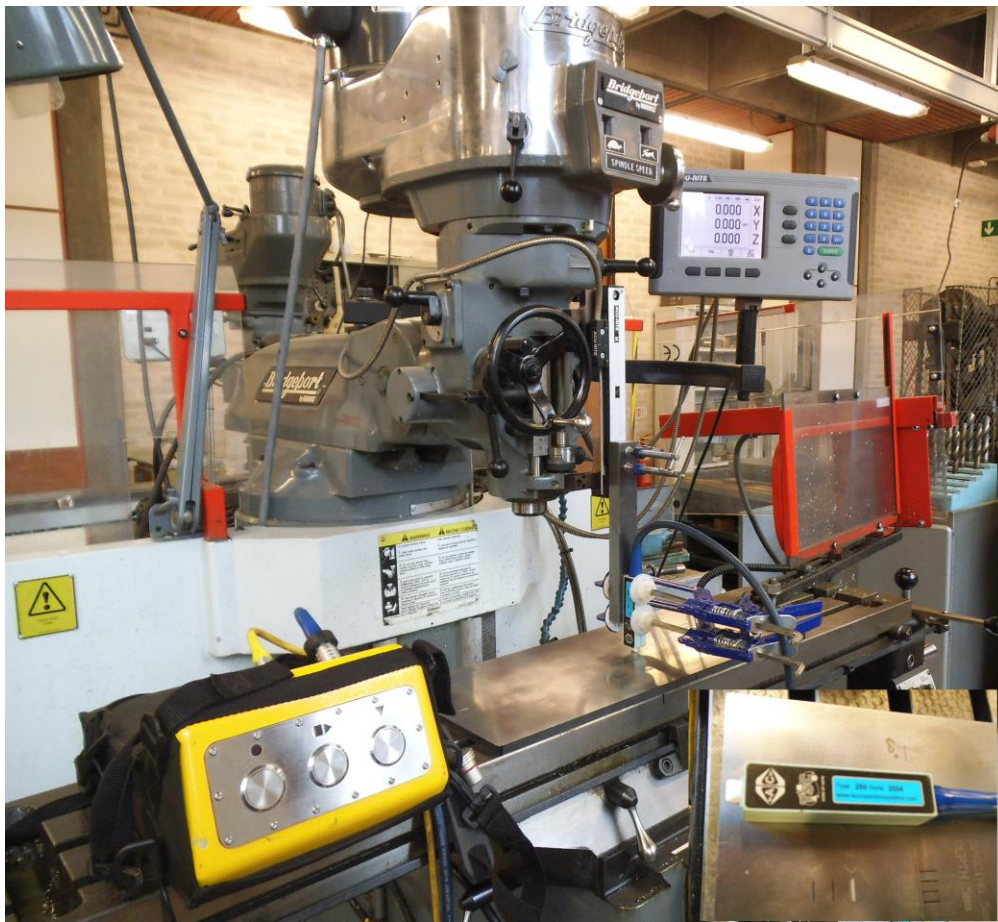
Figure 7.5 a digital photograph showing the ACFM system in the bottom left hand corner of the above image together with the probe (inset in the bottom right hand corner of the image).

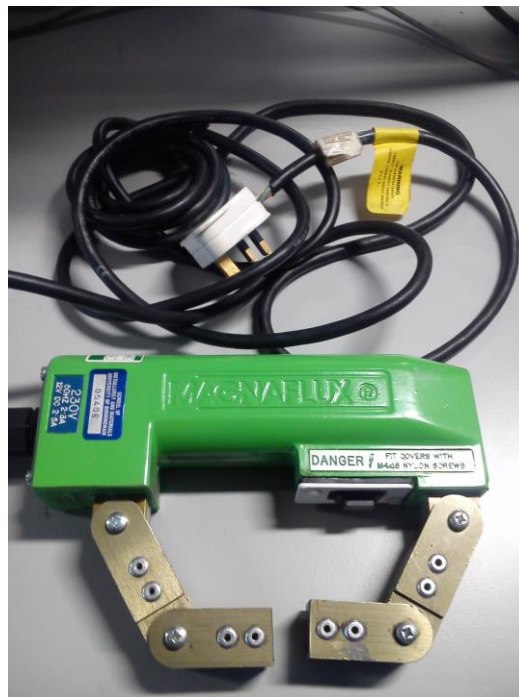
Figure 7.7 a digital photograph showing the magnetic particle inspection (MPI) system.

The magnetic particle inspection (MPI) method is a widely used as a non-destructive technique in various industries that is a fast, efficient and user friendly, inspection method utilised for the detection of defects in ferromagnetic materials. The system employs magnetic fields in conjunction with very small magnetic particles in order to detect defects in materials. The concept behind the MPI technique is that the material under inspection is initially magnetised and in the event that there is a crack present on and/or near the surface the defect will thus result in a leakage field [100-102]. Once the component has been magnetised then iron particles are applied onto the surface of the material's magnetised part under test either in a dry or wet suspended state by a sprinkling or spraying method. Consequently, the particles will be attracted and cluster at the flux leakage fields, thus forming a visible indication that can be inspected and analysed.

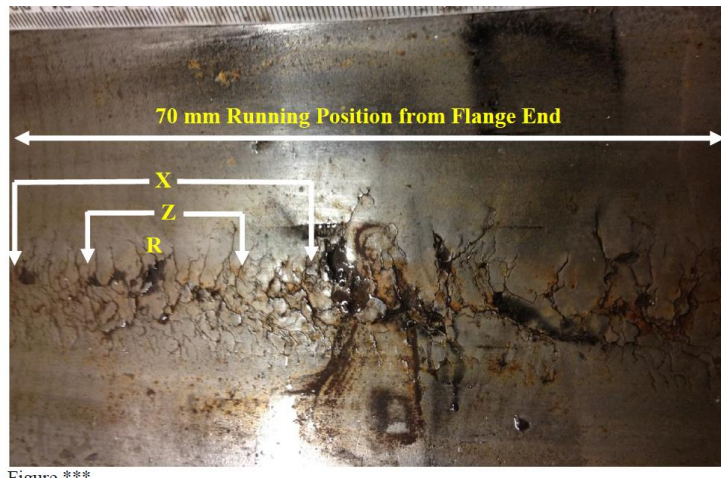
Figure 7.34 shows another image of the RCF prone region on the tread of wheel HSR1 showing the severe level of surface RCF damage that has occurred between 4 and 6 cm from the non-flange end of this wheel. Locations at which the subsequent ACFM scans (shown in the figures below) conducted on this wheel tread have been clearly labelled on the photograph.

Figures 7.35 (a)-(c) incl. above show ACFM (5 kHz) scans carried out in the RCF prone region on the tread of wheel HSR1 at the maximum run-out tread position as shown above in figure 7.34 demonstrating that the sensor is capable of detecting severely critical defects in railway wheels in service, however, the cracks are superimposed on one another and it is difficult to distinguish between the individual cracks due to the limits on the ACFM sensitivity.

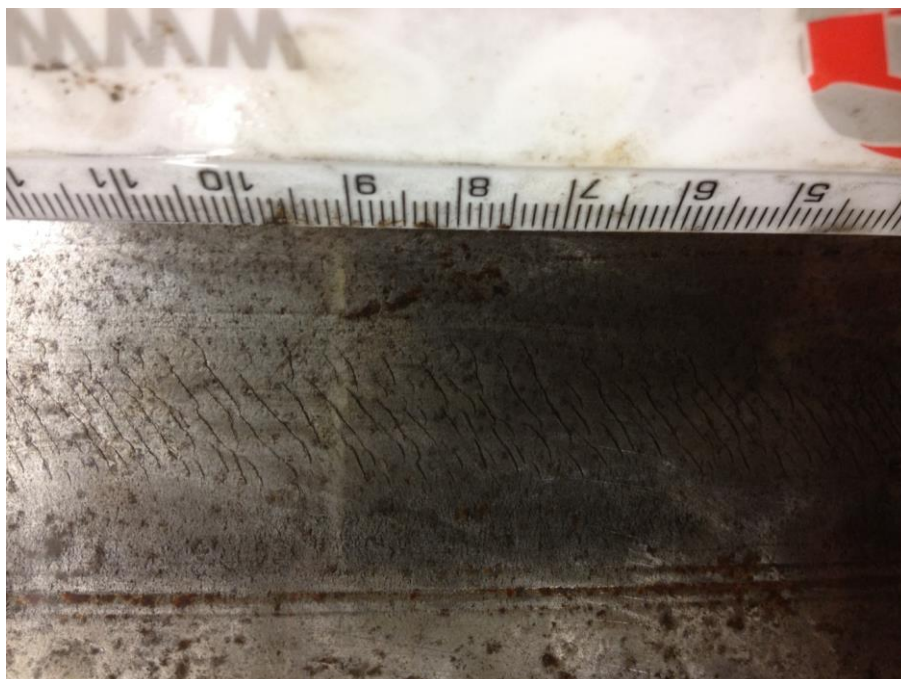
Figure 9.56 Fine cracks found near the flange end and across most of the entire circumferential length of the HSR2 railway wheel at a position of 9.0 cm from the non-flange end.

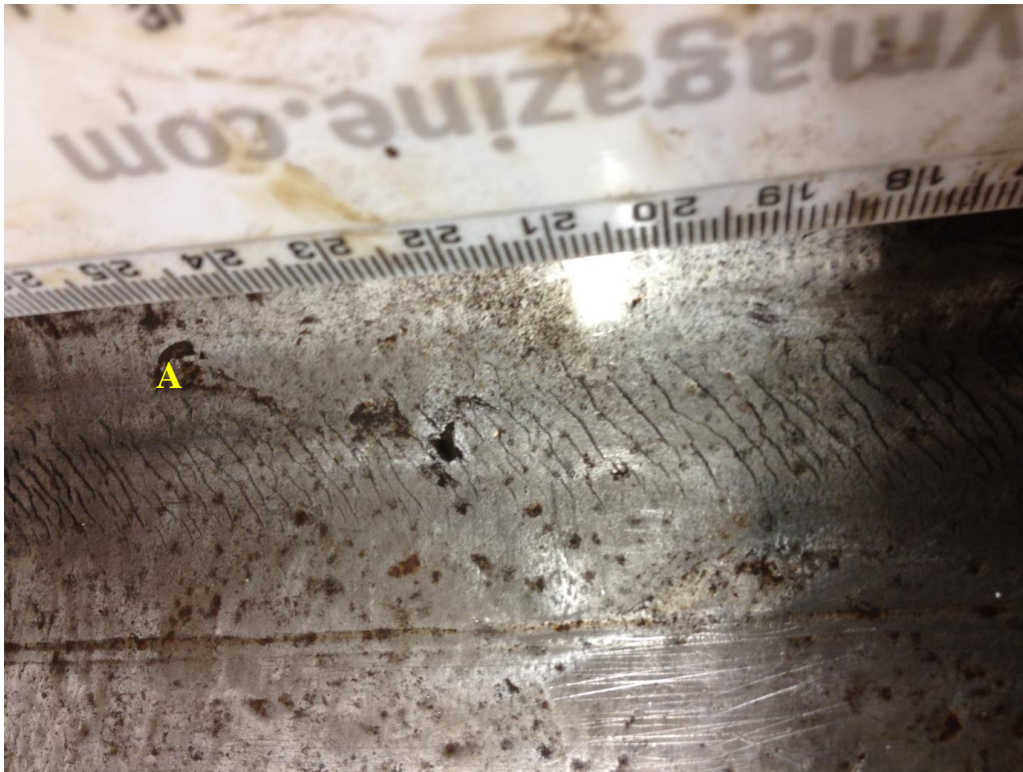
Figure 9.59 shows closely spaced and shallow cracks found near the flange of the HSR2 railway wheel and oriented approx. at 60° to the circumference of the wheel tread surface and present across most of the entire circumferential length of the wheel.

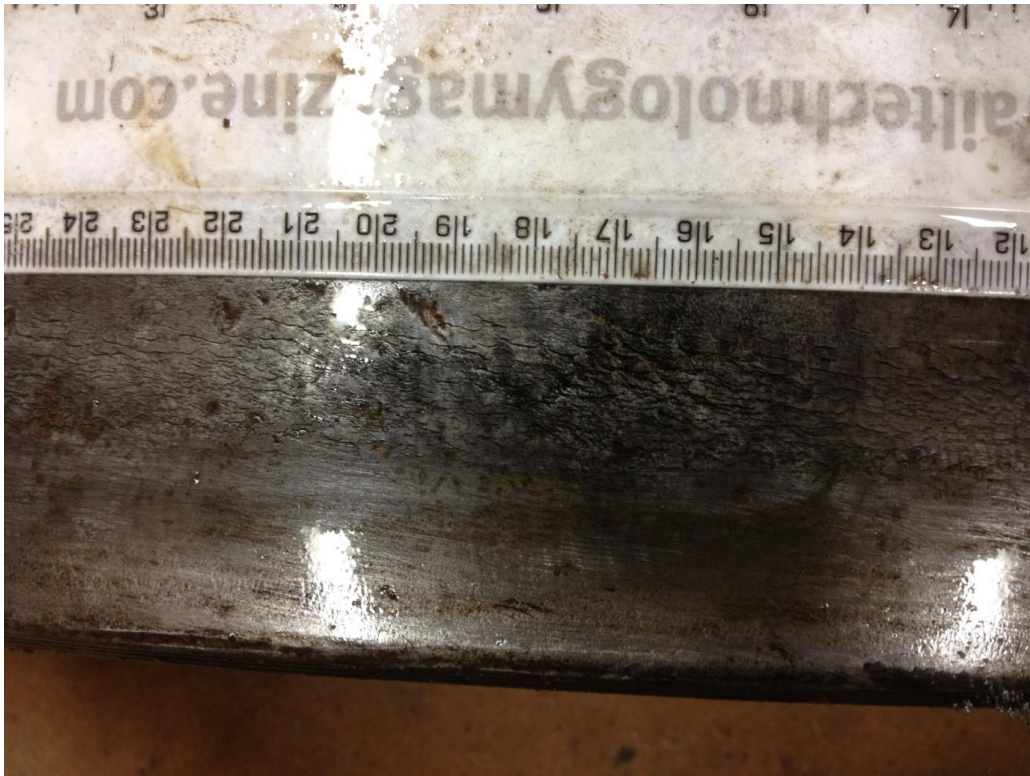
Figure 9.61 shows fine cracks found near the non-flange end of the HSR2 railway wheel and oriented approx. at 90° to the circumference of the wheel tread surface and present across most of the entire circumferential length of the wheel at a position of 3 cm from the non-flange end.

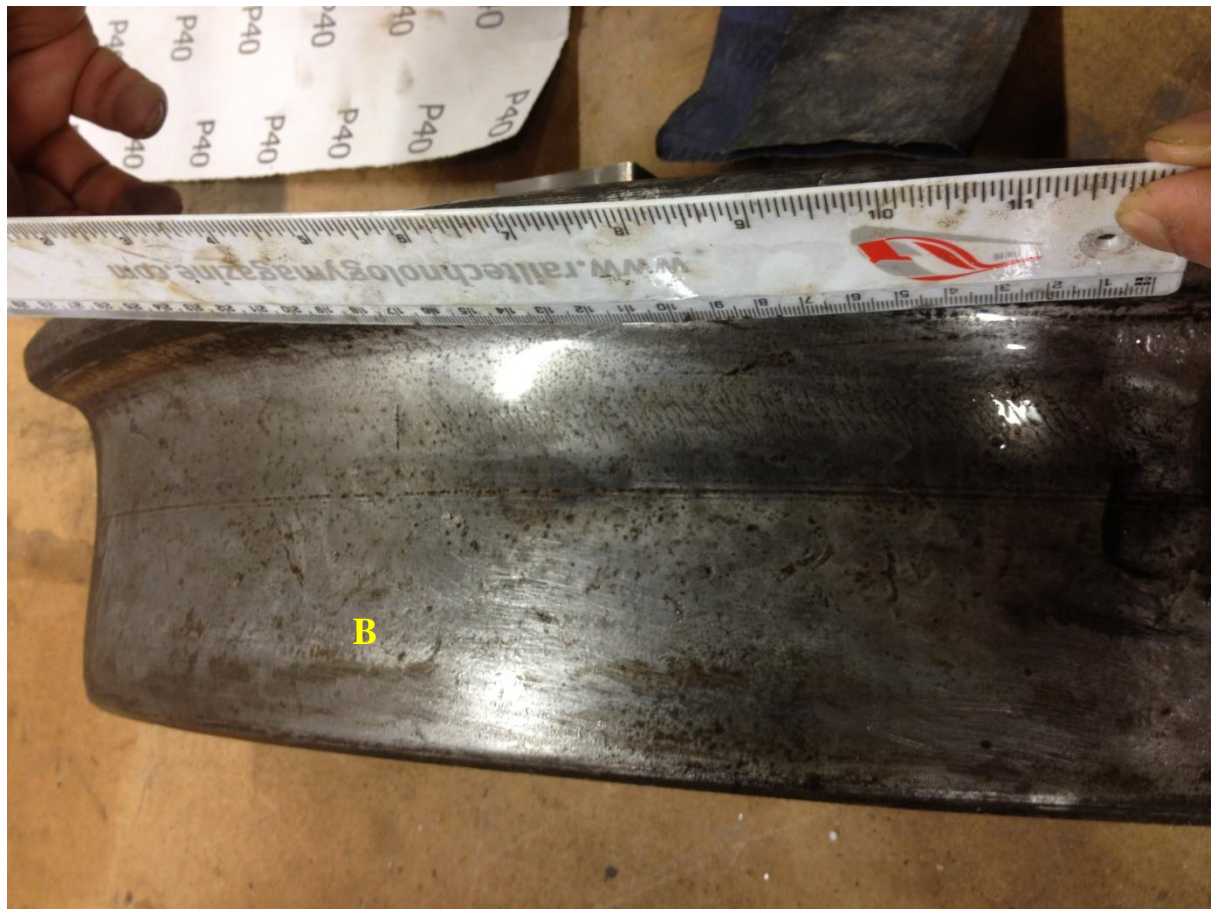
Figure 9.62 Feature B on railway wheel HSR2 scanned by ACFM.

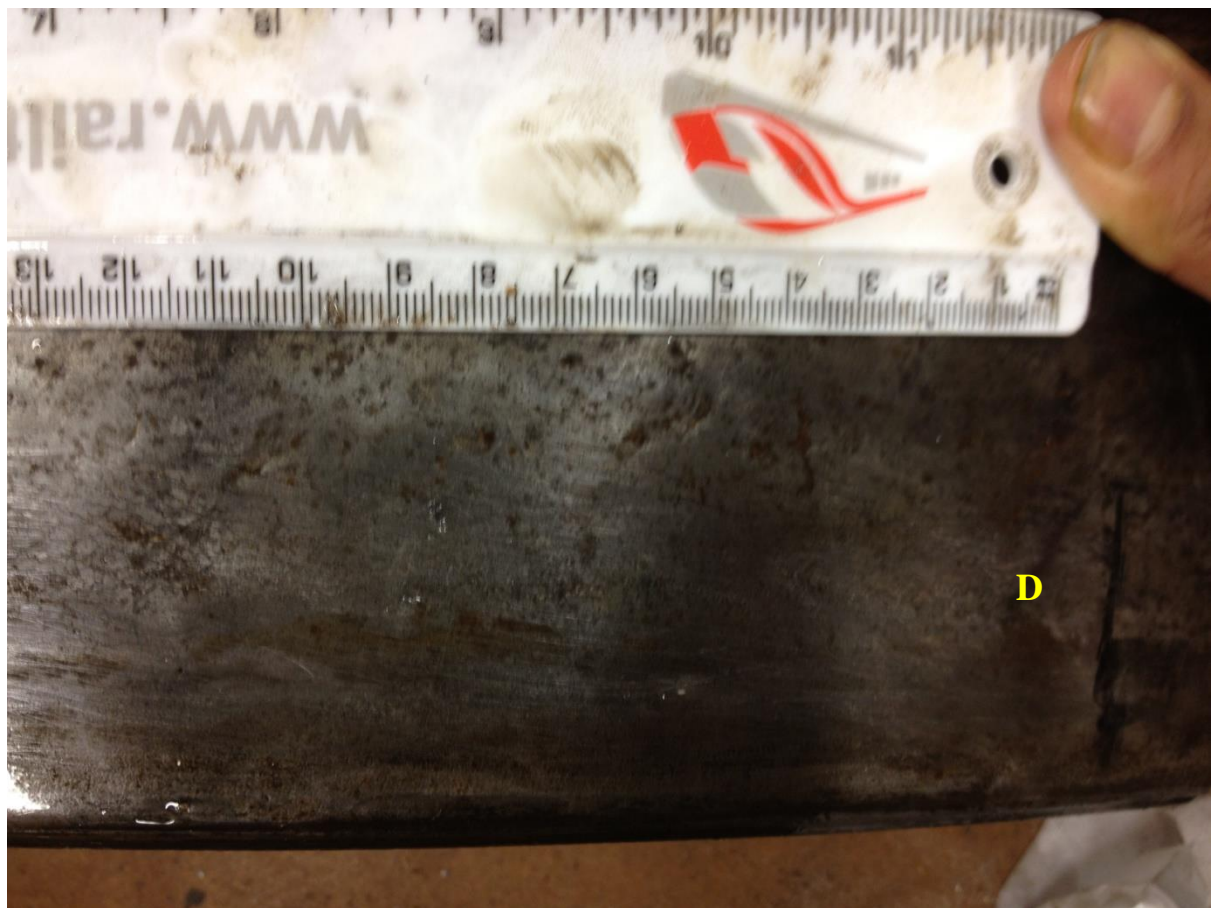
Figure 9.64 Feature D found on the tread of railway wheel HSR2 scanned by ACFM.

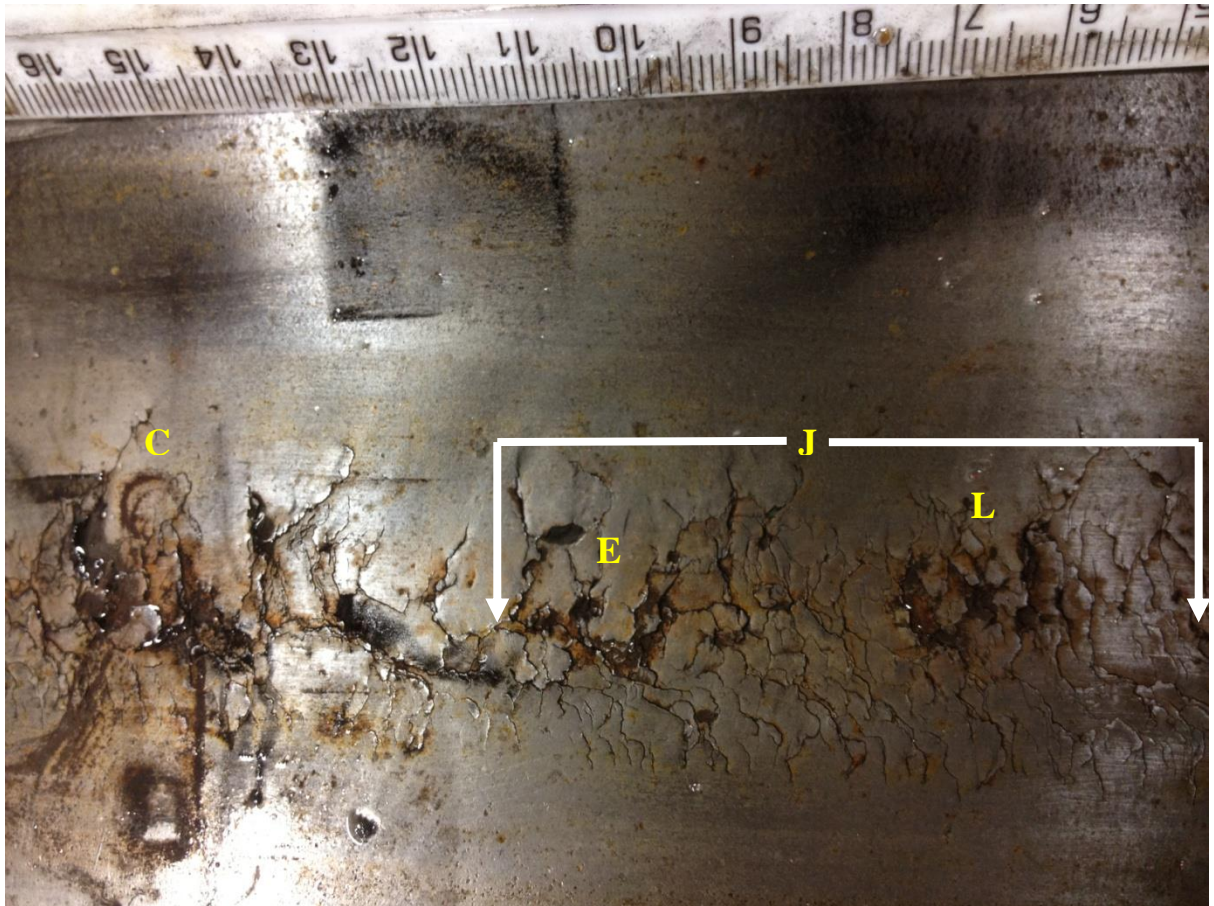
Figure 9.66 shows an image of the RCF prone region on the tread of wheel HSR1 showing the severe level of surface RCF damage that has occurred between 4 and 6 cm from the non-flange end of this wheel. Locations at which the subsequent ACFM scans (shown in the figures 9.65 and 9.66 below) conducted on this wheel tread have been clearly labelled on the photograph. Note that this figure is shown as figure 7.31 in chapter 7 of the PhD thesis above and has been reproduced here to keep it in context as it is part of this report and for the ease of the reader.

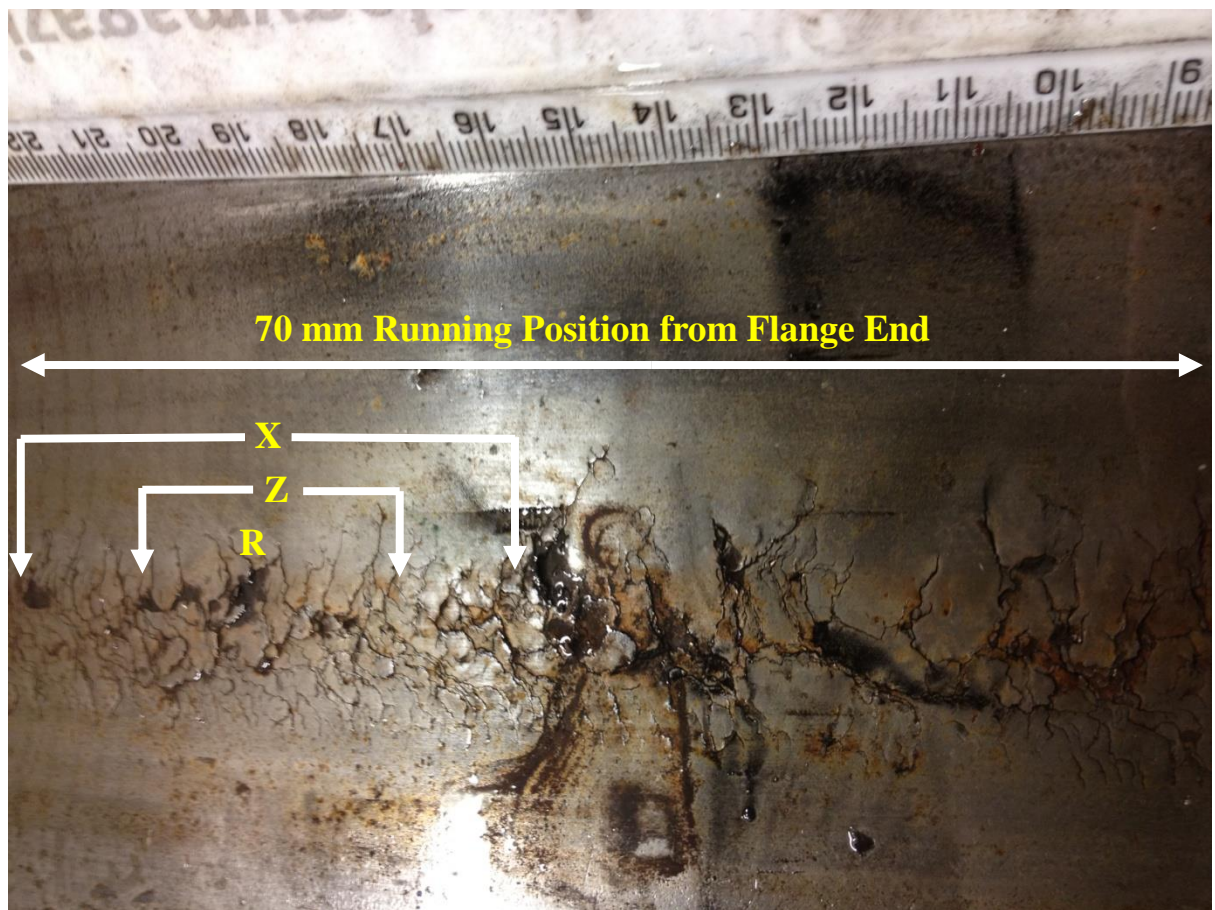
Figure 9.72 shows another image highlighting specific areas of the RCF prone region on the tread of wheel HSR1 showing the severe level of surface RCF damage that has occurred between 4 and 6 cm from the non-flange end of this wheel. Locations at which the subsequent ACFM scans (figures 9.71-9.73 incl. below) conduct+ed on this wheel tread have been clearly labelled on the photograph. Note that this figure is shown as figure 7.33 in chapter 7 of the PhD thesis above and has been reproduced here to keep it in context as it is part of this report and for the ease of the reader.
