**ACCELERATING THE THAUMASITE FORM OF
SULFATE ATTACK AND AN INVESTIGATION OF
ITS EFFECTS ON SKIN FRICTION**

A Thesis Submitted to
The University of Birmingham
for the Degree of
DOCTOR OF PHILOSOPHY

School of Civil Engineering
University of Birmingham
Edgbaston
Birmingham B15 2TT
December 2007

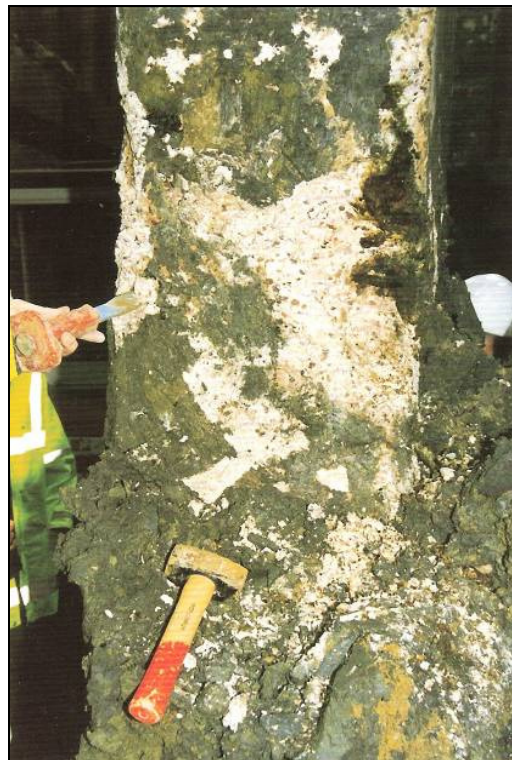
Figure 2.1 - Example of 29-year old bridge column exposed to wet, reworked Lower Lias Clay [1]

Although TSA has been recognised for many years it did not receive any serious attention from either industry or the research community until the discovery of 10 cases of the thaumasite form of sulfate attack in the foundations of overbridges along the M5 motorway in Gloucestershire in 1998 [27]. The seriously attacked columns (Figure 2.1) had been all buried in backfilled Lower Lias Clay and were discovered during strengthening works. In response to this discovery the UK Government convened the Thaumasite Expert Group (TEG) with ‘the remit to produce interim advice and guidance on the implications for existing buildings and structures and for the design and specification of new constructions in the UK’ [1].

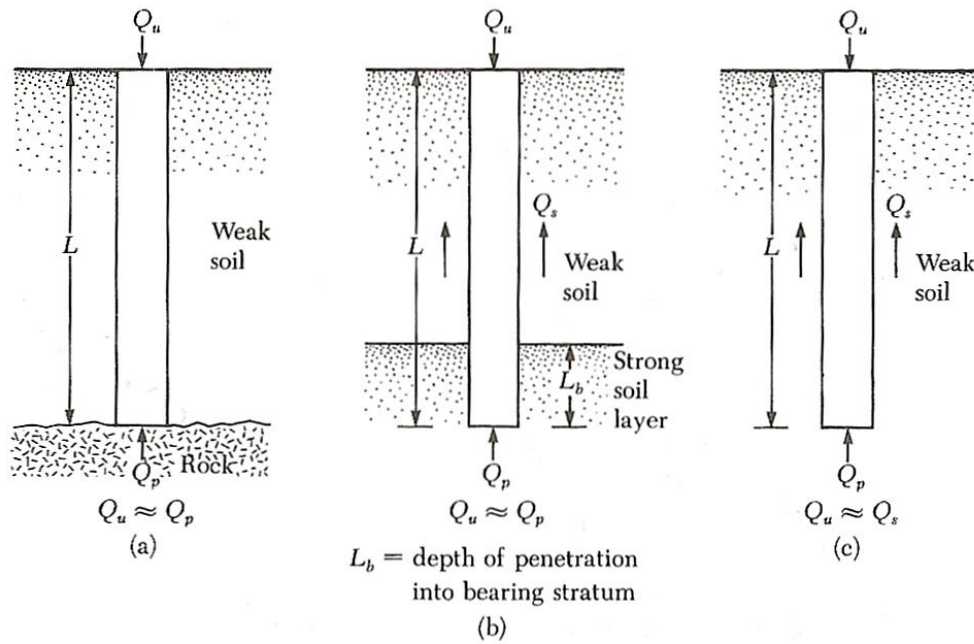
Figure 2.5 - Pile categories: (a) and (b) point bearing piles; (c) friction piles [113]

Deep foundations which encompass piles, drilled piers and caissons are mainly subjected to an axial compressive load and the load transfer to the ground is achieved through skin friction, end-bearing capacity or a combination of both. Drilled piers and caissons are designed as end-bearing members and the side friction is neglected. Piles can be differentiated between friction and end-bearing piles; however, the load capacity is derived from a combination of end-bearing and skin friction [112].

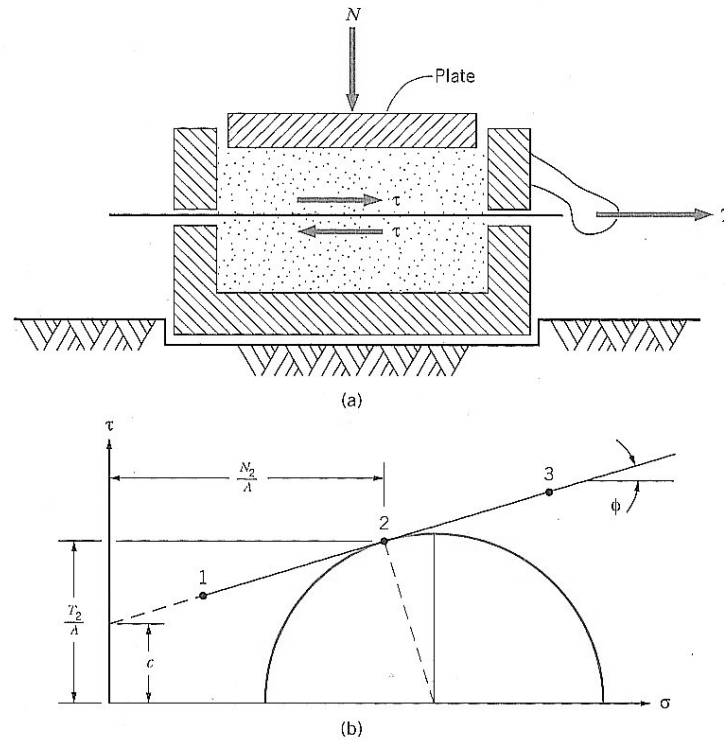
Figure 2.6 - (a) Schematic direct shear apparatus (b) Representation of results using Mohr circle [111]

The parameters relevant for the estimation of the frictional resistance, such as the shear strength parameter, internal friction ' ϕ ' and cohesion ' c ', of soil are determined experimentally using different shear strength tests in the laboratory. These are the direct shear test, the triaxial compression test and the unconfined compression test [111]. The direct shear test is a simple and widely used test for the determination of the shear strength parameter of the soil itself and of skin friction at interface systems. The direct shear test is relevant to the current investigation.

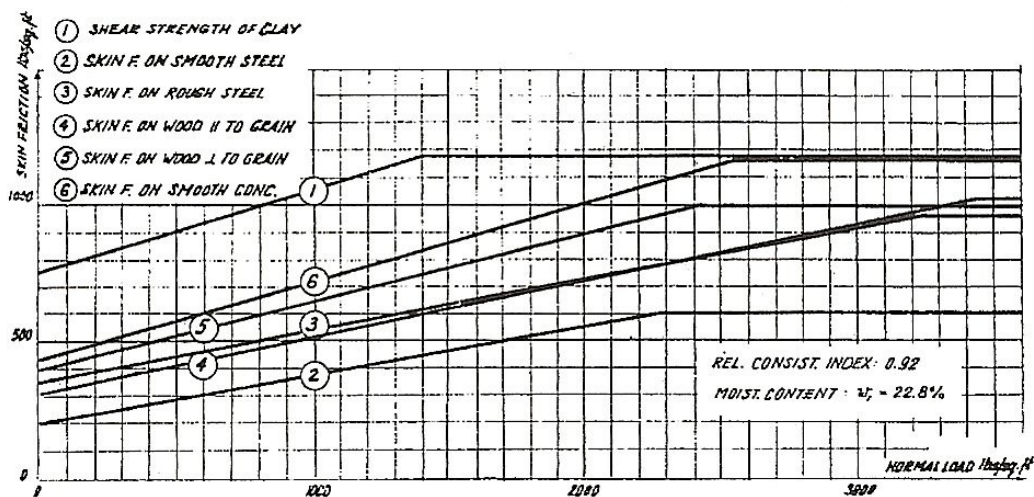
Figure 2.7 - Skin friction/normal load relationship of clay [122]

The investigation of skin friction on concrete-clay showed that after a certain increase of normal load the skin resistance achieved a constant value, see Figure 2.7, and the maximum shearing strength on smooth concrete reached nearly the strength of the clay itself. In every other case the skin friction was lower than the shearing strength of the soil, Table 2.6. Furthermore Potyondy calculated the relative changes of the shear strength parameters at the interface (δ , c_a) to the parameter obtained from the pure clay (ϕ , c), $\frac{\delta}{\phi}$ and $\frac{c_a}{c}$ (Table 2.6). This showed reduced shear strength at interfaces. Based on this Potyondy [122] concluded that the skin friction values should be reduced in cases where the skin friction is responsible for the bearing capacity. It should be noted, however, that these tests were performed without allowing long term interactions between construction material and soil.

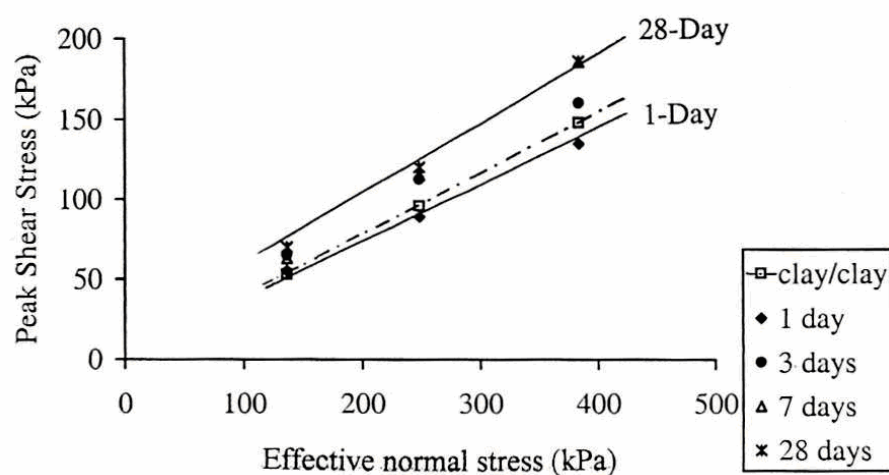
Figure 2.8 - Skin friction/normal load relationship of concrete/clay interface depending on curing time [126]

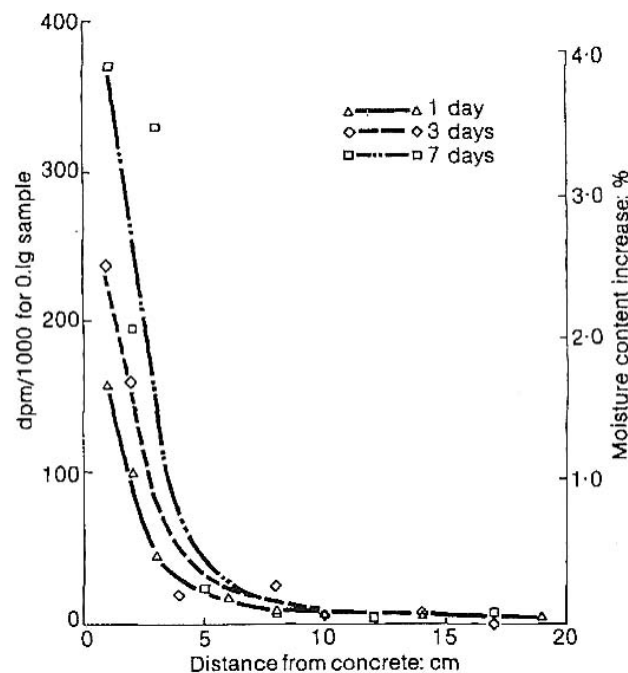
Figure 2 9 - Moisture content increase according to Milititsky et al. [138]

Investigations on soil-structure interactions have been performed by several authors. Milititsky et al. [138] investigated the moisture movement between fresh concrete and clay where they observed an increase in moisture content of up to 4% after 7 days, Figure 2 9. Furthermore they confirmed the findings of several researchers [139-141] that the moisture content increase falls off rapidly as the sampling point moves away from the interface.

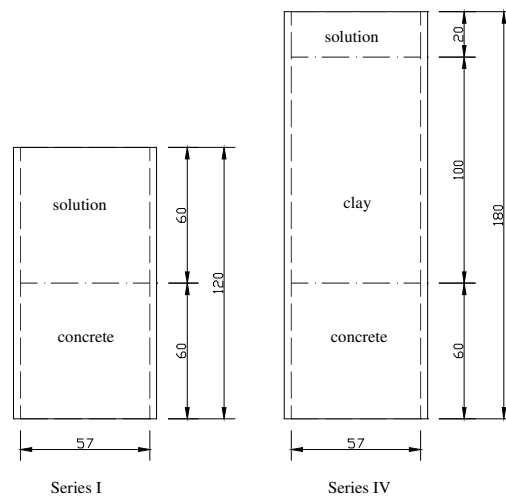
Figure 3.1 - Specimen type for Series I (left) and Series IV (right)

Series I specimens were cylindrical with an internal diameter of 57mm and a height of 120mm and were filled with concrete to about 60mm and, after 28 days curing, were immersed into one of two solutions – sulfate, as magnesium sulfate, or carbonate-sulfate (MgSO₄) solution. A typical Series I specimen is illustrated in Figure 3.1. The progress of deterioration was determined from the surface inwards towards using a needle apparatus which is described in Section 3.2.1.

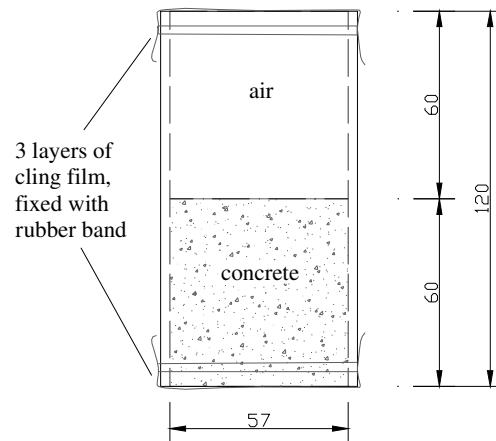
Figure 3.4 - Principal curing arrangement of Series I specimens

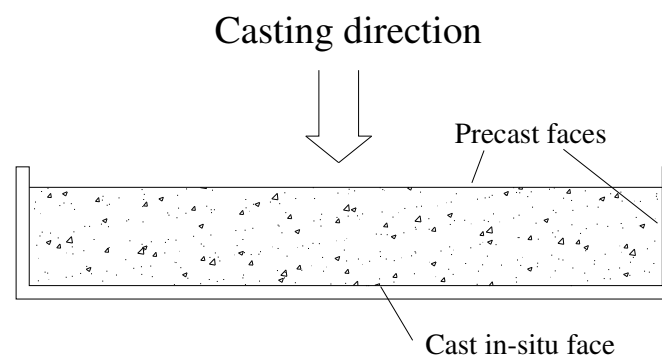
Figure 3.5 - Casting surfaces

The second method of casting involved placing the clay first and casting the concrete directly against it. This method has been called cast in-situ (CS) and models the direct casting of foundations or other structural elements in the field. It should be noted that the clay against which the concrete in the in-situ specimens was cast not undisturbed but had been taken from a stockpile of weathered material and then placed into the mould and compacted in three layers. In the in-situ specimens the bottom cast face is in contact with the clay whereas in the pre-cast specimens the backfill clay is placed against the top cast face. Figure 3.5 illustrates the casting faces.

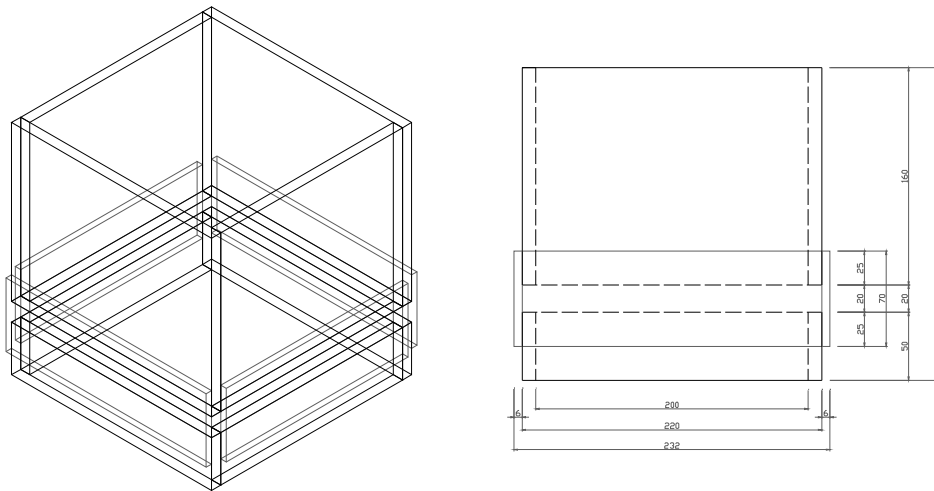
Figure 3.7 - Shear test specimen

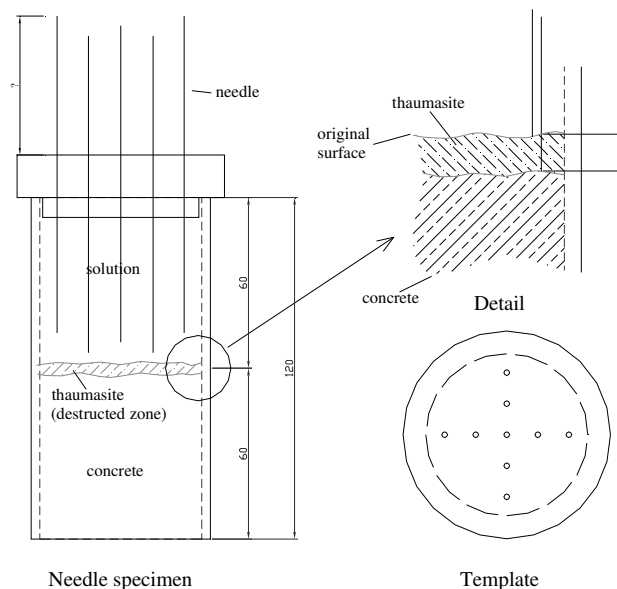
Figure 3.10 - 'Needle'-test apparatus

Manual measurement of the depth of attack was performed using a needle test rig where the depth of the deterioration was measured with a needle at nine defined points on the specimen's surface. Formation of thaumasite causes the cement matrix to change into a soft white paste which, in the initial stages, causes the surface of the concrete to heave. The depth of deterioration was determined by pushing the needle into the concrete until solid concrete was reached and measuring the movement relative to a zero measurement describing the distance between template and needle end taken at the start of the investigation period. Illustrations of the test rig are shown in Figure 3.10 to Figure 3.12.

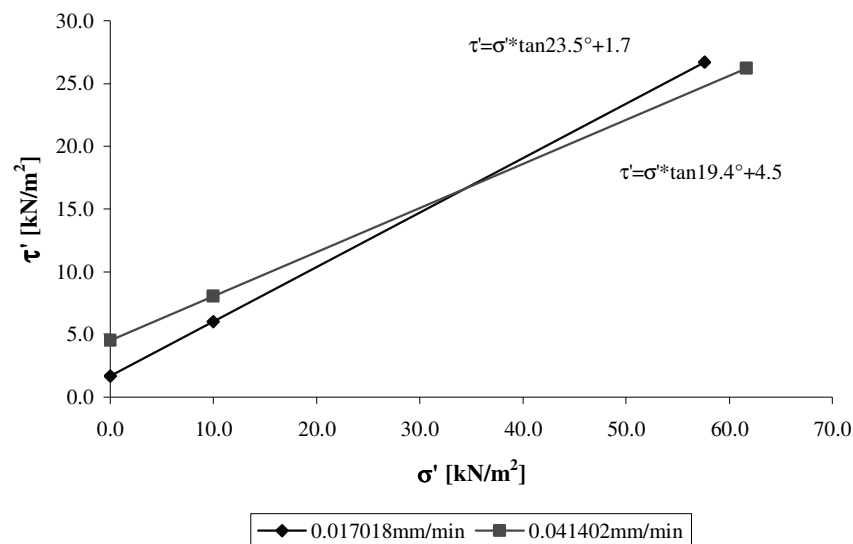
Figure 3.17 - Peak shear strength of trial tests with different rates

A second parameter for this condition is that the test has to be performed very slowly to avoid development of new pore pressure. However, the test had to be completed in reasonable time and therefore a rate of 0.041402mm/min was chosen this corresponds to a displacement of 15mm in about 6 hours excluding the one hour for re-consolidation. The testing rate varied by about $\pm 5\%$. Preliminary tests at different rates of 0.017018 and 0.041402mm/min were undertaken to determine the effect of rate on shear strength. During these tests it was observed that there was a slight difference in the peak shear strength as shown in Figure 3.17; however, the residual shear strength was the same for both rates, this is illustrated in Figure 3.18.

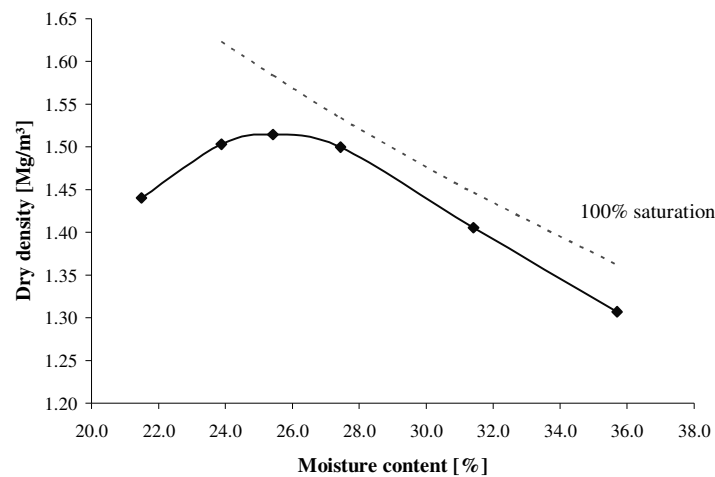
Figure 3.20 - Dry density/moisture content relationship - English China Clay

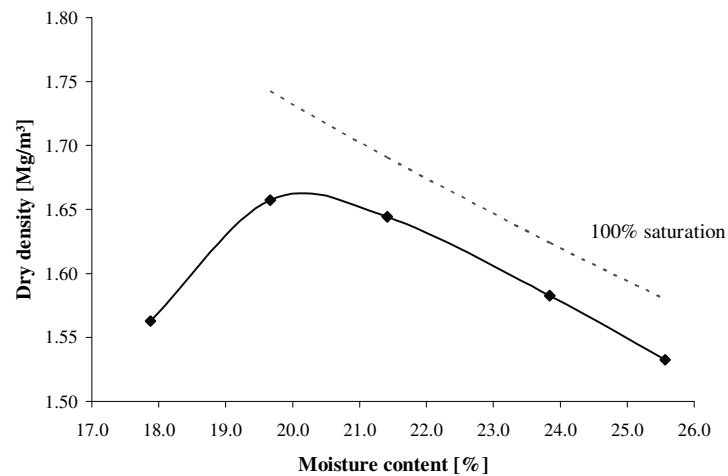
Figure 3.21 - Dry density/moisture content relationship – Lower Lias Clay

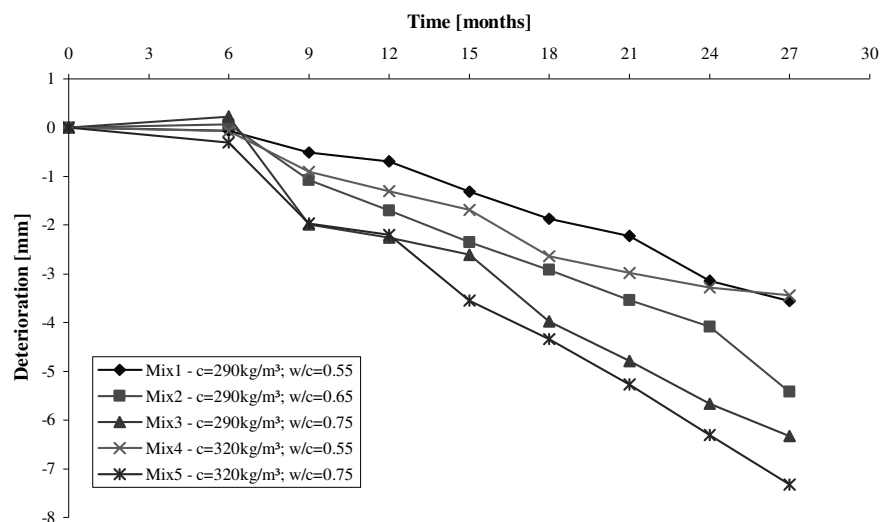
Figure 4.1 - Thaumasite progress in 1.8% sulfate solution depending on mix design

The test specimens used for this part of the investigation were the cylindrical Series I specimens consisting of only concrete and aggressive solution. These and the methodology adopted are described in more detail in Section 3.1.2.1.

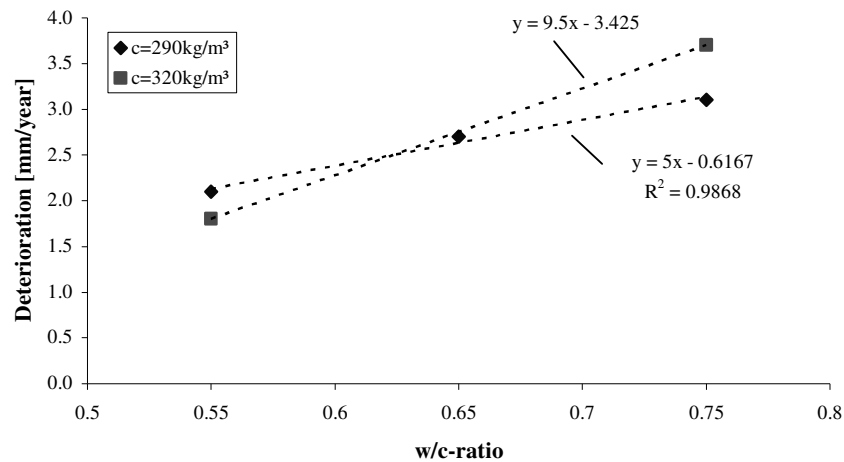
Figure 4.2 - Relationship between w/c ratio, cement content and deterioration, SO₄-solution

cement content was found to have a lower resistance than that with the low cement content. It is suggested that this phenomenon is caused by the increased porosity, i.e. the increase in cement to aggregate ratio caused by increasing the cement content at a given w/c-ratio results in a relative increase in the area of cement paste in the concrete and, hence, an increased susceptible surface. However, the opposite effect which is important for structural engineering that high quality concretes are less susceptible is confirmed based on the trend of the graphs in Figure 4.2.

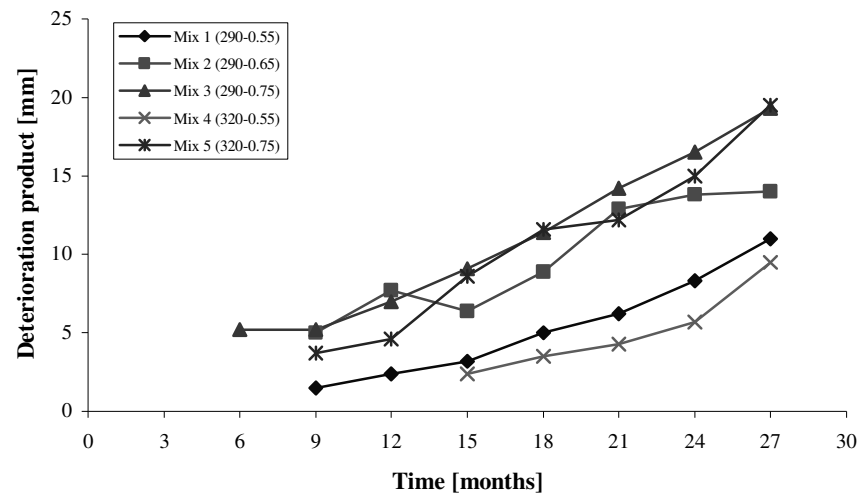
Figure 4.9 - Development of amount of deterioration product, SO_4 -solution

Measurements of the height of the deterioration products were undertaken and similar trends to the deterioration in pure SO_4 -solution were obtained, however, the difference between Mix 3 and Mix 5, which differed in the cement content, were more significant, Figure 4.16. Mix 5 with the higher cement content exhibited lower total expansion compared to Mix 3 in the combined solution and Mix 3 and 5 in the pure sulfate solution, see Figure 4.9.

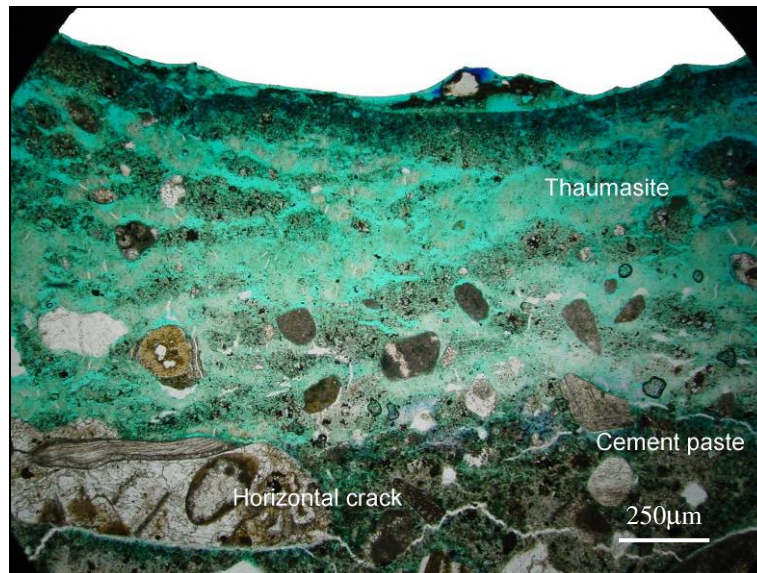
Figure 4.10 - TSA attack of surface area after 9 months, plane polarised light (PPL)

cement paste remain. Below this brighter zone and until the large horizontal crack the cement paste is less affected, however, a system of small cracks is visible. The horizontal crack can be assumed as boundary between Zone 1 and 2 because only little deposits of thaumasite (TF) which are typical of Zone 1 were found below and in a close vicinity to this crack.

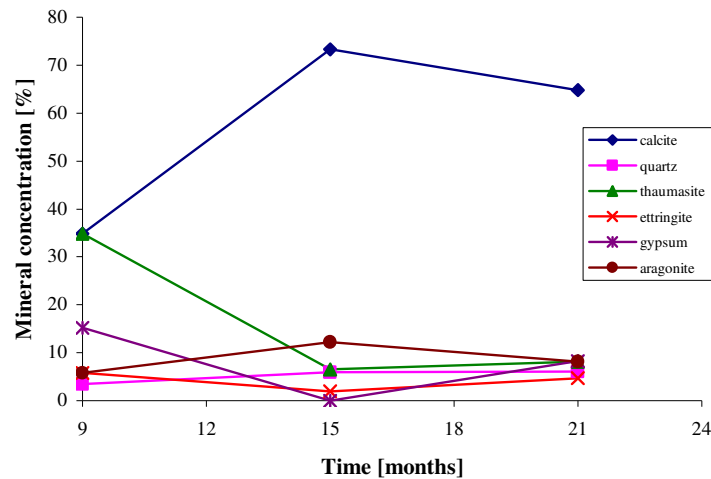
Figure 4.11 - Development of mineral concentration at Mix 2 (290-0.65) samples, SO₄-solution

X-ray diffraction analyses confirmed the presence of the main reaction product thaumasite in all samples tested at an ages of 9, 15 and 21 months. Besides the typical cement hydration products such as calcite, quartz and ettringite [28, 86] reaction products due to TSA such as the sulfate-bearing minerals secondary ettringite and gypsum as well as aragonite were detected. The development of a typical mineral concentration of one mix design using semi-quantitative analysis is represented in Figure 4.11. Further X-ray diffraction analyses are illustrated in Appendix C.

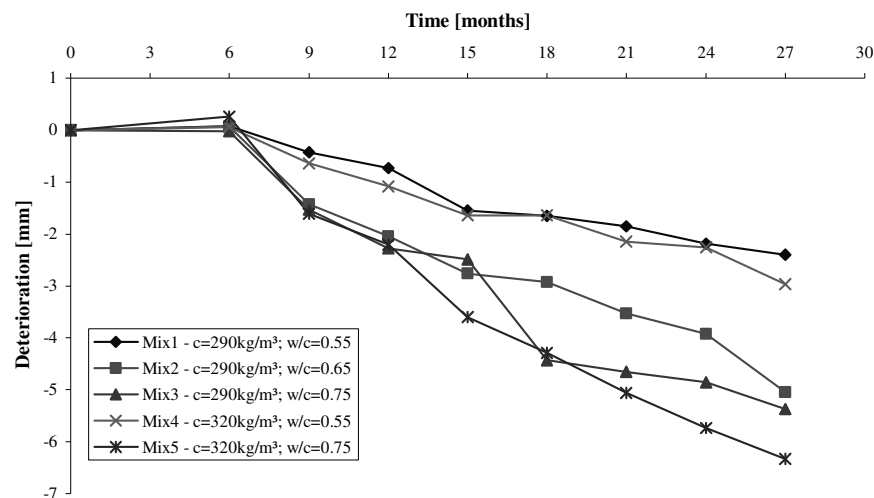
Figure 4.12 - Thaumasite progress in combined sulfate-carbonate solution depending on mix design

The aim of this part of Series I was to investigate the effect of two different aggressive solutions on the rate of TSA. The results of concrete immersed into a pure 1.8% SO_4^{2-} solution (as MgSO_4) are presented in Section 4.2.1 and are extended with the use of a combined sulfate-carbonate solution (1.8% SO_4^{2-} + 370mg CO_3^{2-} /l) in this section. The progress of TSA during an observation period of 27 months is illustrated in Figure 4.12.

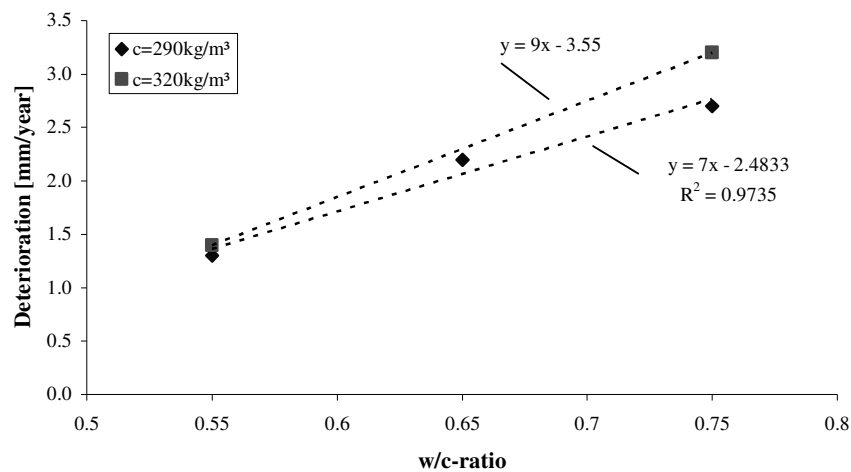
Figure 4.13 - Relationship between w/c ratio, cement content and deterioration, SO_4 - CO_3 -solution

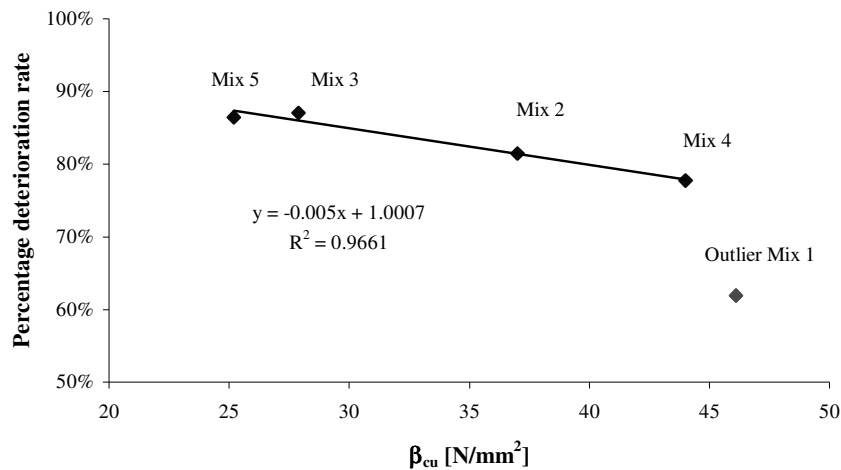
Figure 4.14 - Percentage rate of deterioration in SO₄-CO₃-solution compared to the SO₄-solution

was reduced to 60-90% of the rate measured in the 1.8% sulfate solution. The highest reduction to 60% occurred in the Mix 1 specimens, this reduction is considered as an outlier which is clearly shown based on the regression in Figure 4.14. On the other hand Mix 1 could also show the trend of a curve. Excluding the Mix 1 value there was a clear linear dependency of the deterioration rate in the combined sulfate-carbonate solution on the compressive strength. Specimens in the combined sulfate-carbonate solution deteriorated 5% per 10N/mm² increasing strength slower than specimens in the pure sulfate solution, i.e. the additional carbonate decelerated the deterioration in concretes with less permeability. It is suggested that excess supply of carbonate favoured the precipitation of calcite in the concrete pores hence the density of the cement matrix increased and the transportation of aggressive sulfate ions was reduced. A lower amount of additional carbonate in solution may enhance the rate of deterioration. The optimum carbonate content in solution for the acceleration of TSA should be investigated in future work.

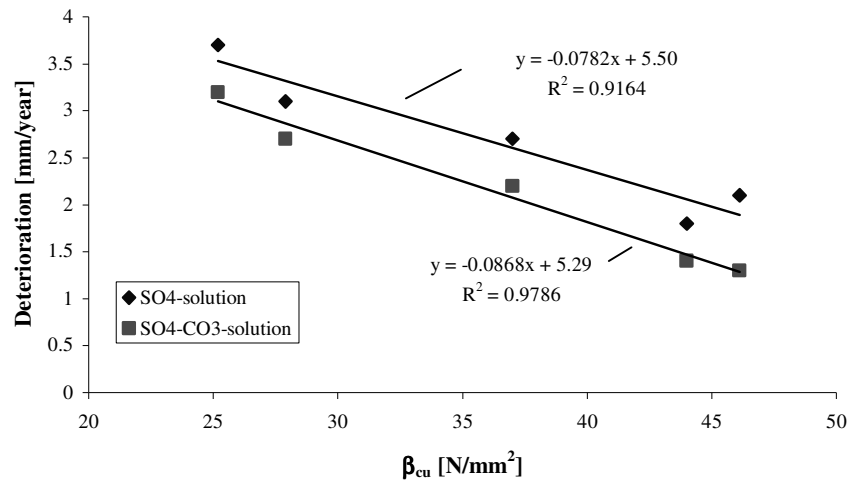
Figure 4.15 - Relationship between compressive strength and annual deterioration

In order to summarise the dependency between mix design, type of solution and rate of deterioration a relationship of annual deterioration to the concrete compressive strength was established. Due to the linear dependency between the rate of deterioration ‘y’ and w/c-ratio, $y \propto w/c$, as well as the dependency between compressive strength β and the w/c-ratio, $\beta \propto 1/w/c$, there exists a relationship between deterioration and the compressive strength, $y \propto 1/\beta$, as illustrated in Figure 4.15.

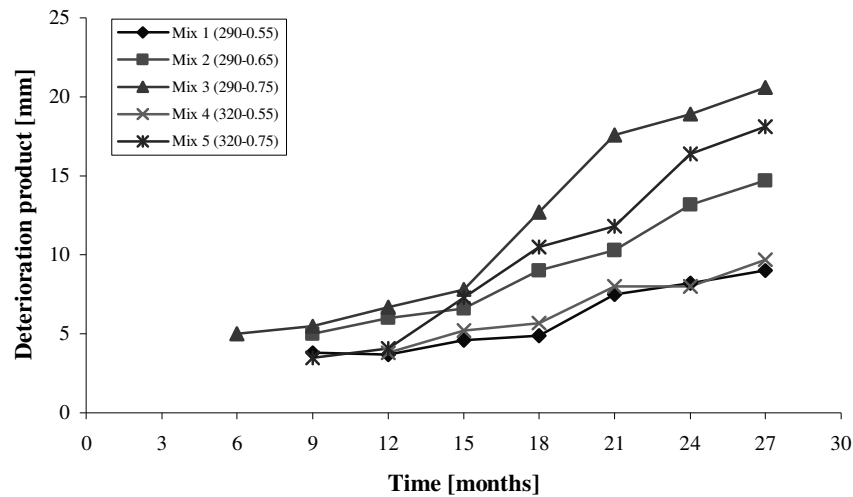
Figure 4.16 - Development of the amount of deterioration product, $\text{SO}_4\text{-CO}_3$ -solution

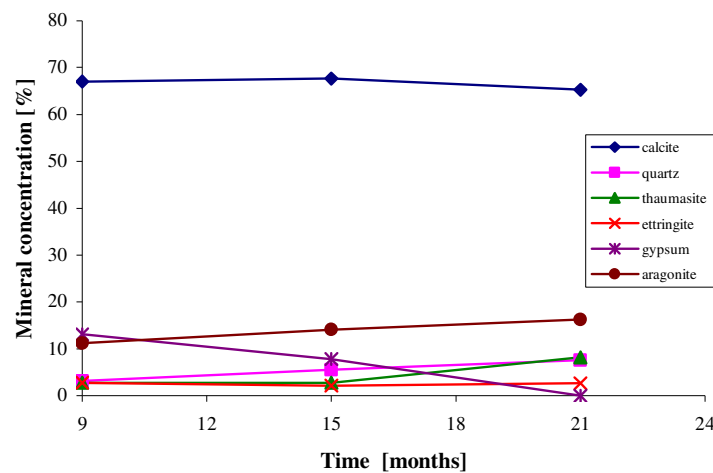
Figure 4.17 - Development of mineral concentration at Mix 2 (290-0.65) samples, $\text{SO}_4\text{-CO}_3$ -solution

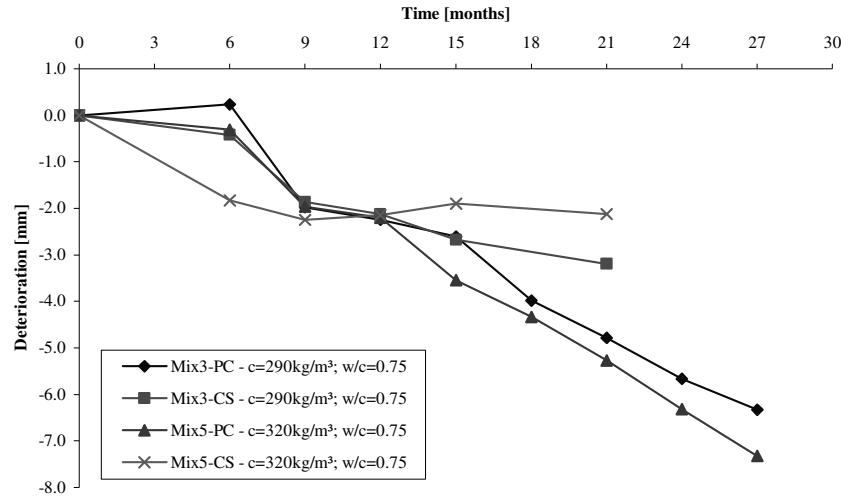
Figure 4.18 - Thaumasia progress in 1.8% sulfate solution depending on casting position

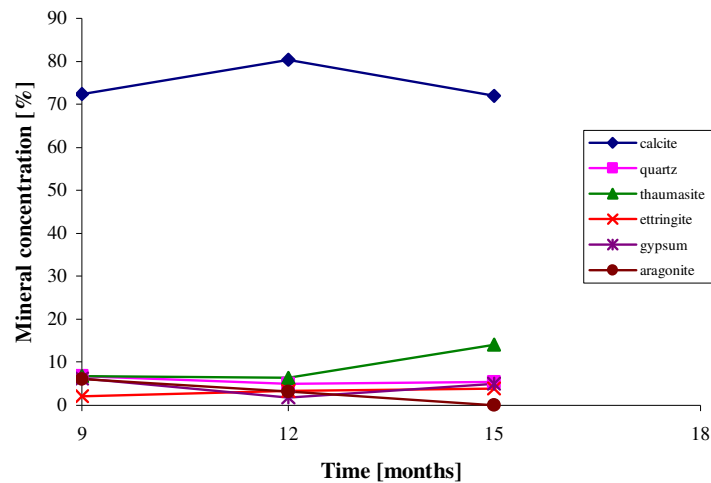
Figure 4.21 - Development of mineral concentration at Mix 5-CS (320-0.75) samples

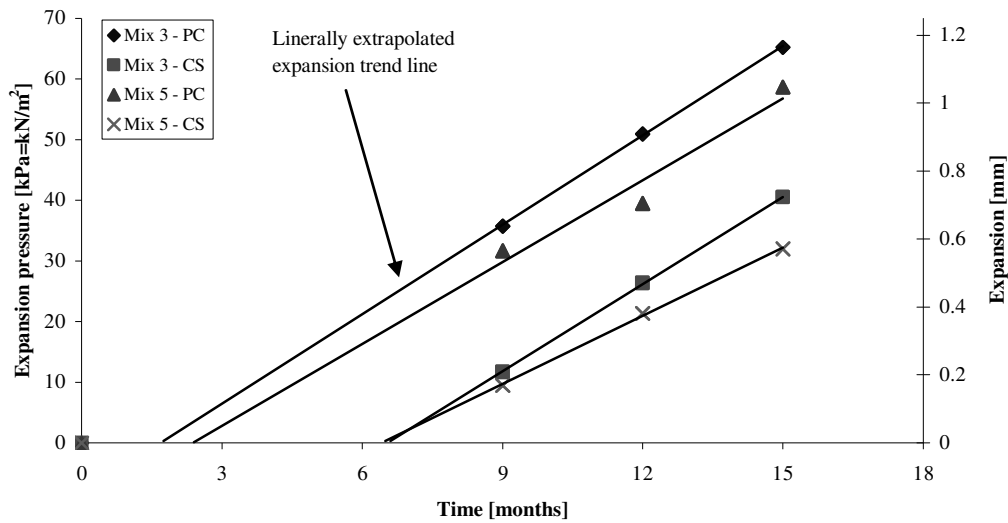
Figure 4.22 - Pressure development due to TSA

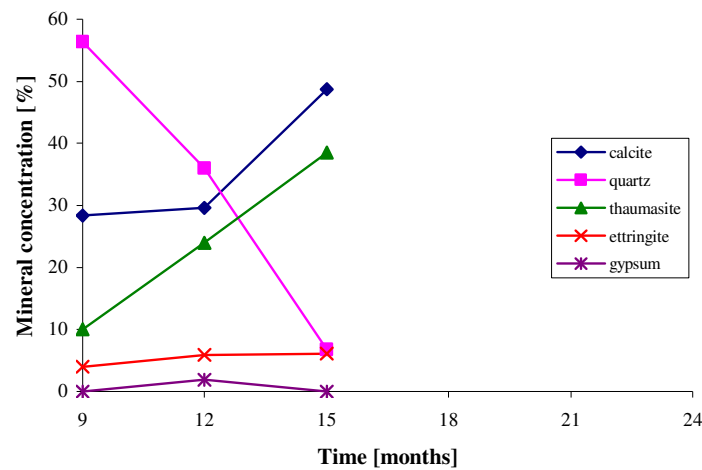
Figure 4.23 - Mineral concentration of Mix 3 - PC (290-0.75) samples, restrained

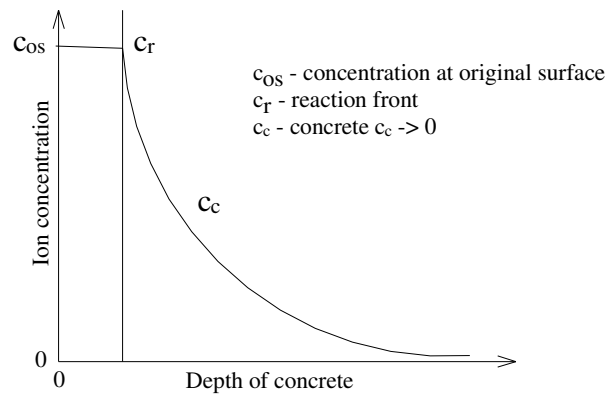
Figure 4.27 - Ion diffusion into TSA affected concrete

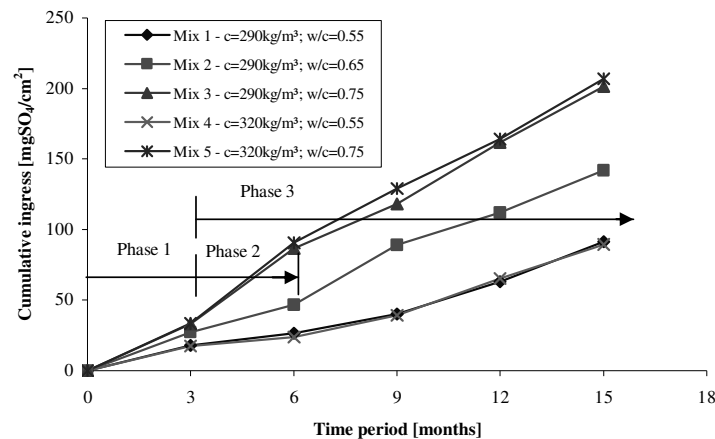
Figure 4.28 - Cumulative ingress of SO_4 over precast surface in 1.8% SO_4 solution

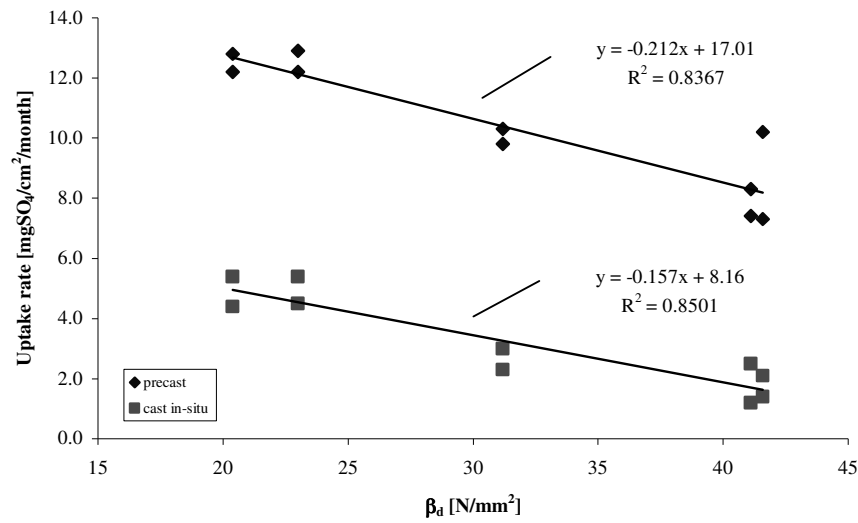
Figure 4.32 - Relationship between sulfate uptake rate and concrete compressive strength for SO₄- and SO₄-CO₃-solution

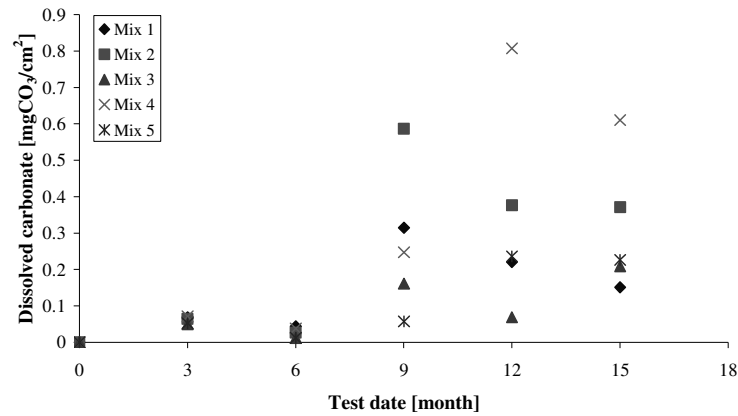
Figure 4.34 - Carbonate exchange concrete-distilled water, 3monthly renewed

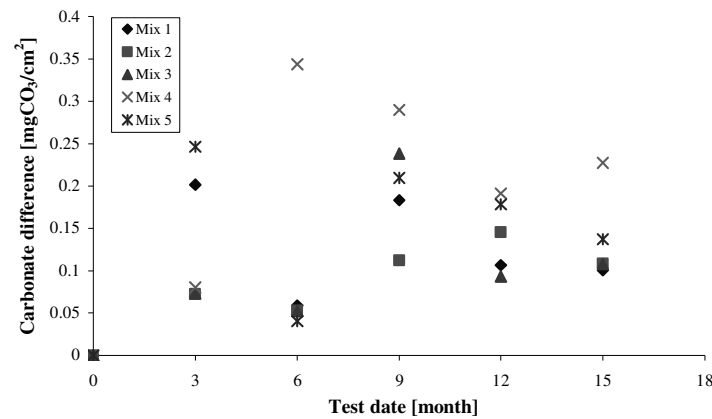
Figure 4.37 - Change of carbonate content in System II, precast surface

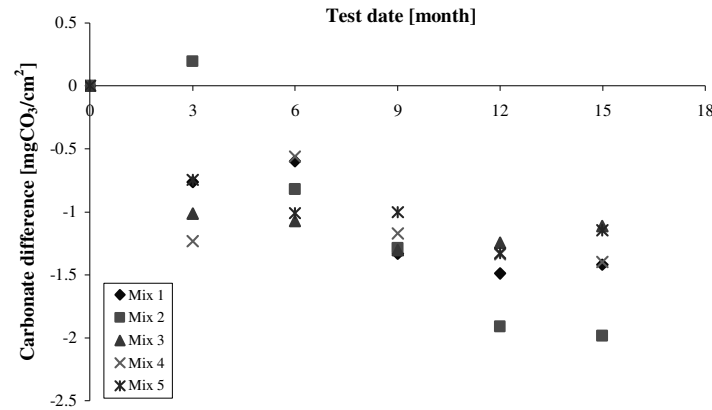
Figure 4.41 - Change of carbonate content in System III, precast surface

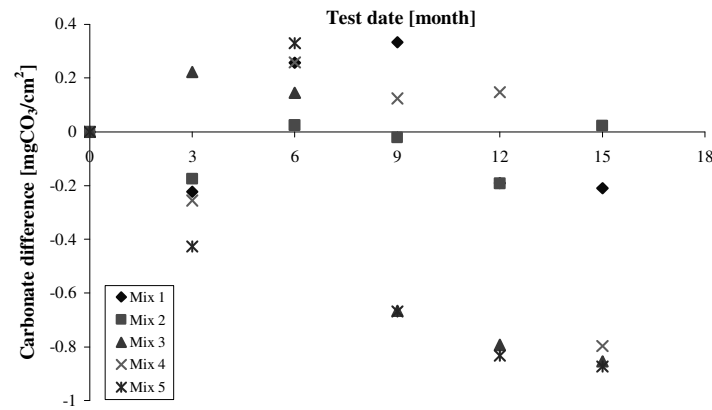
Figure 4.42 - Change of carbonate content in System III, cast in-situ surface

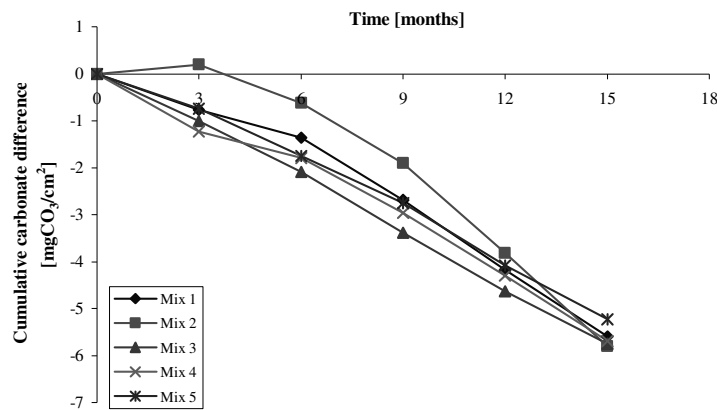
Figure 4.43 - Cumulative carbonate difference in System III , precast surface

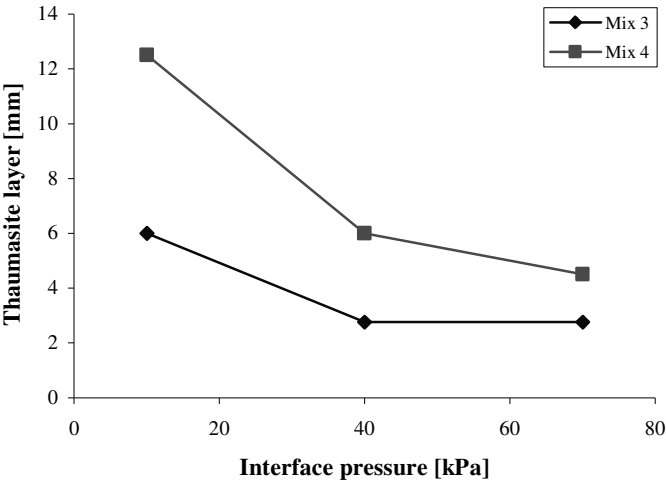
Figure 5.1 - Relationship thaumasite formation-pressure at 27th month, LLC-precast

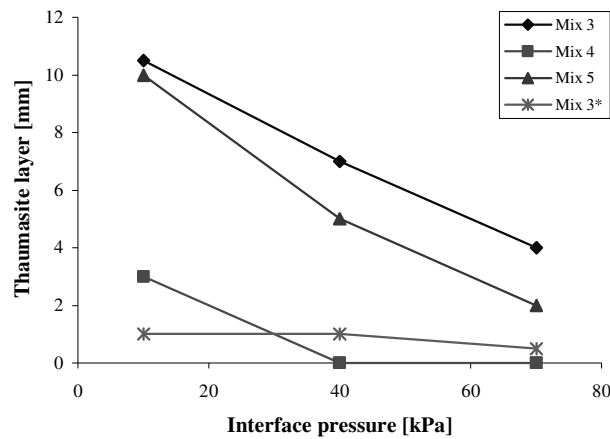
Figure 5.4 - Relationship thaumasite formation-pressure at 27th month, ECC-cast in-situ (*18th month)

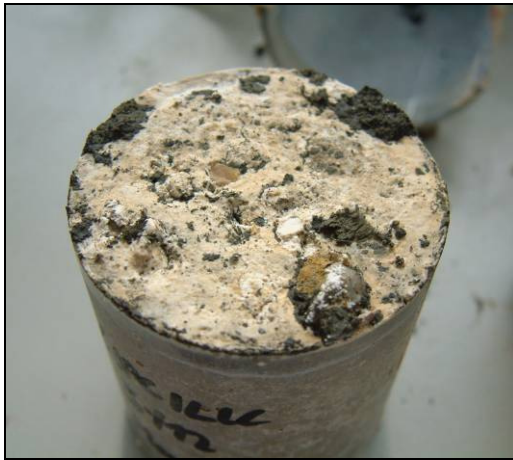
Figure 5.5 - Thaumasite layer at precast - LLC

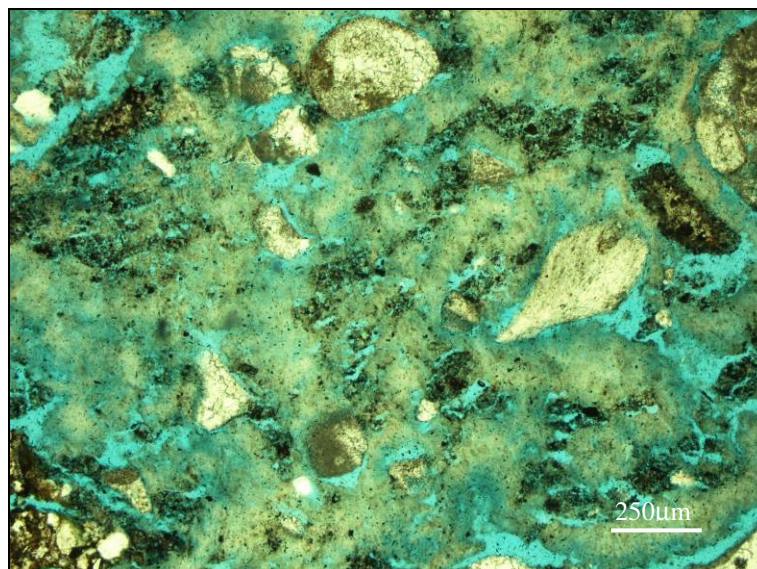
Figure 5.8 - Severe TSA at precast sample in contact with ECC after 15 months, plane polarised light (PPL)

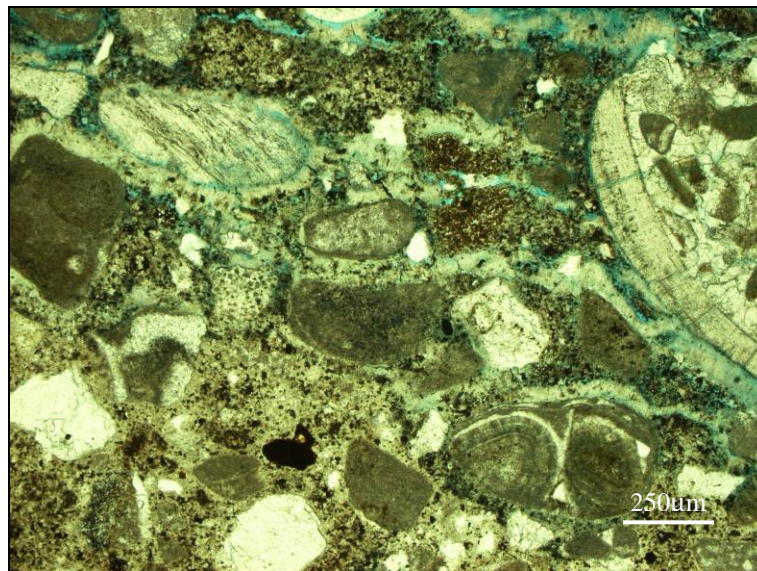
Figure 5.9 - Fully carbonated zone underlying degraded concrete surface at precast sample in contact with ECC after 15 months, plane polarised light (PPL)

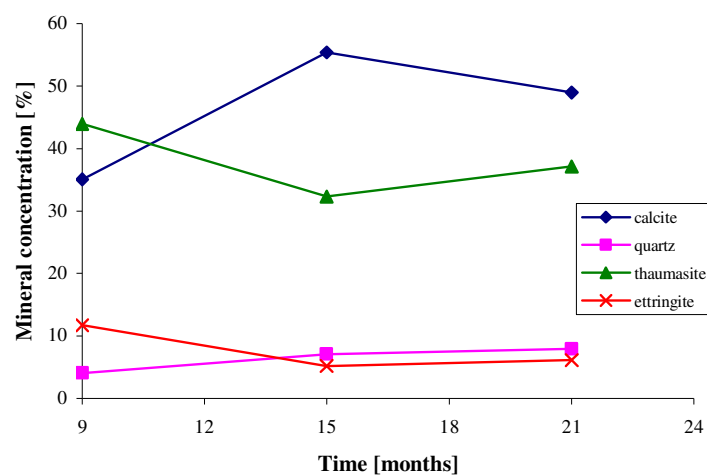
Figure 5.10 - Development of mineral concentration at Mix2/PC/LLC (290-0.65)

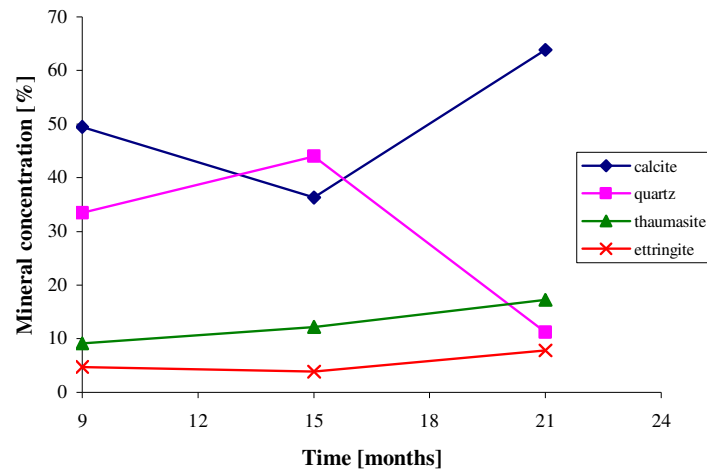
Figure 5.11 - Development of mineral concentration at Mix2/CS/LLC (290-0.65)

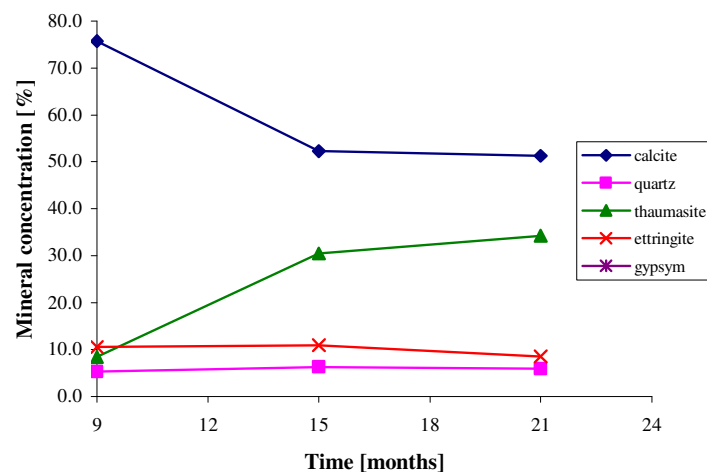
Figure 5.12 - Development of mineral concentration at Mix2/PC/ECC (290-0.65)

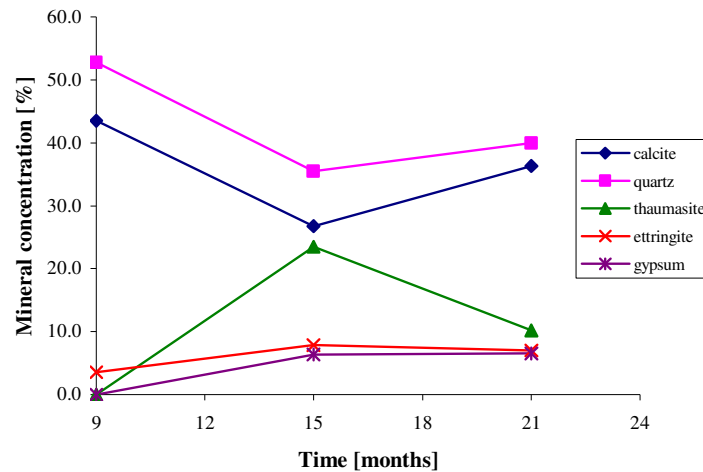
Figure 5.13 - Development of mineral concentration at Mix2/CS/ECC (290-0.65)

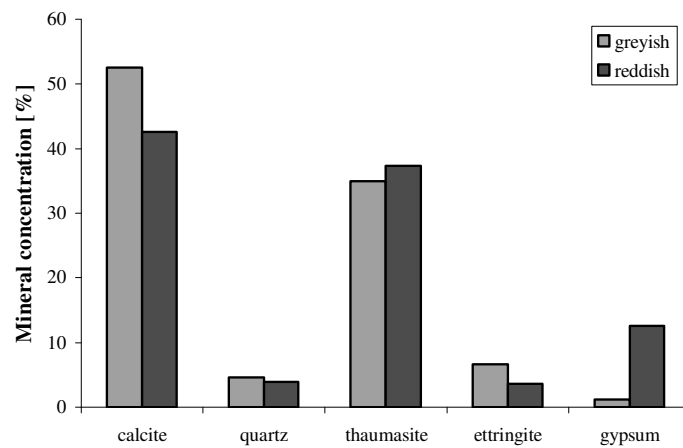
Figure 5.14 - Reaction product distribution of the two layers

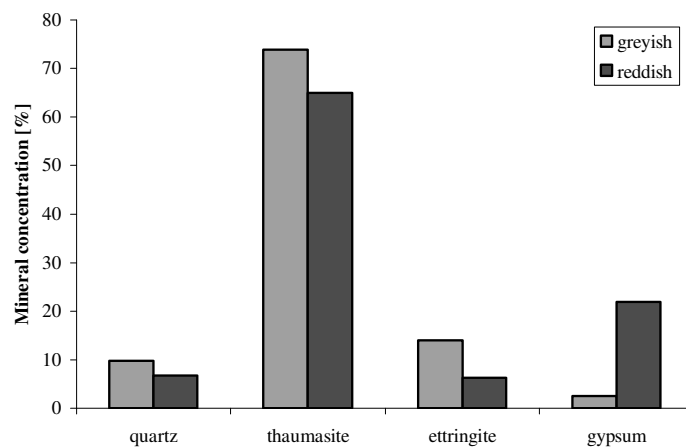
Figure 5.15 - Reaction product distribution of the two layers, excluding calcite

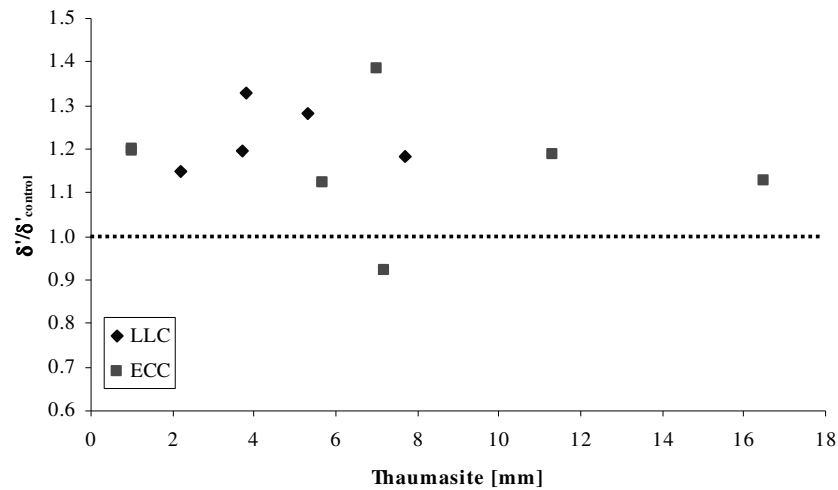
Figure 5.19 - Thaumaside influenced changes of skin friction δ' for all specimen sets, age 27 months

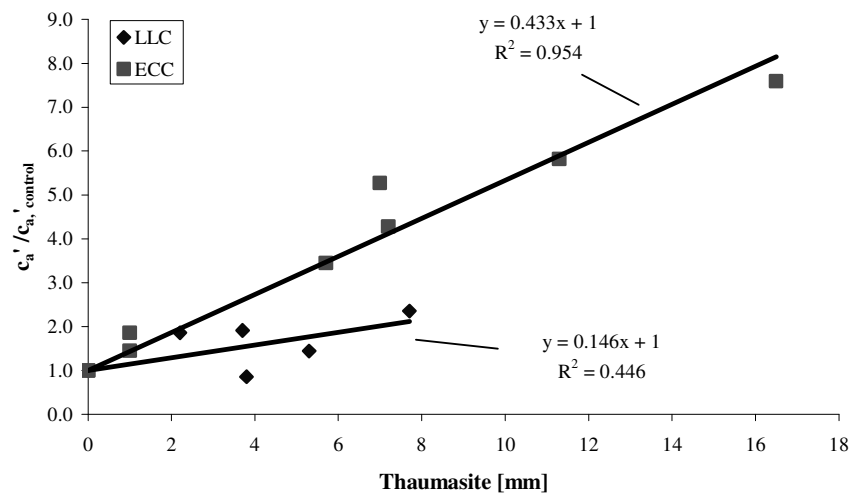
Figure 5.20 - Thaumaside influenced changes of cohesion c'_a for all specimens sets, age 27 months
