**ACCELERATING THE THAUMASITE FORM OF
SULFATE ATTACK AND AN INVESTIGATION OF
ITS EFFECTS ON SKIN FRICTION**

A Thesis Submitted to
The University of Birmingham
for the Degree of
DOCTOR OF PHILOSOPHY

School of Civil Engineering
University of Birmingham
Edgbaston
Birmingham B15 2TT
December 2007

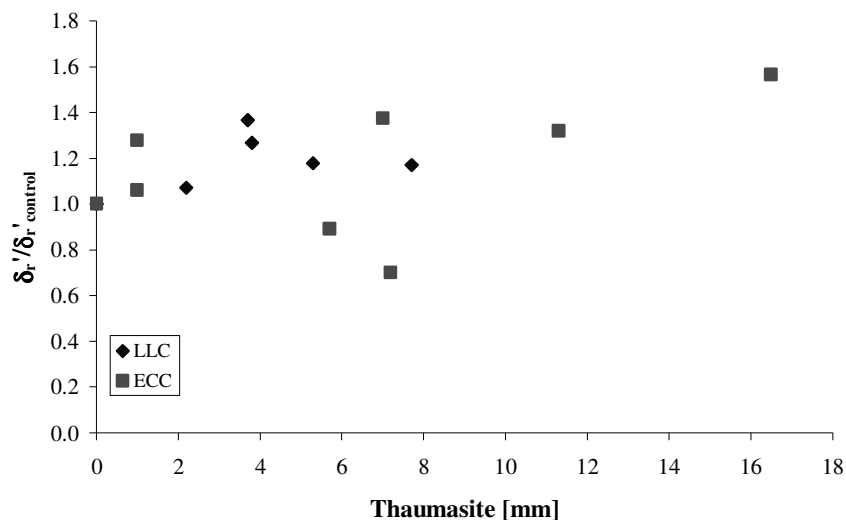
Figure 5.21 - Thaumasite influenced residual skin friction δ'_r , all specimen sets, 27 months

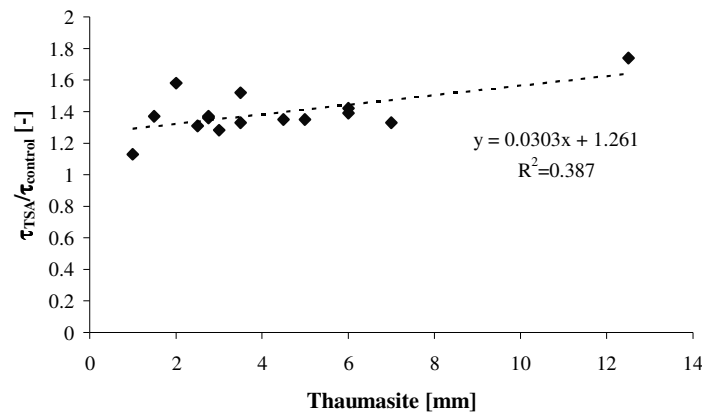
Figure 5.23 - Relationship TSA-factor/taumasite for LLC samples, peak strength, 27 months

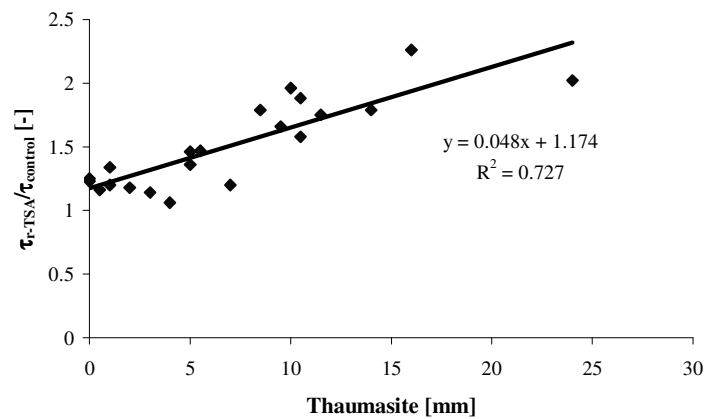
Figure 5.26 - Relationship TSA-factor/taumasite for ECC, residual strength, 27 months

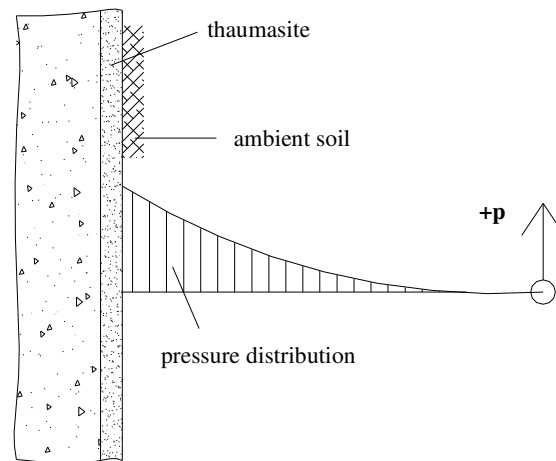
Figure 5.27 - Expansion pressure distribution in adjacent soil caused by TSA

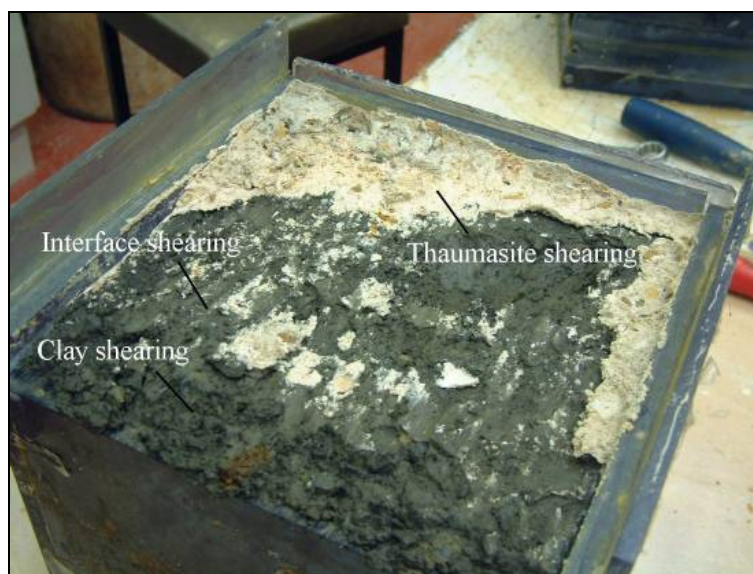
Figure 5.28 - Combined interface shear plane, clay view

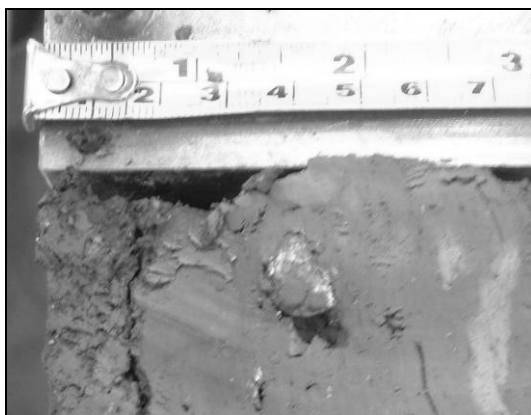
Figure 5.30 - Interface adjacent macroscopical clay structure, LLC

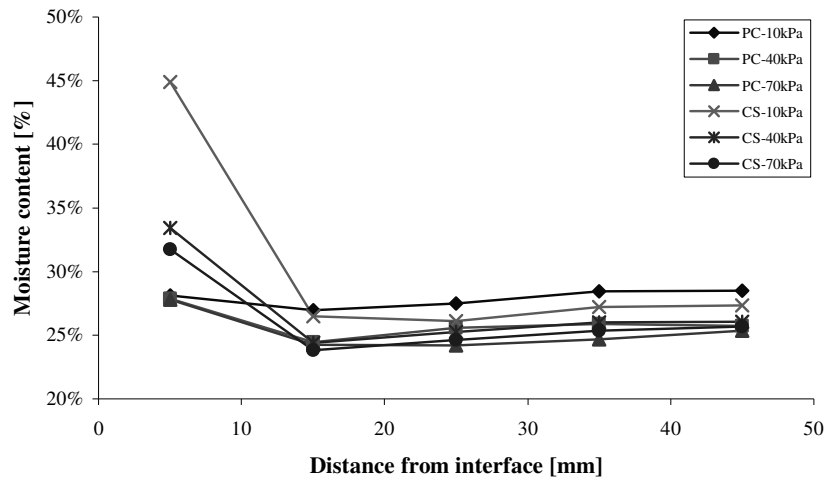
Figure 5.32 - Relationship moisture content - interface distance, Mix 3-LLC (290-0.75)

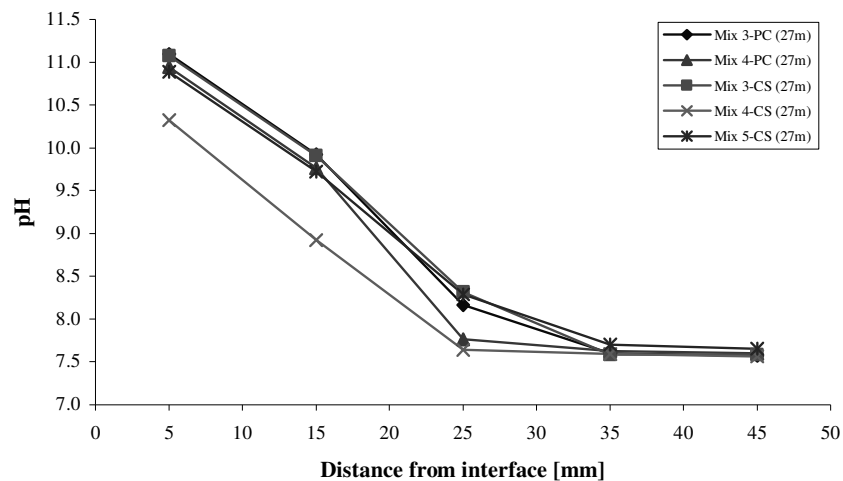
Figure 5.33 - pH-value distribution at adjacent clay, interface PC/CS-LLC

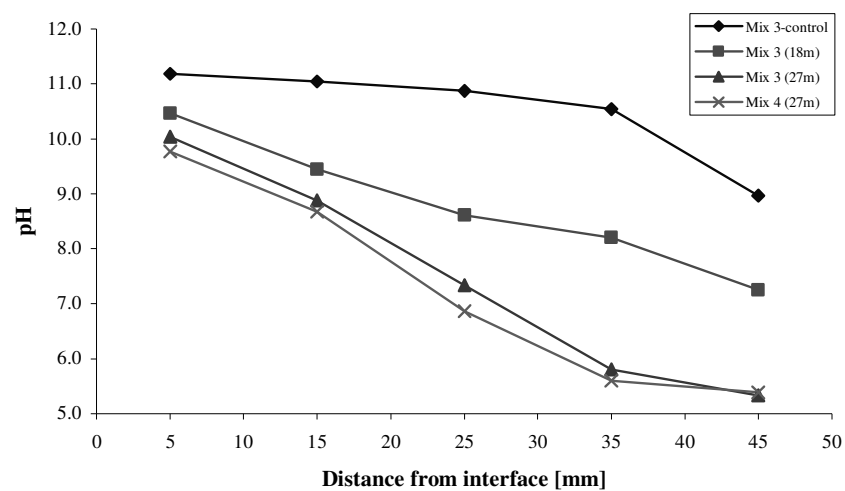
Figure 5.34 - pH-value distribution at the adjacent clay, interface PC-ECC

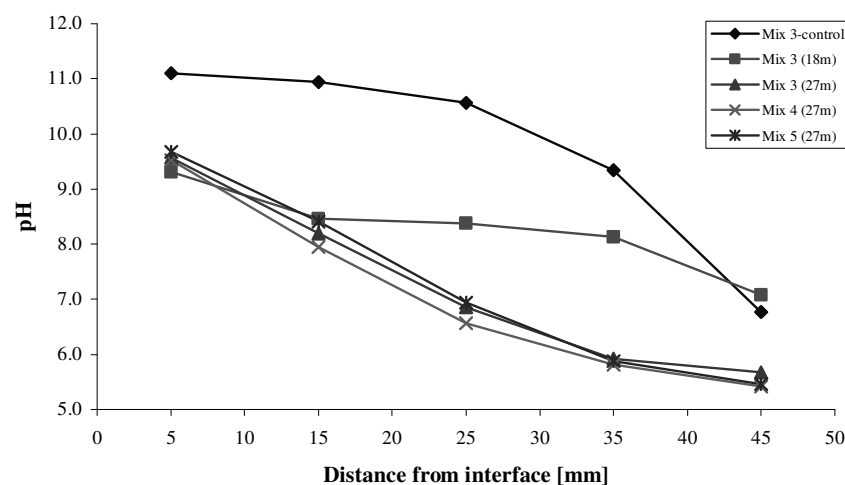
Figure 5.35 - pH-value distribution at the adjacent clay, interface CS-ECC

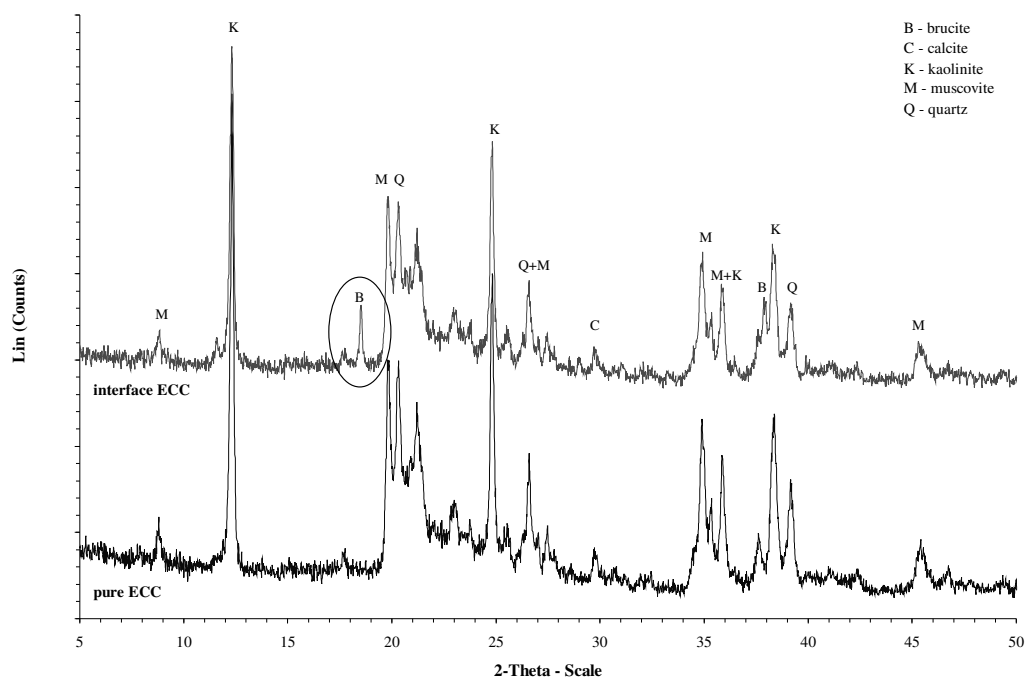
Figure 5.36 - Mineralogical composition of pure and interface ECC clay

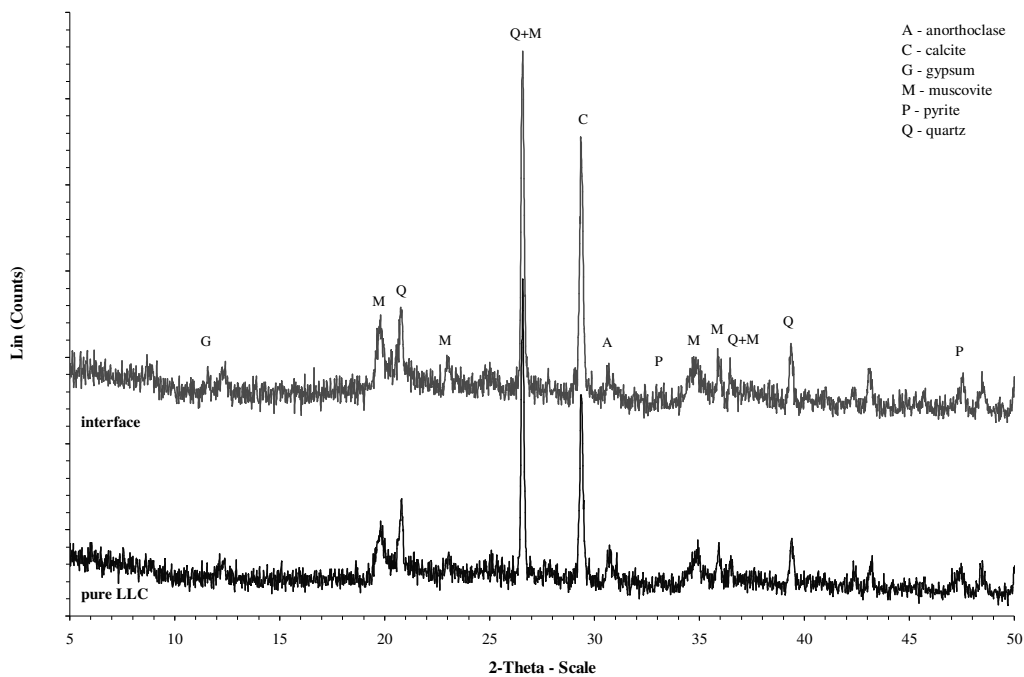
Figure 5.37 - Mineralogical composition of pure and interface LLC clay

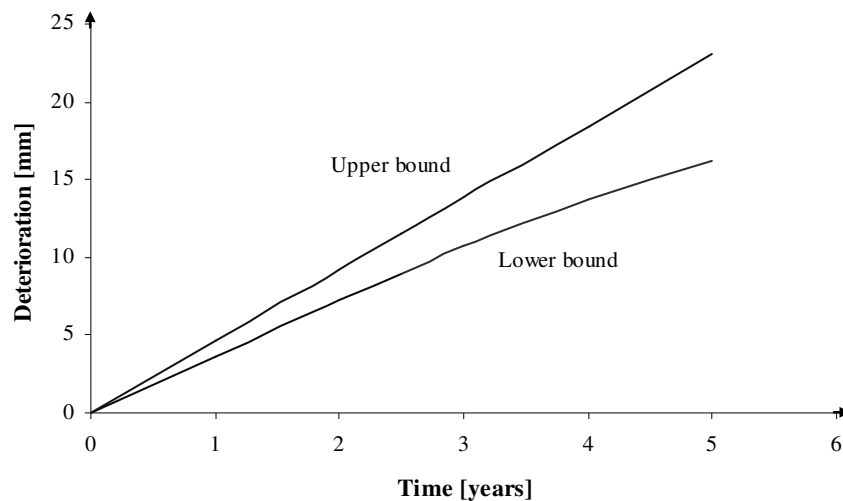
Figure 6.1 - Lower-upper bound deterioration in Mix 4/PC-ECC-10kPa samples

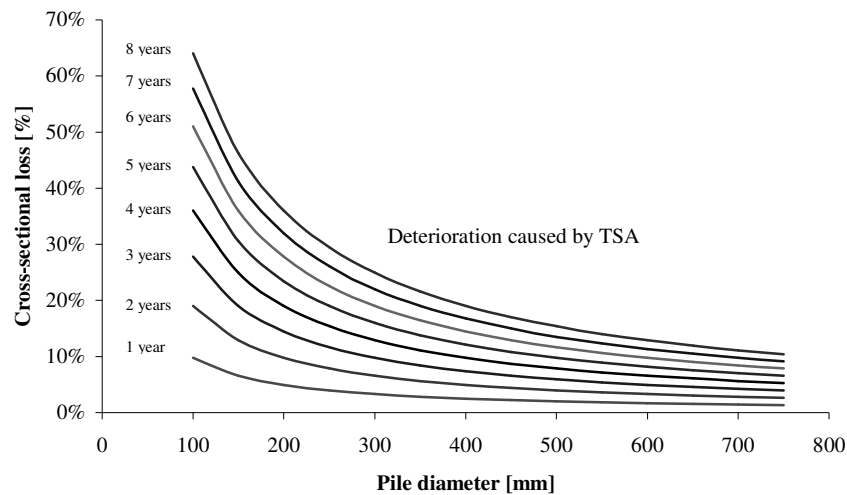
Figure 6.2 - Cross-sectional loss depending on pile diameter and thaumasite

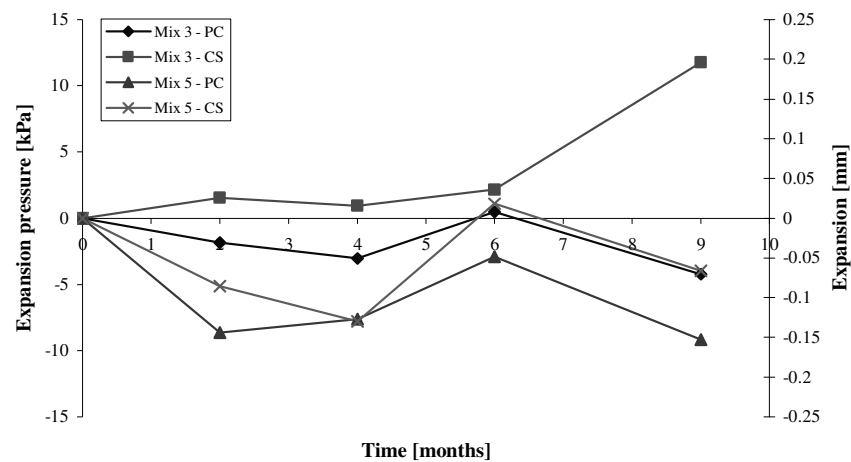
Figure A-29 - Pressure development due to TSA at sub-type with physical barrier

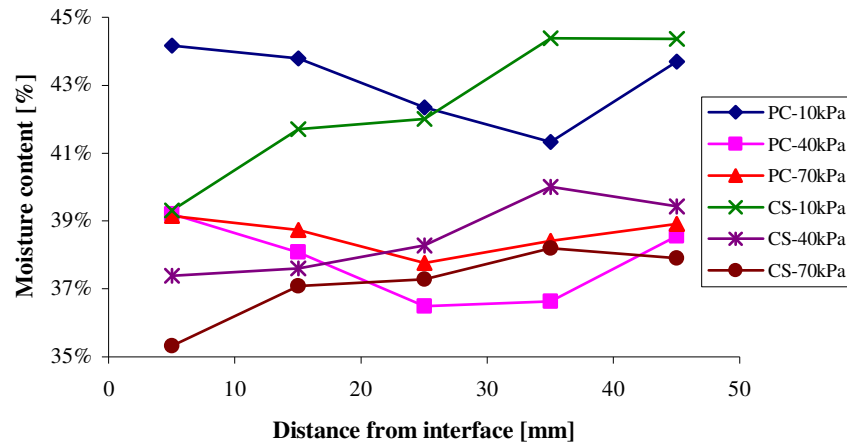
Figure A-32 - Mix 3 - ECC-control

Moisture Content Development towards the Concrete/TSA/Clay Interface

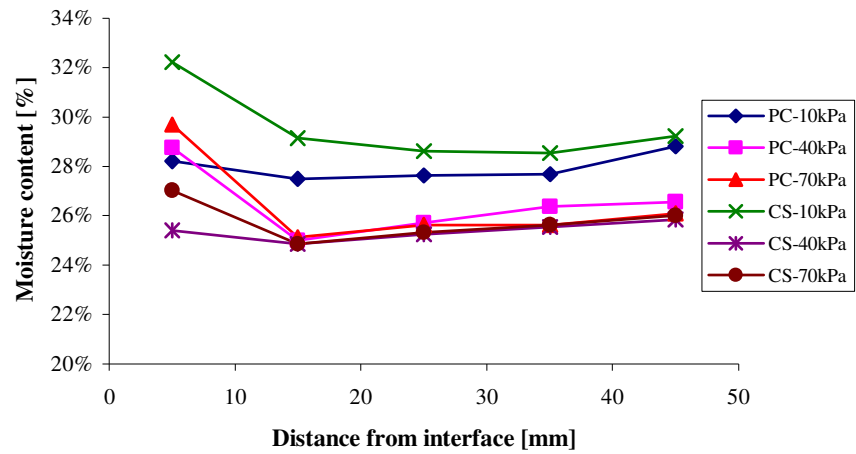
Figure A-35 - Mix 4 - LLC - 27months

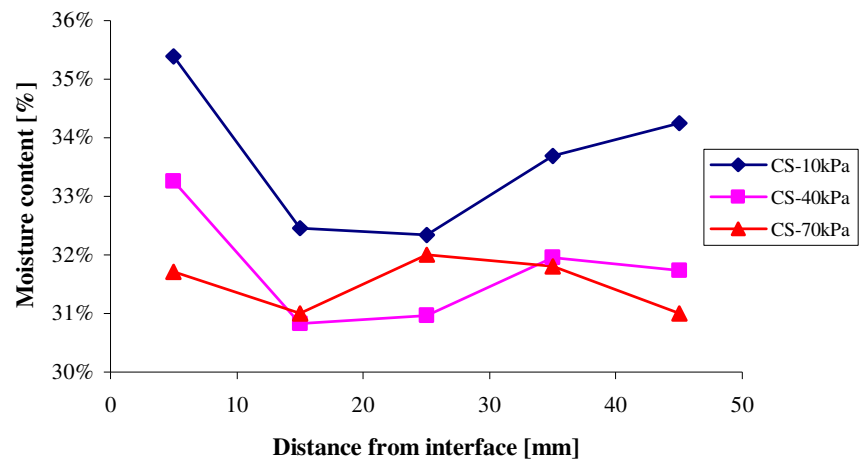
Figure A-38 - Mix 5 - ECC - 27months
