***INVESTIGATION OF SURFACE ENGINEERING AND MONITORING
FOR RELIABLE WIND TURBINE GEARBOXES***

A thesis submitted to
The University of Birmingham
for the degree of
DOCTOR OF PHILOSOPHY

by
JUN ZHOU

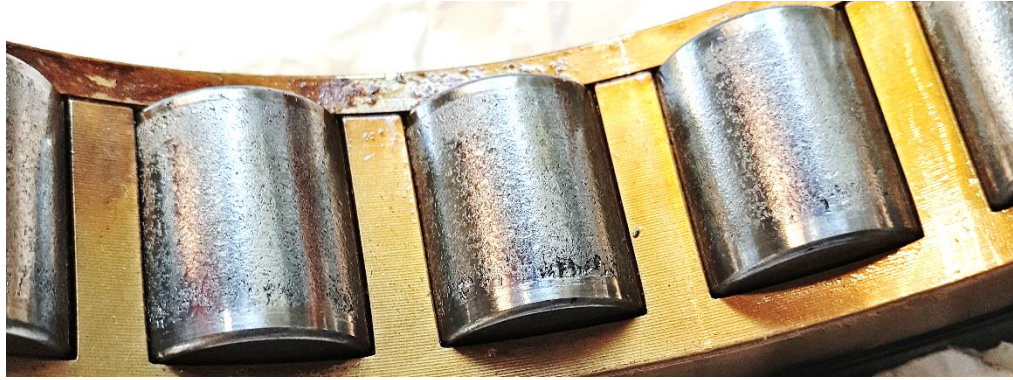
Each of the cylindrical rollers were visually checked. All of them were observed to have accumulated identical type of damage of similar severity (Figure 4.1.1-2). From the cylindrical rollers, one of them was randomly selected for more in-depth observation and investigation.

Figure 4.1.1-2 All the rollers are severely damaged

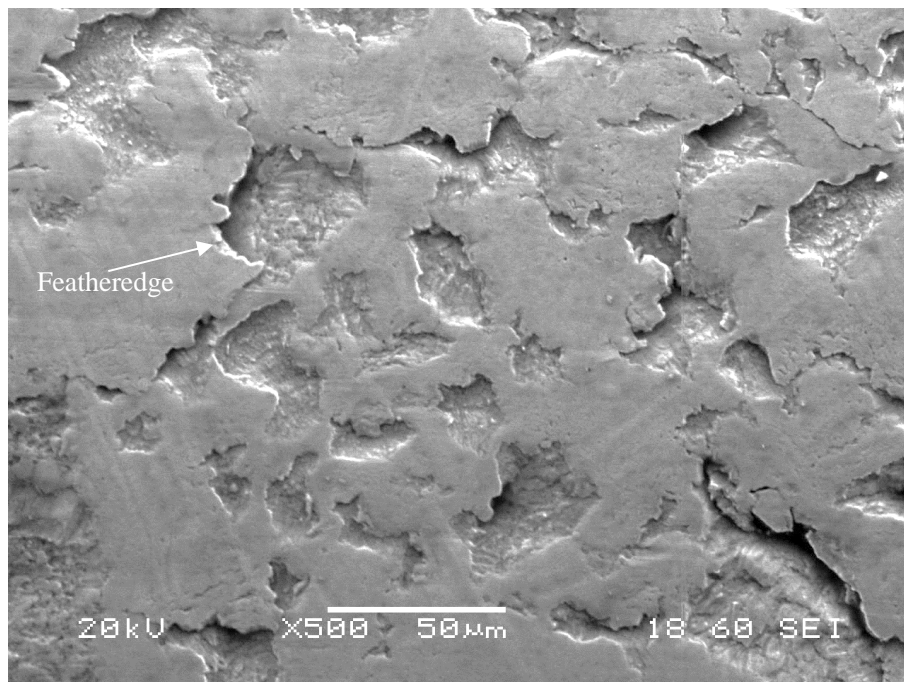
Figure 4.1.1-4 shows a high-magnification SEM micrograph of the surface of the roller affected by micro-pitting damage. The bottom of a micro-pit crater, has a rough surface which is typically caused due to ductile fatigue crack propagation (RL Errichello, 2012). As

indicated in Figure 4.1.1-4, the featheredge of the pit has formed at the back of the micro-pit crater, having a white colour appearance under SEM. This is due to the edge effect, i.e. the emission of secondary electrons is enhanced at the edges of the samples, resulting in brighter appearance in the SEM micrograph image obtained (Bob Hafner, 2007). The formation of the featheredge is caused by plastic flow of material over the crater rim (RL Errichello, 2012). The surface outside micro-pits are mostly smooth and featureless. It is noticed that the direction of the micro-pits in rollers is non-uniform. According to RL Errichello (2012) the nonuniform sliding directions in rolling-element bearing components leads to the random direction of the micro-pits.

Figure 4.1.1-4 SEM image of micro-pitting on cylindrical roller surface

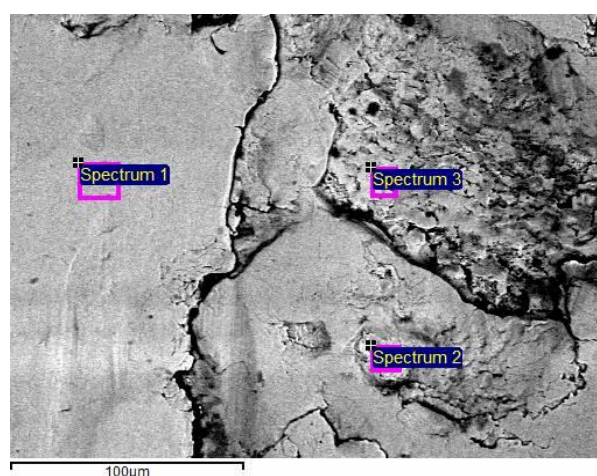
Figure 4.1.1-5 shows the back-scattered-electron (BSE) image and EDX analysis of the roller surface. Firstly, Spectrum 1 indicates that the roller is made of steel with a Cr content of around 1.71 in wt%, Si 0.17 in wt%, Mn 0.69 in wt% and C 2.22 in wt%. Because of the C contamination in the SEM chamber (e.g. from pump oil), the tested C value is commonly

higher than the real value, so the actual C content in the steel examined should be less than 2.22 in wt%. The compositions of the steel from which the rollers were manufactured was measured using EDS. The EDS findings place the steel used within the limits reported in the relevant standards for bearings (Xiaolan Ai and Charles Moyer, 2001). Also, some areas in the BSE image appear brighter than the rest of the sample. This suggests that elements heavier than Fe exist on the roller surface. Elements with higher atomic number can generate more BSEs than elements with lower atomic numbers, hence resulting in a brighter region in the micrograph obtained. Cu has been detected on the brighter areas of roller surface through EDS analysis. Since it is known that the cage is made of soft brass, this would suggest that some material had been transferred from the surface of the cage to the roller while the bearing was still in service. The composition of cage has been analysed using EDS as shown in Figure 4.1.1-20 of section 4.1.1.1.2.

Figure 4.1.1-5 The back-scattered-electron image and EDX results of the roller surface, indicating the roller is made of steel and copper is detected on the surface

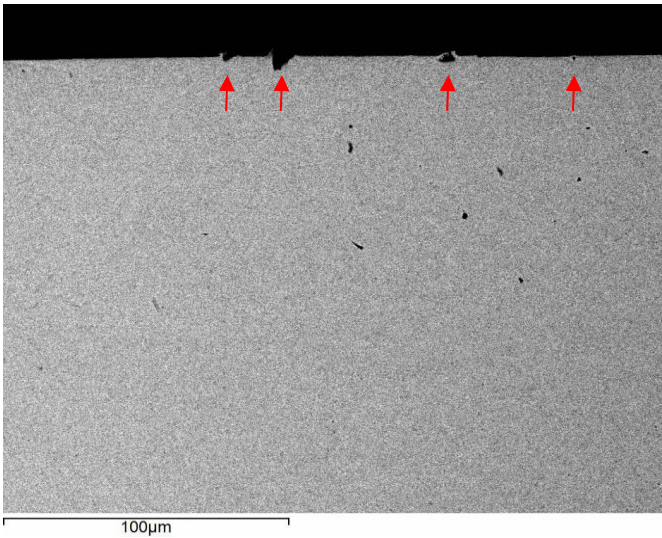
Figure 4.1.1-7 Rolling contact fatigue initiated at roller surface as arrowed

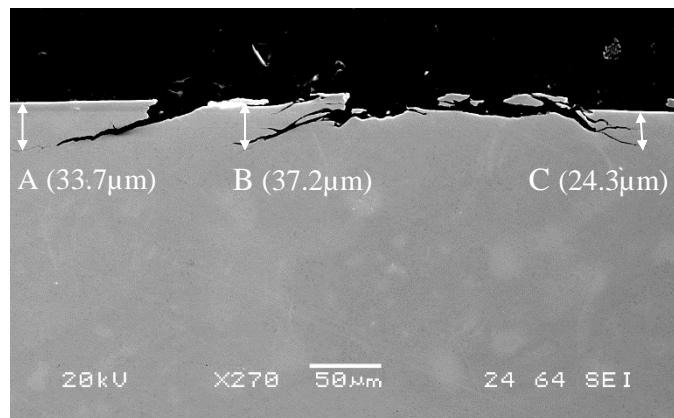
Except of these typical rolling contact fatigue pits shown in Figure 4.1.1-6, some unusual micro-pits were also observed. For instance, in Figure 4.1.1-8, the direction of crack C is from upper left to lower right, which is opposite to the direction of the other cracks. This suggests that crack C is likely to have been caused by another force opposite to the dominant friction force. The crack depth/angle to the surface of crack A, B and C are $33.7\text{ }\mu\text{m}/20.6^\circ$, $37.2\text{ }\mu\text{m}/18.2^\circ$ and $24.3\text{ }\mu\text{m}/30.3^\circ$ respectively. In Figure 4.1.1-9, the small initial part of the crack on the right has an angle of 41.8° to the surface, but the following main part of the crack changed direction and became parallel to the roller surface at a depth of $23.5\text{ }\mu\text{m}$ below the surface. The explanation is that if the subsurface crack entered a sufficiently strong compressive stress field in the proximity area of the subsurface, then its propagation direction would change dramatically causing it to propagate parallel to the surface without breaking the surface.

Figure 4.1.1-8 Crack C has a different propagation direction with A and B on the roller

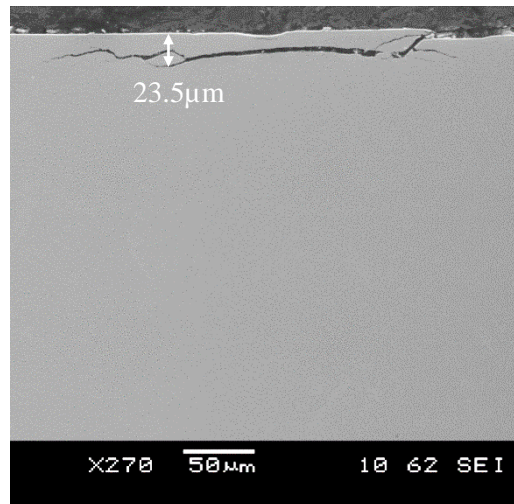
Figure 4.1.1-9 One crack propagated parallel to the surface on the roller

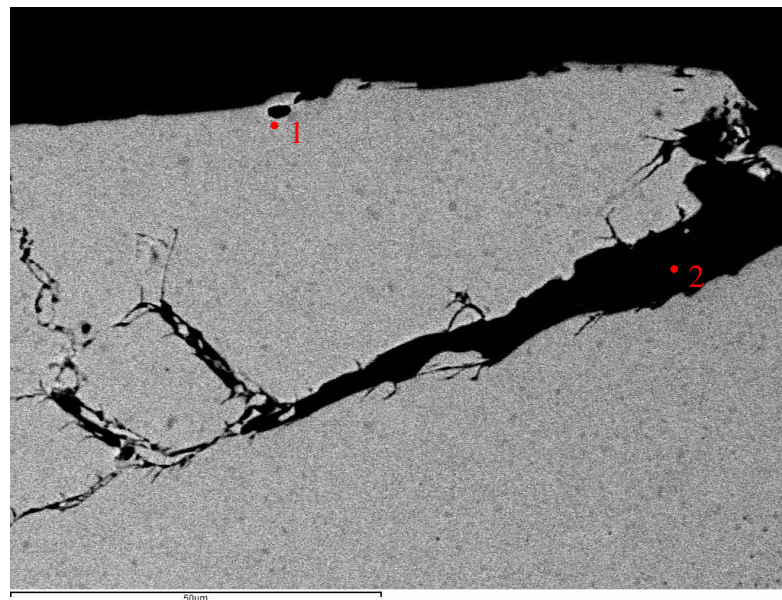
Although the surface fatigue cracks in the roller were considered to have initiated from surface defects instead of sub-surface inclusions, it is still important to notice that some coarse non-metallic inclusions are present in the steel from which the roller was manufactured. The inclusions were observed in the surface and sub-surface areas of the roller, including SiC (Figure 4.1.1-10), Al_2O_3 (Figure 4.1.1-11), and $\text{MgO} \cdot \text{Al}_2\text{O}_3$ (Figure 4.1.1-12). The sources of SiC inclusion could be related to the material that the refractory brick of furnace is made of, or the deoxidizing agent used for steel making. SiC is one of the most widely used refractory materials in steel-making furnace, because of its high thermal stability, good thermal conductivity, shock resistance, and high enough chemical stability (R. Amavis, 1990). Also, SiC may be used during the steel making process, in order to de-oxidise steel and adjust the content of C and Si (Pierre-Marie Cabanne, 2006, Electro-Abrasives, 2015, Miller-and-Company LLC, 2015). The common Al_2O_3 inclusion is the de-oxidising product in the steel arising when Al is used as de-oxidising agent. Moreover, alumina could even form in the steel melt with less than about 200 ppm Al present if the steel melt had been mainly deoxidised using Si (Joo Hyun Park, 2007). With respect to the $\text{MgO} \cdot \text{Al}_2\text{O}_3$ inclusion, there are two possible reasons behind its presence. In some cases, $\text{MgO} \cdot \text{Al}_2\text{O}_3$, an inclusion with spinel

Figure 4.1.1-10 Back-scattered-electron image of a crack and a SiC particle was detected in roller surface through EDS analysis

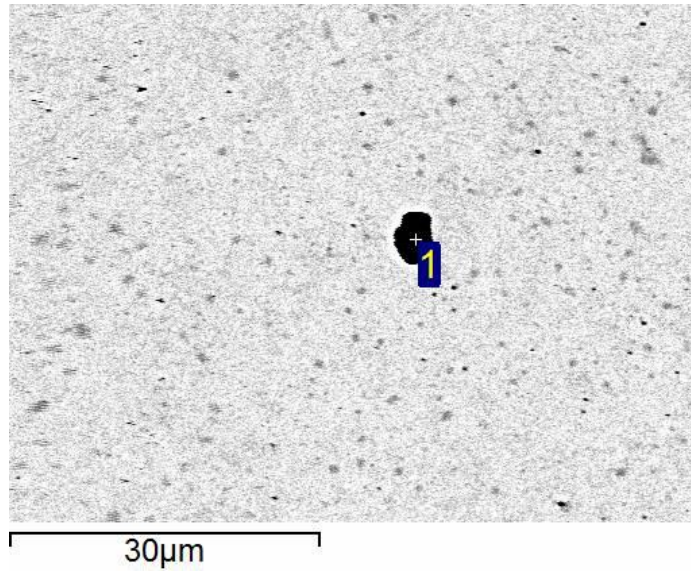
Figure 4.1.1-11 Back-scattered-electron image and the EDS results of a coarse Al₂O₃ inclusion particle in roller subsurface

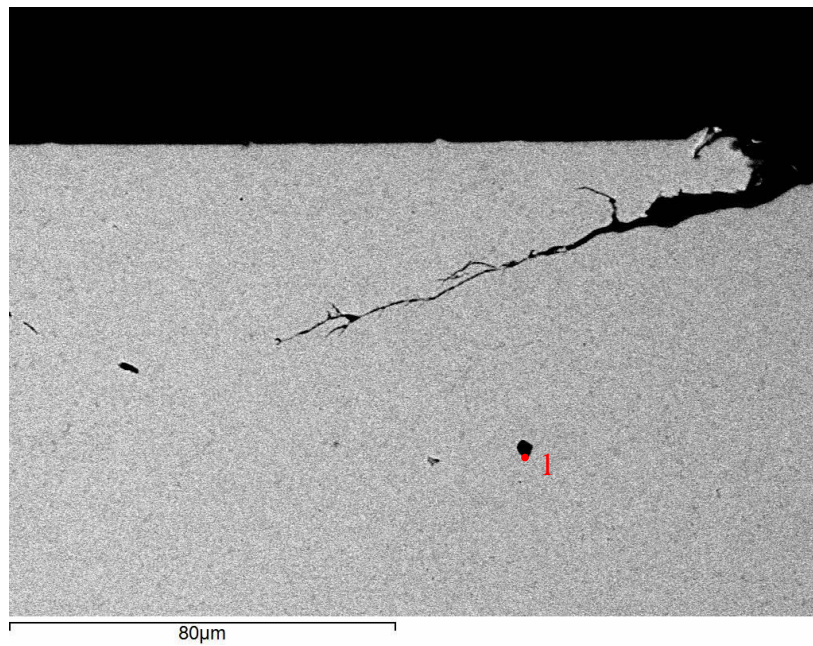
crystal structure, could form in steel. This has also been reported by other researchers (Shufeng Yang et al., 2010, Neslihan Dogan et al., 2015, Joo Hyun Park, 2007). Since MgO is widely adopted for desulfurization of steel, some retained MgO in the ladle slag may be present after the desulfurisation step, The MgO present may react with dissolved aluminium in liquid steel to form $\text{MgO} \cdot \text{Al}_2\text{O}_3$ inclusion (Chris Pistorius et al., 2011, Obinna Adaba, 2015). It is also possible that $\text{MgO} \cdot \text{Al}_2\text{O}_3$ inclusions arise from the refractory material used in the steel-making process (Raymond P Racher et al., 2004).

Figure 4.1.1-12 Back-scattered-electron image and the EDS results of a coarse MgO·Al₂O₃ inclusion particle in roller subsurface

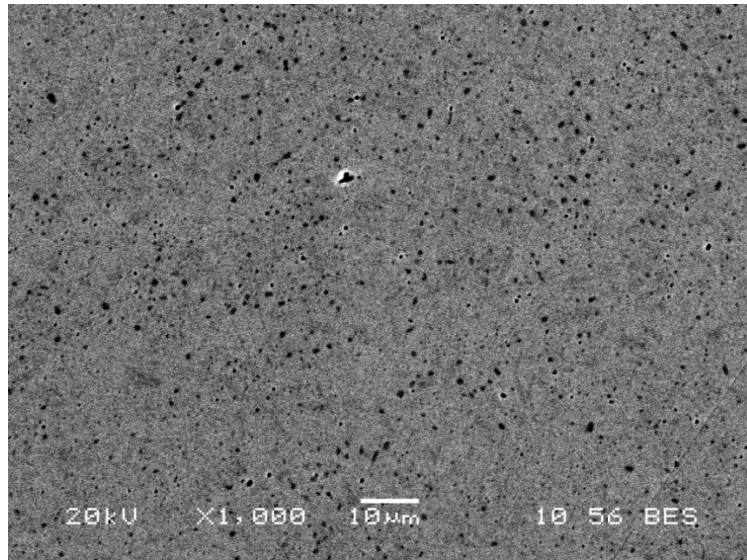
Despite the presence of coarse inclusions, fine well-dispersed spheroidised carbides were observed under high magnification back-scattered-electron microscopy carried out on the polished but not etched roller sample (Figure 4.1.1-13). The sample was subsequently etched using 2% nital. Figure 4.1.1-14 shows the optical micrograph obtained at a magnification of 500×. Figure 4.1.1-15 shows the SEM micrograph of the etched microstructure of the roller cross-section. They both show a typical tempered martensite microstructure containing dispersed spheroidised fine carbides (spheroidite). The findings are in accordance with the results of the back-scattered-electron microscopy (Figure 4.1.1-13). In addition, the EDS analysis presented in Figure 4.1.1-15 revealed that the carbides are rich in Cr and Fe. These carbide particles are possibly formed because of the spheroidisation annealing process and their composition is likely to be M_3C ($M=Fe/Cr$) (H Fu et al., 2017). The presence of the fine uniformly dispersed carbides in the microstructure is desirable since it improves the fatigue damage resistance of the bearing. Hence, carbide refinement treatment is commonly conducted on bearing steel after machining. One of the usual methods is spheroidisation followed by quenching and tempering heat treatment (Philip K Pearson and Thorn W Dickinson, 1988, CA Stickels, 1974, Jaromir Dlouhy et al., 2014, Wenwen Song et al., 2014, HKDH Bhadeshia, 2012).

Figure 4.1.1-13 Back-scattered-electron image shows dispersed carbide (the black dots) in the roller material

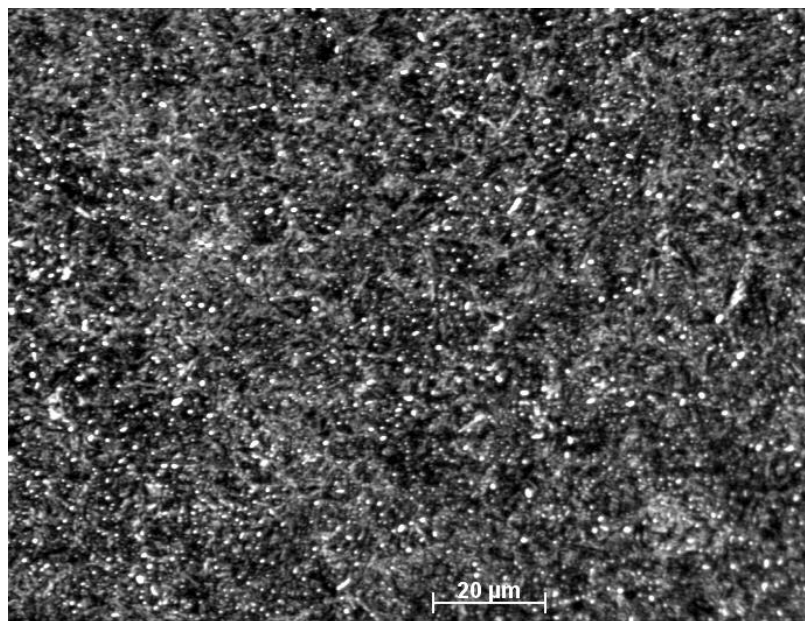
Figure 4.1.1-14 Metallography of the roller microstructure, composed of tempered martensite and dispersed spheroidised fine carbides (2% natal, 500×)

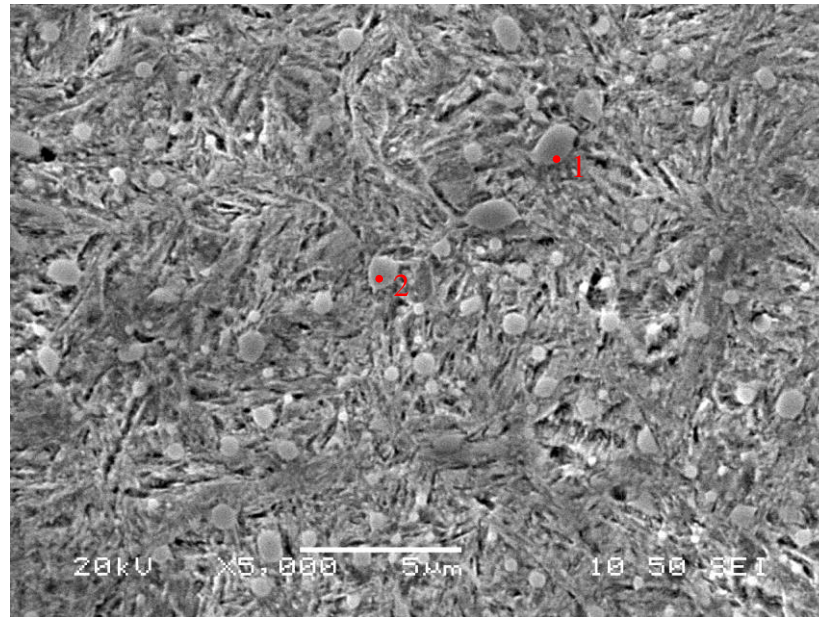
Figure 4.1.1-15 SEM image and EDS analysis of the spherical carbide in roller

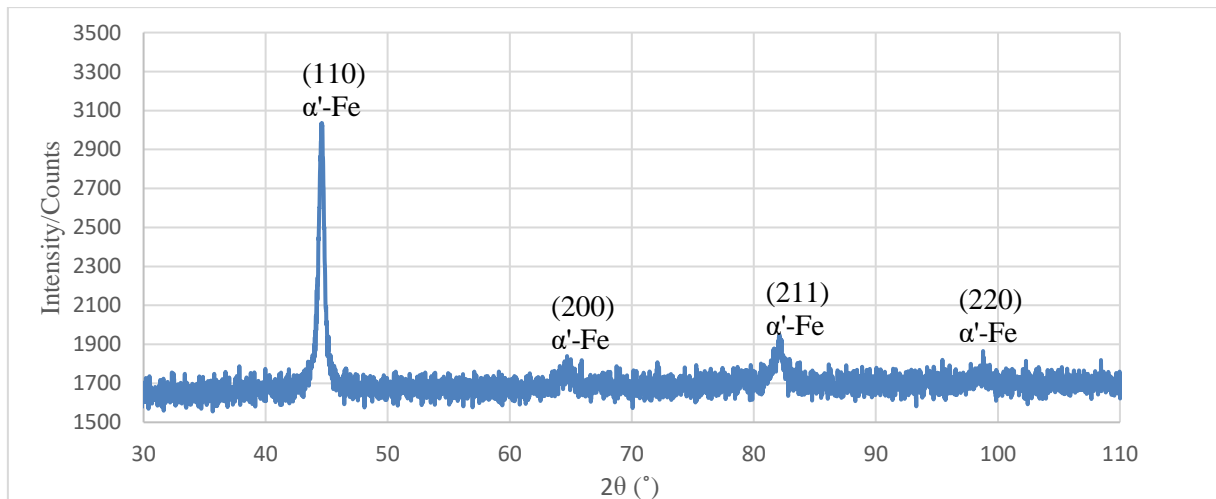
Figure 4.1.1-17 XRD pattern showing the main phase of the roller

To sum up, the microstructure of roller material is tempered martensite with dispersed fine carbides and some inclusions, specifically SiC, Al₂O₃ and MgO·Al₂O₃. The hardness of the rollers has been measured to be 706 HV in average, which is relatively low and just reaches the lowest hardness level required by the bearing industry. The mechanisms that have led to the failure of the rollers have been identified to be micro-pitting and macro-pitting. In addition, most of the rollers show more severe surface damage at one end side than the other one, which is clearly evidence of misalignment effects. Misaligned rollers suffered uneven distribution of contact stress over the surface, leading to local stress concentration, and subsequently prompting the initiation and propagation of rolling contact fatigue in the contact area.

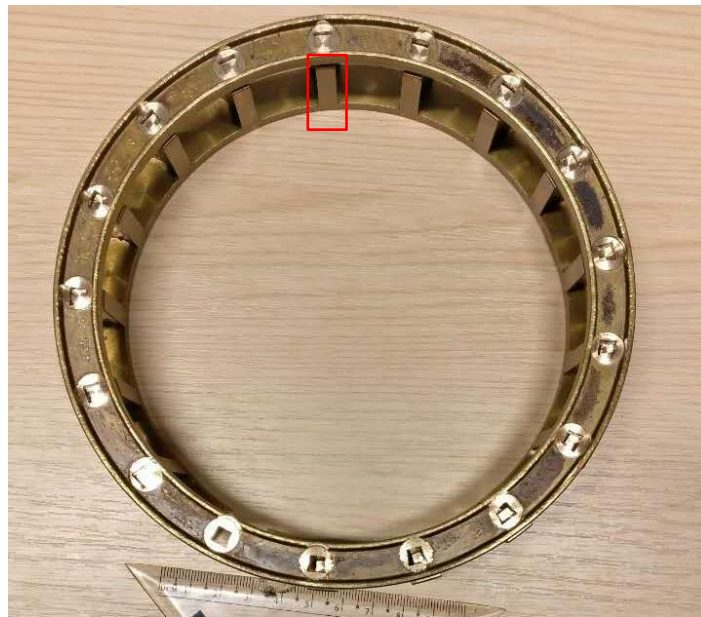
The photograph of the bearing cage with yellow colour is displayed in Figure 4.1.1-18. For the convenient observation of the cage, concave surface which is in contact with the rollers, i.e. the part highlighted by the framed area in Figure 4.1.1-18 was cut off from the cage. The photograph of the concave roller-cage contact surface of the removed part is shown in Figure 4.1.1-19. It can be seen that the surface condition is really poor. Observation by naked eye reveals white shining particles on the roller-cage contact surface of the yellow cage part. Also, the distribution of the white particles is uneven. The number of the white shining particles increased from the area A to the area B (A & B are shown in Figure 4.1.1-19).

Figure 4.1.1-18 The cage of the shaft bearing of the high-speed stage

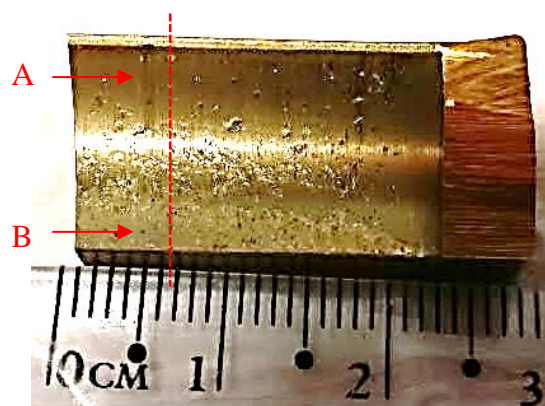
Except from the presence of the aforementioned white particles, it can be easily seen that the surface morphology of area B is different from the other area.

Figure 4.1.1-19 The worn concave surface of the cage

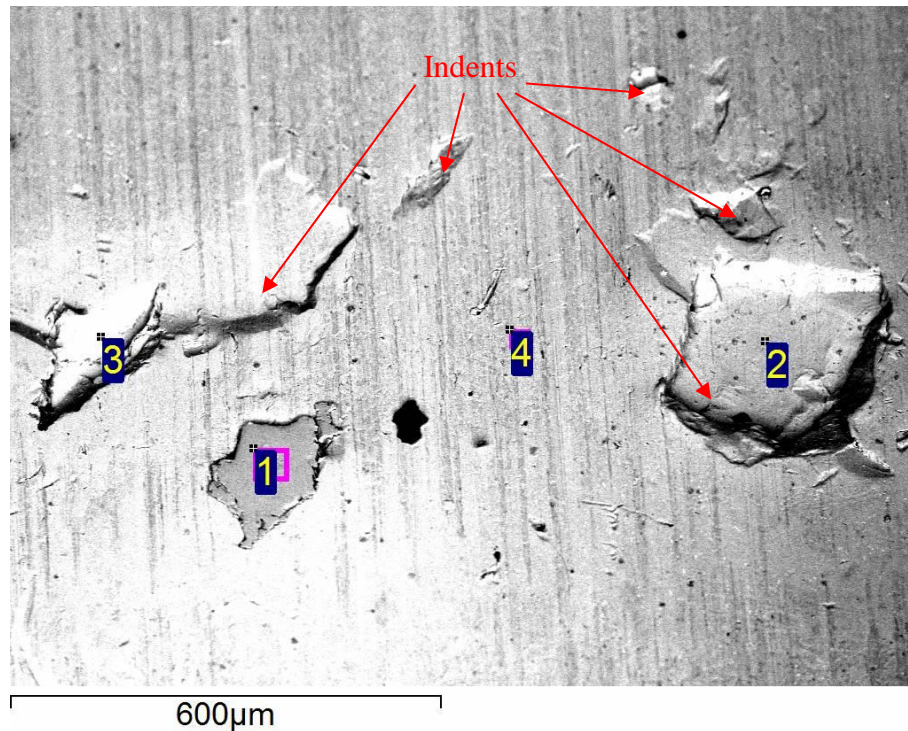
In area A (Figure 4.1.1-20), most of surface is covered by scratches in the same direction which were possibly produced by machining. Also, two larger and several smaller indents can be seen on the surface. Apart from that, one darker particle (with approximate dimensions of

180 μm \times 130 μm) was discovered to be embedded in the matrix material. Based on backscattered electron microscopy, the darker particle has been identified to be mostly composed of lighter elements compared with surrounding material. Following from the results of EDX analysis, the darker particle has similar composition to that of the roller steel. Hence, it has quite likely broken off from the steel roller. The EDX results also suggest that the whiter matrix material is proved brass alloy, containing Cu and Zn. The micro-hardness of the brass cage was tested and the average value is only $108.73 \pm 1.67 \text{ HV0.05}$, while the average hardness of the roller is as high as $706.50 \pm 18.09 \text{ HV0.05}$. Therefore, any roller fragments breaking off can very easily cause indents or be embedded in the surface of soft brass cage.

Figure 4.1.1-20 Back-scattered electron image and EDS analysis of area A of the cage worn surface

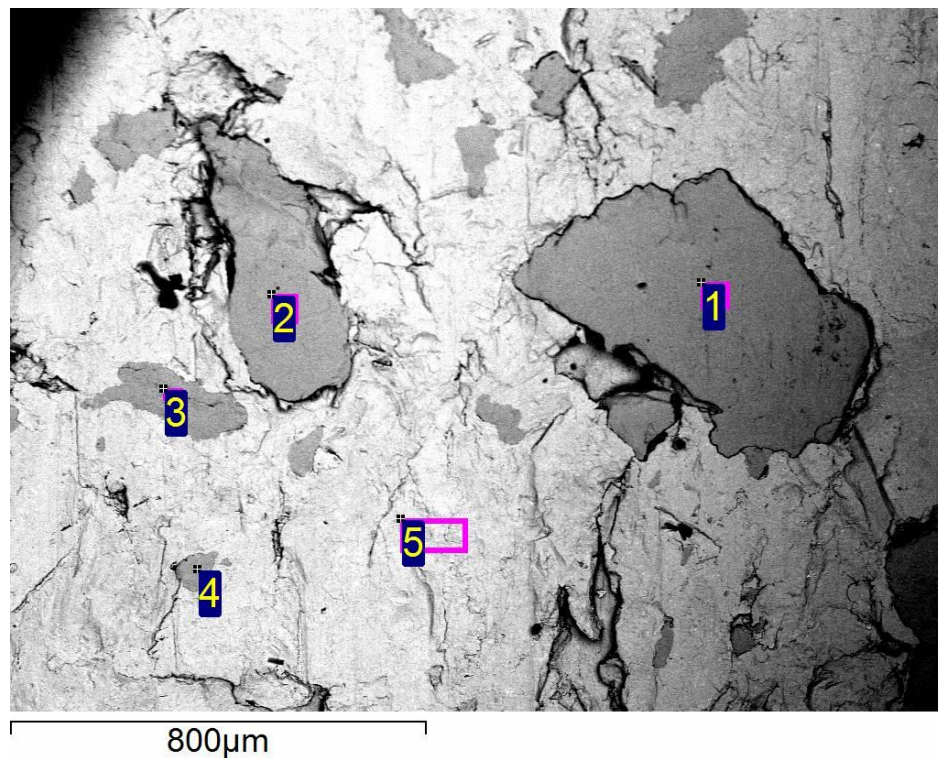
In the area B (Figure 4.1.1-21), more roller debris is embedded. The average size of the debris particles observed is bigger than those seen in area A. The largest embedded steel debris particle in Figure 4.1.1-21 has been measured to be about $450\ \mu\text{m} \times 260\ \mu\text{m}$, which makes it observable even by the naked eye. Due to the large number of indentations made by the large and hard roller fragments, the matrix brass is so severely plastically deformed that all scratches from the machining have disappeared.

Figure 4.1.1-21 Back-scattered electron image and EDS analysis of area B of the cage worn surface

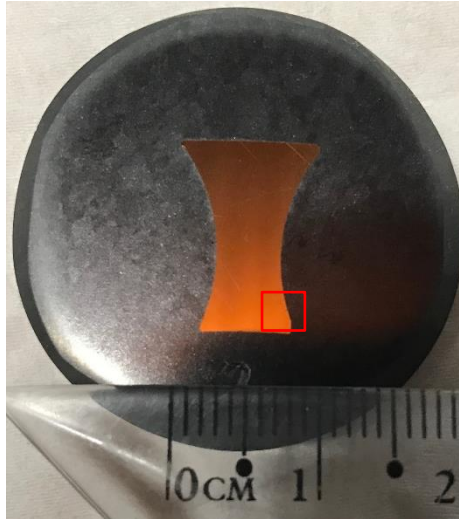
In the framed area in Figure 4.1.1-22, a particle embedded in the cage surface is observed under SEM. The backscattered-electron micrograph and the EDS analysis of the embedded particle is shown in Figure 4.1.1-23. The results from both techniques indicate that the embedded particle is a steel fragment which has most likely broken off from the rollers. In addition to that, small cracks can be seen in the steel fragment. The penetration depth of the fragment is at least about 15.3 micron from the cage surface.

Figure 4.1.1-22 Cross section of the part removed from brass cage

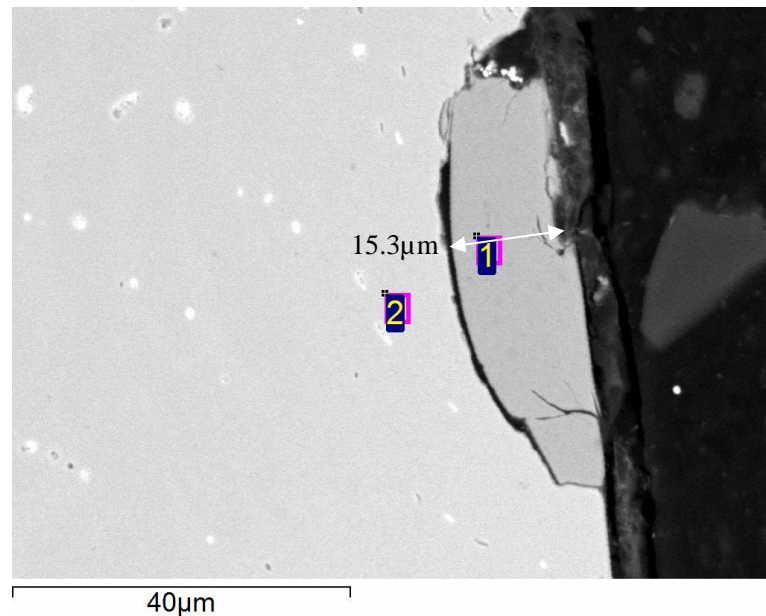
One of the lubricant's functions is to remove wear debris from the contact area to prevent debris concentration. But when the large and hard roller fragments are embedded in the soft brass cage, it is impossible for the lubricant to remove them. Moreover, due to the hard debris remaining as third-body components between the roller and cage, the wear rate is accelerated (Jennifer A Kleinhans et al., 2009). The mechanism is that the hard third-body embedded in the soft material can act like the asperities of a hard material (Timothy M Wright and Stuart B Goodman, 2001, Seppo S Santavirta et al., 1999). In this case, rubbing with the roller surface and increasing the contact stress, causes removal of more roller material in its path and promotes the acceleration of the wear rate of the rollers. The original intention of adopting soft material for manufacturing the cage is to prevent the rollers from adhesive wear or abrasive wear which arises from rubbing with a cage made from material with similar or higher hardness. However, third-body wear occurred instead, due to the low hardness of brass cage.

Figure 4.1.1-23 Back-scattered-electron image of one steel fragment embedded in the brass cage surface and the EDS results

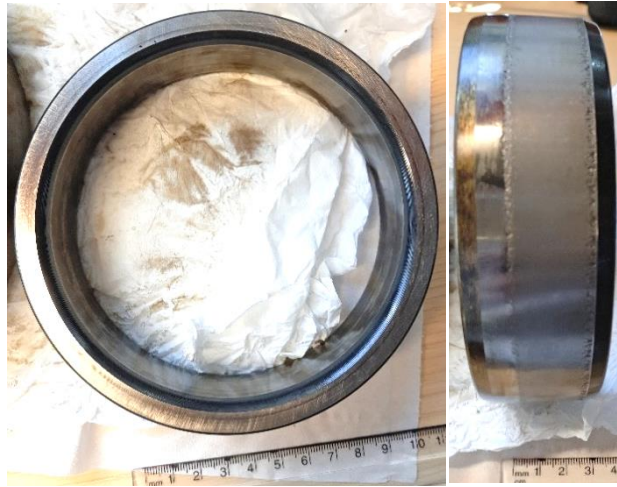
The front and side view of the inner race is shown in Figure 4.1.1-24. On the entire surface of the inner ring raceway (see Figure 4.1.1-25), macro-pitting and micro-pitting are identified, same failure mode as observed in the roller surface. In the middle part of the raceway, area II, the surface damage mode observed is related to micro-pitting. At each end of the raceway, areas I and III, the damage is more severe than the middle area II, as larger fragment of material has broken off resulting in macro-pitting. The macro-pitting damage at the ends of the raceway is thought to have followed micro-pitting damage in the raceway (RL Errichello, 2012). The explanation is that the micro-pitting reduced the contact area between the roller surface and the raceway, leading to higher contact stresses, especially at the ends of the rollers (Geometric Stress Concentration), eventually causing macro-pitting at the raceway. Moreover, it is noticed that the macro-pitting damage on the right-side area III is more severe than the left side I. This hints the effect of misalignment in the shaft connected to this particular component. Misalignment effects are important issues for materials used to manufacture the components of the gearbox and drive-train in general. This is due to the fact that

Figure 4.1.1-24 The front and side view of the inner race

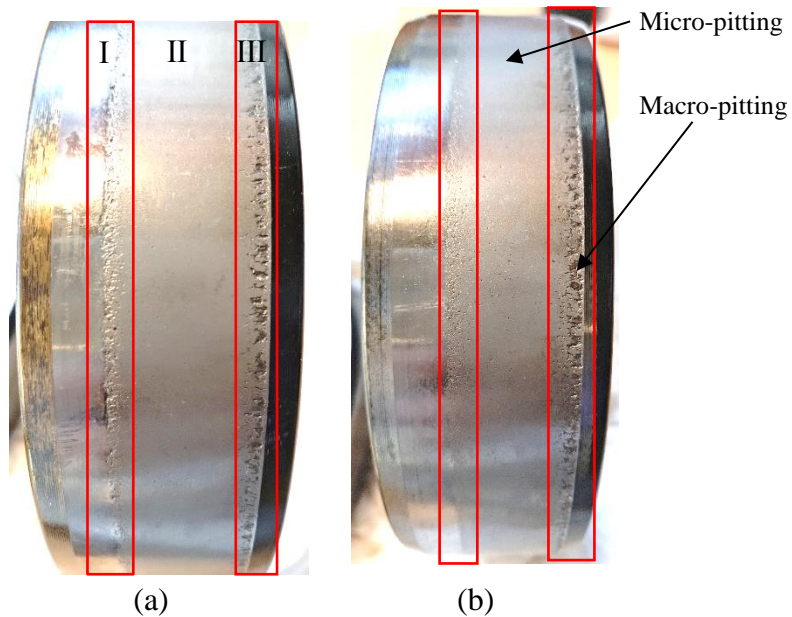
misalignment dramatically increases the contact stress levels, accelerating material wear and fatigue leading to premature failure due to micro-pitting and macro-pitting.

Figure 4.1.1-25 Macro-pitting and micro-pitting are observed on the surface of inner ring raceway, (b) is the back side of (a). The surface damage at the end of raceway I & III (macro-pitting) is more serious than the middle part II (micro-pitting or frosting). Moreover, the macro-pitting damage on the right side III is severer than the left side I.

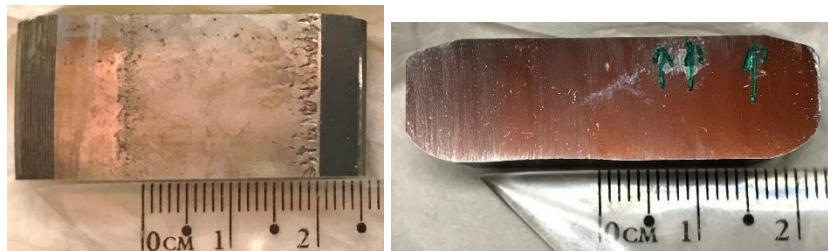
Figure 4.1.1-26 The raceway and the cross section of a small piece cut from the inner race for observation and test

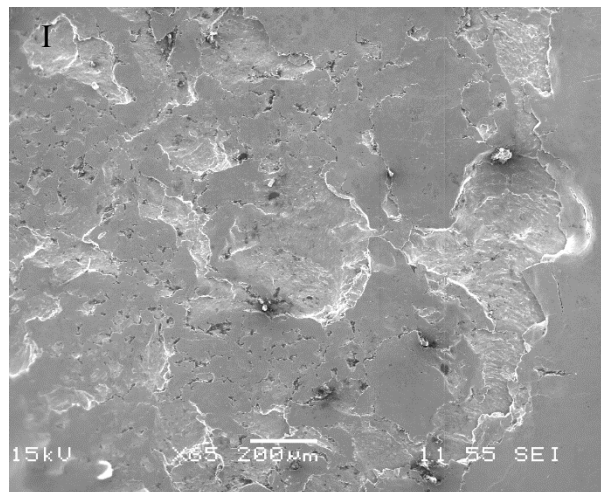
For the purpose of convenient observation and testing, a small piece of the inner race was cut off along the radial direction as shown in Figure 4.1.1-26. Figure 4.1.1-27, Figure 4.1.1-28 and Figure 4.1.1-29 show the SEM micrographs obtained from the areas I, II and III of the inner race, respectively. It can be seen that area II is affected by micro-pitting. Both areas I and III are affected by macro-pitting. The macro-pits in area III are much larger than those in area I.

Figure 4.1.1-27 The SEM image of the area I of the inner race shows the area is macro-pitted

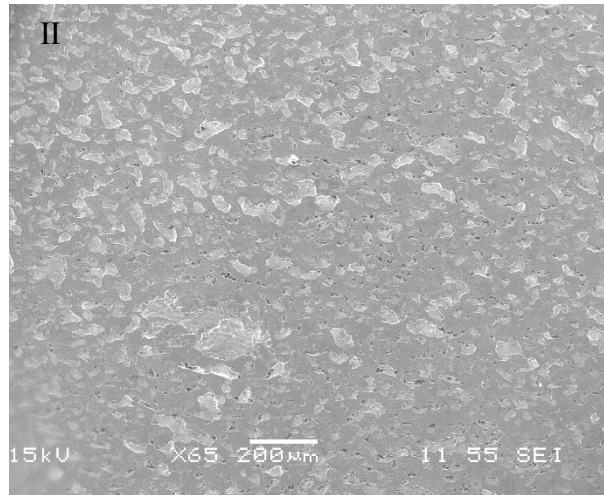
Figure 4.1.1-28 The SEM image of the area II of the inner race shows the middle area is micro-pitted

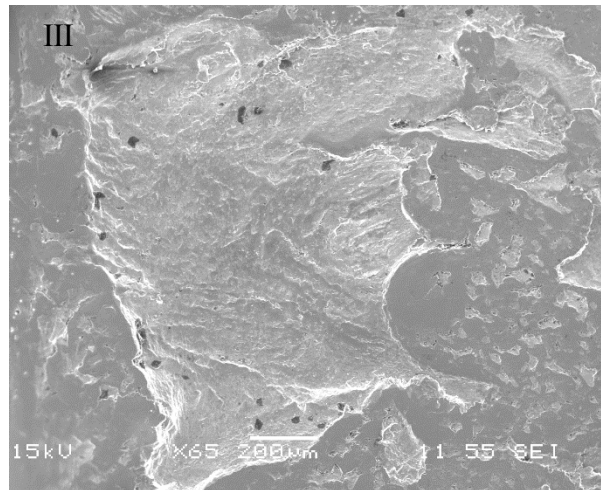
Figure 4.1.1-29 The SEM image of the area III of the inner race shows the area is macro-pitted, and these pits are bigger than those in area I

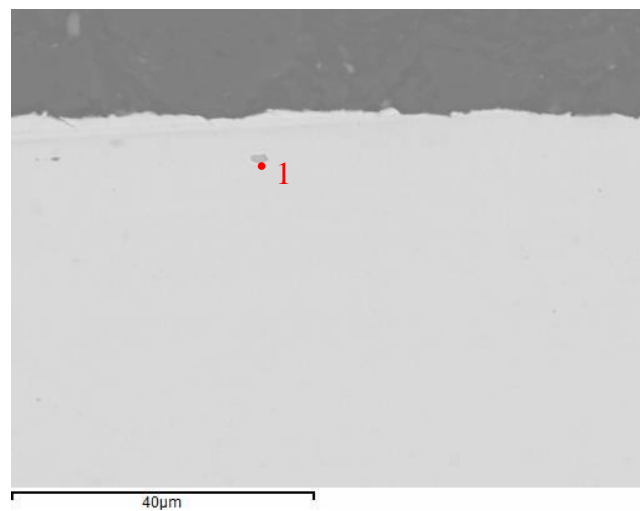
In the subsurface of the cross-section of the inner race, a large number of non-metallic inclusions, such as MnS, MnS surrounded Al_2O_3 (i.e. $\text{Al}_2\text{O}_3+\text{MnS}$), and SiC are observed. Some cracks are observed to have initiated from the SiC inclusions. MnS inclusions and MnS surrounded Al_2O_3 inclusions can be seen in Figure 4.1.1-30, Figure 4.1.1-31 and Figure 4.1.1-32. However, none of these subsurface MnS or $\text{Al}_2\text{O}_3+\text{MnS}$ inclusions are related to the surface micro- or macro-cracks.

Figure 4.1.1-30 Back-scattered-electron image and the EDS results of a coarse MnS inclusion particle in inner race subsurface

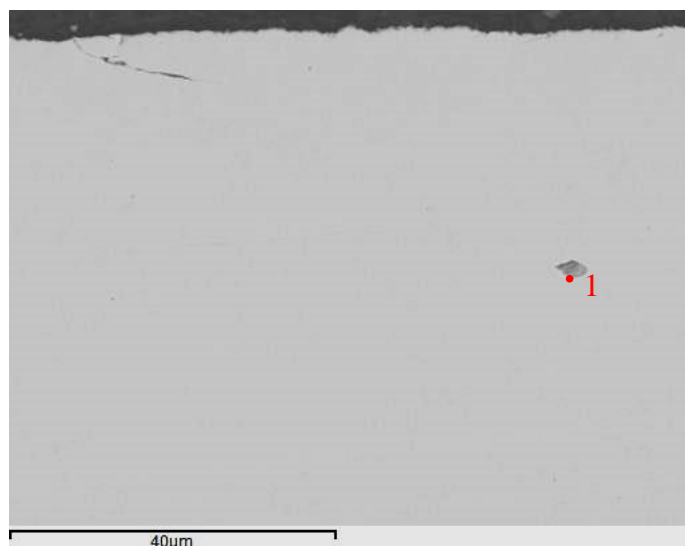
Figure 4.1.1-31 Back-scattered-electron image and the EDS results of a coarse MnS surrounded Al₂O₃ inclusion particle in inner race subsurface

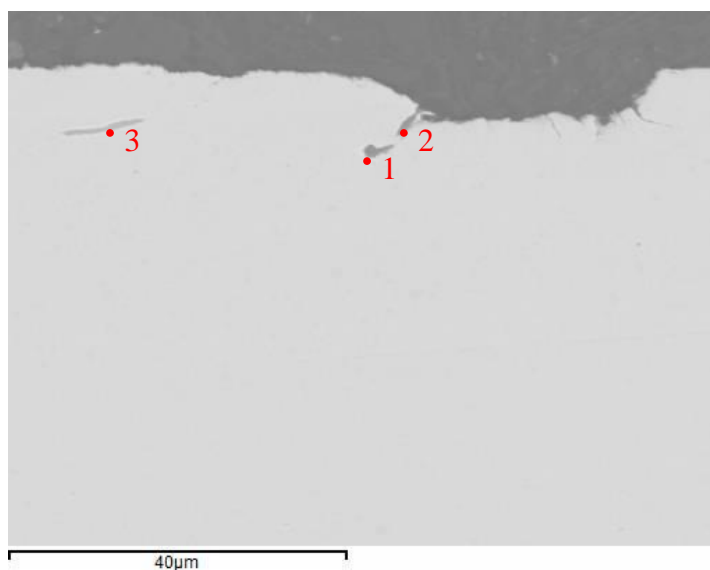
The formation mechanism of MnS surrounded Al_2O_3 is that the Al_2O_3 particles form first during the cooling stage. They act as the nuclei around which MnS solidifies later. SiC inclusions are shown in Figure 4.1.1-32, Figure 4.1.1-33 and Figure 4.1.1-34. It is worth noticing that the SiC inclusion in Figure 4.1.1-32 is connected to a pit. A crack is seen propagating through a SiC inclusion in Figure 4.1.1-33. Therefore, it is possible that some of the surface fatigue cracks in the inner race have initiated from subsurface inclusions, while others have initiated from the surface.

Figure 4.1.1-32 Back-scattered-electron image and the EDS results of two SiC inclusion particles and a stripe MnS inclusion particle in inner race subsurface

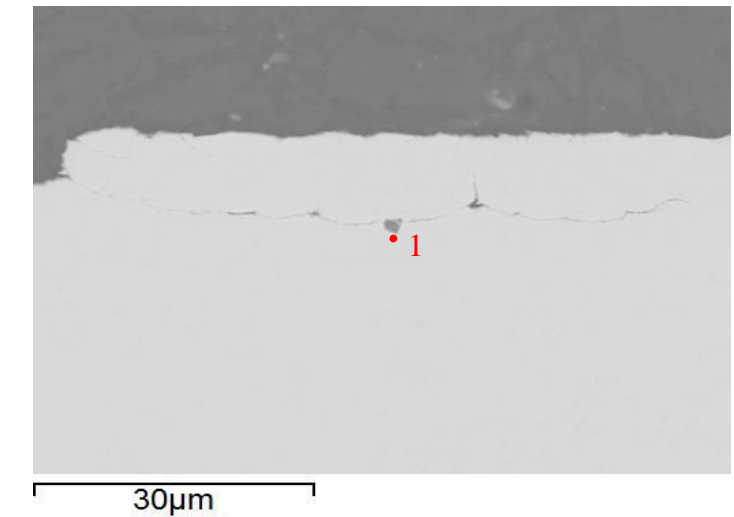
Figure 4.1.1-33 Back-scattered-electron image and the EDS results of a coarse SiC inclusion particle in inner race subsurface

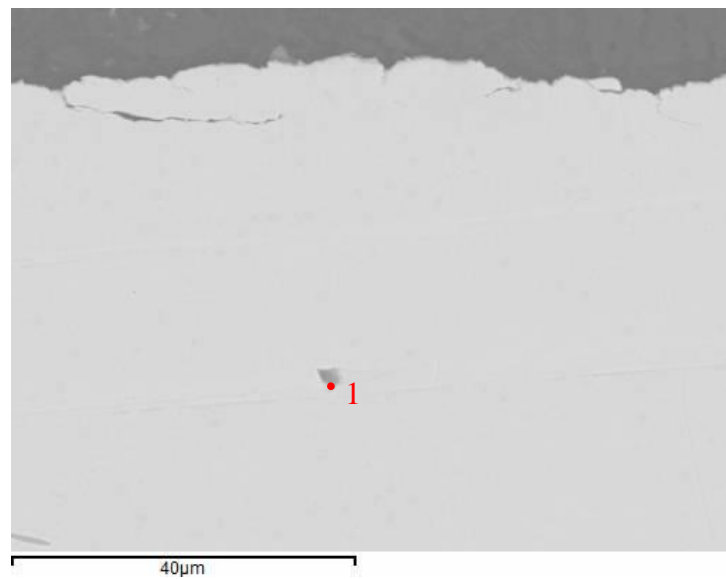
Figure 4.1.1-34 Back-scattered-electron image and the EDS results of a coarse SiC inclusion particle in inner race subsurface

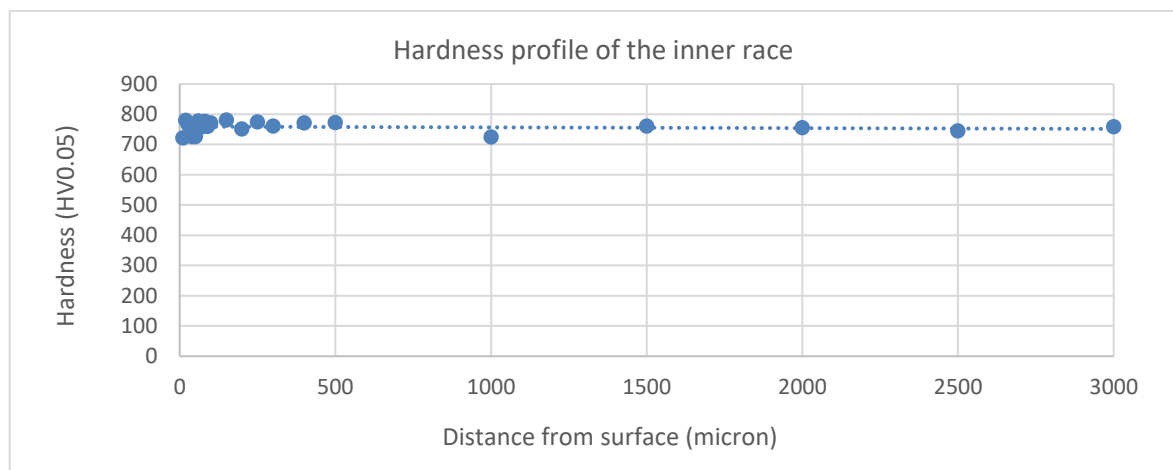
manufacturing. The average hardness of the inner race material is 757.76 ± 19.17 HV0.05 which meets the minimum hardness requirements 60 Rockwell C (about 697 HV) (Erwin V Zaretsky, 2012). The XRD analysis of the inner race material is shown in Figure 4.1.1-36. Only peaks of α' -Fe are observed. Figure 4.1.1-37 is the micrograph at a magnification of 500x of the inner race steel material after being etched with 2% nital. The microstructure observed consists of tempered martensite with fine dispersed spheroidised carbides.

Figure 4.1.1-35 The hardness profile of the inner race suggesting the inner race is possibly through hardened. The average hardness of the inner race material is 757.76 ± 19.17 HV0.05

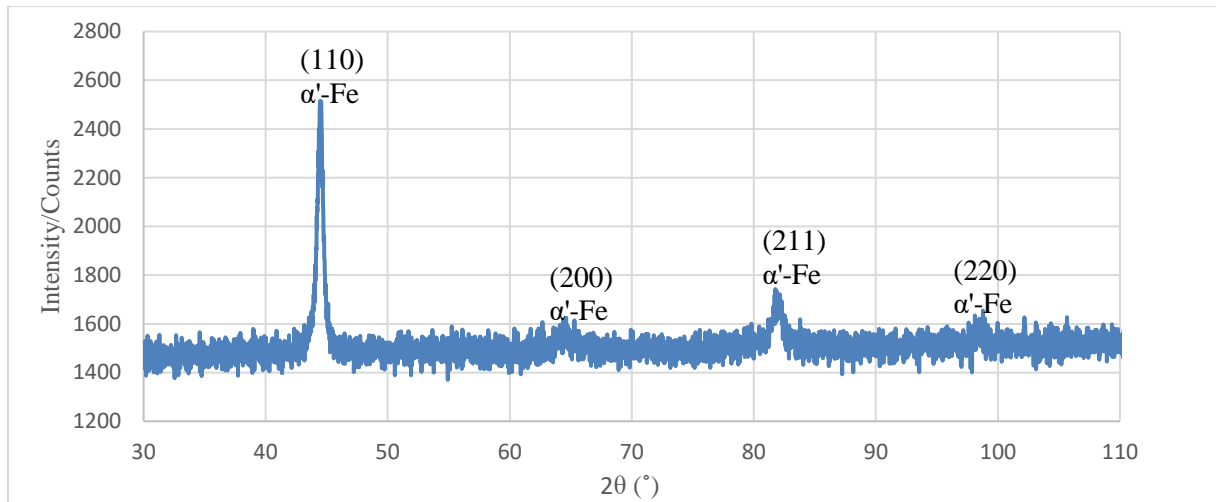
Figure 4.1.1-36 XRD pattern showing the main phase of the inner race steel

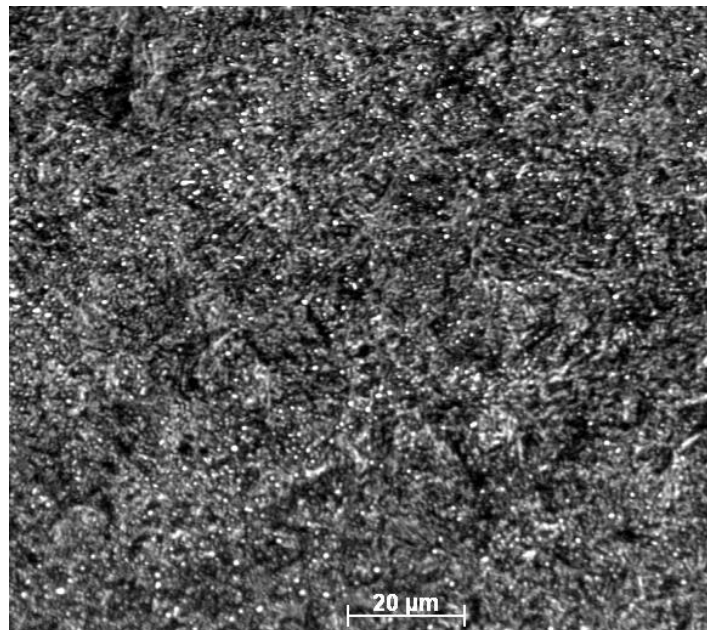
Figure 4.1.1-37 Metallography of the inner race microstructure, composed of tempered martensite and dispersed spheroidised fine carbides (2% natal, 500×)

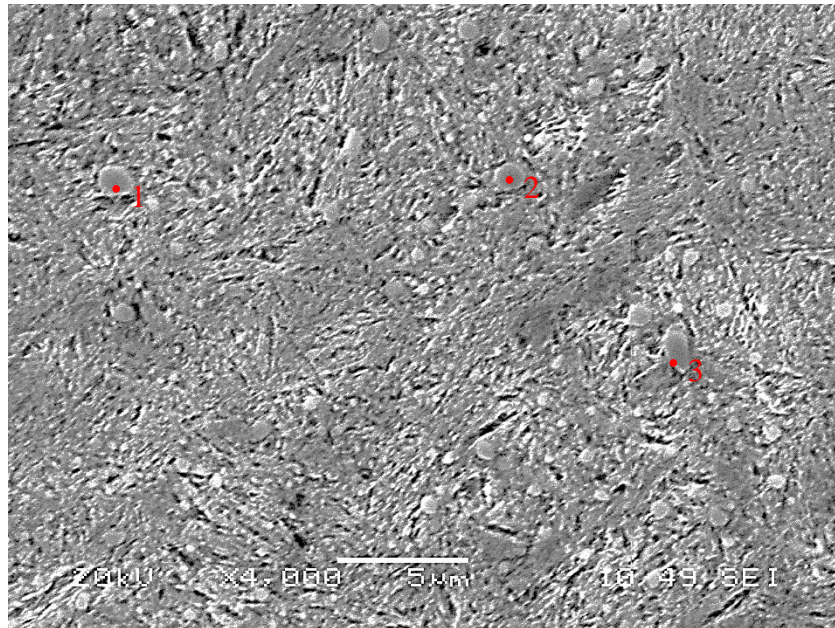
The SEM image of the etched sample and the EDS analysis of the carbide (Figure 4.1.1-38) revealed the same microstructure whilst the carbide was found to be rich in Cr and Fe content. The microstructure observed is in agreement with the micro-hardness measurement and XRD analysis of the inner race.

Figure 4.1.1-38 SEM image and EDS analysis of the spherical carbide particles in inner race

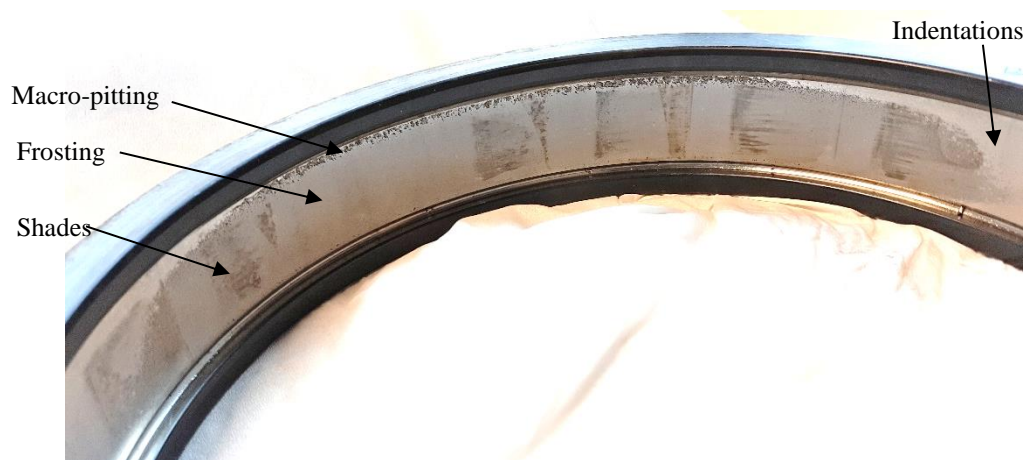
Only about one third of the outer ring raceway surface is damaged. This suggests that the loading is unevenly distributed along the outer race, and the damaged region can be used as an indicator of the load distribution (load zone) of the bearing. The macro-pitting on one edge of the outer race proves the existence of severe angular misalignment in the bearing once again. It indicates misalignment is a critical issue which did affect the bearing under examination. The indentations found adjacent to the micro-pitted area could act as surface stress raisers, subsequently prompting the initiation and growth of micro-pits. These indentations were thought to have been caused by harder debris, suggesting that the cleanliness of the lubricant was poor (FAG, 2001). The light brown and dark grey shades, i.e. the raceway discolouration, were mainly a result of chemical reactions between the steel and the lubricant when the local

temperature exceeded 80 °C. These surface shades appear very frequently in the loading zone, having no negative effect on the bearing service life themselves (FAG, 2001). However, they give clues to local surface heating due to severe sliding friction between the rollers and the outer race, which could cause degradation of the properties of the lubricant and steel. However, the local surface temperature is unlikely to have been too high. Hence, the degradation effect was very likely limited since no steel deformation was observed inside the shadow area.

Figure 4.1.1-39 In the outer ring raceway, grey micro-pitted area (i.e. frosting), macro-pitting damage, separated light brown and dark grey shades, and small indentations were identified

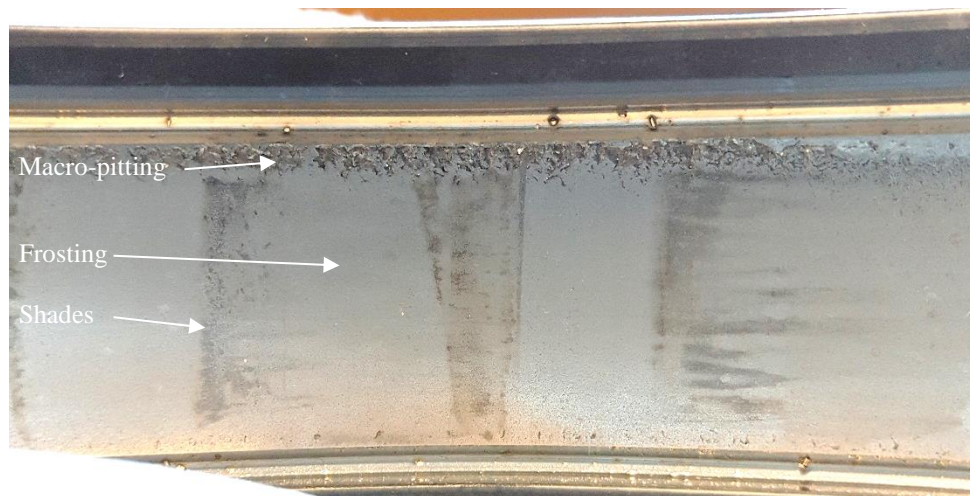
Figure 4.1.1-40 Closer observation of the main damaged area in the outer ring raceway

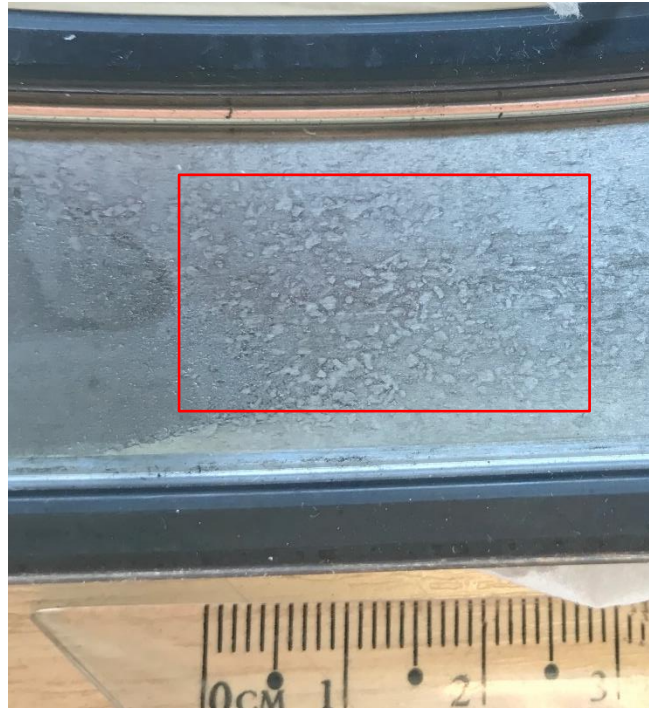
Figure 4.1.1-41 Closer observation of the small indentations by wear debris in the raceway, as framed

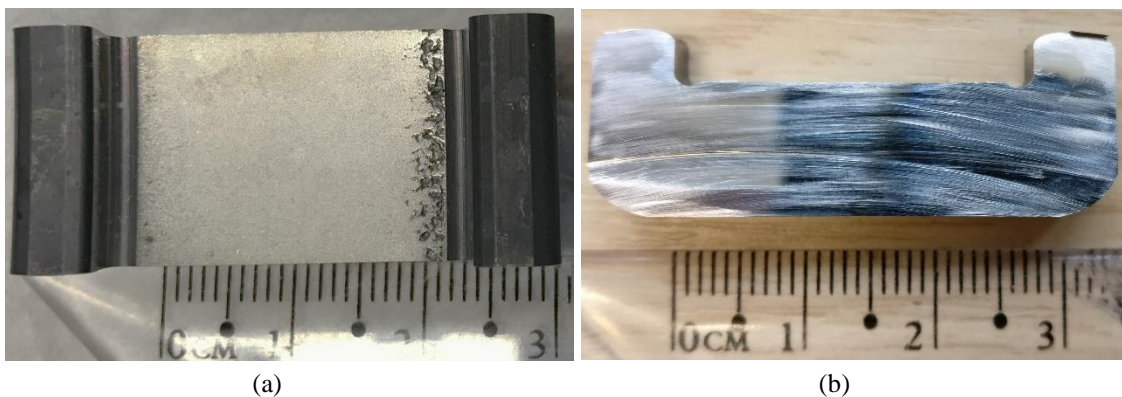
One section of the outer race was cut off from the main body for further examination as shown in Figure 4.1.1-42. The surface morphology of the damaged outer ring raceway observed under SEM is shown in Figure 4.1.1-43. It illustrates more clearly than visual checking that micro-pitting exists in the left end and in the middle of the raceway. Macro-pitting can be seen at the right end of the raceway. In the cross-section, a large number of elongated MnS and $\text{Al}_2\text{O}_3+\text{MnS}$ inclusions were observed, as shown in Figure 4.1.1-44, Figure 4.1.1-45 and Figure 4.1.1-46. Almost every inclusion lies parallel to the raceway surface. The top MnS inclusion in Figure 4.1.1-44 is very close to the raceway surface and it connects with the micro-pit. It is very likely that the micro-crack initiated from this inclusion and subsequently the micro-pit formed. Other MnS inclusions in Figure 4.1.1-44, Figure 4.1.1-45 and Figure 4.1.1-46 are seen deeper from the surface of the outer race. Thus, deeper

Figure 4.1.1-42 (a) The outer ring raceway surface and (b) the cross section of a small piece cut from the outer race
