***INVESTIGATION OF SURFACE ENGINEERING AND MONITORING
FOR RELIABLE WIND TURBINE GEARBOXES***

A thesis submitted to
The University of Birmingham
for the degree of
DOCTOR OF PHILOSOPHY

by
JUN ZHOU

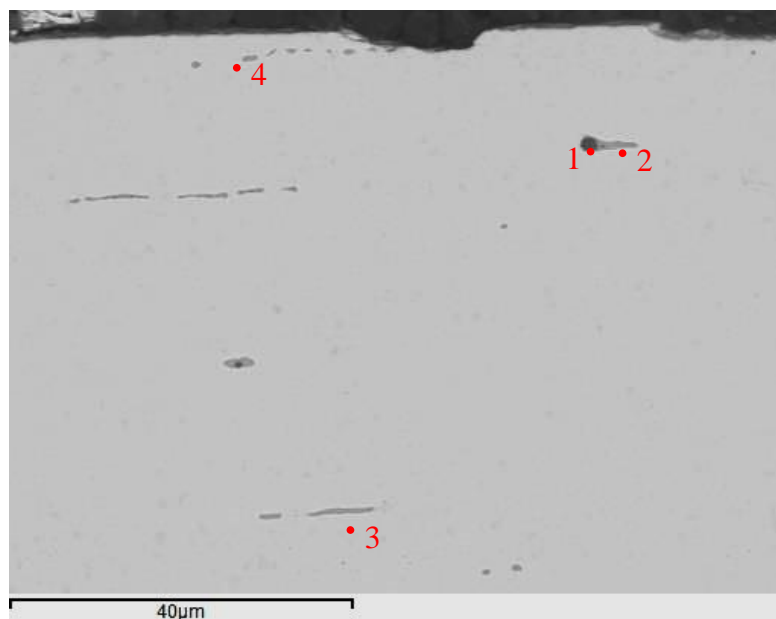
One section of the outer race was cut off from the main body for further examination as shown in Figure 4.1.1-42. The surface morphology of the damaged outer ring raceway observed under SEM is shown in Figure 4.1.1-43. It illustrates more clearly than visual checking that micro-pitting exists in the left end and in the middle of the raceway. Macro-pitting can be seen at the right end of the raceway. In the cross-section, a large number of elongated MnS and $\text{Al}_2\text{O}_3+\text{MnS}$ inclusions were observed, as shown in Figure 4.1.1-44, Figure 4.1.1-45 and Figure 4.1.1-46. Almost every inclusion lies parallel to the raceway surface. The top MnS inclusion in Figure 4.1.1-44 is very close to the raceway surface and it connects with the micro-pit. It is very likely that the micro-crack initiated from this inclusion and subsequently the micro-pit formed. Other MnS inclusions in Figure 4.1.1-44, Figure 4.1.1-45 and Figure 4.1.1-46 are seen deeper from the surface of the outer race. Thus, deeper

MnS inclusions have no effect on the surface damage but can influence subsequent crack propagation.

Figure 4.1.1-44 Back-scattered-electron image of some inclusions and the EDS results indicating two stripe MnS inclusions and a coarse Al₂O₃ particle surrounded by MnS inclusion in outer race subsurface

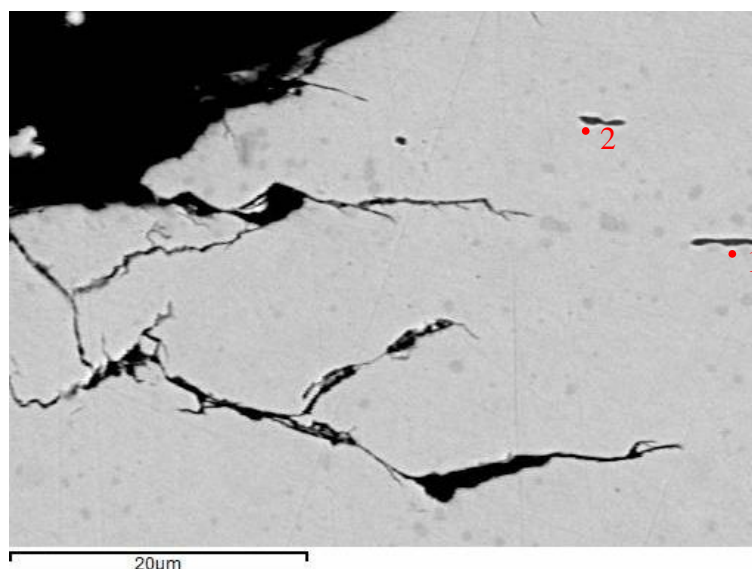
Figure 4.1.1-45 Back-scattered-electron image and the EDS results of two stripe MnS inclusion particles in outer race subsurface

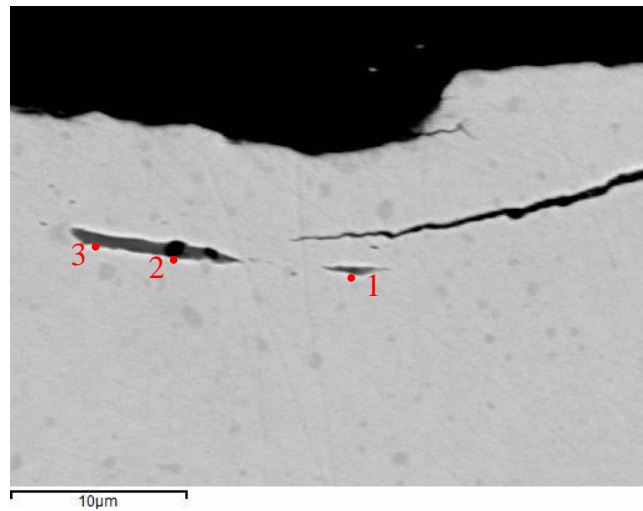
Figure 4.1.1-46 Back-scattered-electron image and the EDS results of a stripe MnS inclusion and a coarse Al₂O₃ inclusion particle surrounded by a stripe MnS inclusion in outer race subsurface

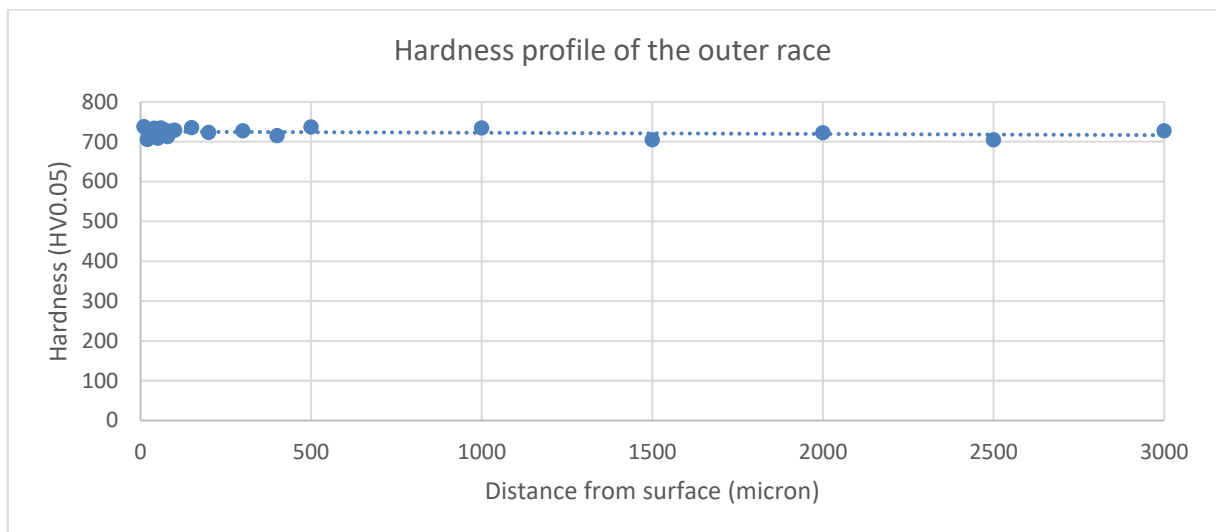
Figure 4.1.1-47 The hardness profile of the outer race suggesting the outer race is very likely through hardened. The average hardness of the outer race material is 723.66 ± 11.36 HV0.05

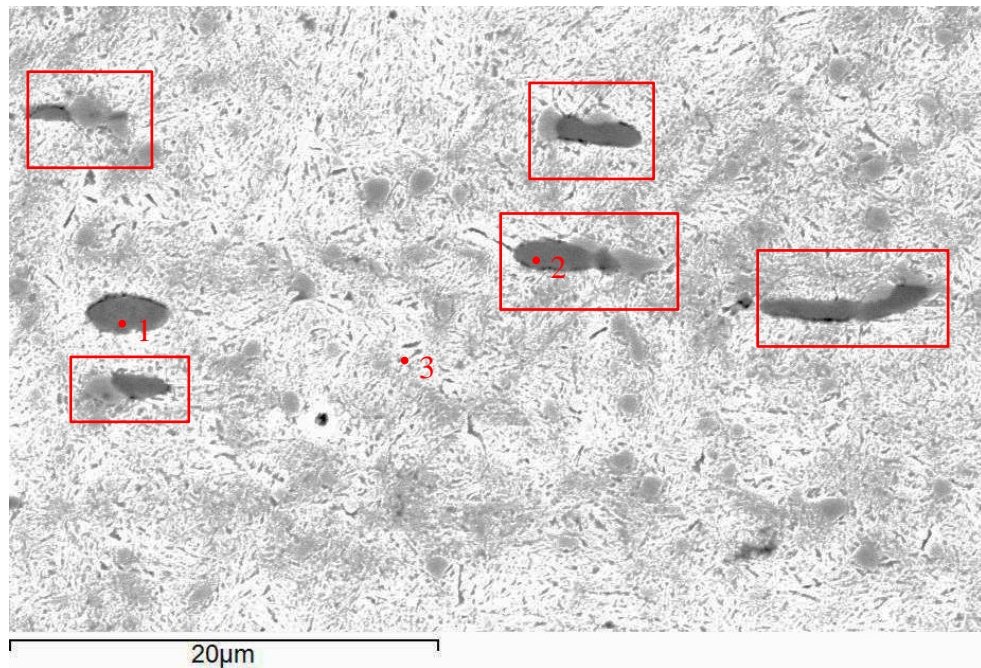
Figure 4.1.1-49 shows the micrograph of the outer race section at a magnification of 500 \times after etching using nital. The microstructure observed appears to be that of tempered martensite with fine dispersed spheroidised carbides. This is similar to the microstructure observed in the rollers and inner race. The SEM micrographs of the etched sample and the EDS analysis (Figure 4.1.1-50) revealed that the spherical carbides dispersed in tempered martensite matrix are rich in Cr/Fe. The microstructure observed is in agreement with the measured micro-hardness values and the XRD analysis of the outer race. In addition to that, large amount of MnS inclusions were also observed in the etched sample (Figure 4.1.1-51), and some of the MnS inclusions are in conjunction with the carbides which were framed in the Figure 4.1.1-51.

Figure 4.1.1-51 SEM image and EDS analysis of the MnS particles in outer race, some carbides can also be seen. Some of the MnS inclusions are in conjunction with the carbides as framed

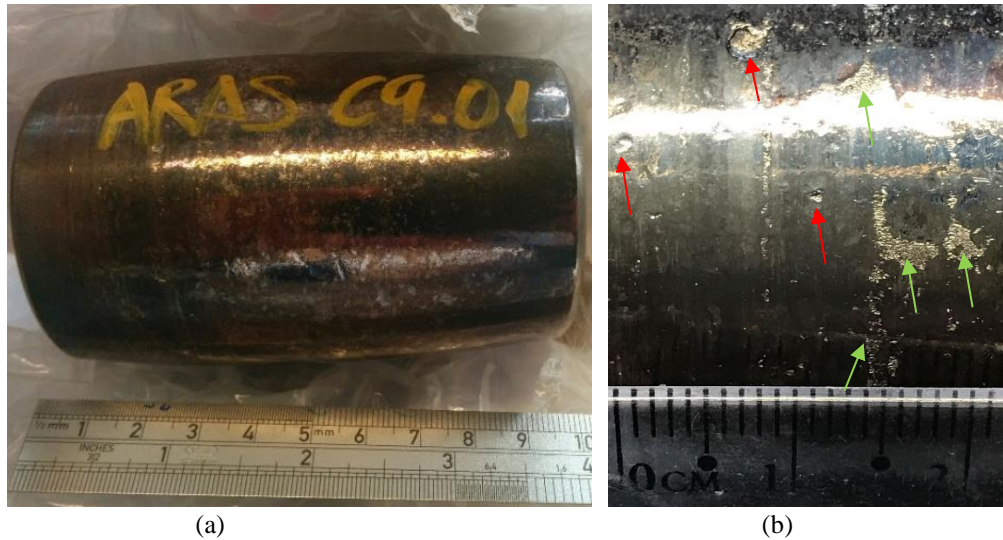
The damaged large spherical roller retrieved from the planetary bearing at the low-speed stage of the gearbox was shown in Figure 4.1.1-52(a). Firstly, unaided visual inspection was carried out on the whole surface area of the spherical roller. The roller surface exhibited different surface finish, texture and colour from that of a freshly machined steel surface, due to unsteady rolling/sliding under high cyclic load conditions. According to the preliminary visual examination (Figure 4.1.1-52(b)), several discrete macro-pits of various sizes and mild adhesive wear area were observed, especially in the central area. Among the observed surface defects, big craters due to macro-pitting were deemed to be the main failure mode.

Figure 4.1.1-52 Photos of the spherical roller, a) over look of the whole roller, and b) close look of the roller surface, discrete craters (red arrow) and mild adhesive wear area (green arrow) were identified

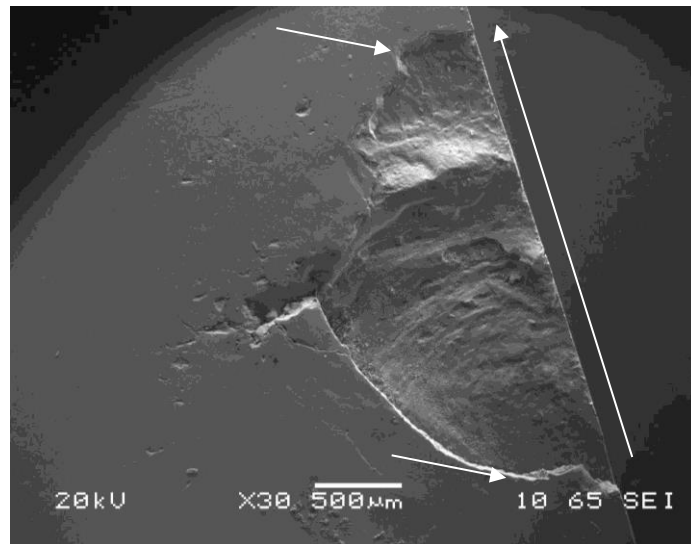
The SEM micrograph of one large crater is shown in Figure 4.1.1-53. The dimensions of the crater can be seen to exceed $3 \text{ mm} \times 3 \text{ mm}$. The dominant friction direction is indicated in the figure based on the position of leading-edge and the featheredge of the crater. The bottom of the large crater shown in Figure 4.1.1-54 is relatively smooth, implying brittle crack propagation.

Figure 4.1.1-53 SEM image of the half big crater in spherical roller surface

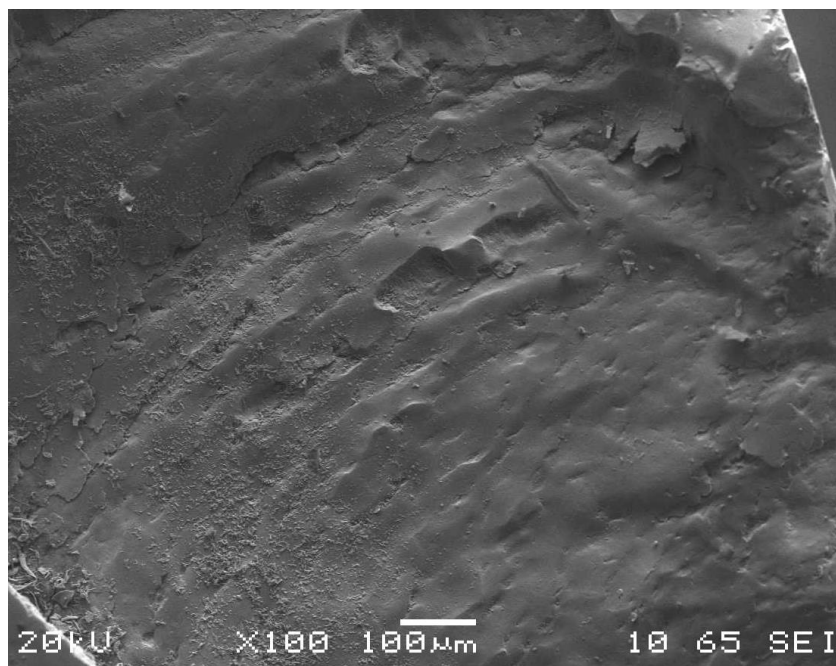
Figure 4.1.1-54 The floor of the big crater is smooth

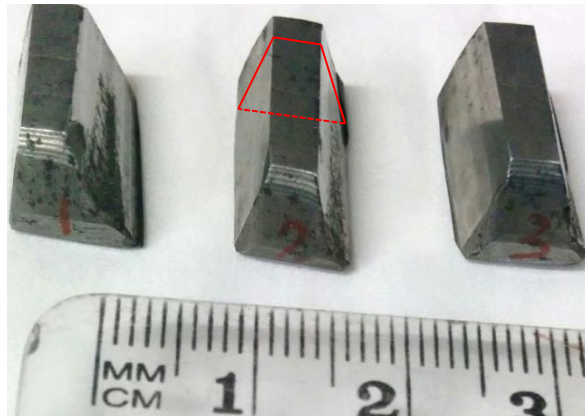
Gear tooth fracture of high-speed gears is common due to the high mesh frequency and stresses sustained. Three fractured gear teeth from the gears of the high-speed stage of the gearbox were retrieved from the field as shown in Figure 4.1.2-1. It is known that they have been manufactured from 18CrNiMo7-6 carburising steel. The failure modes of all the three teeth are micro-pitting, destructive wear and final tooth fracture.

Figure 4.1.2-1 The three gear teeth from the high-speed gear

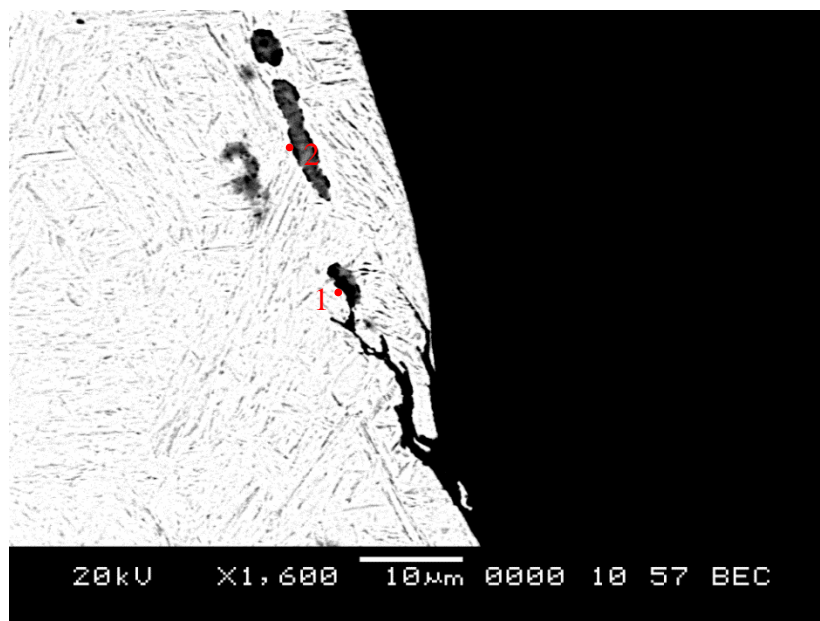
seen to be up to 10 μm . Most micro-pitting cracks are thought to have initiated at the surface. The formation of some other micro-cracks has been related to the presence of MnS inclusions in the surface or subsurface of the sample. For instance, as shown in Figure 4.1.2-7, one coarse MnS particle was found in the micro-pitting crack. In the vicinity of the crack, another MnS particle with larger size was also observed, which may easily cause enlargement of the local crack. The number of MnS inclusions in the gear material is so high that many of them are close to the gear surface, some even exposed to the surface as seen in Figure 4.1.2-8. The high number of coarse MnS inclusions in steel can improve machinability, but they are harmful to the strength and homogeneity of the material.

Figure 4.1.2-7 One MnS particle was observed in the crack, and another in the vicinity of the crack

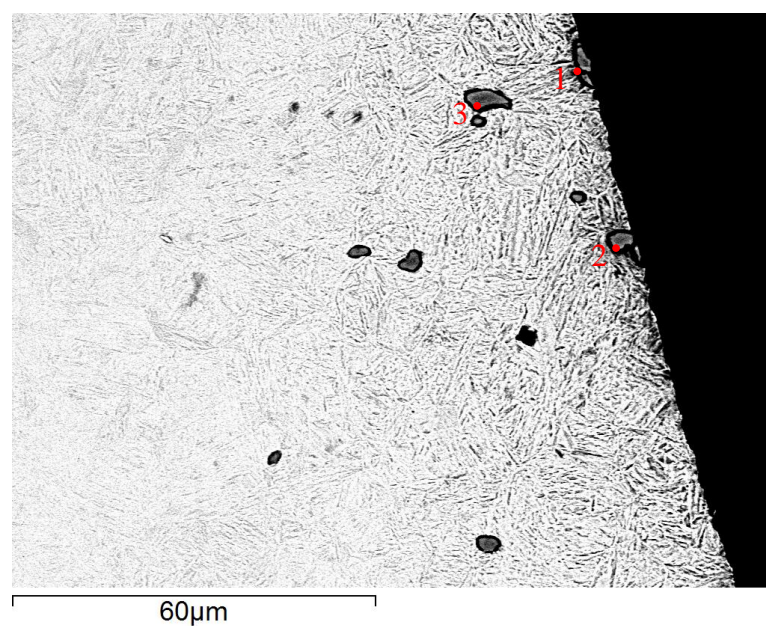
Figure 4.1.2-8 Two MnS particles were observed in the contact surface, also many in the subsurface area

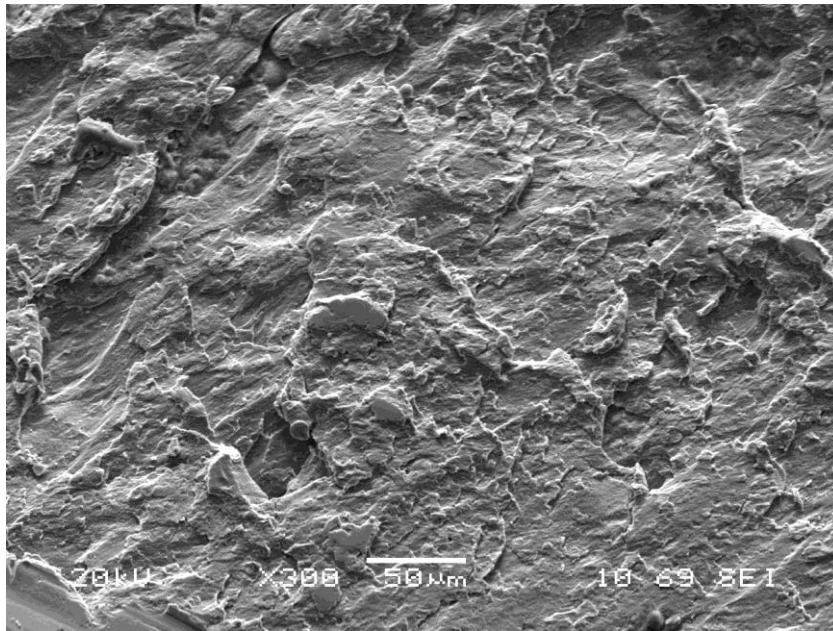
The second failure mode is partially attributed to excessive wear. The surface morphology of the concave surface due to destructive wear is shown in Figure 4.1.2-9, illustrating the wear mode is severe adhesive wear. When lubrication has failed, adhesive wear occurs in the metal-to-metal contacted meshing gear pair due to the combination of adhesion force, normal contact pressure and frictional shear stress. Adhesion results from attractive atomic forces between the real contact regions (i.e. the contacting asperities on surface) of two friction bodies, which ‘weld’ the contacting asperities together. Enough normal contact pressure and frictional shear stress could strengthen the local material of contacting asperities through plastic deformation, increasing the area of the asperity junction (G. Stachowiak and A.W. Batchelor, 2013). Then the movement of the gear pair would tear the ‘welded’ and cold worked asperity material away from the main body leading to rapid material removal from the tooth surface. The gear pair in the high-speed stage of wind turbine gearbox is prone to severe adhesive wear. This is due to the fact that the gear pair is made of same material and the operating conditions involve high rotational speed and heavy loads which can result in large plastic deformation, high surface temperature and large adhesive area (Shizhu Wen and Ping Huang, 2012). Furthermore, adhesive wear selectively occurs in the area where contact pressure is high (normally around the pitch line), and also at the tip and root of the gear tooth where sliding velocities are high (Rexnord-Industries, 1978). Excessive and destructive adhesive wear that has caused changes in the tooth profile impairs the smooth meshing action of gears, increases vibration and can eventually lead to tooth fracture (Rexnord-Industries, 1978, NOVEXA, 2017). In order to prevent destructive adhesive wear and secondary tooth fracture, gear surface hardness and lubrication need to be further improved (G. Stachowiak and A.W. Batchelor, 2013). The friction force between the gears of a pair also needs to be decreased whilst the contact pressure should also be reduced.

Figure 4.1.2-9 Surface morphology of the concaved surface

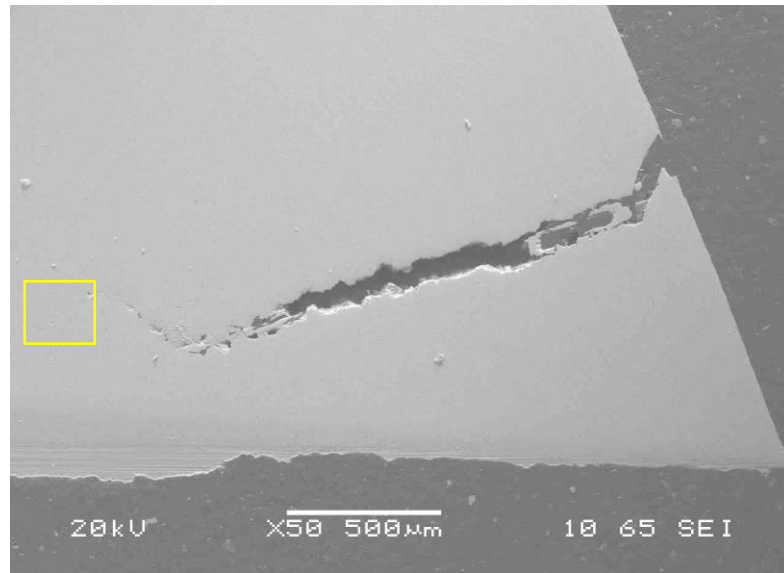
The third type of failure of gear teeth is tooth fracture. Gear tooth fracture is thought to be related to misalignment effects, coarse MnS inclusions, micro-pitting and excessive wear. Figure 4.1.2-10 shows the SEM micrograph of the obtained cross-section of the cracked area. Due to the severe deformation and possible loss of the material in the outer section of the cracked area, little information can be obtained. However, in the deeper section of the cracked area as shown in Figure 4.1.2-10, where crack has reached its maximum depth and material deformation is limited, valuable clues can be found. The framed area shown in Figure 4.1.2-10 was observed under higher magnification using back-scattered electron microscopy. As indicated in the back-scattered electron micrograph shown in Figure 4.1.2-11, four inclusions can be identified along the crack path, easily seen due to the colour contrast with respect to the bright surrounding matrix material. From the EDS results, it has been ascertained that these inclusions are MnS. MnS inclusions exhibit low hardness making them much softer than the matrix material. MnS inclusions may act as the crack initiation points (L. de Campos

Franceschini Canale, 2008). It is worth noticing that the crack propagation followed the path along these inclusions. It is likely that the soft MnS inclusion caused stress concentration, weakening the local strength of the material. As a result, the crack was prompted to grow along these weaker MnS inclusions. MnS inclusions were also observed in other sections of the cracked area in the gear tooth, as indicated in Figure 4.1.2-12. The propagation of cracks along the soft MnS inclusions has been successfully simulated in section 4.2.2 (as shown in Figure 4.2.2-2). Therefore, the effect of MnS inclusions on the gear teeth bending fracture need to be taken into consideration, especially when the size of MnS particles is coarse and their number present in the matrix is high (as shown in Figure 4.1.2-13).

Figure 4.1.2-10 Cross section of the big crack in the high-speed gear tooth

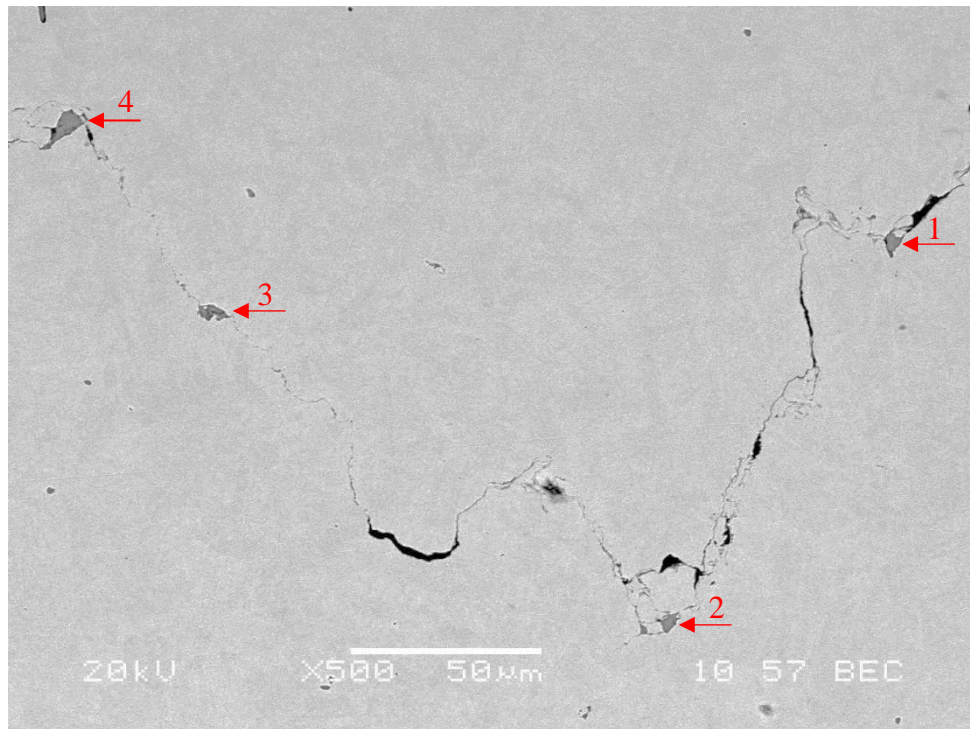
Figure 4.1.2-11 SEM/EDS results of inclusions in the end of the big crack, indicating the crack propagated along the soft MnS inclusions. This phenomenon has been successfully simulated in section 4.2.2 (as shown in Figure 4.2.2-2).

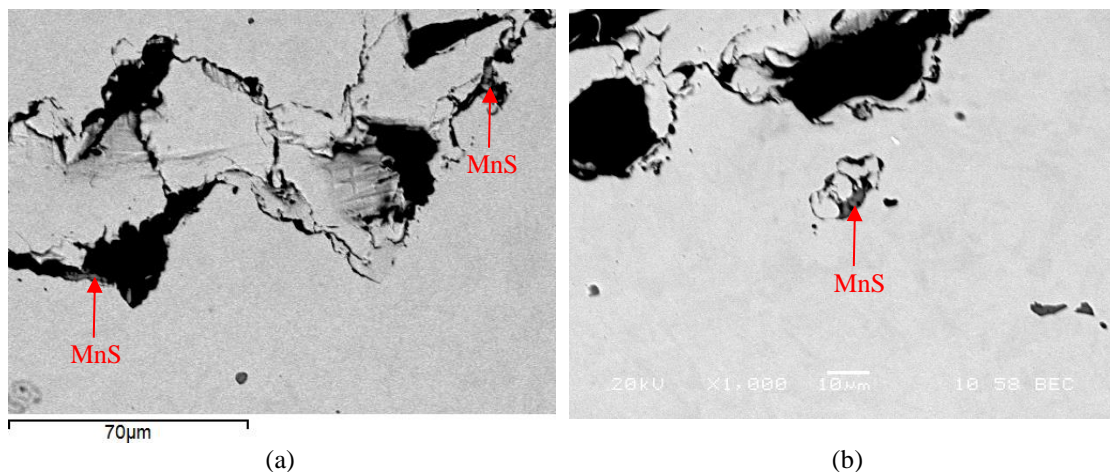
Figure 4.1.2-12 MnS inclusions were also observed under SEM and proved by EDS, as arrowed, in other sections of the big crack in the gear tooth

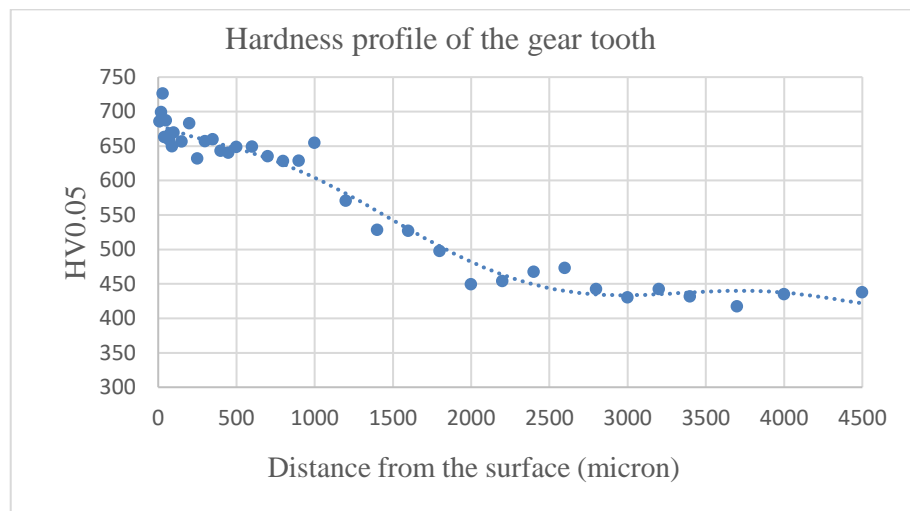
The cross-section of the broken tooth was examined to obtain more information. The hardness profile of the gear tooth is plotted in Figure 4.1.2-18, indicating a case hardened material. The surface hardness increased to about 720 HV0.05, whilst the core hardness was measured to be about 440 HV0.05. The thickness of the case-hardened layer is about 2,000 μm . The hardness of the gear teeth met the recommended value of the international standard ISO 6336-5:2003. In the XRD pattern of the tooth material, shown in Figure 4.1.2-19, only peaks of α' -Fe phase are observed.

Figure 4.1.2-18 The hardness profile of the gear tooth from intermediate stage indicating a case hardened material. The surface hardness is about 720 HV0.05, whilst the core hardness was measured to be about 440 HV0.05.

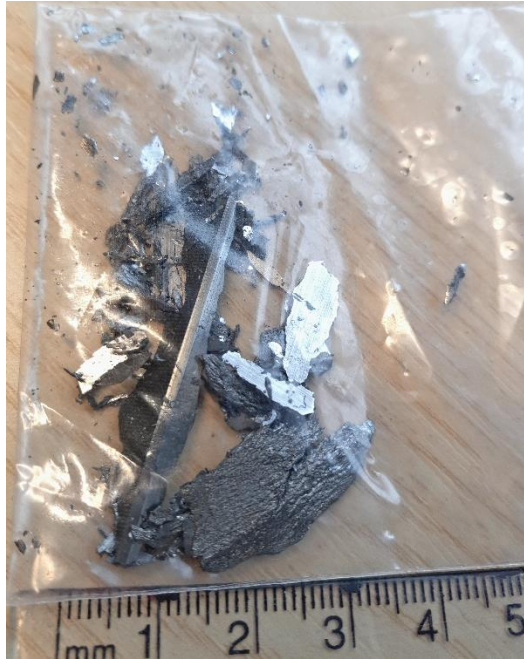
damaged planetary gear at the low-speed stage of the gearbox were retrieved (as shown in Figure 4.1.2-22) to study the failure causes. The retrieved debris particles have a grey metallic appearance, without any black, red or brown oxide colour present. The dimension of the retrieved debris particles varies from less than 1 mm to more than 4 cm. Those large debris particles indicate a catastrophic damage event occurred in the planetary gears.

Figure 4.1.2-22 The debris from the low-speed planetary gears

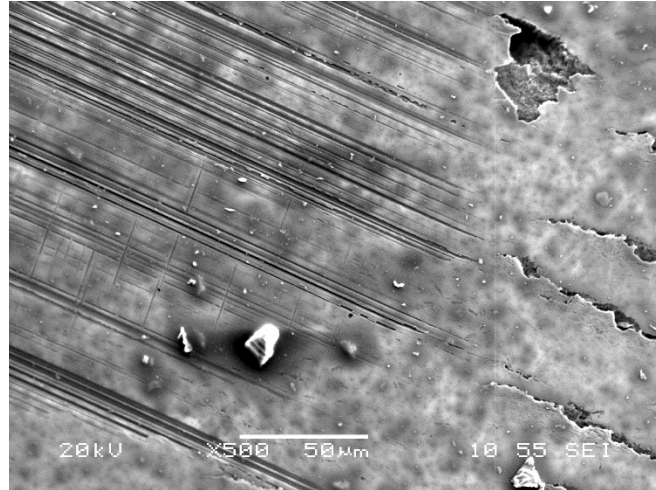
Under SEM examination, the debris particles are chunky, while they display a non-uniform shape and morphology. Six representative debris particles are shown in Figure 4.1.2-23. The surface of Particle 1 is very flat, with scratches and cracks present as seen in Figure 4.1.2-24. It is very likely that Particle 1 was broken off from the tooth surface, judging from its flat surface and features present. The surface of Particle 2 is concave, while the surface of Particle 3 is convex. Particle 4 has two relatively flat surfaces meeting, forming a ridge. The morphology of the surface of Particle 5 is granular and step-like, which is a symptom of brittle cleavage fracture. The surface of the Particle 6 is crushed and full of deep cracks. It

Figure 4.1.2-24 The flat surface with scratches and cracks of particle 1

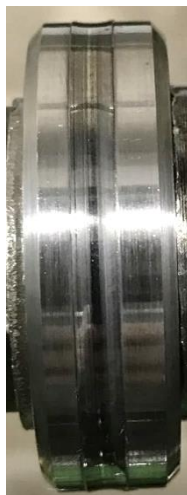
No AE hit above the threshold set was detected during the 1st period. At the end of this period, a concaved surface was observed in the untreated EN36 wheel (as shown in Figure 5.2-4), and the weight loss was negligible, indicating the concave surface was because the result of significant plastic deformation. Since acoustic emission signals are related to the release of elastic strain energy, the generated signals during plastic deformation would be too weak to be detectable. The FFT spectrum of the vibration signal provided in Figure 5.2-5, did not show any significant changes from the beginning to the end of 1st period either.

Figure 5.2-4 Photo of the untreated EN36 wheel after the 1st period of Test 1

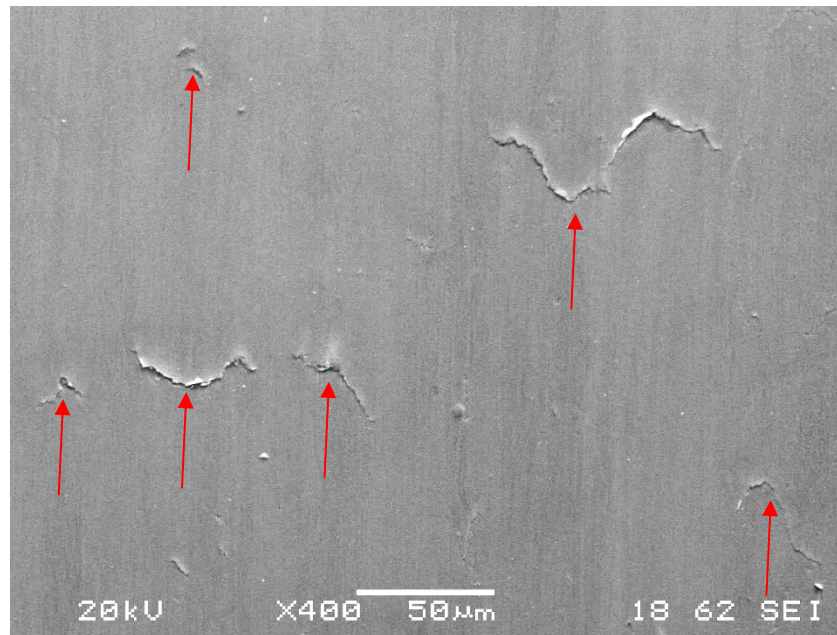
Under SEM, only micro-cracks were observed in the untreated EN36 surface after the second period as shown in Figure 5.2-8. This suggests that most of these micro-cracks were too small to generate AE signals with sufficient energy/amplitude higher than background noise and

Figure 5.2-8 SEM image of the wear track surface after the 2nd period of Test 1, micro-cracks can be observed as arrowed

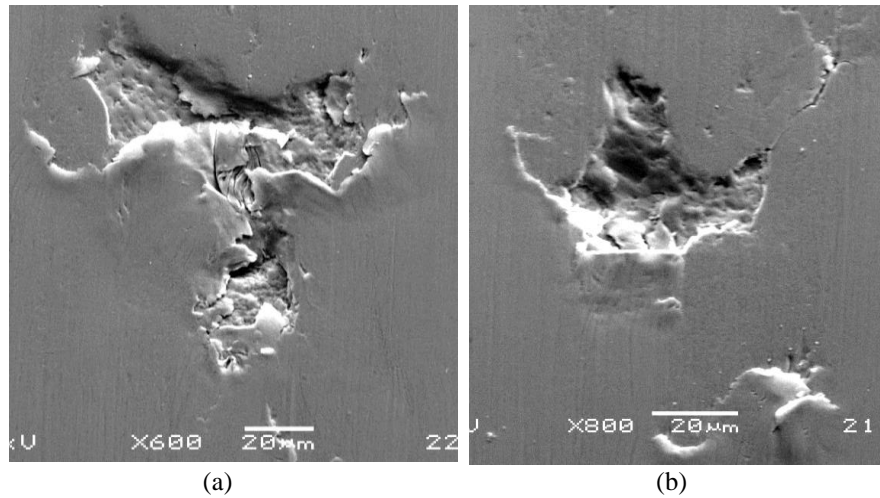
At the end of this period, the wheel sample was examined using SEM. Some micro-pits with a diameter of around 50 μm (as shown in Figure 5.2-13) were observed in the steel wheel sample examined. No damage was observed in the WC wheel (as shown in Figure 5.2-14). The formation of these micro-pits may be the source of the detected discrete AE signals. But the formation of these micro-pits did not change the vibration pattern of the wear tester as

Figure 5.2-13 SEM image of the wear track surface of untreated EN36 wheel after the 3rd period of Test 1, micro-pits can be observed

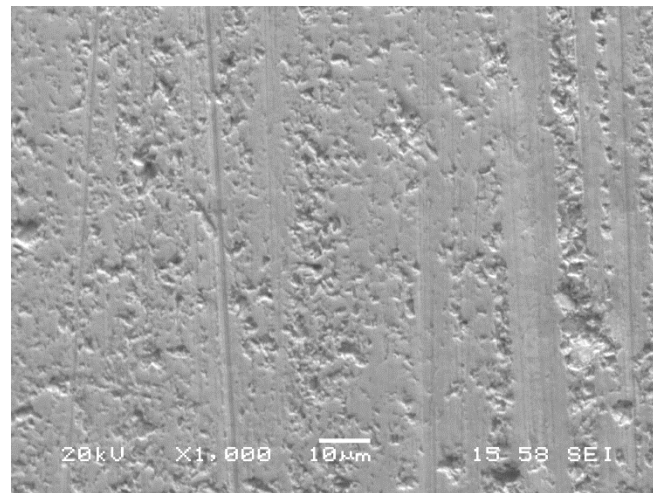
Figure 5.2-14 SEM image of the contact surface of WC wheel after the 3rd period of Test 1, no obvious damage formed

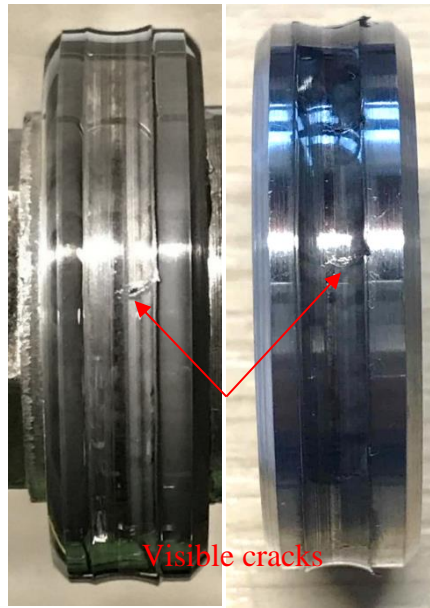
In agreement with the AE signals, 5 visible axial cracks were found with the naked eye in the wheel made of untreated EN36 (as shown in Figure 5.2-19). Using SEM, these cracks were measured to be approximately 1,500 μm long. Some craters with dimensions up to 500 $\mu\text{m} \times 500\mu\text{m}$ were also observed (as shown in Figure 5.2-20). The formation of these large cracks and craters generated AE signals. No significant change in the vibration spectrum occurred during this period, except for two new peaks with amplitude lower than 10 μV (as shown in Figure 5.2-21). The WC wheel remained undamaged.

Figure 5.2-19 Photos of visible cracks formed during the 4th period of Test 1

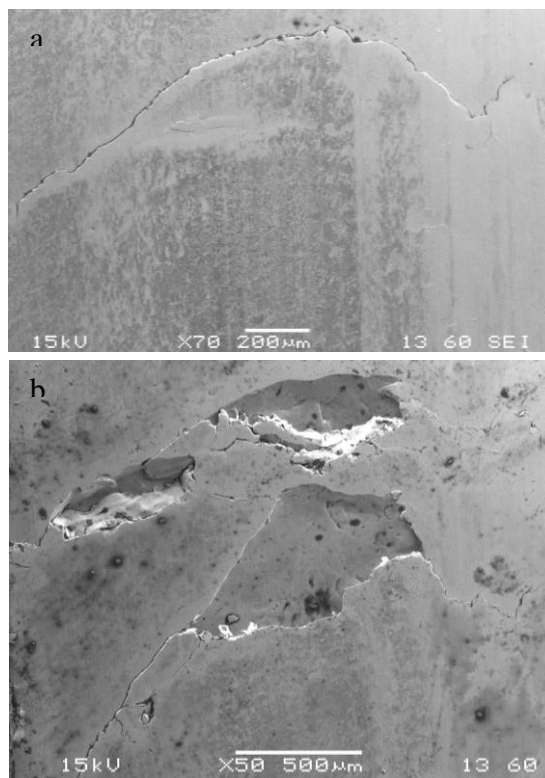
Figure 5.2-20 SEM images of big cracks and craters formed during the 4th period of Test 1, (a) crack longer than 1,500 μm, and (b) long crack and crater larger than 500 μm × 500 μm

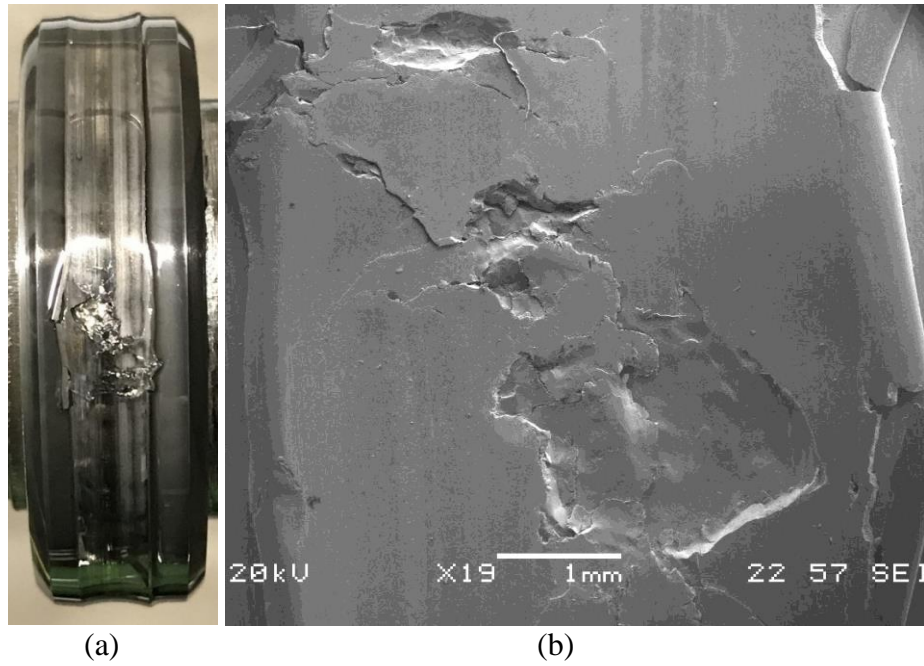
Surface defects including one big crater larger than 1 mm² and other visible cracks were observed in the EN36 wheel at the end of this period (as shown in Figure 5.2-25). The AE cluster and increased vibration of wear tester was very possibly arising from the presence of the big crater. There was no damage in the WC wheel (as shown in Figure 5.2-26).

Figure 5.2-25 One big crater and several small craters formed in the untreated EN36 wheel surface after the last period of Test 1, (a) the photo, and (b) the SEM image

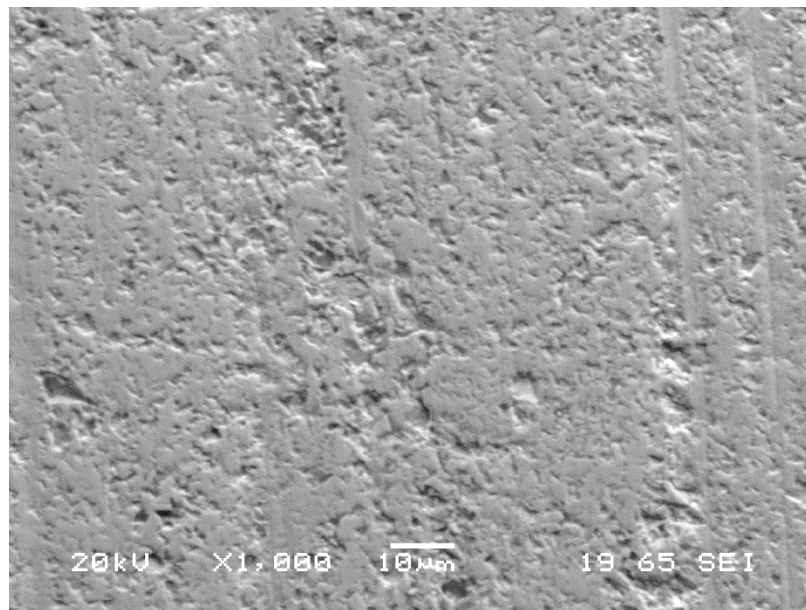
Figure 5.2-26 The contact surface of WC wheel without severe damage at the end of Test 1

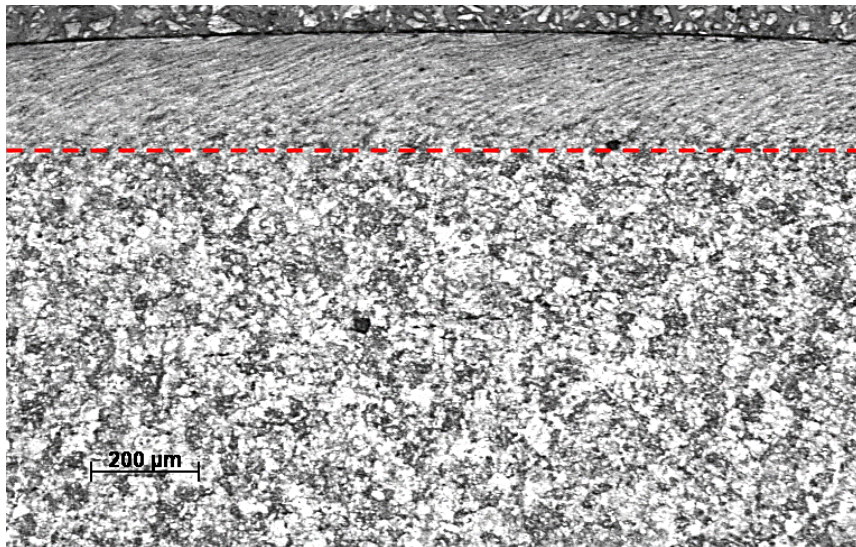
Using optical microscopy, the microstructure of the top 200 μm of the tested EN36 wheel were found to differ from the core area (as shown in Figure 5.2-28). The modified microstructure of the top area shows a texture from left to right, which illustrates a directional plastic deformation (strain hardening) caused by the compressive rolling-sliding contact. The friction induces shear stress and when it exceeds the shear yield strength, the plastic deformation would occur, particularly in high load and high slippage conditions (DI Fletcher et al., 2008).

Figure 5.2-28 The top 200 μm zone of untreated EN36 was severely plastic deformed after rolling-sliding Test 1

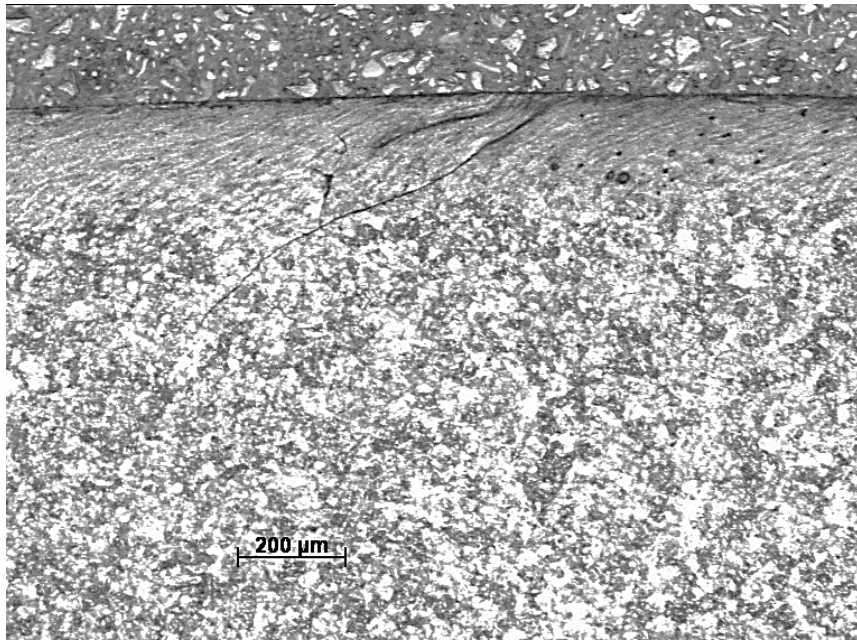
The cross-section micrographs of the cracks in the untreated EN36 are shown in Figure 5.2-29 and Figure 5.2-30. Some of them have reached the wheel sample's surface whilst others propagated towards the core. These rolling contact fatigue cracks formed after thousands of loading-unloading cycles and they propagated along the texture direction to the surface. The initiation of these RCF cracks is due to the strain/ductility exhaustion of wheel material at or near the surface after repeating load cycles (DI Fletcher et al., 2008).

Figure 5.2-29 Cross section of cracks in the sample surface formed during Test 1

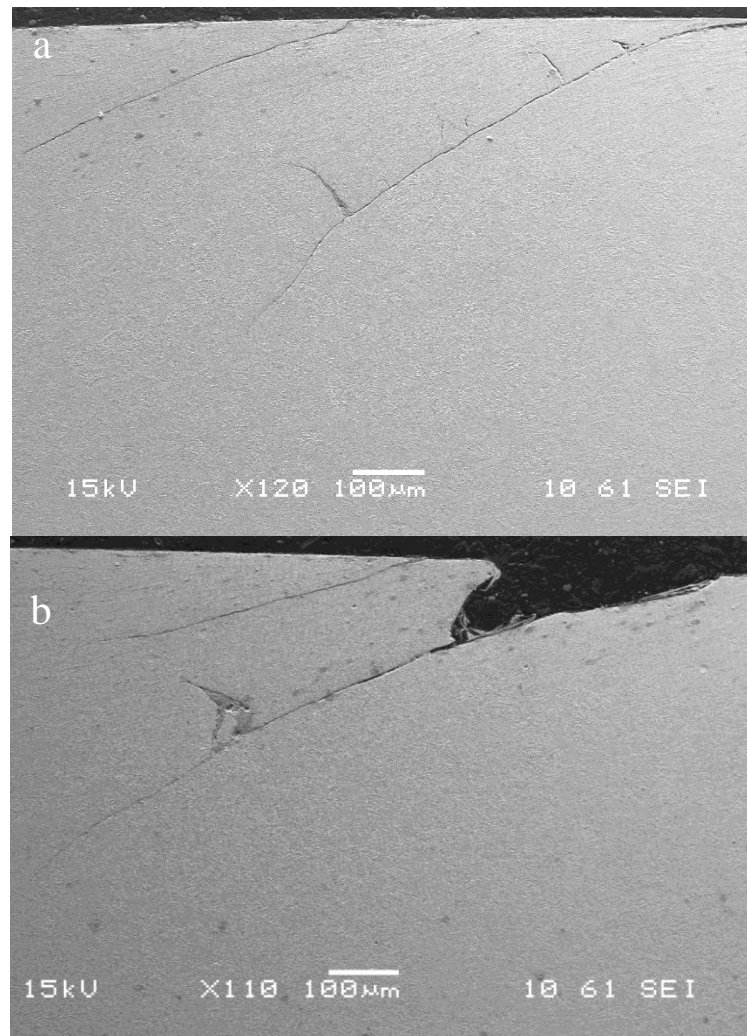
Figure 5.2-30 SEM images of long crack and crater formed during Test 1, (a) crack with long branches, and (b) cracks and a crater due to crack branch breaking off

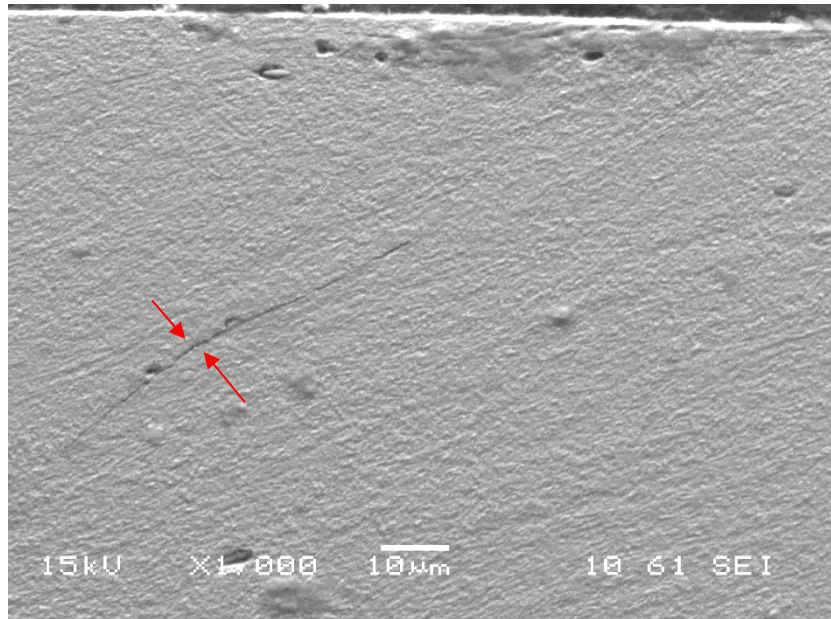
In addition to those major surface defects, subsurface initiating cracks were also observed (as shown in Figure 5.2-31). The formation and propagation of some of these subsurface cracks may generate detectable AE as well, which means AE signals could indicate the development of subsurface cracks before visible surface cracks have formed. Particularly, if the subsurface cracks develop rapidly then an AE signal cluster may be generated.

Figure 5.2-31 SEM image of subsurface initiated crack in the plastic deformation zone formed during Test 1

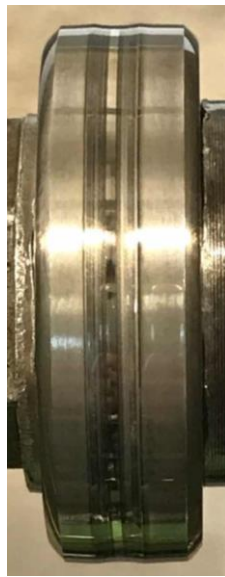
A concaved surface due to plastic deformation formed on the as-received EN40BT wheel (as shown in Figure 5.3-1) soon after the load was applied. No AE was detected during that moment.

Figure 5.3-1 A concave surface formed in the untreated EN40BT wheel due to plastic deformation during the 1st period of Test 2

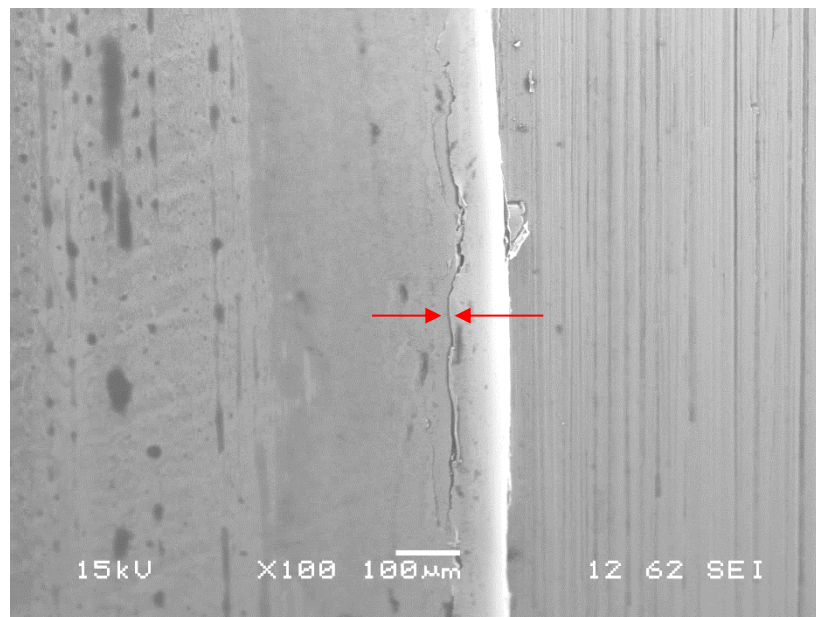
The test was interrupted at the end of this period, and a significant crack, longer than 1,000 μm was observed along the edge of the contact area in EN40BT wheel (as shown in Figure 5.3-5). The WC wheel was still damage-free (as shown in Figure 5.3-6). It is very likely that the cluster of AE was from this crack. The direction of this early-formed crack is different from the axial rolling contact fatigue crack, and it has a different formation mechanism. The wear track cross-section of the tested wheel is shown in Figure 5.3-7. The plastic flow pushed the material from the centre to the sides of the contact area, causing the edge of the wear scar to protrude over the original wheel surface. Hence, the edge is easy to concentrate stress and eventually fracture. The crack formed very early, which could be due to some local defects or weak points introduced from the wheel machining or grinding process.

Figure 5.3-5 SEM image of a big crack longer than 1,000 µm at the edge of contact surface of untreated EN40BT wheel after the 1st period of Test 2

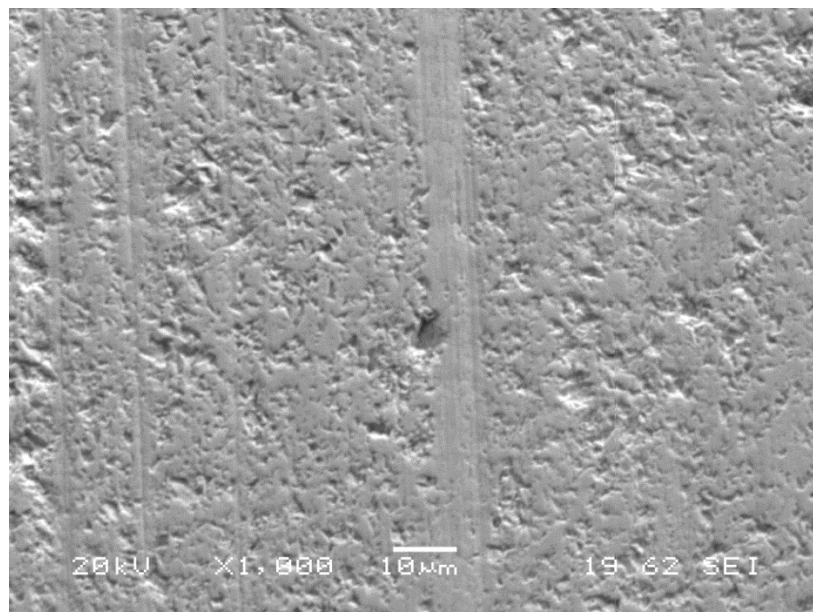
Figure 5.3-6 SEM image of damage-free surface of WC wheel after the 1st period of Test 2

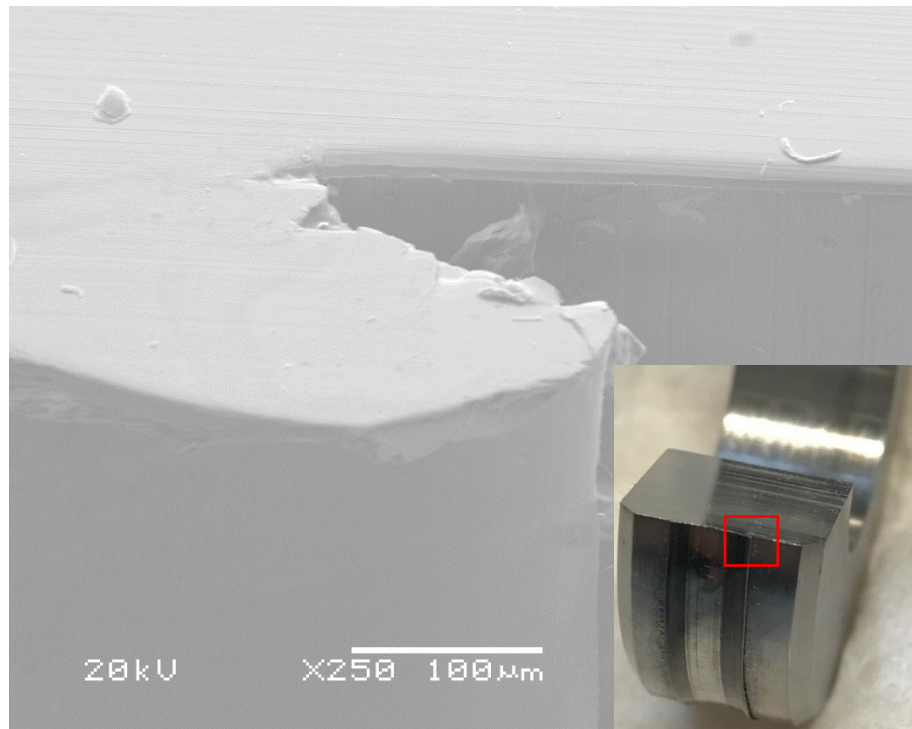
Figure 5.3-7 Images of cross section of wear track formed during Test 2, material was pushed to the edge of wear track and extruded over the original wheel surface

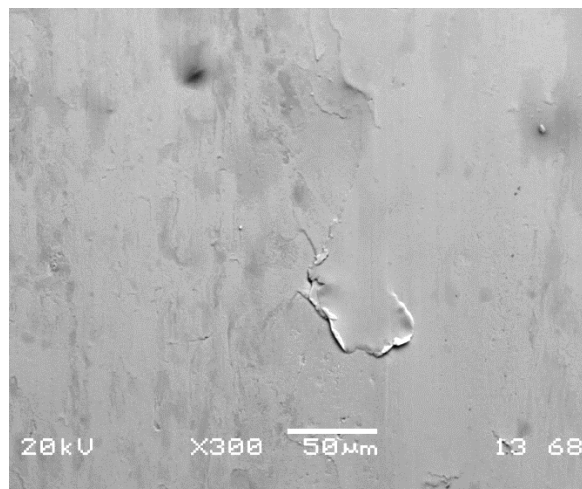
In the other contact surface, no severe damage was observed apart from micro-cracks around 50 μm long (as shown in Figure 5.3-8). These minor defects and the long edge crack did not change the wheel profile. Thus, the vibration spectrum was identical to the initial one,

Figure 5.3-8 SEM image of micro-crack in the main contact area of untreated EN40BT wheel after the 1st period of Test 2
