***INVESTIGATION OF SURFACE ENGINEERING AND MONITORING
FOR RELIABLE WIND TURBINE GEARBOXES***

A thesis submitted to
The University of Birmingham
for the degree of
DOCTOR OF PHILOSOPHY

by
JUN ZHOU

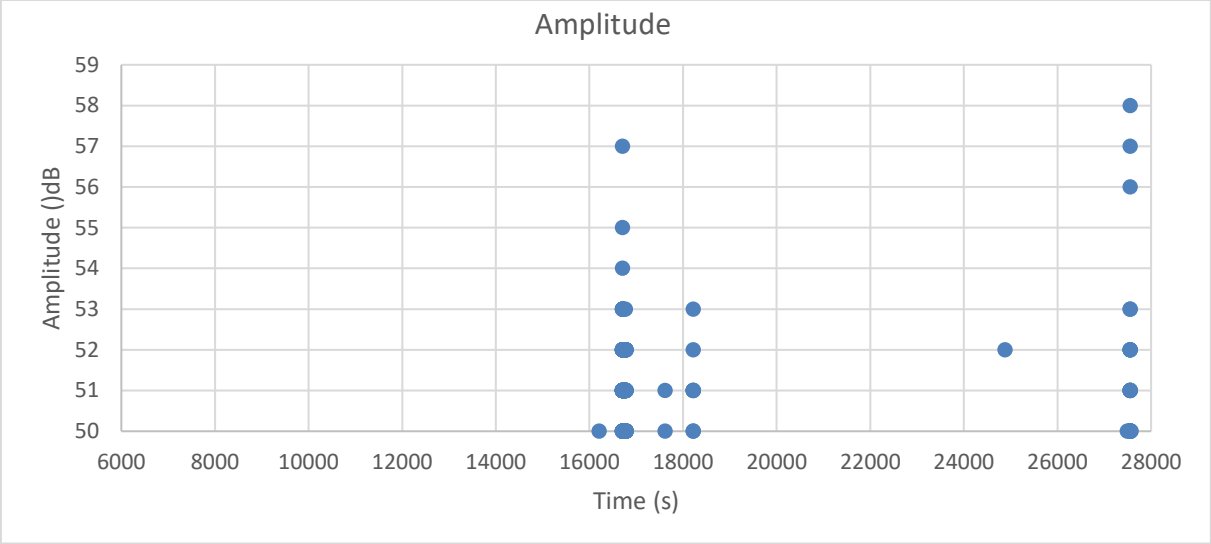
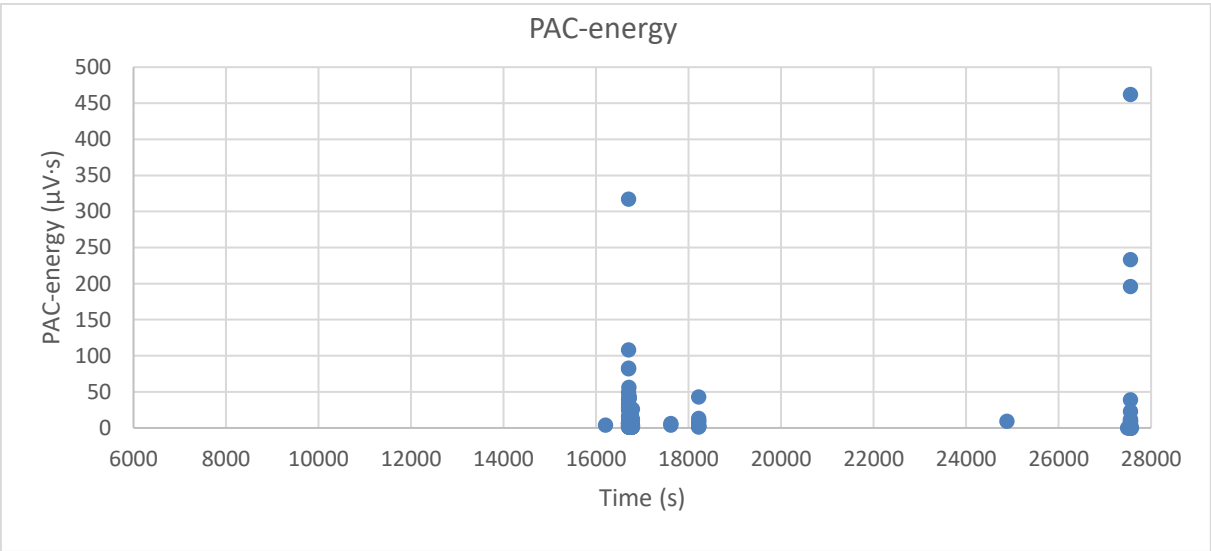
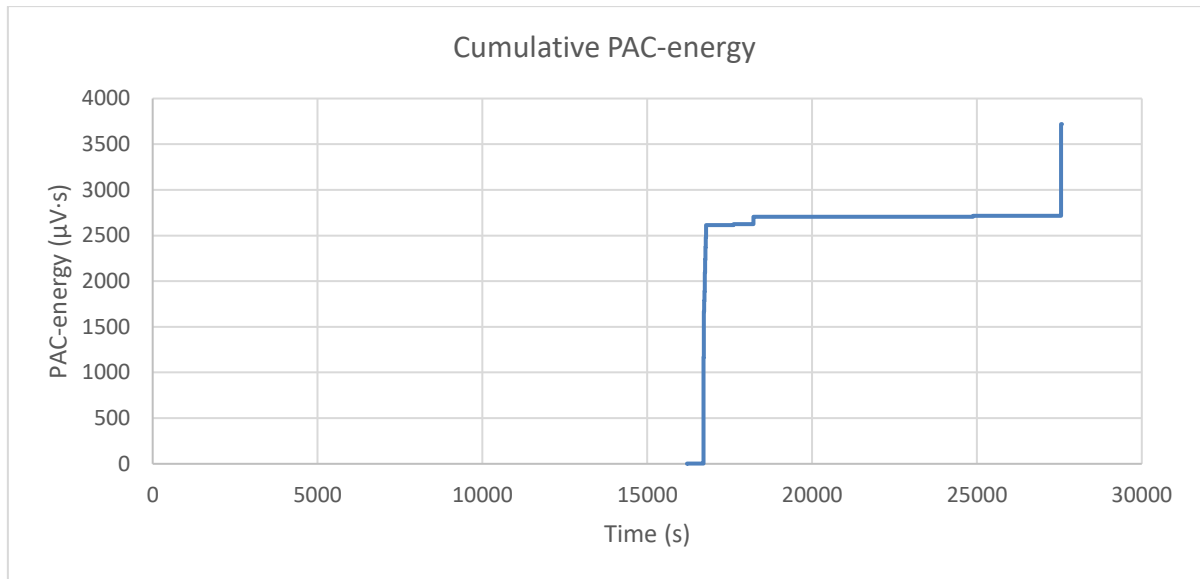
Two clusters of AE signals were detected (as shown in Figure 5.3-10), the first cluster occurred around 16,700 seconds of the test with a peak amplitude of 57 dB. The second cluster occurred at about 27,500 seconds with a peak amplitude of 58 dB. The PAC energy of the detected AE activity during this period is shown in Figure 5.3-11. The peak PAC-energy of the first cluster was 317 $\mu\text{V}\cdot\text{s}$, whilst for the second one it was 462 $\mu\text{V}\cdot\text{s}$. The cumulative PAC-energy (as shown in Figure 5.3-12) of this period is 3,720 $\mu\text{V}\cdot\text{s}$, it increased sharply when the two AE clusters occurred. The other AE signals only slightly changed the trend of

the cumulative PAC-energy. These AE cluster events may indicate severe damage of the wheel.

Figure 5.3-10 The AE hits detected from untreated EN40BT wheel in the 2nd period of Test 2

Figure 5.3-11 The PAC-energy of the AE hits detected from untreated EN40BT wheel in the 2nd period of Test 2

Figure 5.3-12 The cumulative PAC-energy of the AE hits detected from untreated EN40BT wheel in the 2nd period of Test 2

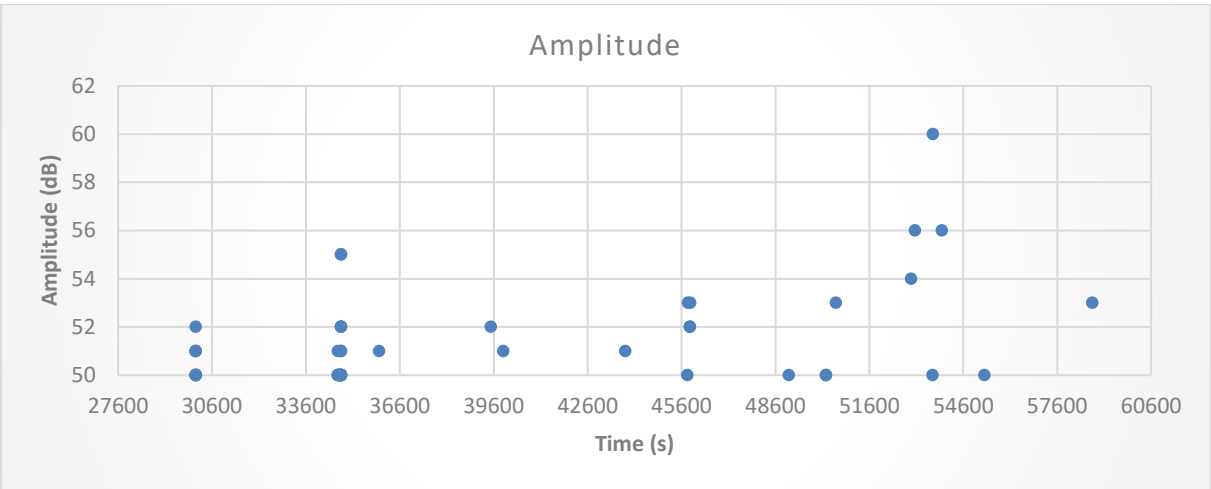
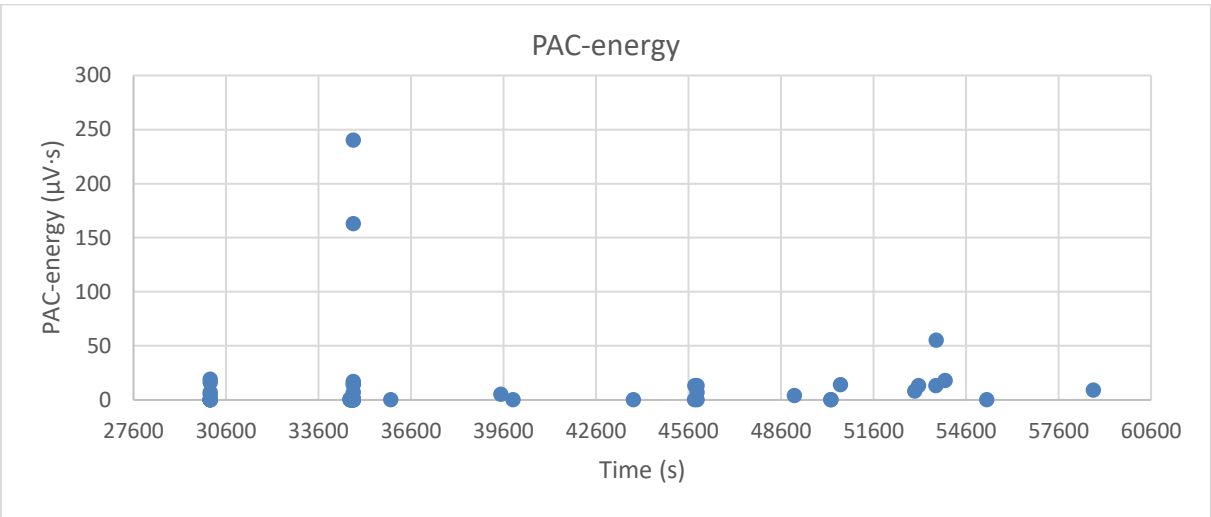
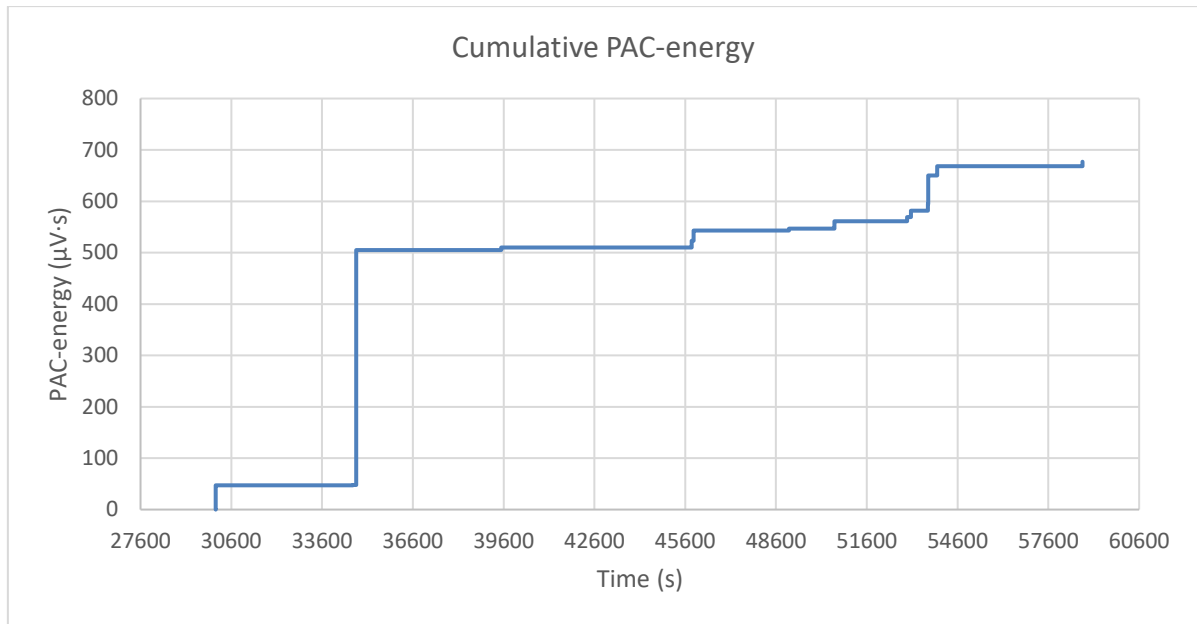
The amplitude and PAC-energy of the detected AE are shown in Figure 5.3-13 and Figure 5.3-14 respectively. These AE signals were in the form of clusters and some discrete signals. The maximum amplitude was 60 dB and the maximum PAC-energy was 240 $\mu\text{V}\cdot\text{s}$. The cumulative PAC-energy was 677 $\mu\text{V}\cdot\text{s}$ and the trend of cumulative PAC-energy during this period is shown in Figure 5.3-15. These AE cluster signals hints continuous rapid propagation of cracks during this period. The discrete signals may be related to the sudden initiation or discontinuous development of defects.

Figure 5.3-13 The AE hits detected from untreated EN40BT wheel in the 3rd period of Test 2

Figure 5.3-14 The PAC-energy of the AE hits detected from untreated EN40BT wheel in the 3rd period of Test 2

Figure 5.3-15 The cumulative PAC-energy of the AE hits detected from untreated EN40BT wheel in the 3rd period of Test 2

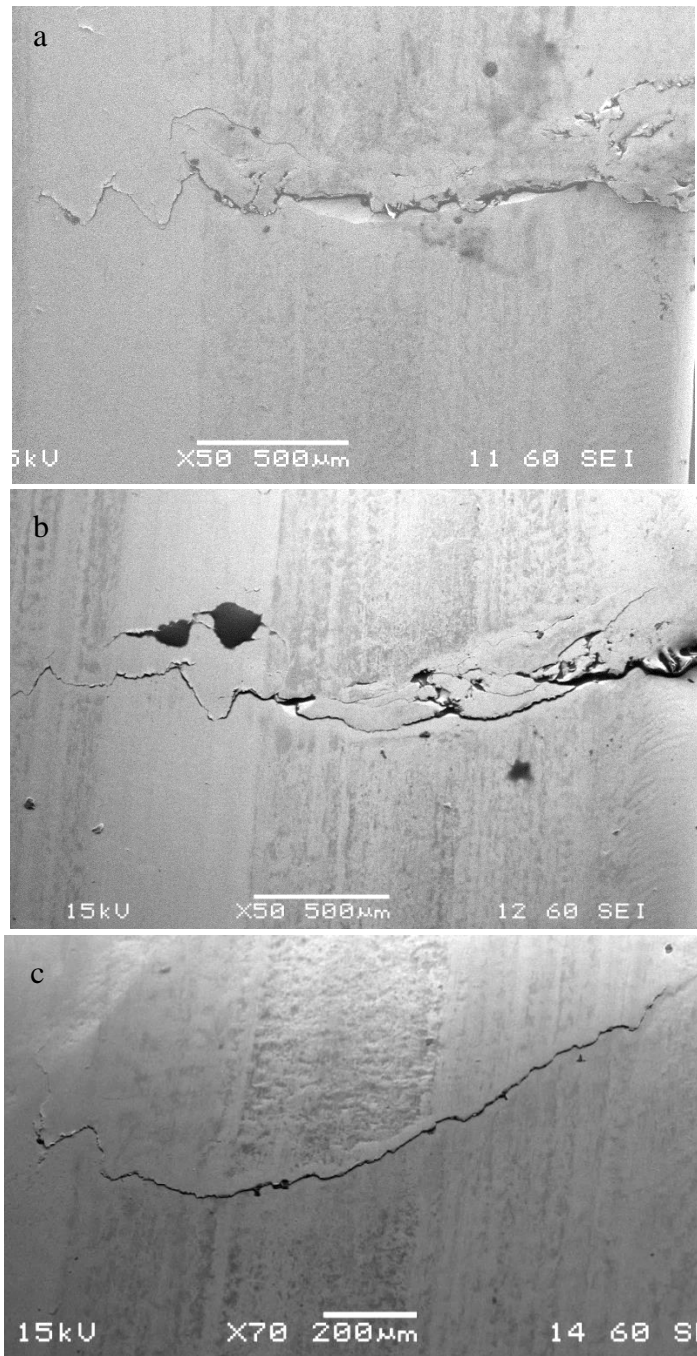
In agreement with the AE signals, 5 visible cracks were found in the steel wheel after naked eye examination. Under SEM examination, these cracks were measured to be approximately 2,500 μm long (as shown in Figure 5.3-16). The formation of these large cracks generated strong AE signals, but no significant change in the wheel profile, thus no change in the vibration spectrum arose during this period (as shown in Figure 5.3-17).

Figure 5.3-16 SEM images of big cracks in untreated EN40BT wheel surface after the 3rd period of Test 2

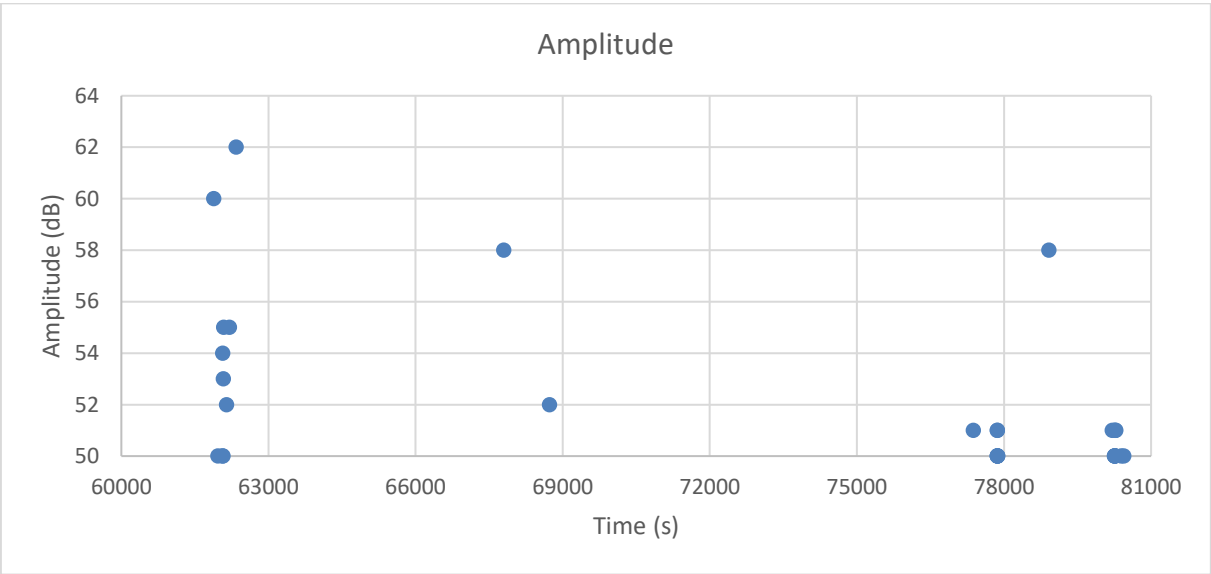
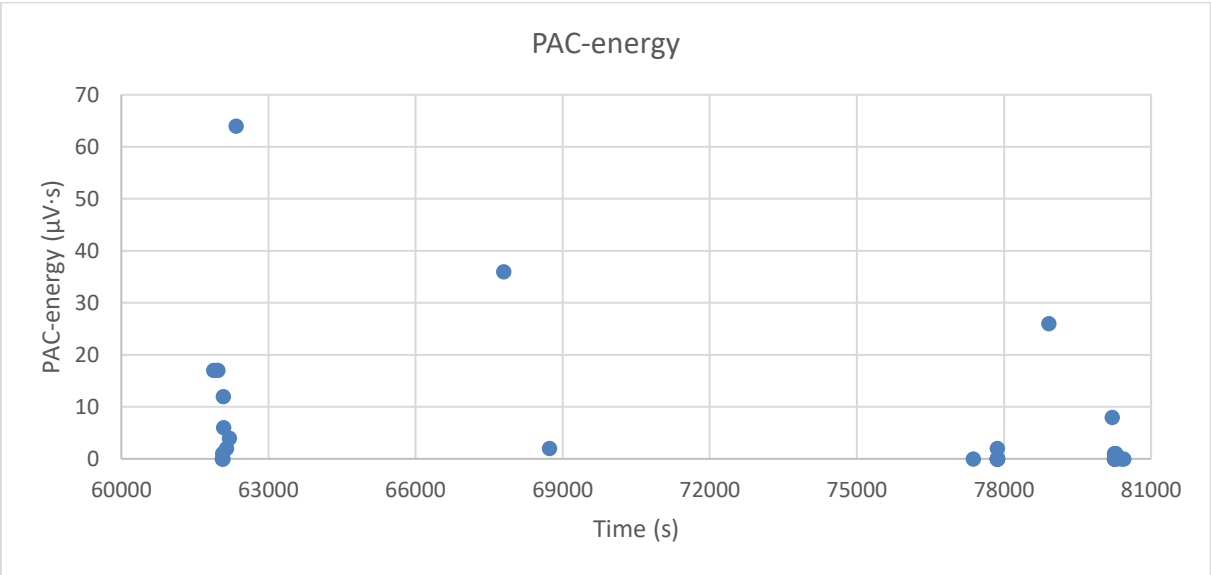
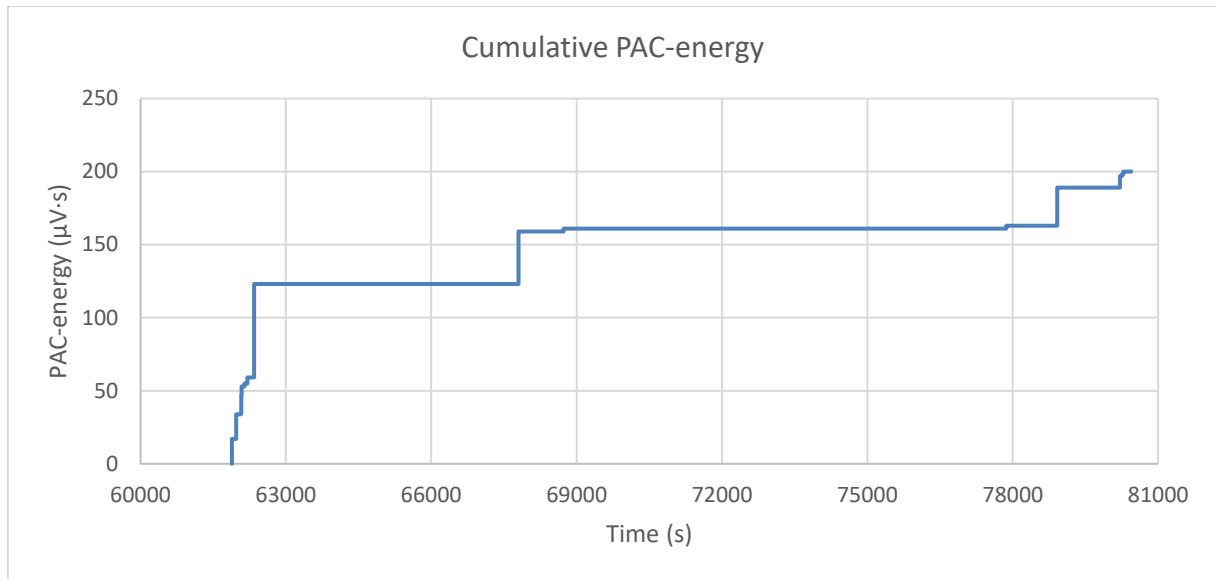
At the end of the first 1,800 seconds of this period, a cluster of 10 AE signals were collected. Then another 22 defect-related AE hits were detected at irregular intervals during the rest of this period. The amplitude and PAC-energy of detected AE signals are shown in Figure 5.3-18 and Figure 5.3-19 respectively. The maximum amplitude was 62 dB and the maximum

PAC-energy was 64 $\mu\text{V}\cdot\text{s}$. The cumulative PAC-energy was 200 $\mu\text{V}\cdot\text{s}$ and increased significantly at the first half of this test period (as shown in Figure 5.3-20).

Figure 5.3-18 The AE hits detected from untreated EN40BT wheel in the 4th period of Test 2

Figure 5.3-19 The PAC-energy of the AE hits detected from untreated EN40BT wheel in the 4th period of Test 2

Figure 5.3-20 The cumulative PAC-energy of the AE hits detected from untreated EN40BT wheel in the 4th period of Test 2

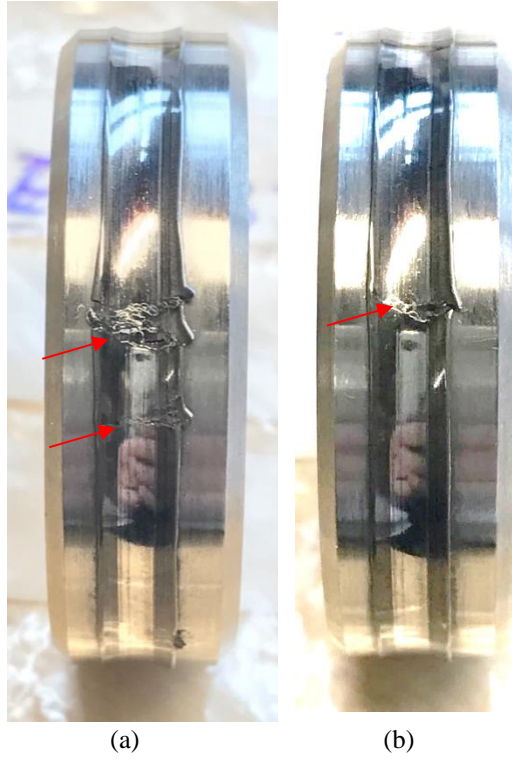
Three visible major cracks with craters formed in the tested steel wheel sample during this period (as shown in Figure 5.3-21 and Figure 5.3-22). The length of the cracks was measured to be up to 4,000 μm , whilst the dimensions of the biggest crater was found to be approximately 0.5mm \times 1.75mm. There was no damage in the WC wheel (as shown in Figure 5.3-23).

Figure 5.3-21 Photos of visible surface damage in untreated EN40BT wheel surface after the 4th period of Test 2

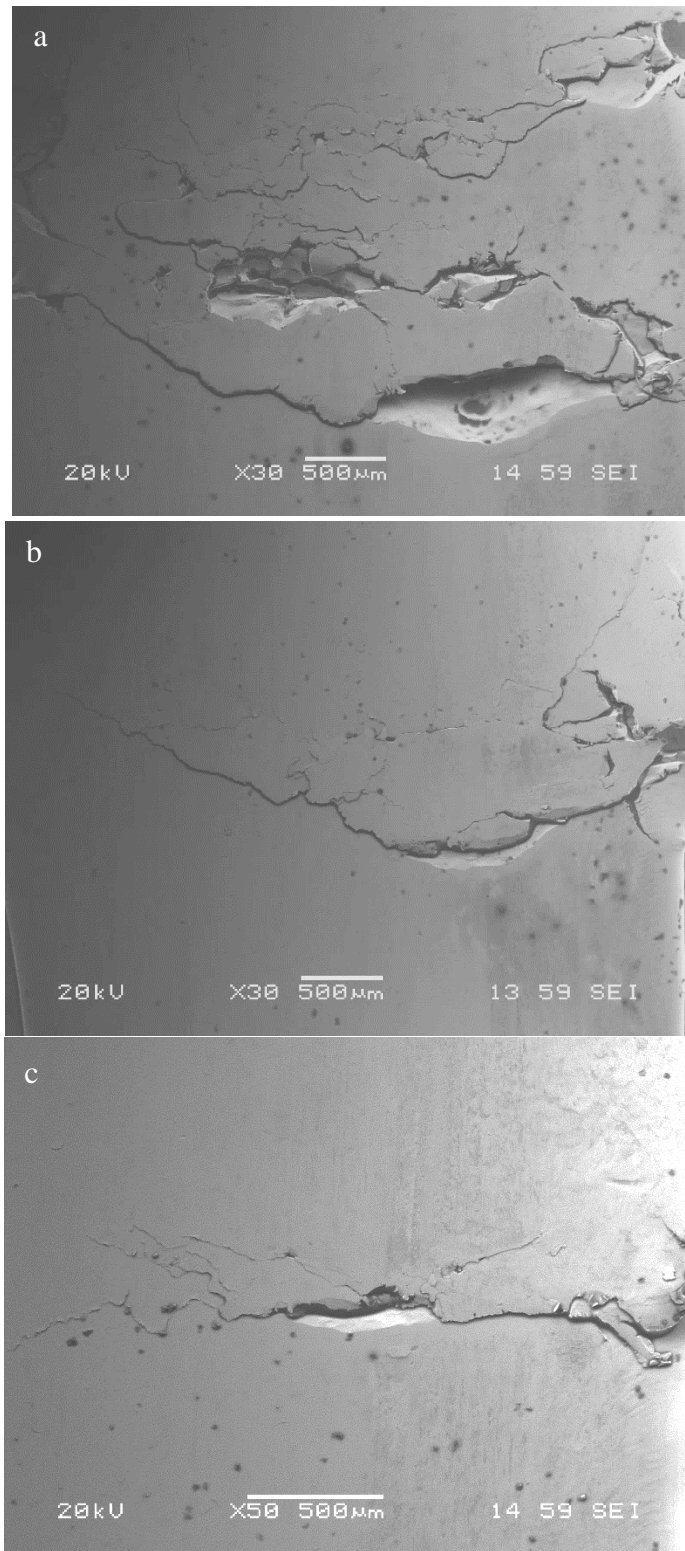
Figure 5.3-22 SEM images of long cracks and craters formed in untreated EN40BT wheel surface after the 4th period of Test 2

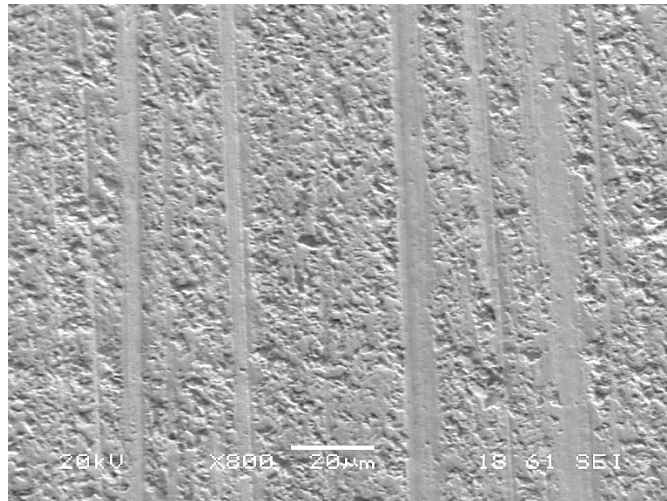
Figure 5.3-23 SEM image of the WC wheel contact surface after the 4th period of Test 2, indicating no severe damage formed in WC wheel surface.

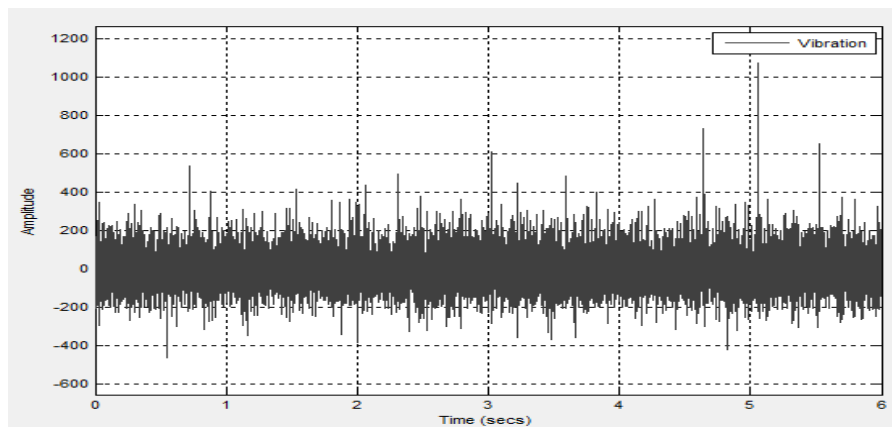
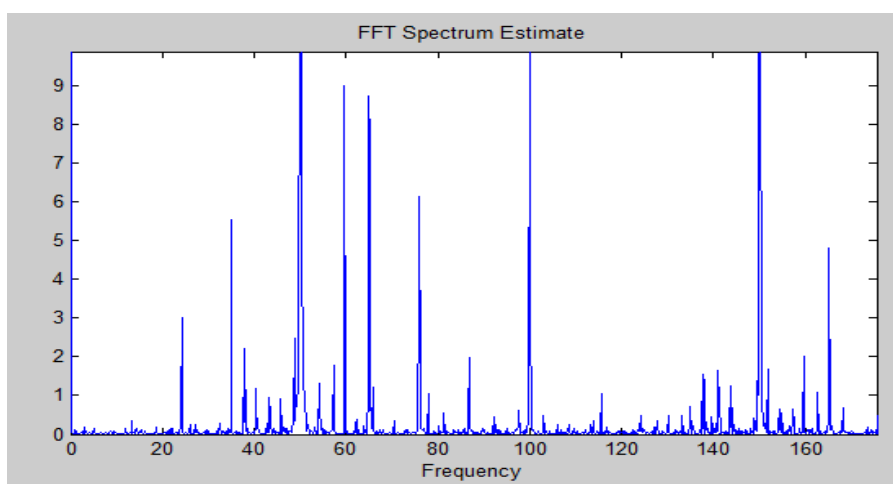
At the end of the test, the weight of the EN40BT wheel was measured at 63.0286 g. Hence, the weight loss was 0.1679 g, indicating an average wear rate of 7.5 mg/hour, which are quite small values. The average wear rate is similar to that for the untreated EN36 sample (7.6 mg/hour). Side-bands of about 3 Hz clearly occurred around the fundamental 50 Hz and its 3rd harmonic 150 Hz peaks in the vibration spectrum (as shown in Figure 5.3-24). This sample was deemed to have failed at this point.

Figure 5.3-24 (a) Raw vibration signal, and (b) the FFT spectrum, after the 4th period of Test 2

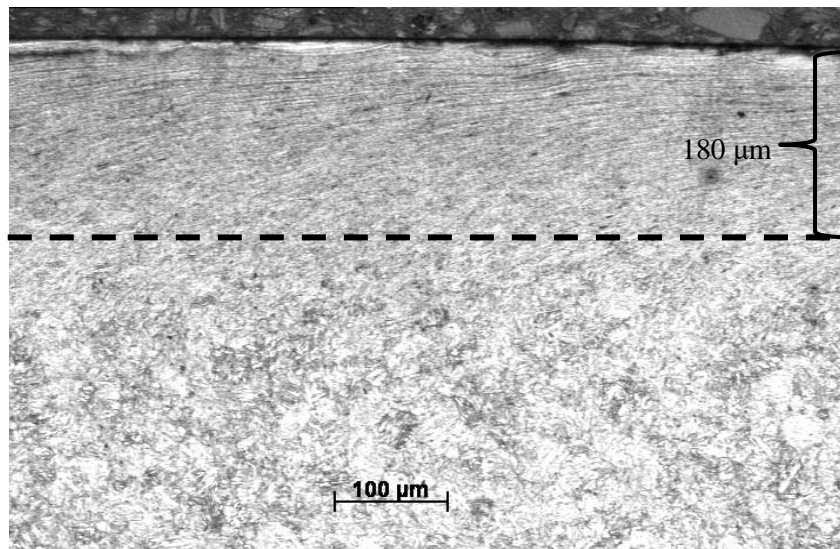
A plastically deformed area was observed at the top 180 μm using an optical microscope (as shown in Figure 5.3-25). The plastic flow can be identified from left to right, which indicates the friction direction. In addition to that, a subsurface crack more than 1,600 μm long was observed (as shown in Figure 5.3-26). It propagated along the boundary between the plastic deformed top area and the undeformed core area. The strong AE signals detected in the 2nd period were very probably generated from the rapid propagation of this long subsurface crack which was invisible from the surface.

Figure 5.3-25 Plastic deformation area formed during Test 2 in the top 180 μm of untreated EN40BT sample

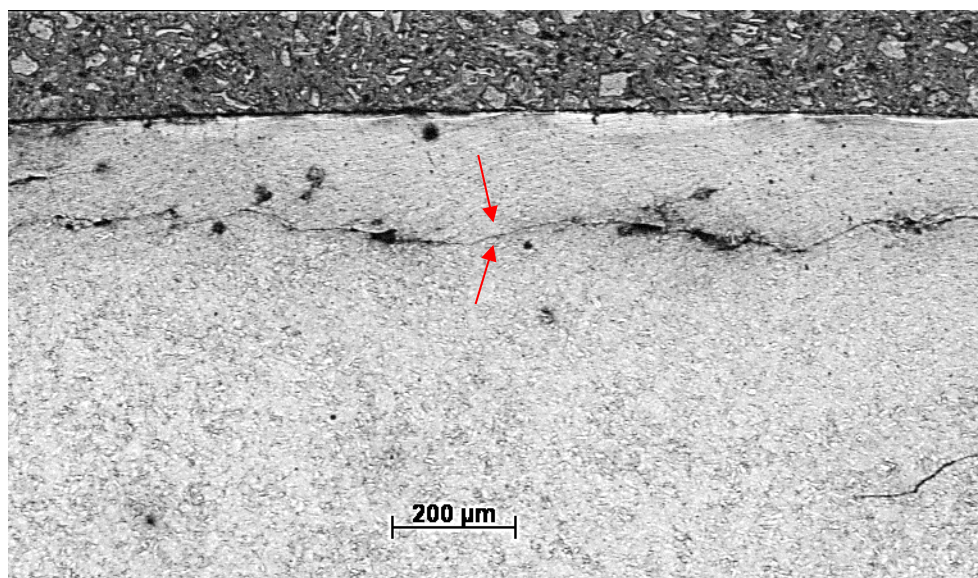
Figure 5.3-26 A long subsurface crack (longer than 1,600 μm) propagated along the boundary between the deformed area and the core area of untreated EN40BT of Test 2.

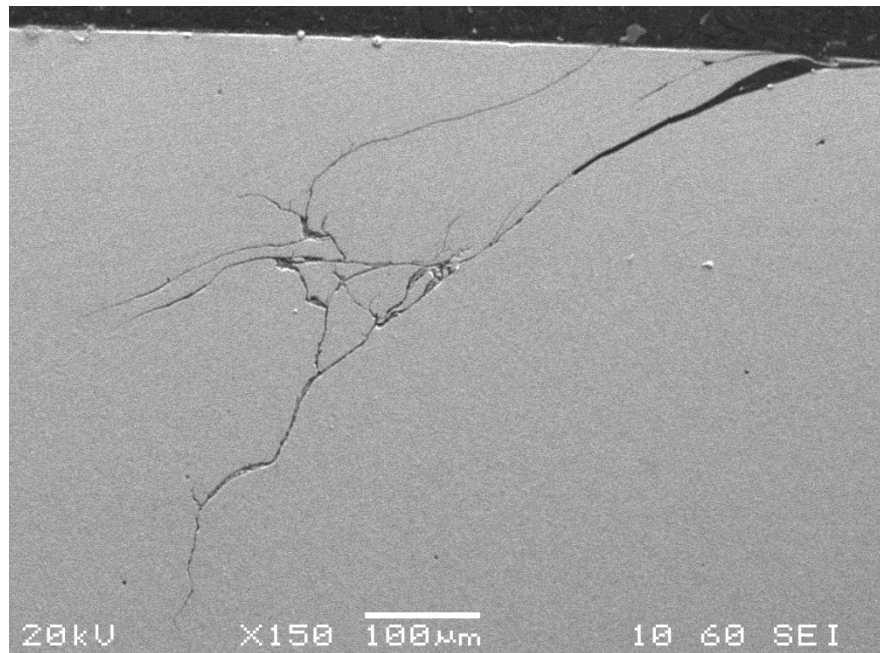
The SEM micrograph of a typical large rolling contact fatigue crack in the untreated EN40BT wheel is shown in Figure 5.3-27. The main crack is about 45° to the wheel surface. It is so long that one end has reached the wheel surface and the other reached the unaffected from plastic deformation core area. Its rapid propagation may have resulted in the generation of strong AE signals. However, this crack did not modify the wheel profile, thus would not change the vibration pattern.

Figure 5.3-27 SEM image of a typical big rolling-contact-fatigue crack in untreated EN40BT wheel of Test 2

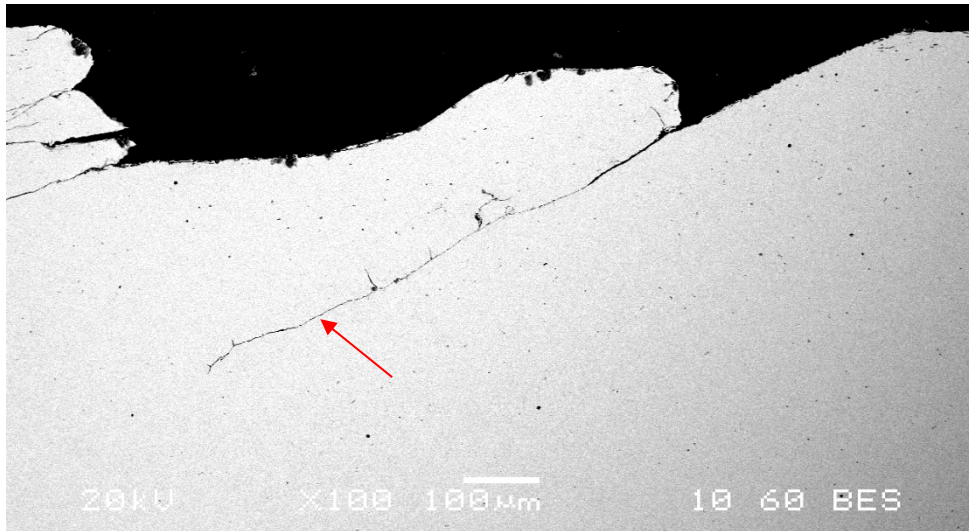
The cross-section of the large crater and the cracks producing it is clearly shown in Figure 5.3-28. The indicated long crack has already reached the deep undeformed core area, based on its distance from the surface. This large crater significantly modified the wheel profile and the contact condition of the wheel pair, causing impacts when the crater rotated to the contact point. Thus, the vibration spectrum significantly changed after the formation of the crater.

Figure 5.3-28 SEM image of the cross section of crater and the cracks formed during Test 2 which may make the crater bigger. The arrowed long crack has reached the undeformed core area.

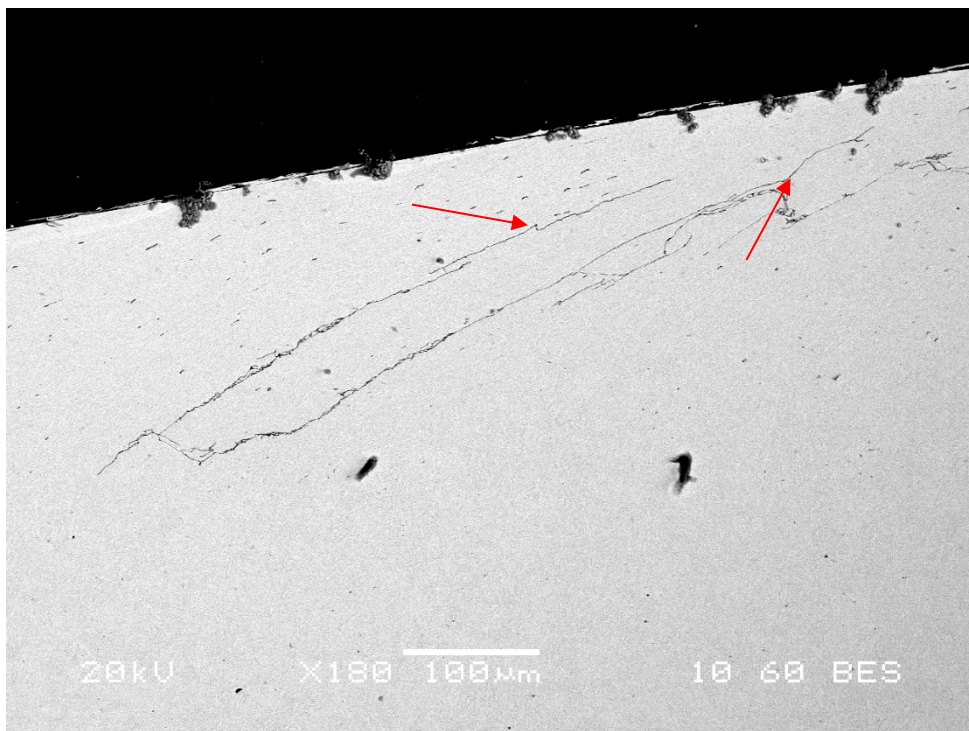
Several subsurface initiating long cracks and their branches (between 100 and 500 μm long) growing towards the wheel surface were also observed (as shown in Figure 5.3-29 and Figure 5.3-30). Although they were invisible from the wheel surface they may have generated detectable AE signals during the test. They would have broken to the surface if the test continued further. Some surface micro-cracks around 50 μm long were also observed (as shown in Figure 5.3-31). Some of the discrete AE signals may have also been generated from them, possibly resulting in the formation of micro-pits in the future.

Figure 5.3-29 SEM image of two subsurface initiated long cracks growing towards the surface as arrowed (Test 2)

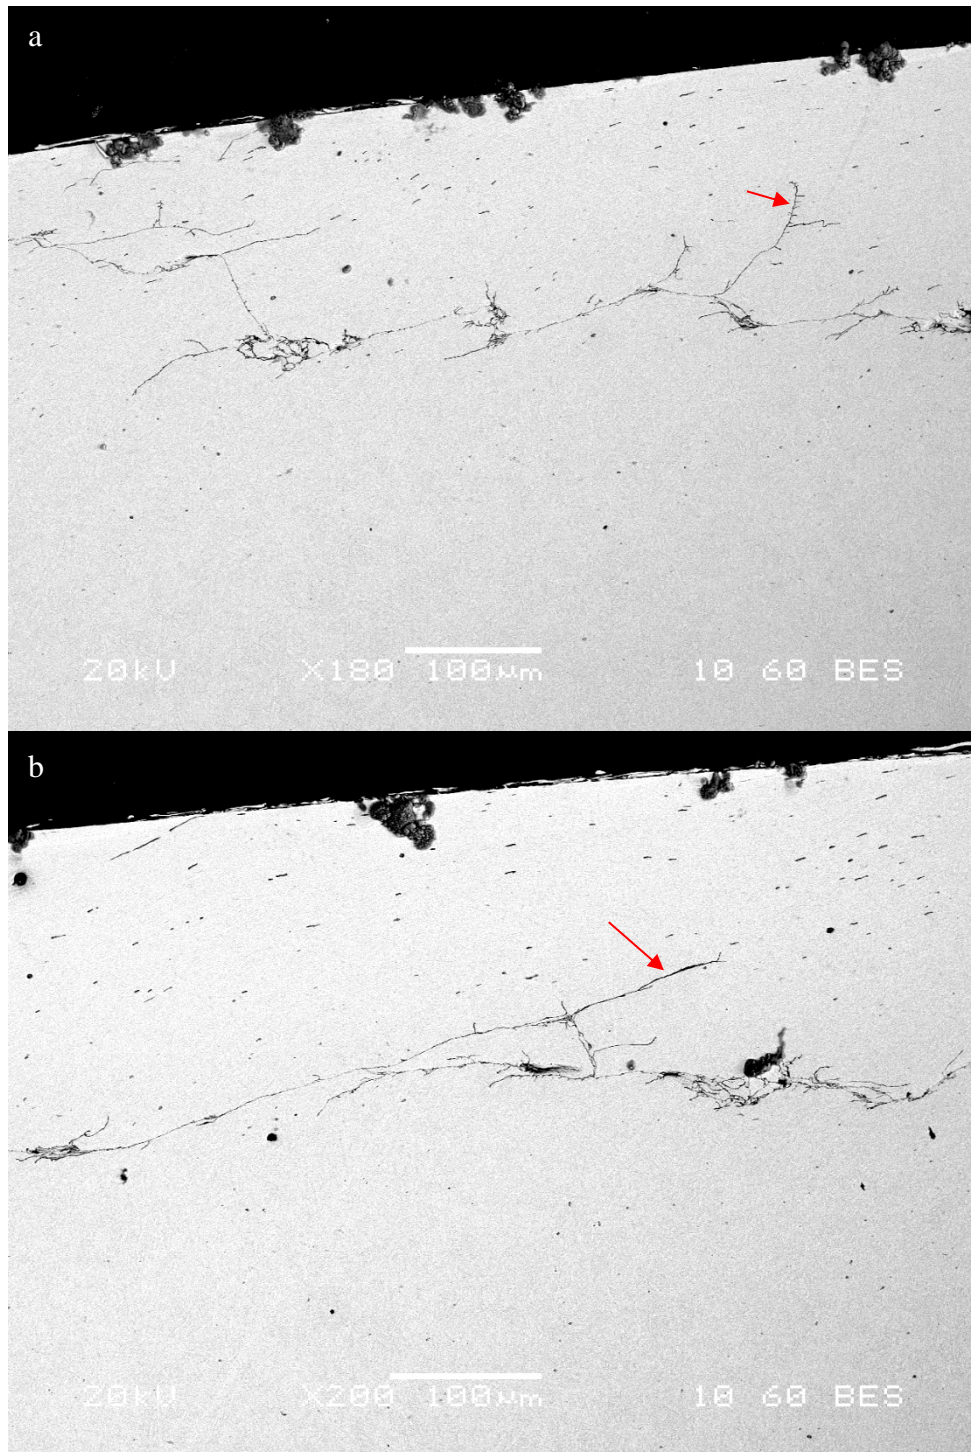
Figure 5.3-30 SEM images of subsurface initiated cracks mainly propagated parallel to surface, while the arrowed crack branches propagated towards the surface in Test 2

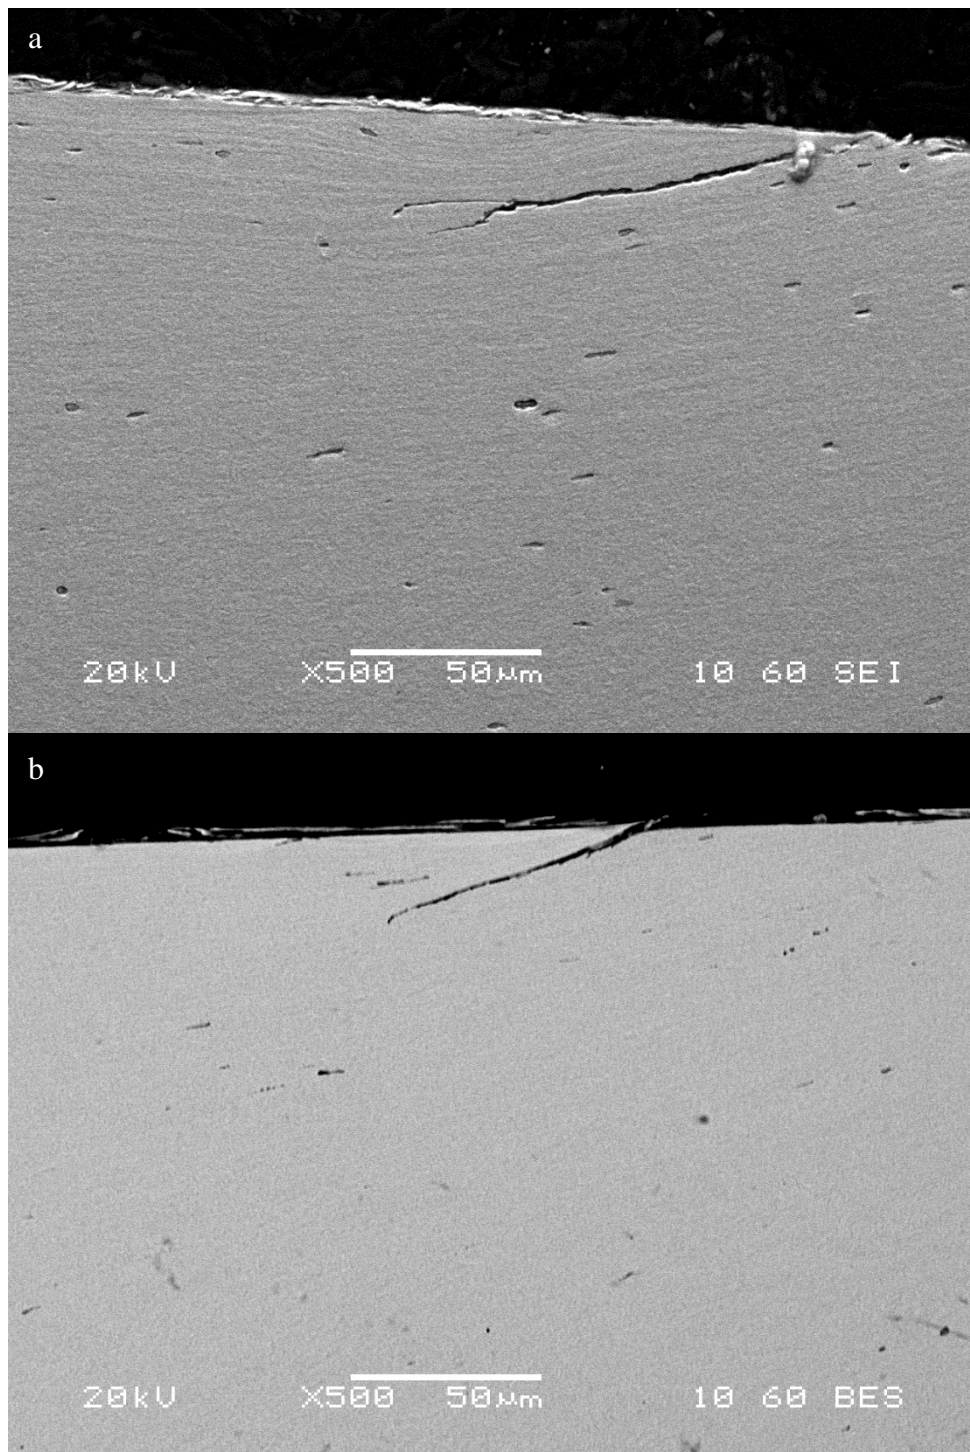
Figure 5.3-31 SEM images of surface minor cracks in untreated EN40BT wheel of Test 2

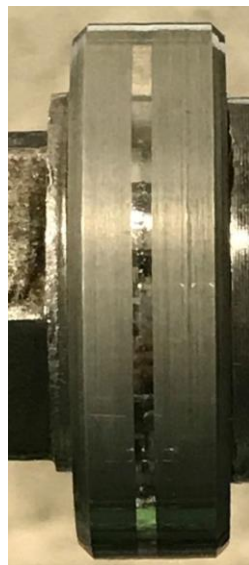
At the end of this period, a shallow and shiny concave surface was observed in the carburised EN36 wheel (as shown in Figure 5.4-1). The weight loss was negligible. The relatively shallow concave surface is due to the hardened surface which has higher resistance to plastic deformation, comparing to the untreated wheels. The surface is shiny after this period due to the polishing effect. No AE hit beyond threshold was detected, and the FFT spectrum of vibration signal did not show any significant change from the beginning to the end of 1st period either.

Figure 5.4-1 A shallow and shiny concave surface formed in the carburised EN36 wheel due to plastic deformation and polishing effect during the 1st period of Test 3

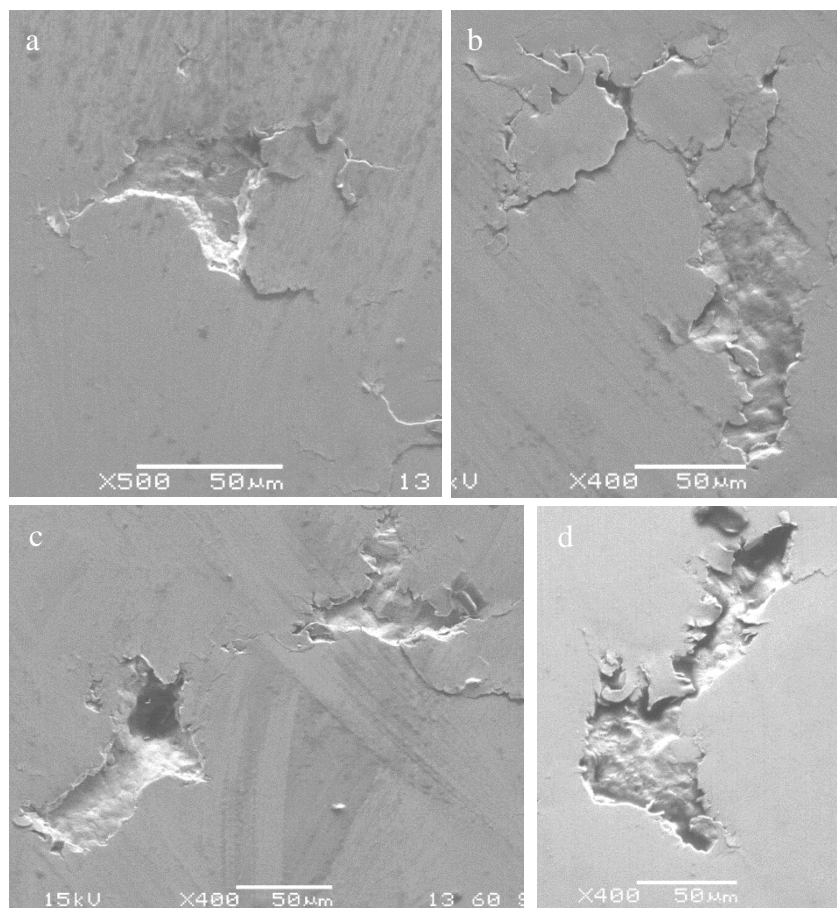
At the end of this period, only micro-pits with diameter between 50 and 100 μm (as shown in Figure 5.4-5) were observed in the carburised steel wheel using SEM. No damage was observed in the WC wheel (as shown in Figure 5.4-6). The formation of these micro-pits may be the source of the detected discrete AE signals. The formation of these micro-pits did not change the vibration pattern of wear tester (as shown in Figure 5.4-7).

Figure 5.4-5 SEM images of the contact surface of carburised wheel after the 2nd period of Test 3, micro-pits can be observed

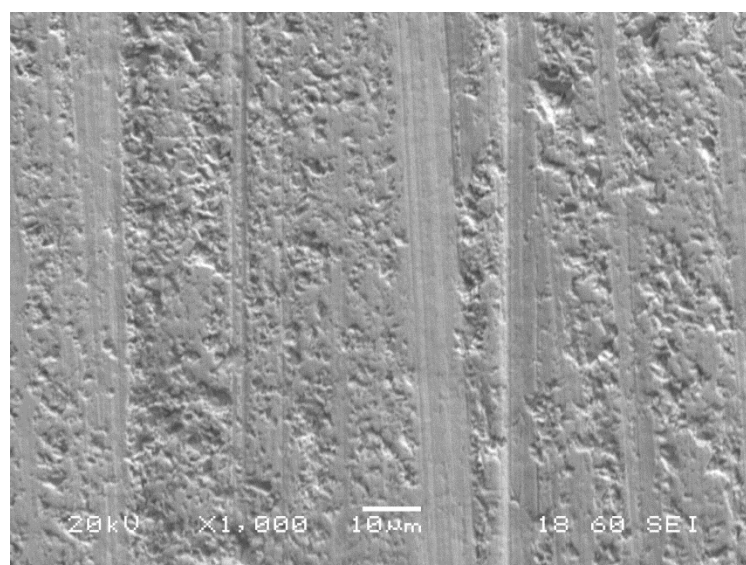
Figure 5.4-6 SEM image of WC wheel surface at the end of Test 3

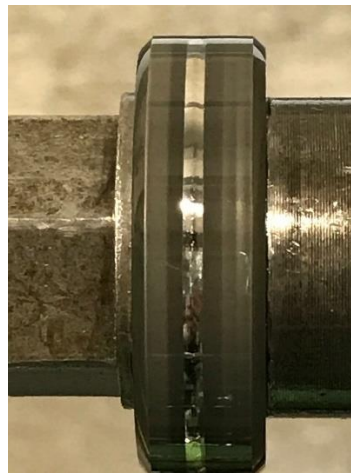
At the end of this period, a shallow and shiny concave surface was observed in the plasma nitrided EN40BT wheel (as shown in Figure 5.5-1). The weight loss was negligible. The relatively shallow concave surface is due to the hardened surface which has higher resistance to plastic deformation, comparing with the untreated wheels as for the sample discussed earlier. No AE hits beyond the threshold were detected. Moreover, the FFT spectrum of vibration did not change from the beginning to the end of the 1st period either.

Figure 5.5-1 A shallow and shiny concave surface formed in the direct-current plasma nitrided EN40BT wheel during the 1st period of Test 4

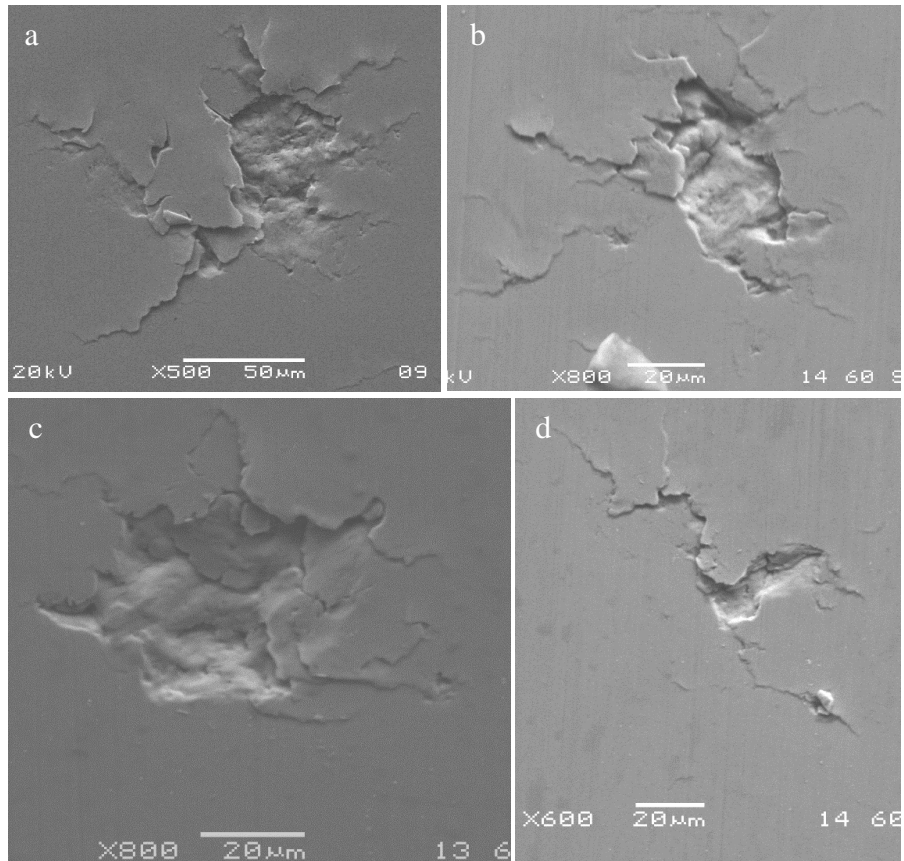
At the end of this period, only micro-pits with diameter between 30 and 50 μm (as shown in Figure 5.5-5) were observed in the DCPN steel wheel using SEM. No damage was observed in the WC wheel (as shown in Figure 5.5-6). The formation of these micro-pits may be the

source of the detected discrete AE signals. The formation of these micro-pits did not change the vibration pattern of wear tester (as shown in Figure 5.5-7).

Figure 5.5-5 SEM images of the contact surface of DCPN sample after the 2nd period of Test 4, micro-pits can be observed

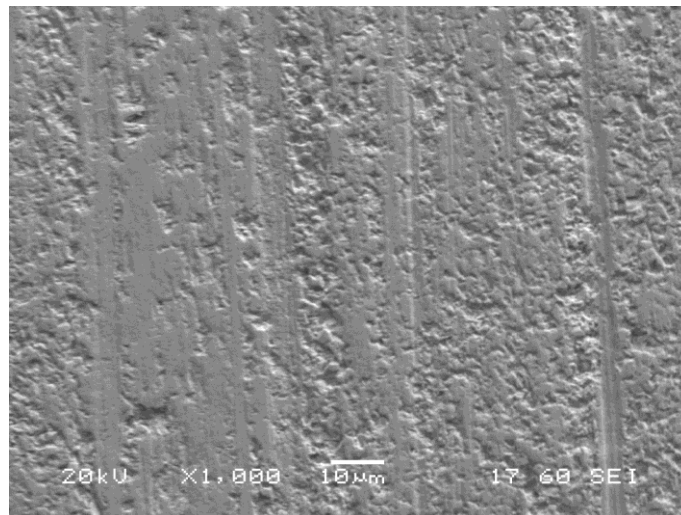
Figure 5.5-6 SEM image of WC wheel surface at the end of Test 4

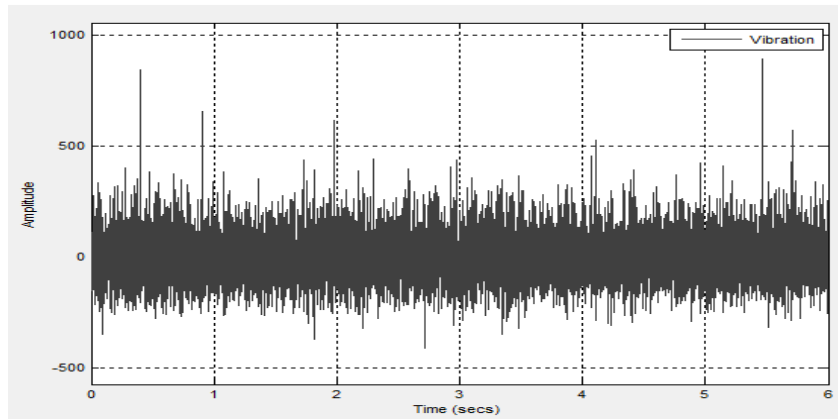
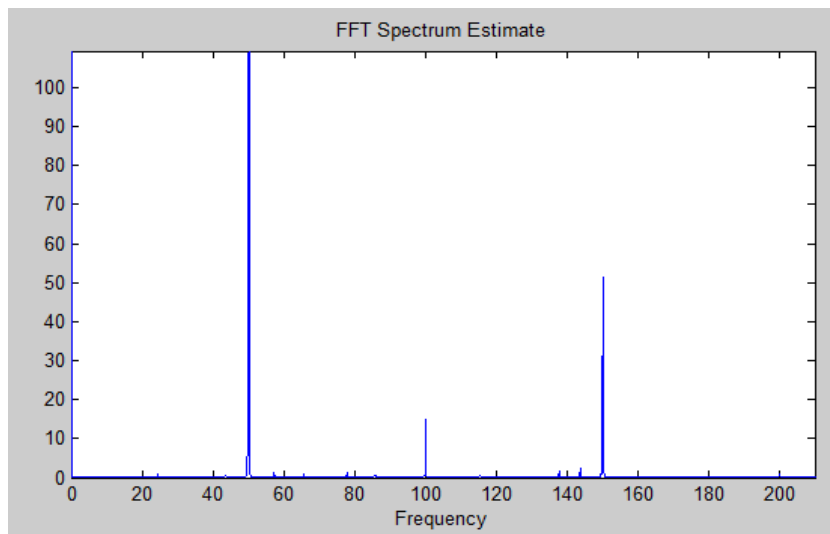
Figure 5.5-7 (a) Raw vibration signal, and (b) vibration spectrum, at the end of the 2nd period of Test 4
